National Register of Historic Places
Registration Form

historic name Camp (2) Greentop Historic District

Name of related multiple property listing:
ECW Architecture at
Catoctin Mountain Park

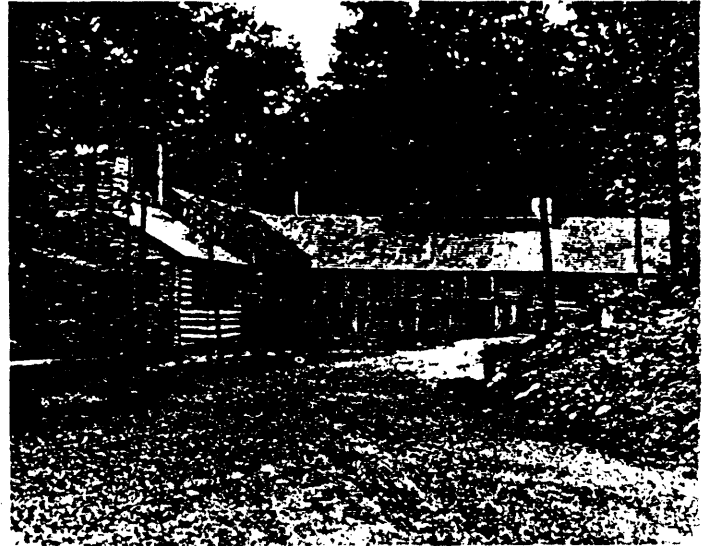
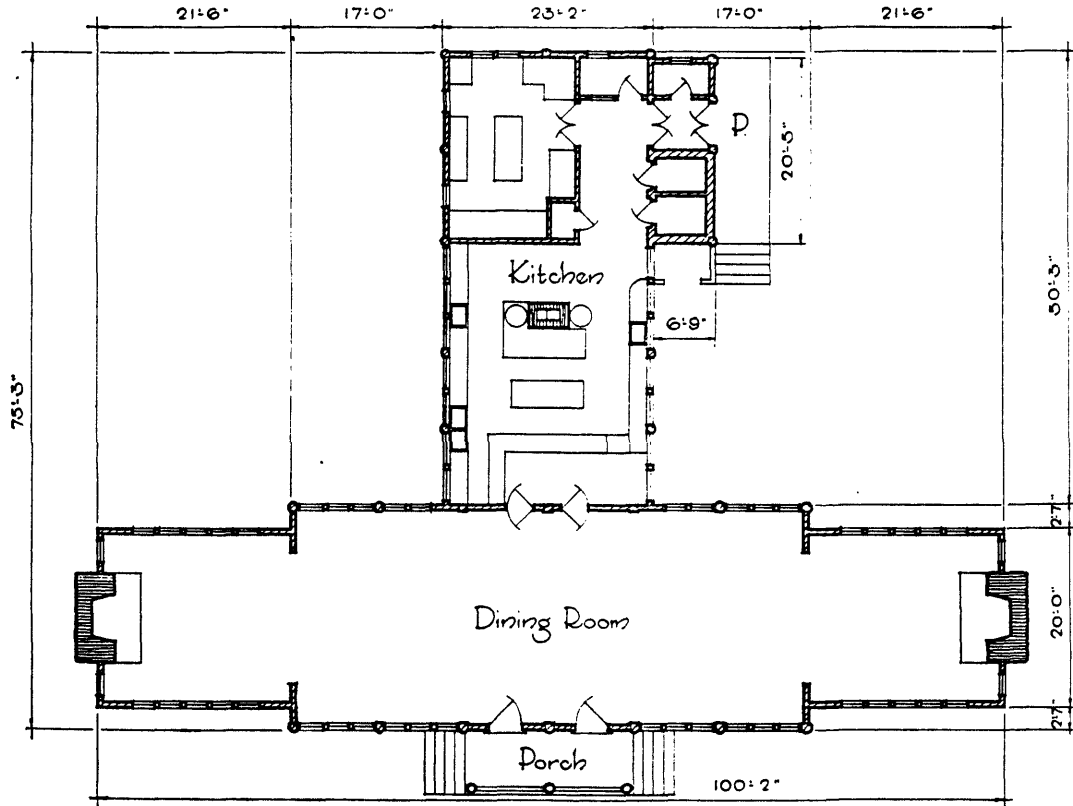
ILLUSTRATION 1

Dining Hall (Good, p. 62-63)

The illustration does not do full justice to this building, which harmoniously combines masonry, logs and slabs in a structure of great interest. The wings which flank the center room to result in a kind of combined dining lodge and recreation building are an unusual plan feature. Ordinarily recreational alcoves, these expand the dining capacity if occasion warrants. If closed off from the main building by doors, two unit lodges for winter use would be created.

Catoctin Recreational Demonstration Area, Maryland

Catoctin Area - Maryland

*Camp Dining Lodges
Scale 1/8" = 1'-0"*

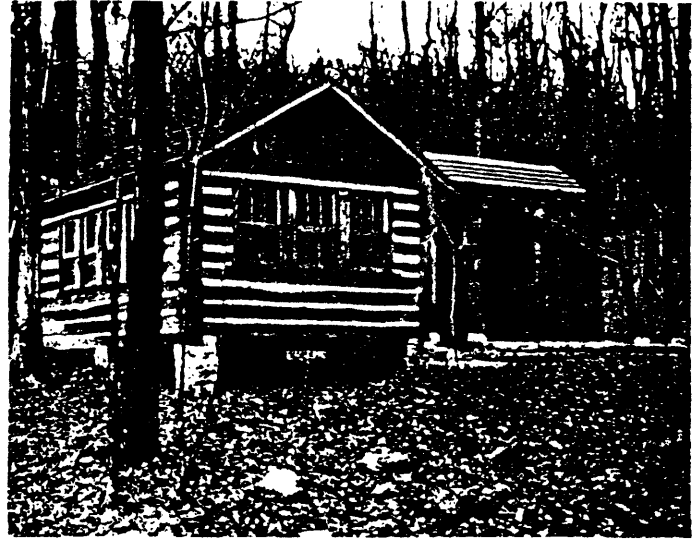
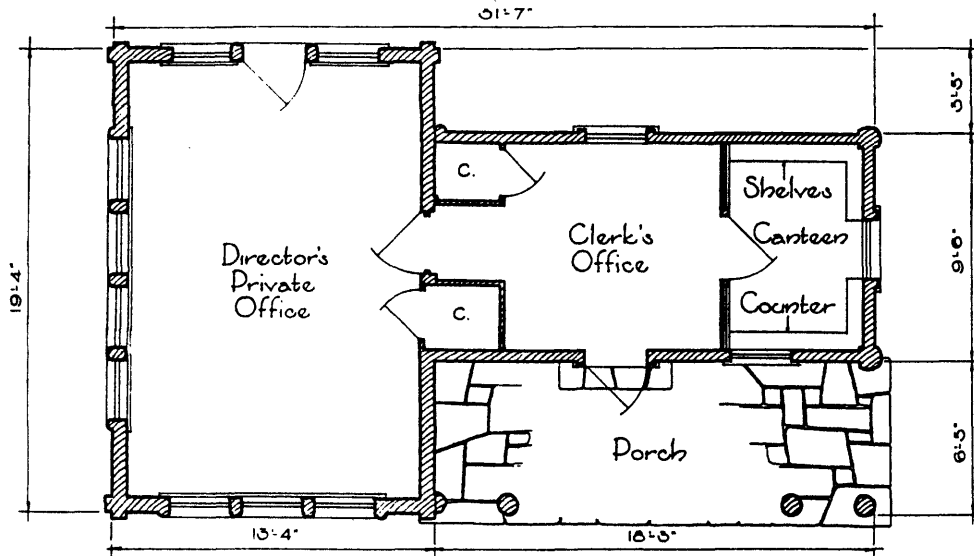
Administration/office (Good, p. 24-26)

In plan, this building and the one directly below follow closely the typical arrangement represented by the administration buildings on the preceding page. For a minimum staffing it is almost the rule to incorporate the trading post in the administration building. Inasmuch as the store is open only for a limited time each day, tending it can be a secondary duty of the camp clerk.

Catoctin Recreational Demonstration Area, Maryland

Catoctin Area - Maryland

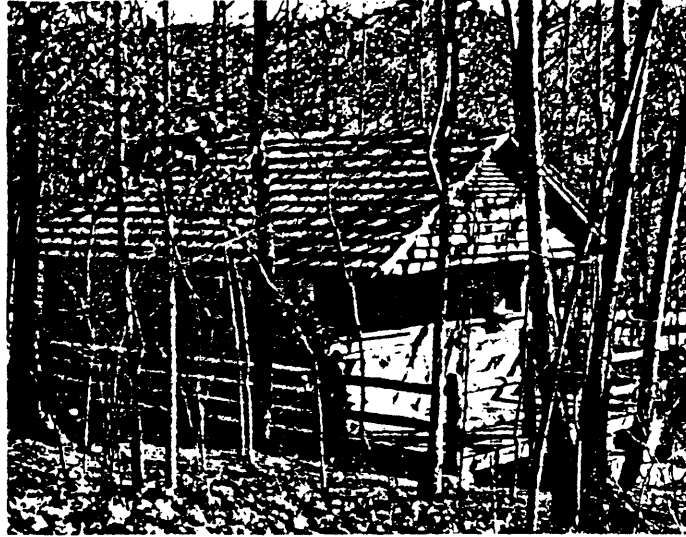
Cabin (Good, p. 75)

Catoctin Recreational Demonstration Area, Maryland

CAMPERS' CABINS IN THE NORTHEAST

Grouping these cabins together is entirely on the basis of geography. They exhibit no special features unknown in other parts of the country. Two have entrances and porches at the end; three are entered on the long side and so have longer side porches. Noteworthy in the group is the Catoctin cabin, outstanding for its simple excellence and true craftsmanship. If built-in benches are not a part of the cabin porches, the steps should be wide enough to offer a place for the occupants to sit out-of-doors.

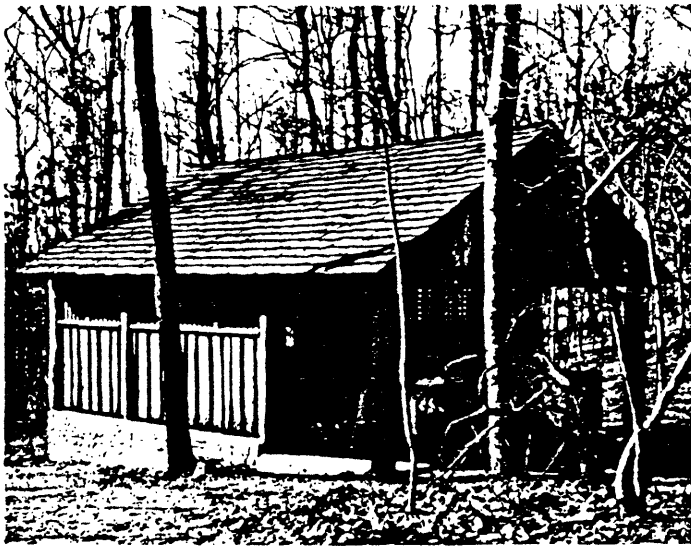
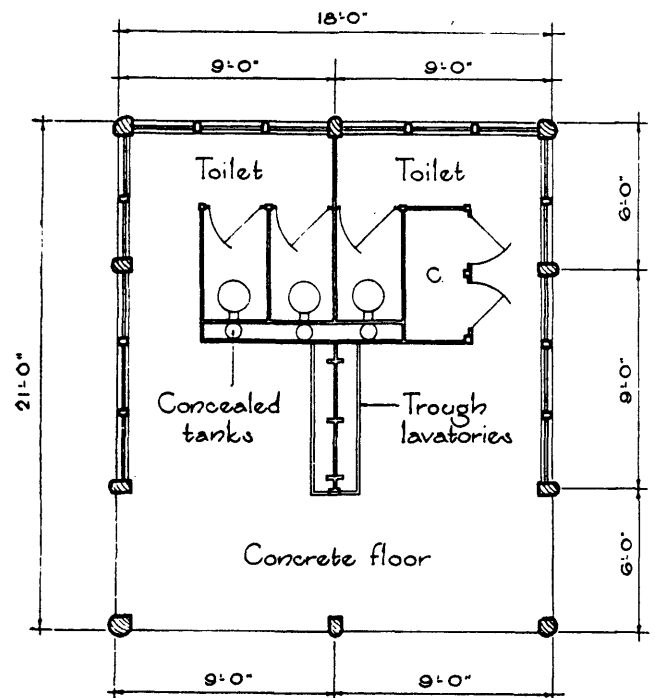
Latrine (Good, p. 32-33)

UNIT LATRINES

Here are unit latrines somewhat more spacious than the examples on the preceding page. Plans are shown opposite. The wash porches of those at Swift Creek and Hard Labor Creek Recreational Demonstration Areas are each provided with a two-part laundry tray, an equipment item usually found only in the centrally located shower house and laundry building of organized camps. Probably

these are made use of, yet it must be in a limited way, for the unit latrine is not supplied with hot water. The unit latrine at Montserrat also departs from the typical in its provision of showers. Even though these are cold showers only, there is unnecessary duplication of fixtures that are best held to one central location. The merit of a hard-surfaced floor for the wash porch is again mentioned.

Catoctin Recreational Demonstration Area, Maryland

Catoctin Area - Maryland

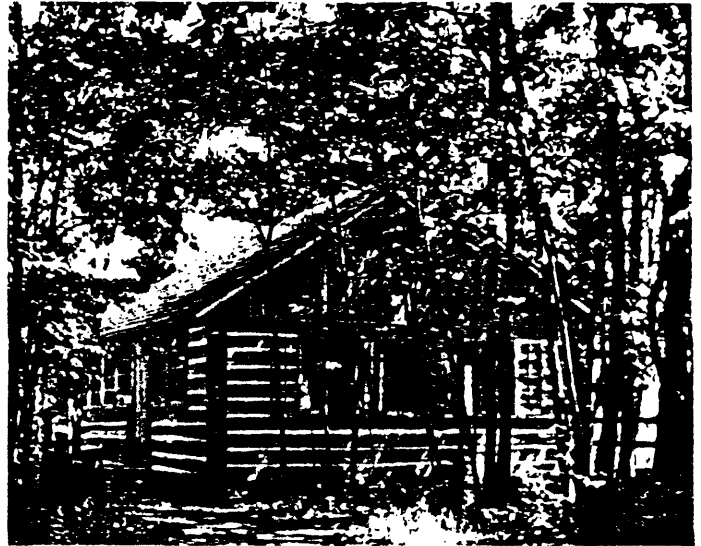
Lodge (Good, p. 40-41)

The appeal to the eye made by this squared log structure, shown in plan at upper right opposite, is unsurpassed by that of any unit lodge that has been pictured. It is not often economically logical to employ such expertly fashioned log construction in a building program having social objectives primarily. This is a great pity in view of the romance that a revival of pioneer methods can conjure up for youth. The plan is good, although ambitious beyond absolute essentials in the added porch. Louvres in the gable end are an aid in ventilation.

Unit Lodge, Catoclin Recreational Demonstration Area, Maryland

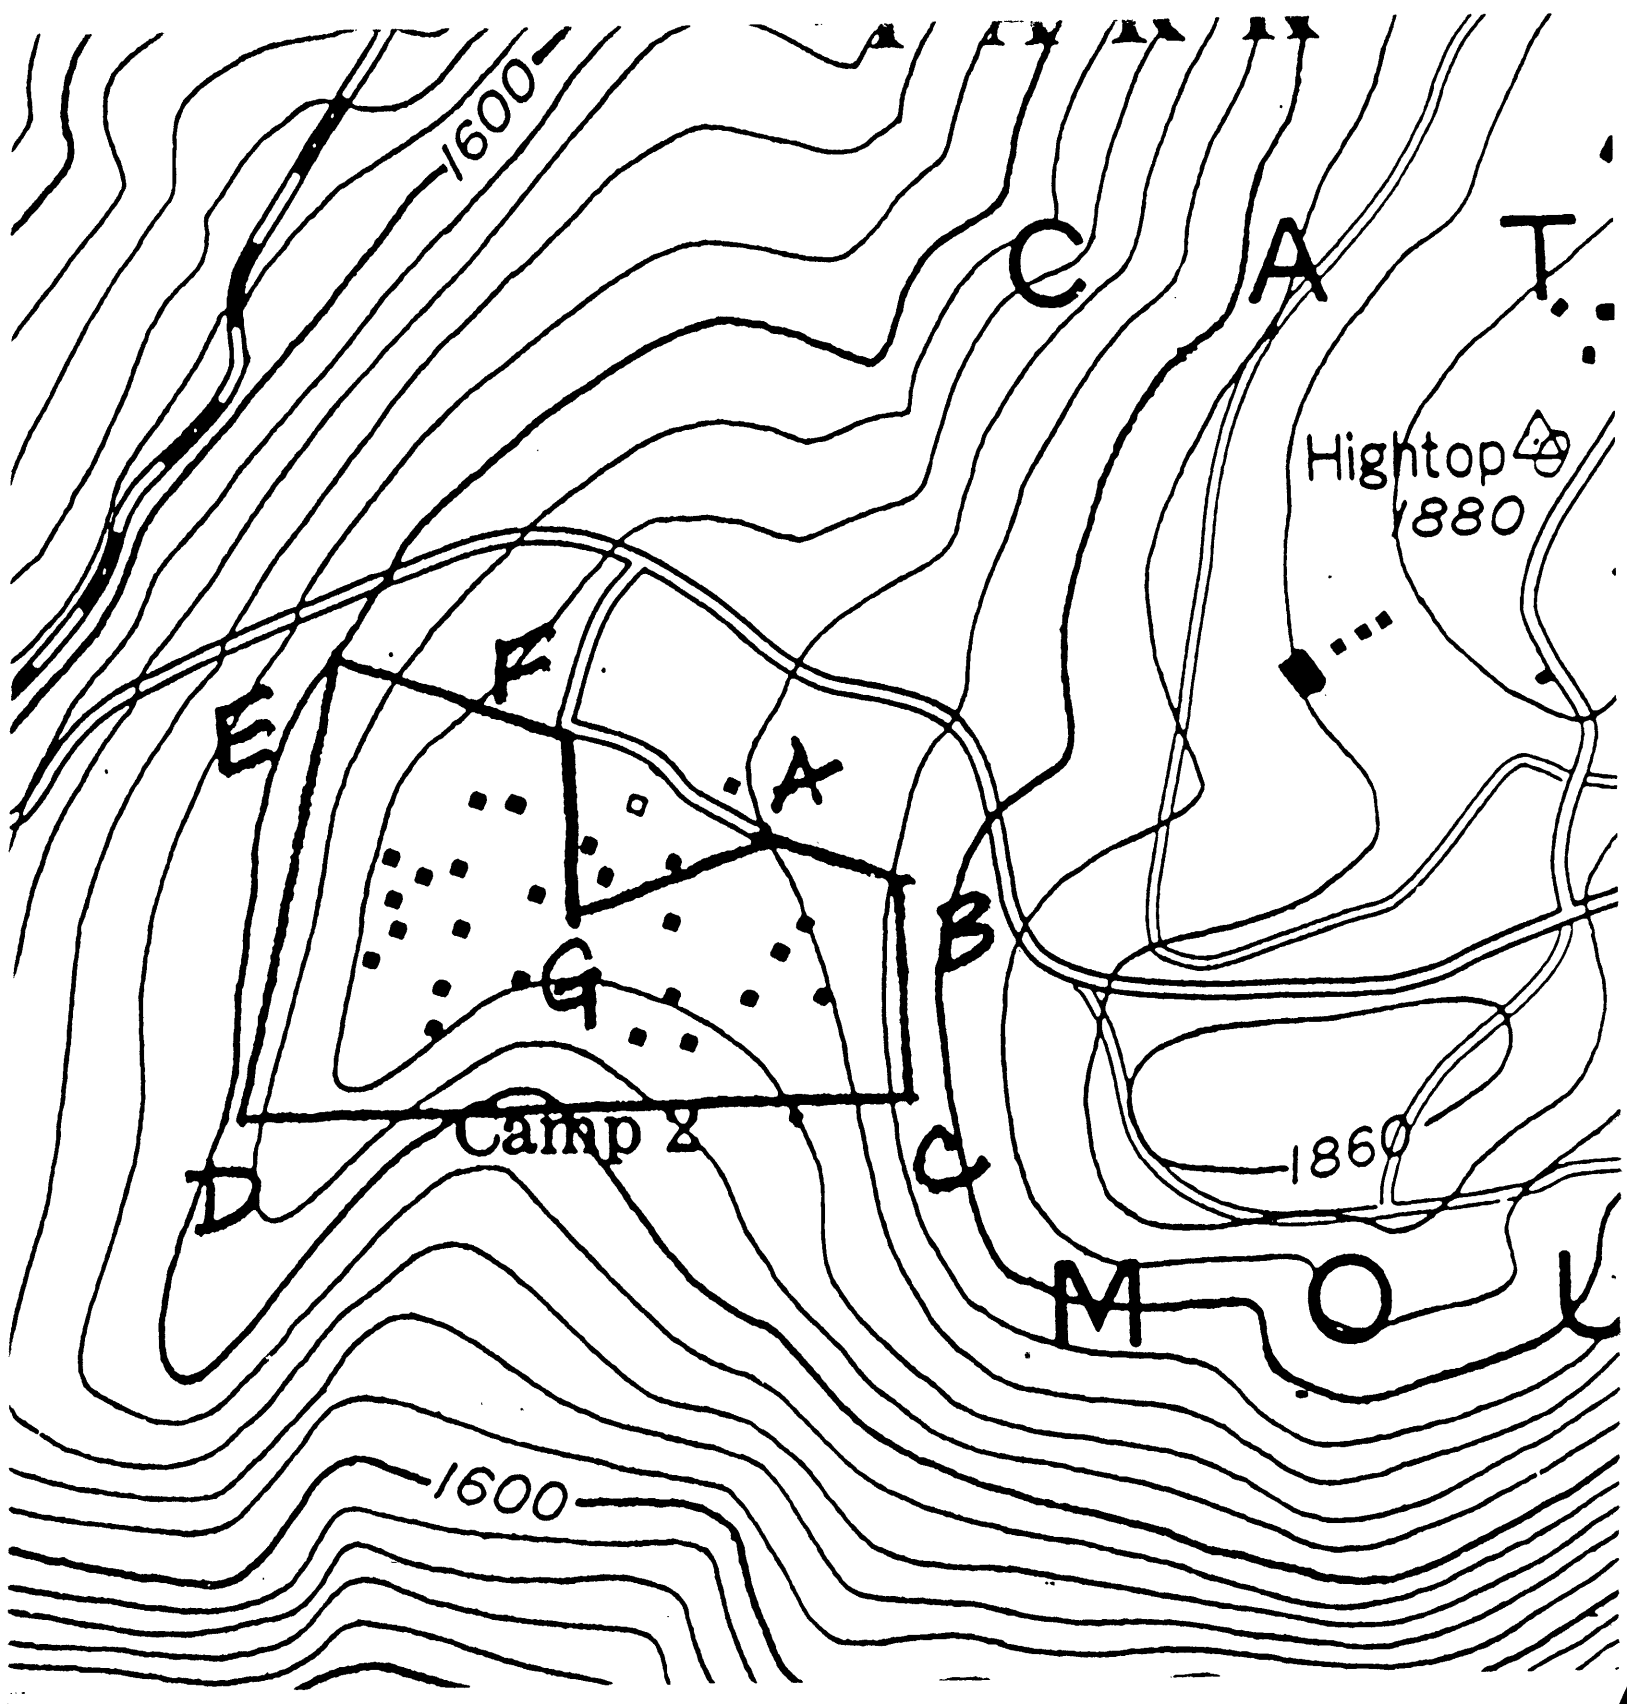
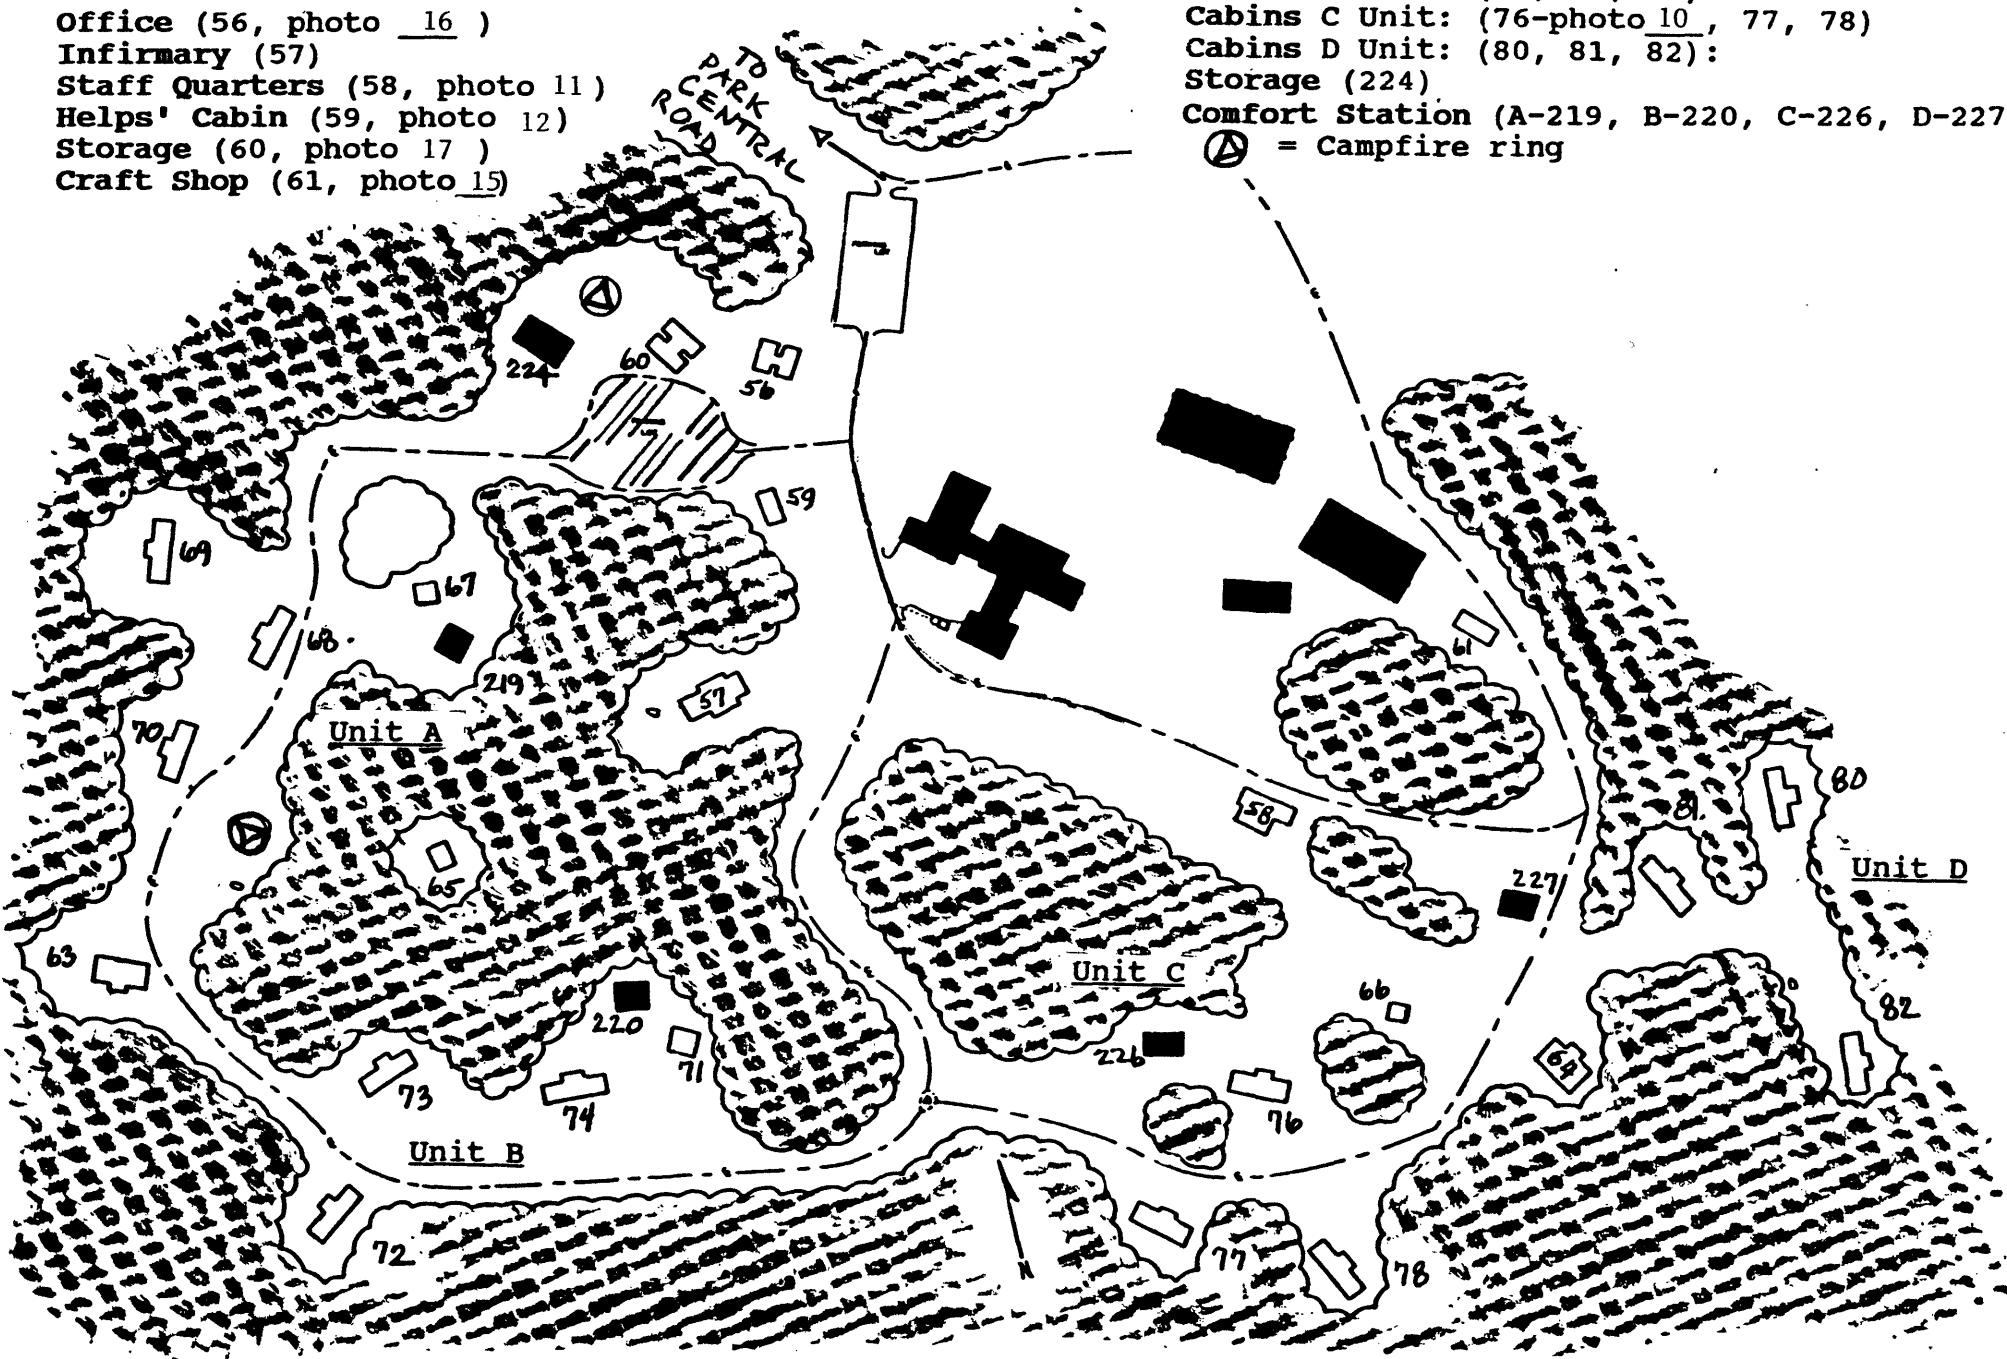
MAP: 4A

CAMP (2) GREENTOP HISTORIC DISTRICT

■ = Non-historic, non-contributing

Office (56, photo 16)

Infirmary (57)

Staff Quarters (58, photo 11)

Helps' Cabin (59, photo 12)

Storage (60, photo 17)

Craft Shop (61, photo 15)

Lodge (63), Good Luck Lodge (64, photo 13)

Leaders' Cabin (65, 66)

Laundry (67, 71-photo 14)

⊙ = Campfire ring
