## National Register of Historic Places Registration Form

historic name Butters - Avery House

street & number 165 Chestnut Street

city or town Wilmington

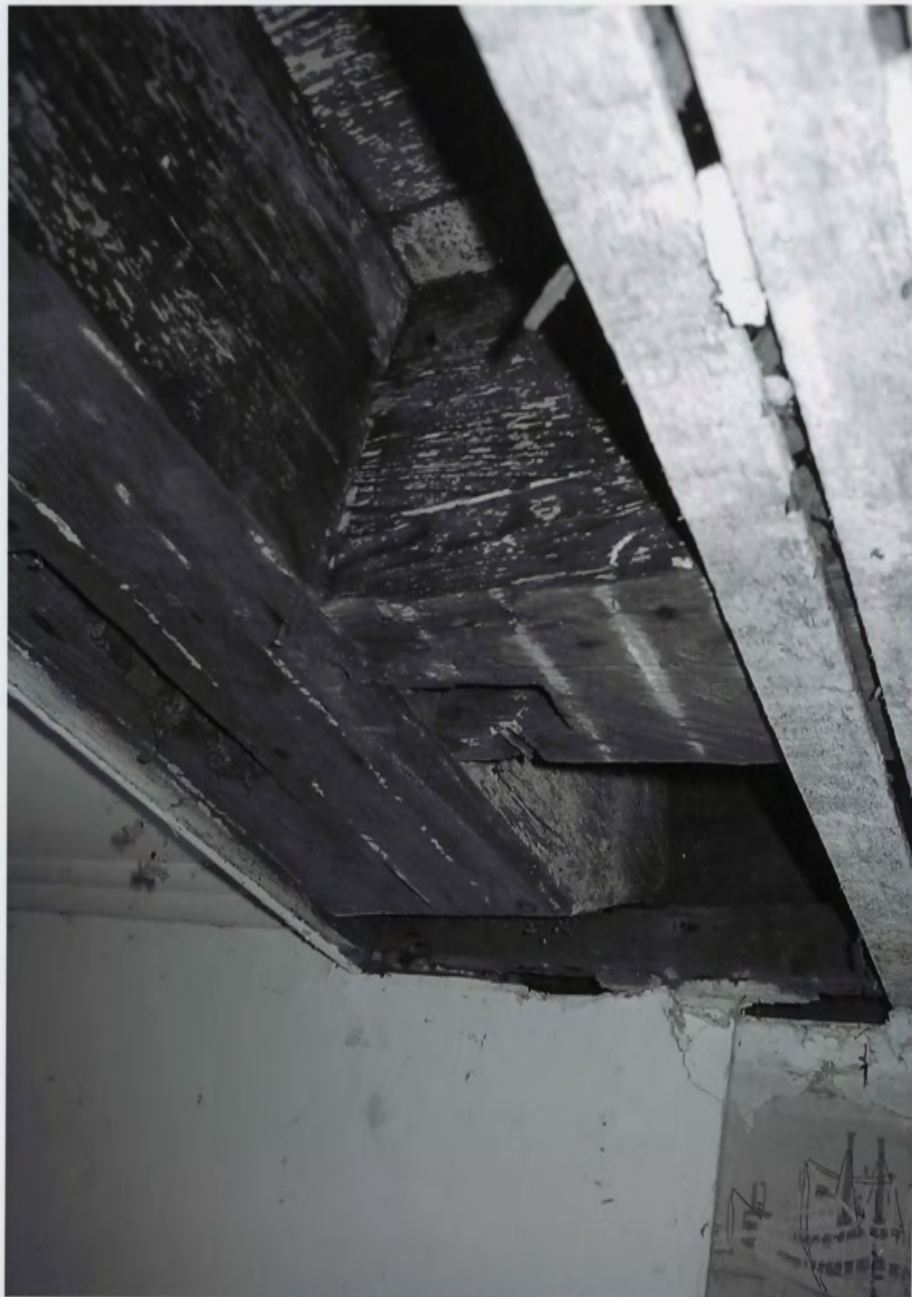
Photo 7

Detail of joint of jetty beam  
and chimney girt

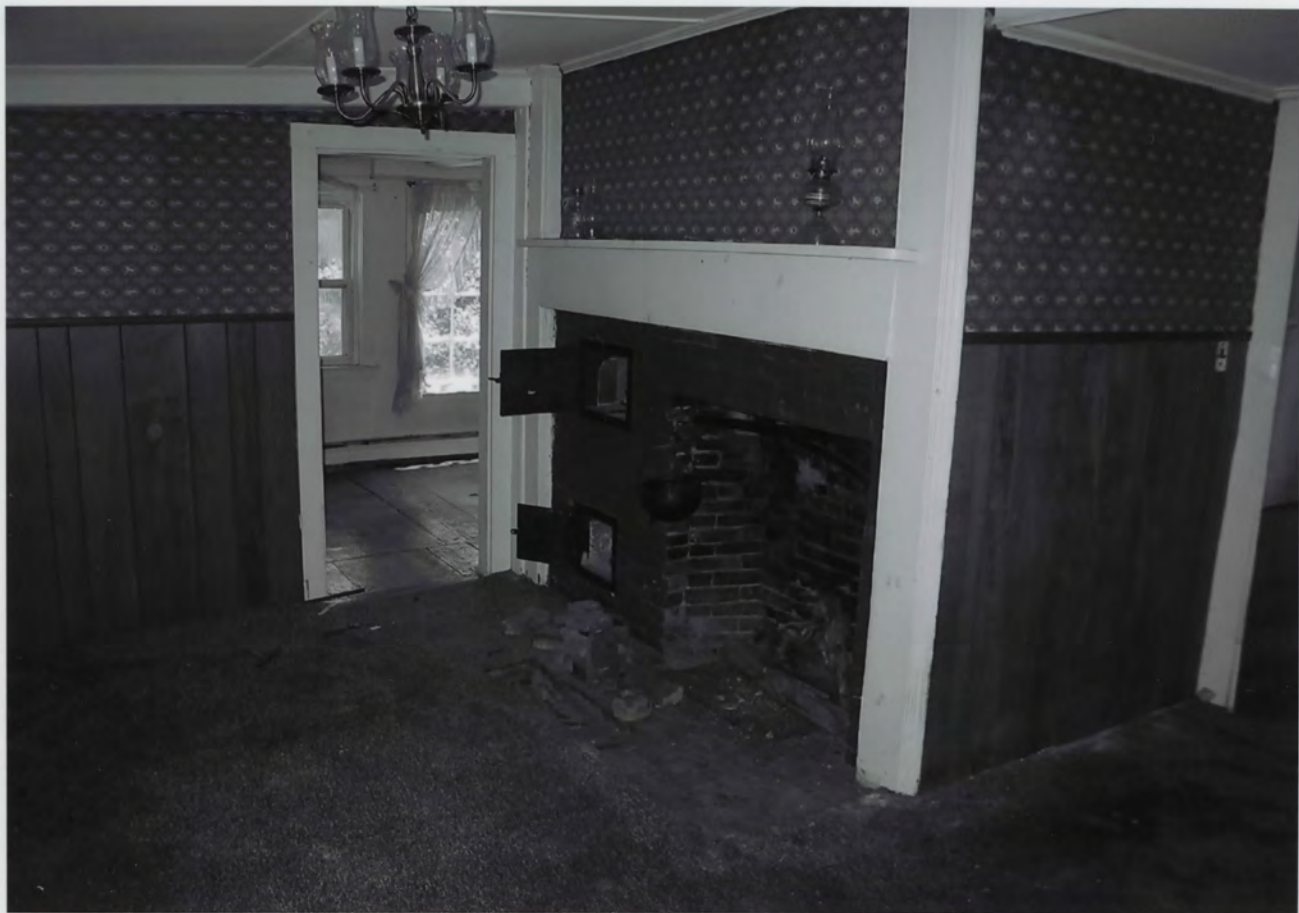
PHOTO 8

Interior, E side kitchen (104)

In the kitchen, the east end of the south wall contains a fireplace and bake oven built into the chimney constructed as part of the renovation (PHOTO 8). The original dimensions of the wide, shallow room in the leanto essentially were preserved. The enclosures on the west end of the south wall are recessed slightly south of the girt in the location of the original south wall; another closet has been added in the northwest corner (Fig. 5). Three small windows are closely spaced at the east end of the north exterior wall of the room. Their odd placement suggests that they are in locations determined by a previous room use or arrangement; one likely was a doorway. A doorway on the east wall leads to the room constructed in the old chimney space (Room 103); there also is a doorway in the west wall that connects to a room in the ell attached to the west side of the house (Room 105).

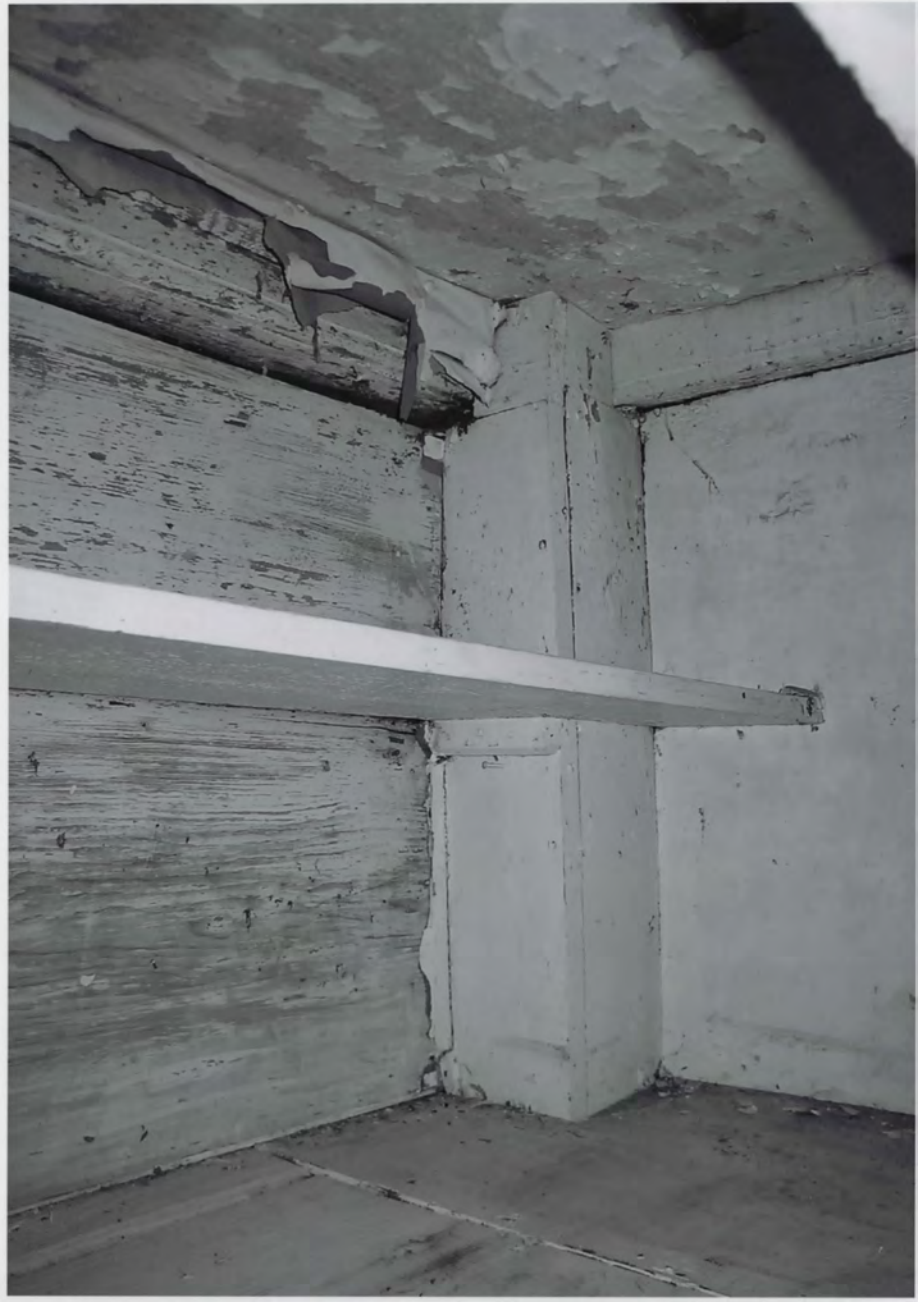
PHOTO 9

Detail of framing NW corner  
of kitchen (104)

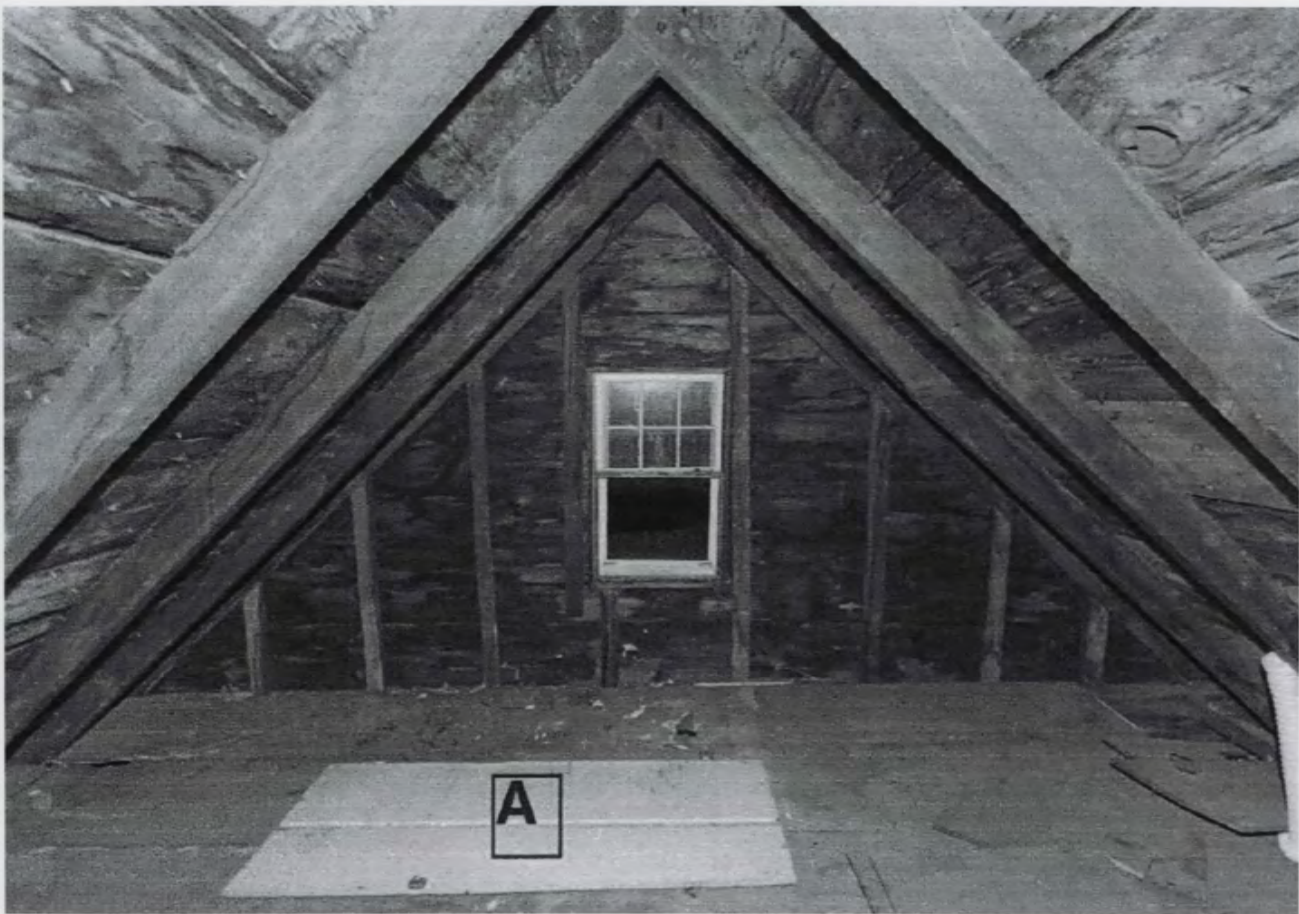
PHOTO 12

Interior, west side of attic

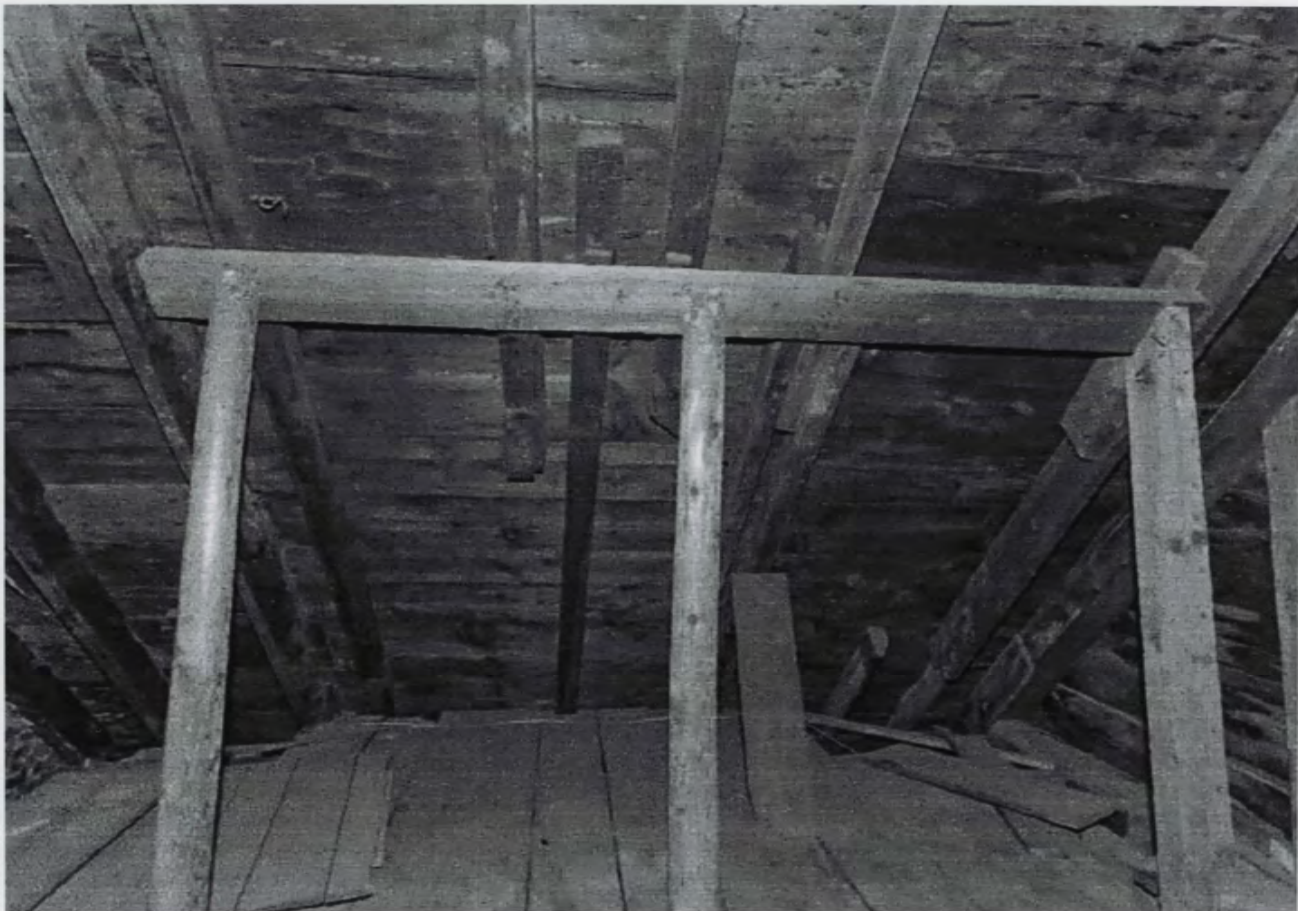
Photo 13

Interior, east side of attic

Conditions analyses conducted on the house prior to and after the Town of Wilmington acquired it as a historic property in 2006 documented the preservation of an early 18<sup>th</sup>-century house frame essentially intact and concealed within later exterior and interior finishes.<sup>1</sup> The framing configuration includes a jettied or overhanging second story, which is a distinctive feature of 17<sup>th</sup>-century New England domestic architecture, and its presence determines the period in which house was built (Figs.5 & 7, PHOTO 7). Alterations made to the ceiling of the principal first-floor room in 1989 exposed the summer beam that traversed that space (PHOTOS 5 & 6).<sup>2</sup> According to the studies, the presence of beaded moldings, rather than chamfering, on the corners of the beams indicate that the house was constructed in the early 18<sup>th</sup> century when this mode of decoration was current.<sup>3</sup> This beading also was found on framing members in the leanto, showing it to have been a part of the original house (PHOTO 9). With the exception of the stud frame of the original first-story front wall, which was removed when the façade was pushed out 18 inches and flush with the second story façade in the mid 19<sup>th</sup> century, virtually all the posts, beams, joists, and rafters used to construct the early house are extant in their original locations, as well as, probably, floorboards that are visible in only a few instances. Feather-edged boards, dating to the initial phase of the house, were also identified but reused in different locations (PHOTOS 11 & 12). One perplexing aspect of the jettied front wall is that it does not appear to have extended across the façade of the entrance lobby on the east side of the existing house (PHOTO 7). There is evidence that indicates a large chimney once occupied the center of this eastern section and, less convincing, that the ancient framing was part of a larger two-room-plan, center-chimney house (Fig.4, PHOTO 13).
