National Register of Historic Places
Registration Form

1. Name of Property Valley National Bank Building

street & number: 27 S. Stone Avenue _____ not for publication
city/town: Tucson _____ vicinity
state: Arizona code: AZ county: Pima code: 019 zip code: 85701

organization University of Arizona Preservation Studies Class date May 10, 2002

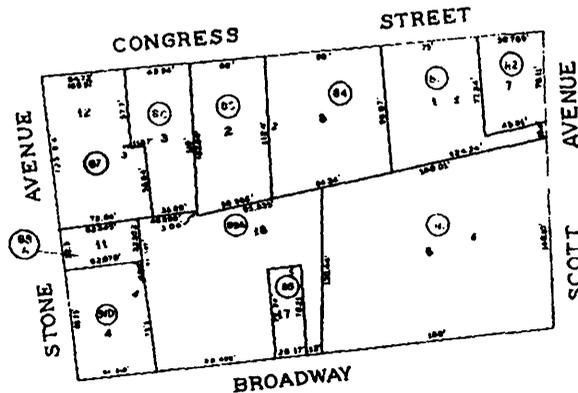
ASSESSOR'S RECORD MAP

Block 208, City of Tucson

SCALE - 1" = 50'

Property currently comprises two parcels in Block 208, city of Tucson. Tax parcel no. 117-12-0870, the northwest portion of the block, is an irregular somewhat rectilinear corner lot, bordered by Congress Street and S. Stone Avenue. On this corner plot is the main skyscraper building. The complicated legal description defines a portion of Lot 3 measuring 64.73 feet long on the north, 123.04 feet long on the west and 72.94 feet long on the south boundaries. The east boundary, divided by an 11.57 foot-wide setback, is 57.7 feet long north of the setback and 58.64 feet south of the setback.

The second plot, tax parcel no. 117-12-088A, describes the Stone Avenue bank annex property south of the principal building block. The legal description is the south 13.46 feet of the west 62.345 feet of Lot 3 and the north 19.04 feet of the west 62.078 feet of Lot 4, Block 208. The parcel is nearly rectangular trapezoid.

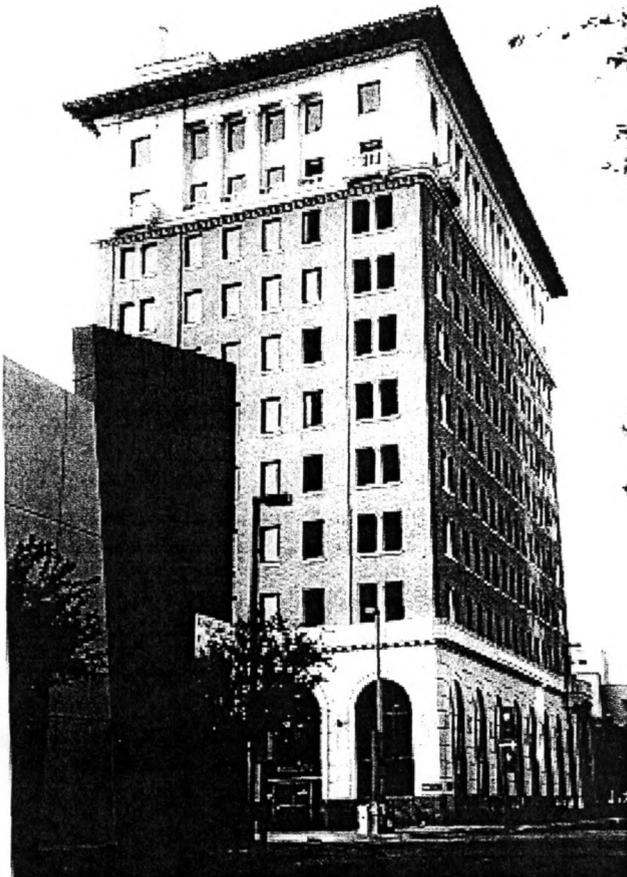
PHOTO #1: Three-quarter view of north and west facades from N. Stone Avenue; Congress Street entrance obscured from view; looking SE.

The north and west side of the exterior of the building are faced with brick and terra cotta of a light cream shade. The base up to the sill line is brown marble while the top two stories are faced with cream colored terra cotta, made to resemble large pieces of cut stone with rusticated joints. The terra-cotta top tier of the building is capped by a classic cornice with dentils, and then by an Italianate hatched overhang painted brown with red tile roofing running back to the parapet. The individual sections on the roof overhang are painted with a repeating black-on red geometric pattern of Southwest Native American design. The pattern repeats after six sections. The front façade, which faces Congress Street, is broken into three horizontal tiers making a top, middle, and bottom tier. The top tier is noted by a false balcony on brackets that extends across the ninth floor. Below the false balcony is a projecting hatched base. Both the ninth and the tenth floor are interrupted by an arcade of eleven superimposed Ionic columns on the west side and three on the north side that terminate at both the east and west office suites. The effect was probably intended to resemble an open loggia (colonnaded space within the lobby of a building but open to the air on one side). The corner office suites on the ninth floor are marked by their extended balconies. The top nine floors once held steel double-hung windows which were later replaced by single fixed panes in black metal frames.

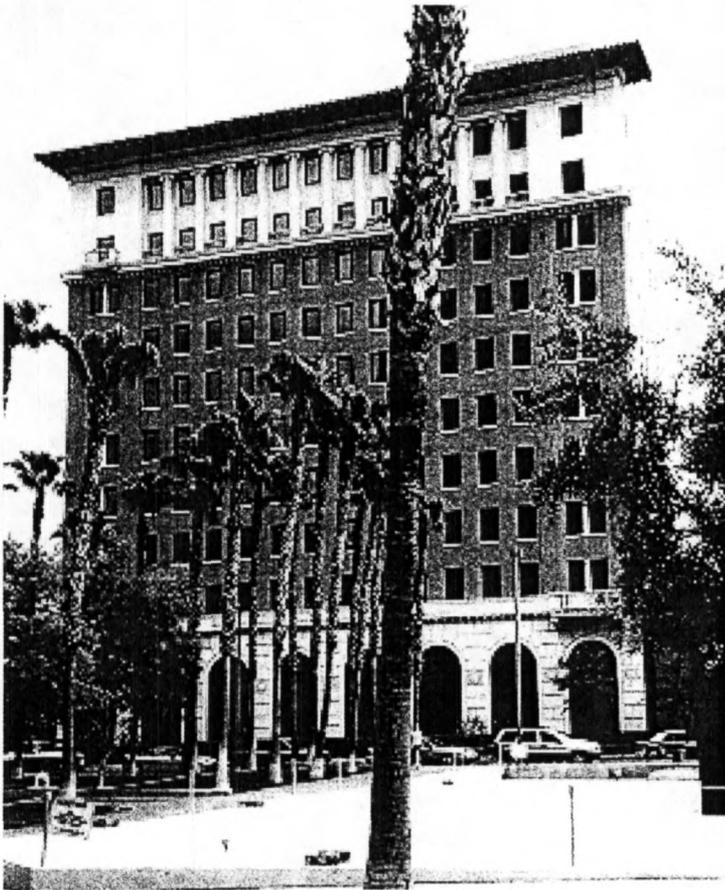
PHOTO #2: West façade from opposite plaza; looking east.

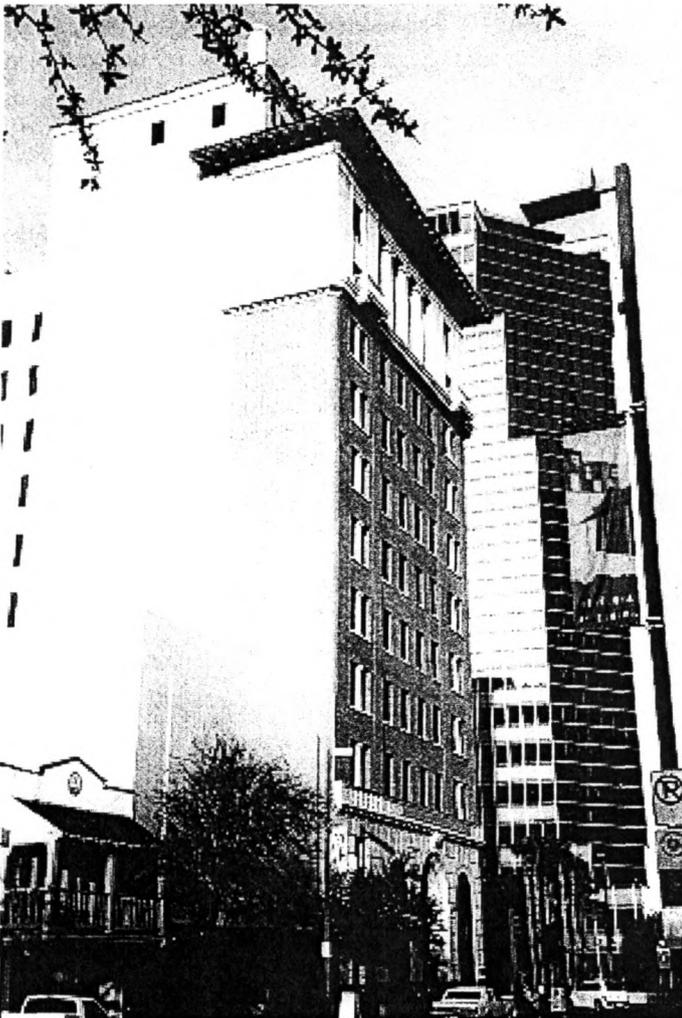
PHOTO #3: Three-quarter view of east and north facades from E. Congress Street showing annex; looking SW.

Abutting the building to the east on Congress Street is a three-story building built in 1912, and now an annex, which underwent some remodeling in 1953 by Marie J. Schiff Construction and a complete remodeling and a new front

façade and entrance in 1960 by F. Knipe, Architect. The front façade of the annex is an eight inch thick wall of reinforced concrete with a painted finish. There are raised concrete panels divided into fifteen sections with a large metal Thunderbird logo at the center and a concrete canopy. Nine foot tall granite veneer from the canopy extends to the ground level. There is terrazzo tile paving in front of the recessed entryway and raised metal signage at eye level. Abutting the west façade on the south is an entry portico designed by the Tucson firm of Cain Nelson Wares & Cook. It is a brick interpretation of the arcaded bottom tier of the main building. A corbel extends across the wall below the flat parapet. Directly south are a series of rectangular brick planters linking a walkway. To the southeast is a parking lot.

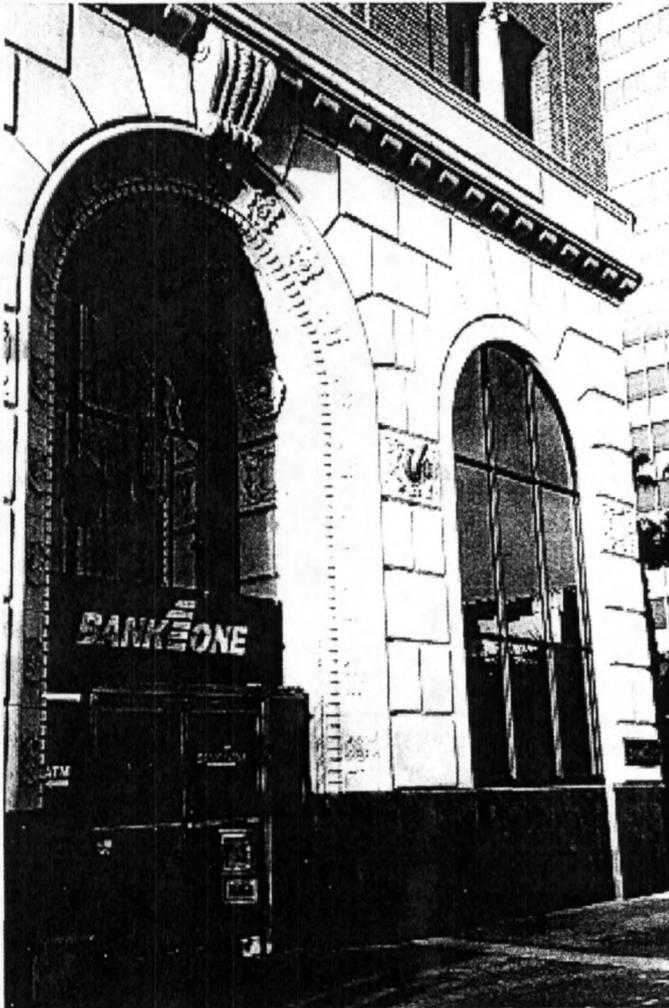
PHOTO #4: Detail of main entrance, Congress Street; looking SW.

The bottom tier of the front façade is marked by high arched windows along the street level; the main entrance to the lobby from Congress Street is through a recessed terra cotta archway, in which is a bronze grille surmounting two large bronze doors topped by a hatchet-shaped keystone. The secondary entrance on the west side of the building has a hatched canopy making a balcony for the mezzanine.

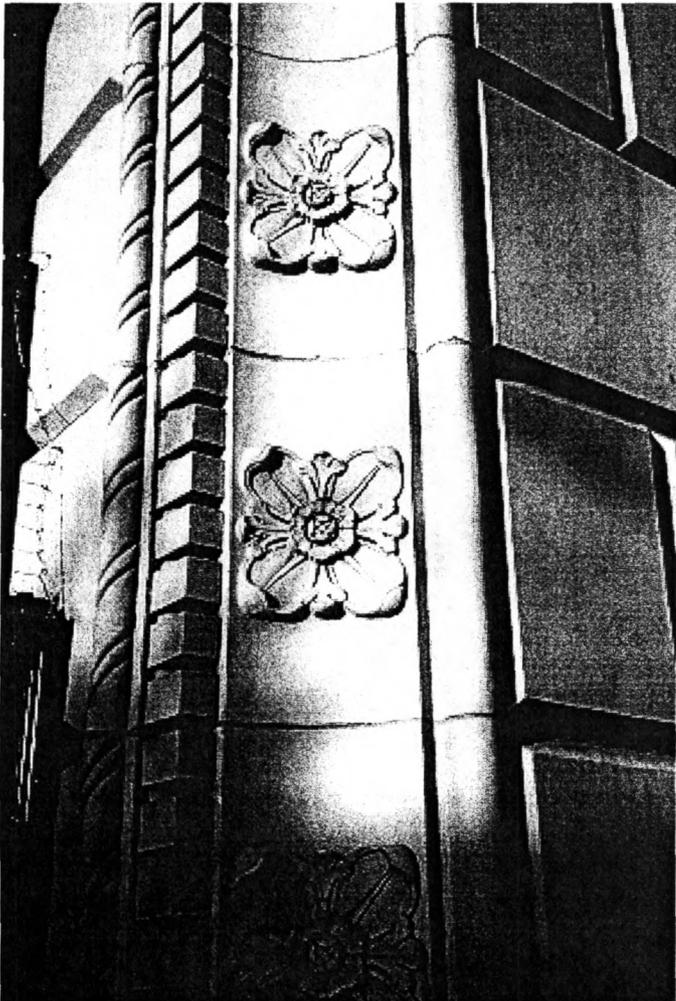
PHOTO #5: Detail of ornamentation, main entrance archway on Congress Street; looking SW.

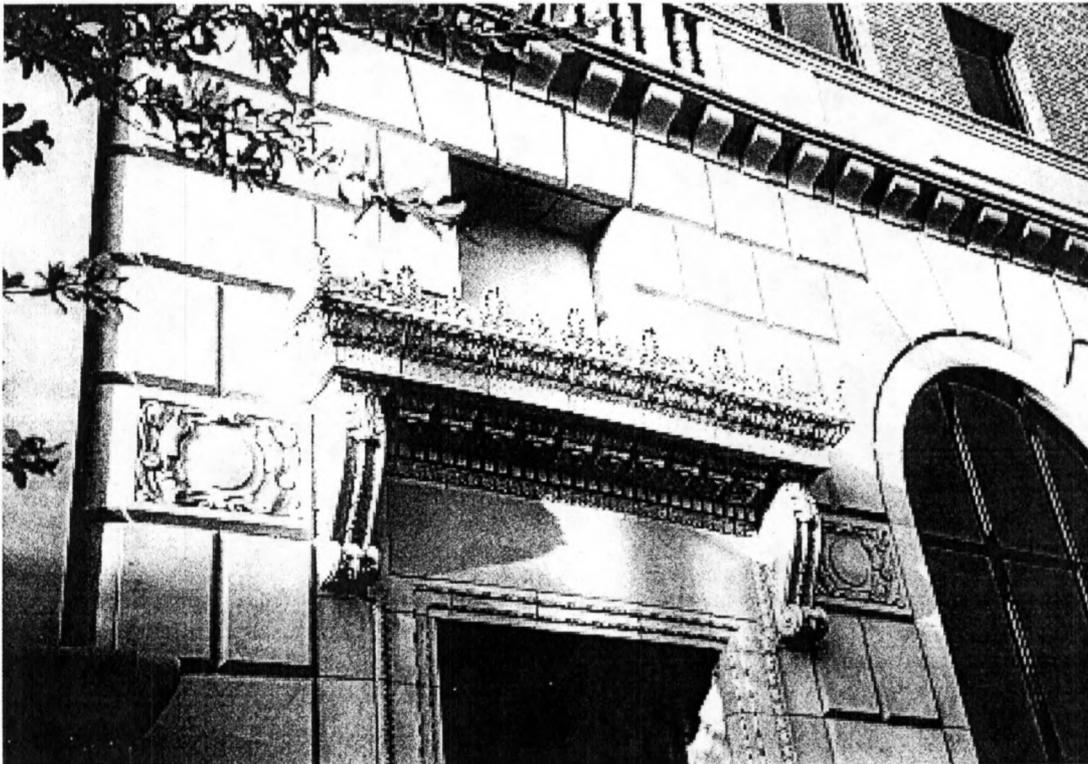
PHOTO #6: Detail of ornamentation at secondary entrance on north facade; looking SW.

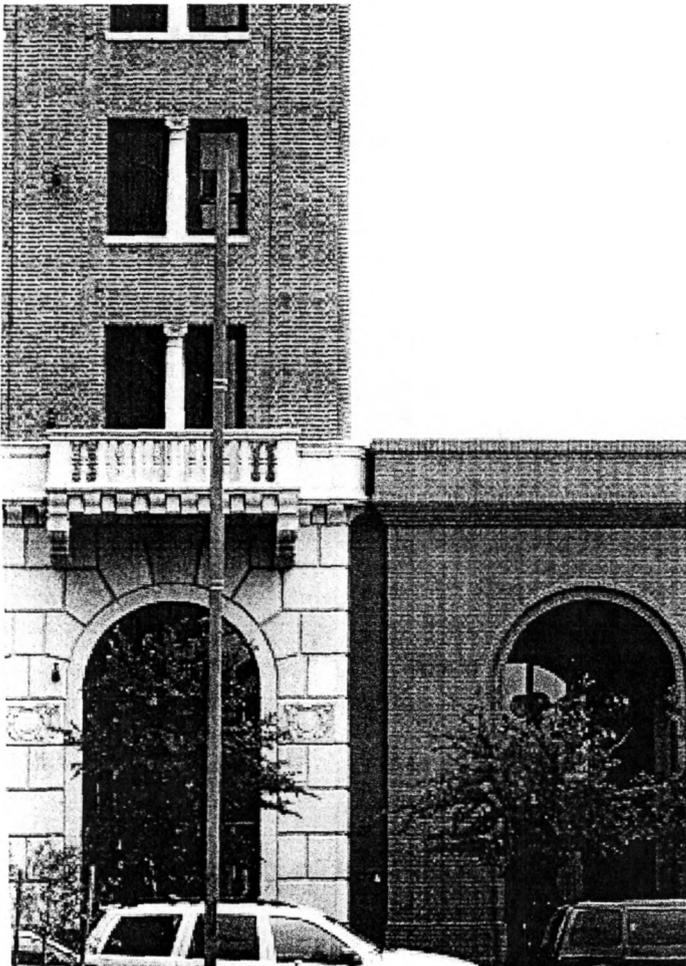
PHOTO #7: West façade at annex showing stylistic treatment between historic and contemporary portions.

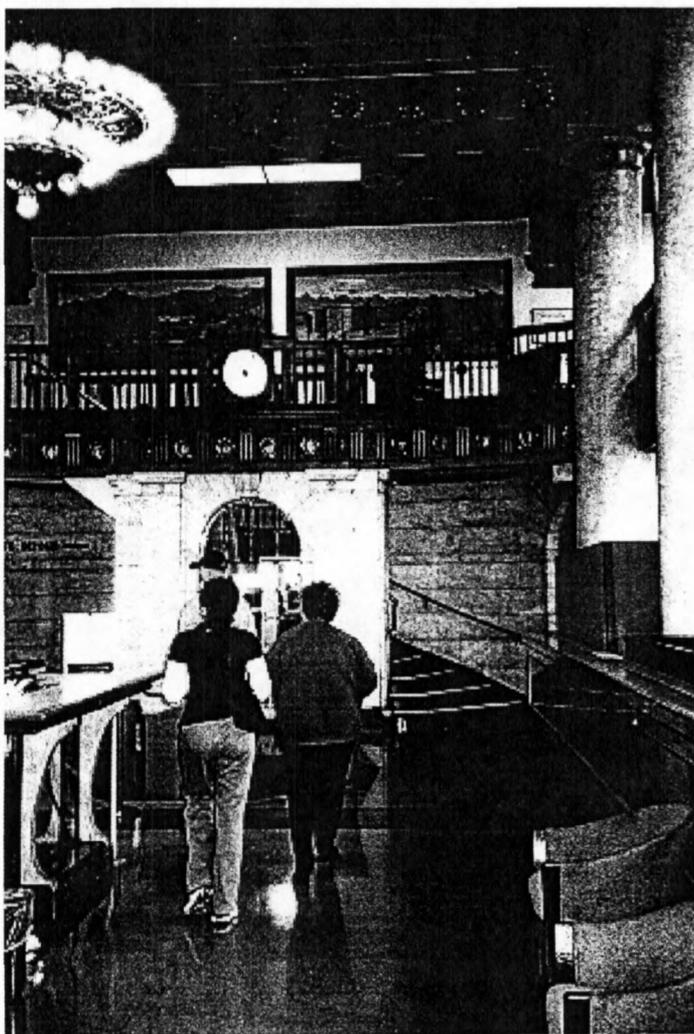
PHOTO #8: Interior view of lobby looking south.

The interior spaces of the building have nine floors dedicated to offices each with mahogany doors and trim. All nine floors originally had sixteen offices to each floor but after some remodeling the number of offices on each floor has changed and varies from floor to floor. Every office has a separate wardrobe and lavatory and each office was originally served with a cooling system and a steam radiator. The bank has always occupied the basement, main floor, and mezzanine floor. On the mezzanine floor, across the Congress Street side, are three rooms, the extreme western one being a tower room which T. N. McCaully used as his office. The walls of this room are in polished Bataan mahogany. The directors' room centers the mezzanine and opens out of the western tower room. Also found on the mezzanine floor is a room that was "especially designed and equipped for the serving of women patrons of the bank, where they may take their financial problems to a woman... in this charming place, which is feminine in all its appointments from the sparkling crystal chandelier to the smartness of its wicker furnishings, and the other touches that all women love," (Hughston, 1929). There are two original chandeliers each one costing one thousand dollars in 1929. Parallel to the tellers are the original tables. The interior of the banking floor was well appointed with fourteen scagliola (faux marble) columns supporting the mezzanine floors and surrounding the public lobby space. These columns are behind the counters that have a facing of rose tavernelle marble and a base of cedar Tennessee marble, blending artistically with the rose-tinted scagliola and pink Tennessee marble floor with a Tennessee marble border. At the end of the banking room is a Venetian mirror with a clock above with its dials illuminated. Two superimposed piers flank either side of this mirror that is fitted into an arch all of which is sheathed in rose tavernelle veneer. Behind this mirror is a grand staircase that leads to the mezzanine and to the basement where the vaults can be found. A solid bronze grill makes up the railing surrounding the mezzanine that is pierced by bronze roundels containing a low relief of the side profile of Columbus, which alludes to the Columbian exposition. Bronze also outlines the tellers' cages.

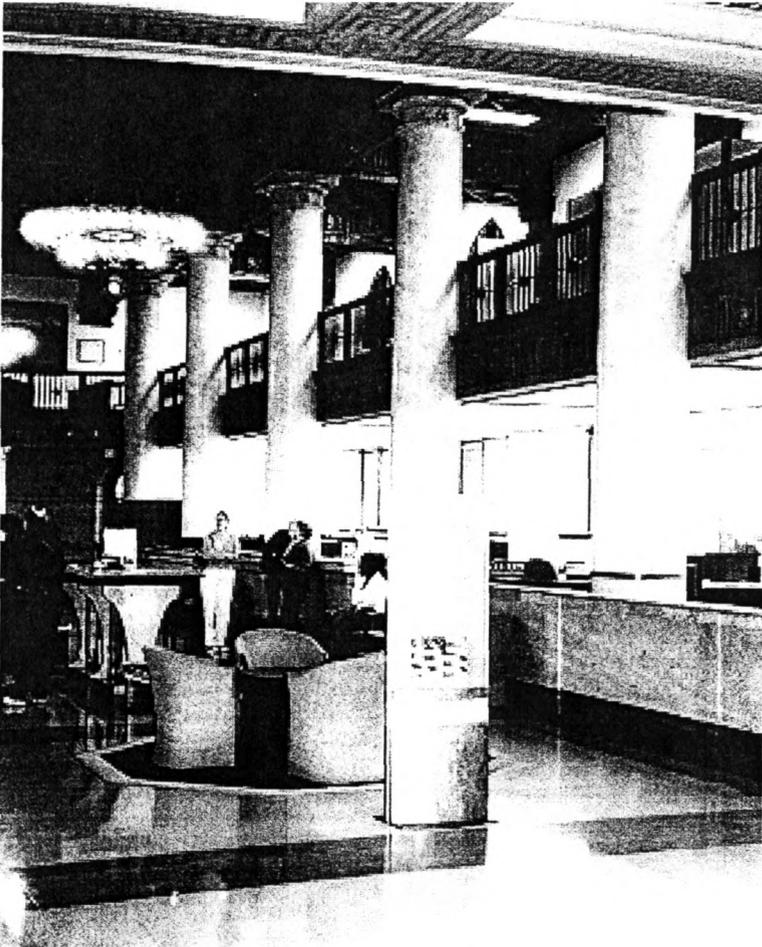
PHOTO #9: Interior view of lobby showing marble columns.

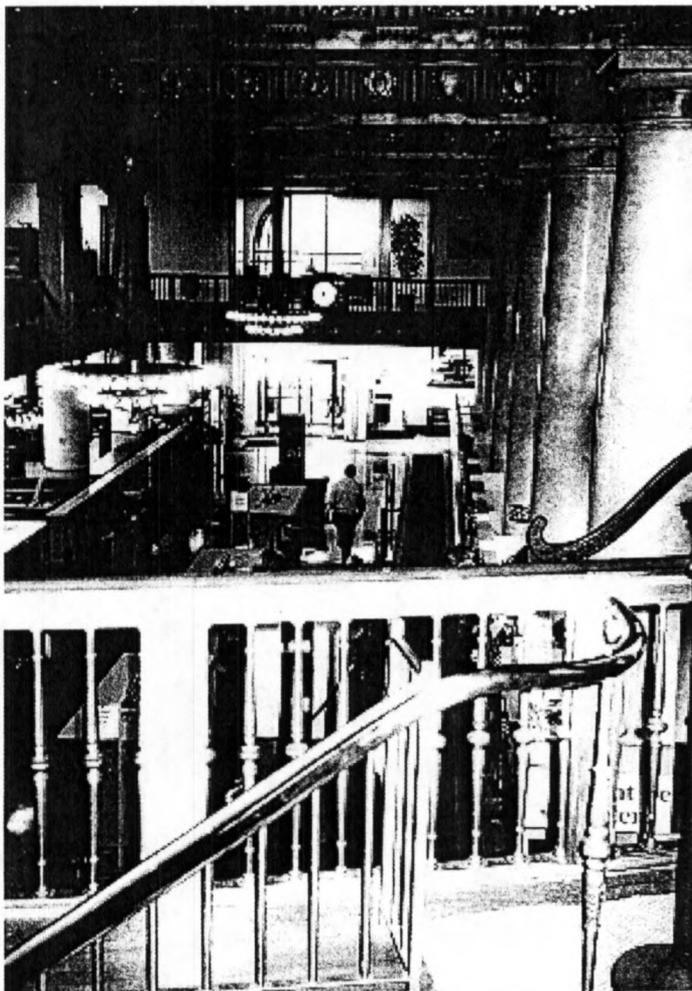
PHOTO #10: Interior view of lobby from mezzanine looking north toward entry.

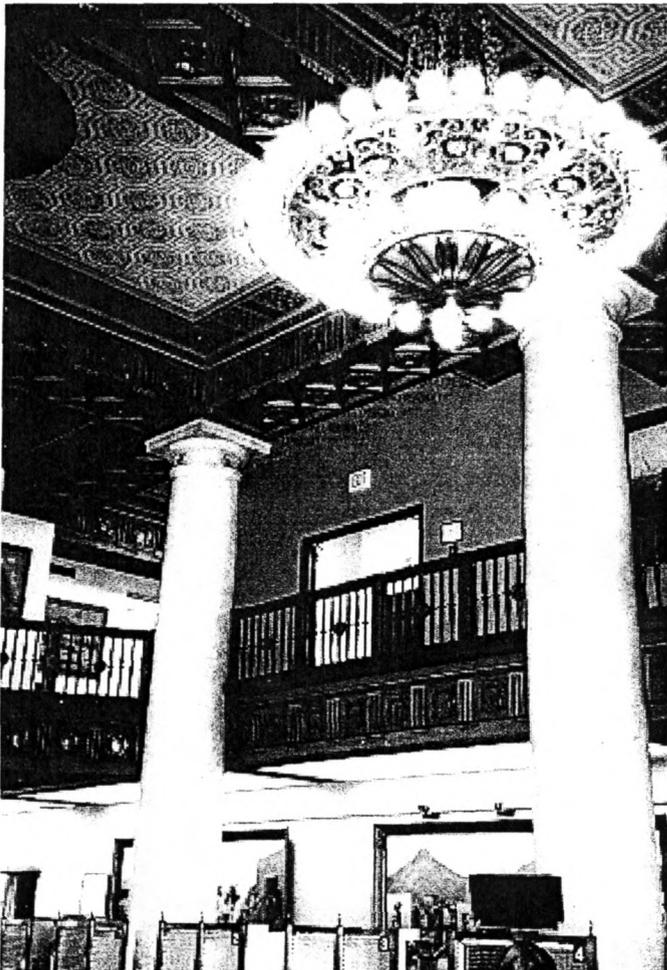
PHOTO #11: Interior view of lobby ceiling.

The walls of the bank were originally painted a gray-green color. The ceiling throughout the bank level is coffered and the ceiling beams are carved with a floral motif, which might be interpreted as symbolic of America's abundance; a popular nineteenth century notion that America was the "new Eden" and reaping the benefits of the natural resources was the right and responsibility of its citizens. This belief would seem appropriate for a bank in a frontier town in which profits were made through the exploitation of local natural resources such as silver, copper, and cotton. This floral motif runs throughout the rest of the bank level and exterior as well where it is carved into the intrados (concave underside of the entrance arch). Throughout the bank level is a geometric neoclassical motif found in the ceiling murals and dentil work along the ceiling beams. The colors that make up the patterns on the ceiling and decorative work are red, rose, blue, green and solid gold leaf in bronze tones. In the lobby there are two elevators serving all floors and there is a stairway adjacent to the elevator shaft running from the roof down to the floor. The lobby is lined with rose tavernelle and the elevator doors are bronze.

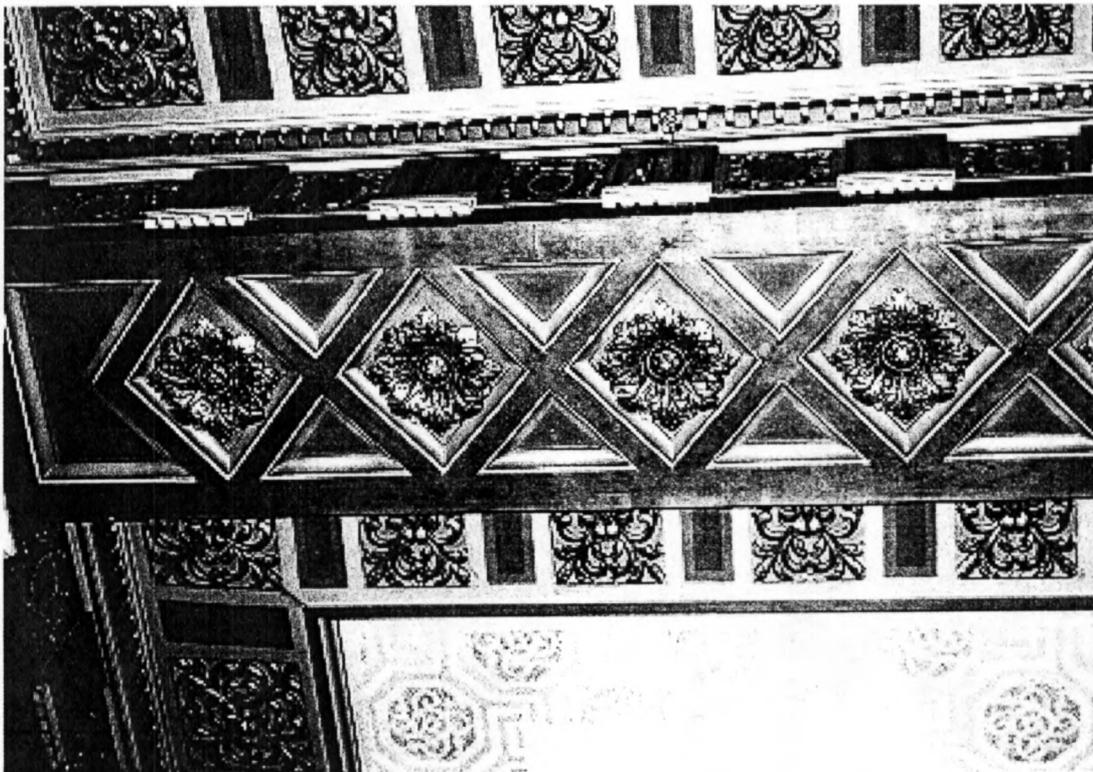
PHOTO #12: Detail view of decorative lobby ceiling.

The various sections of the lobby ceiling are adorned with miniature murals alluding to visions of "manifest destiny," a

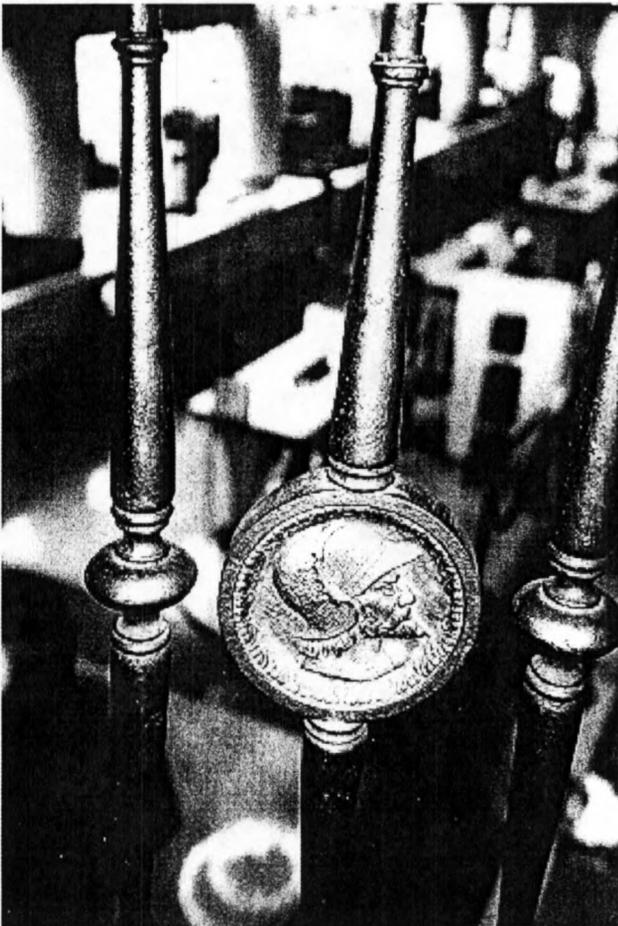
PHOTO #14: Detail view of mezzanine hand railing with medallion of Christopher Columbus.

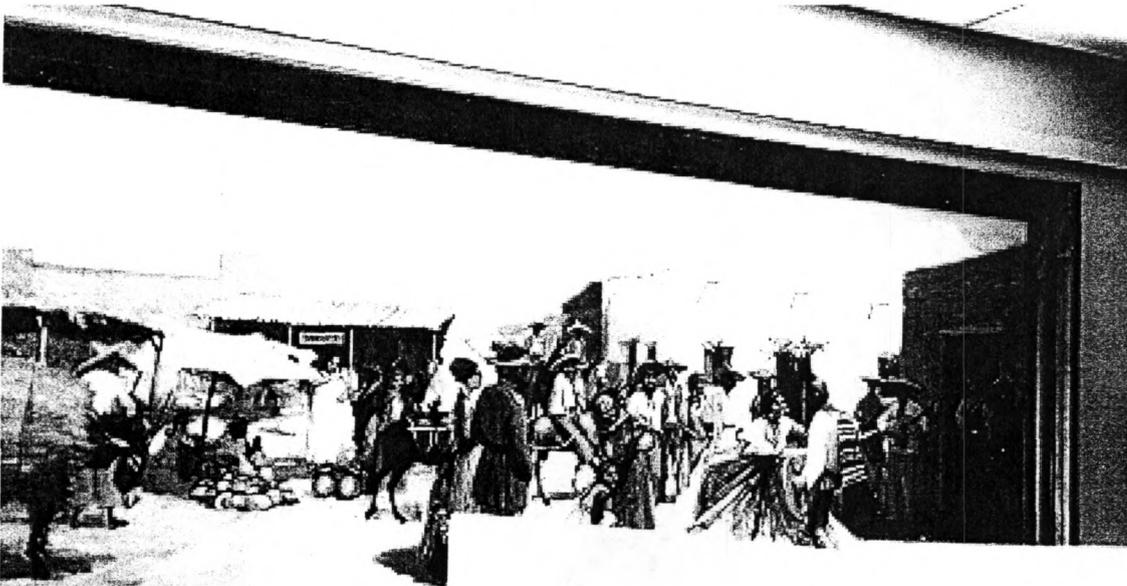
PHOTO #15: Detail view of a typical mural in lobby mezzanine.

term which can be loosely defined as the belief of many Americans that this "new Eden" was given to them by God in order that they might "civilize" the land and the Native Americans by imposing their beliefs on the natives and by utilizing the land. In short, it was seen as the duty of the American settlers to expand westward into areas like Arizona. These images were painted by the artist, Anthony Heinsbergen, on canvases that were attached to the ceiling. They include Columbus crossing the Atlantic, the Conquistadors, the Coming of the Mission Padres, the Mission of San Xavier del Bac, the Spanish Dons, Native Americans, the Discovery of Gold, Covered Wagons, American Settlers, Cattle Ranching, and Women Working. The murals make up a program that can be read as a history of Tucson. The images of Columbus and the Conquistadors depict the discovery and exploration of the America and the southwest. The painting of the Mission and the Padres represents the first attempts of the Europeans to "civilize" the Native Americans and the Discovery of Gold marks the arrival of the American settlers who traveled through Tucson on their way to California. As the American settlers expanded westward many remained behind in Tucson and took up mining, farming, and cattle ranching. The image of the woman washing cloths also relates to this program because she is shown working as to say that progress and profit comes at the price of hard labor.

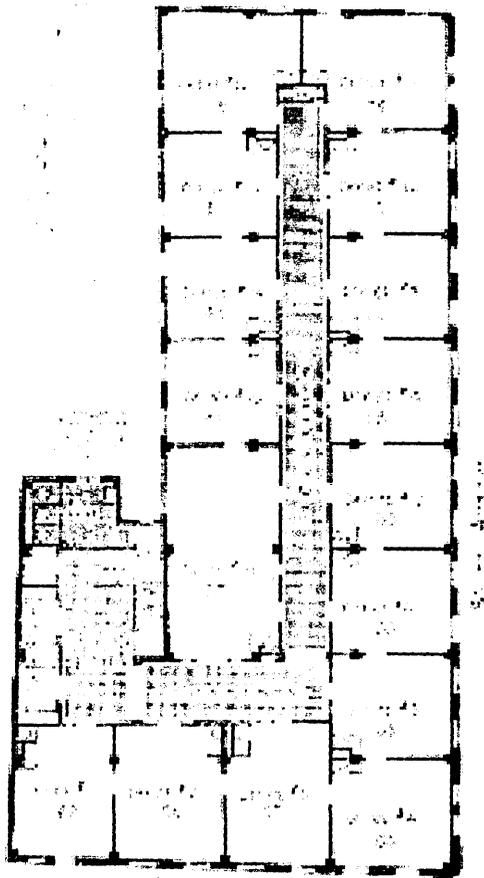
HISTORIC PHOTO # 2: Valey National Bank floor plan for office floors 3-8 (plan courtesy of Bank One)
