National Register of Historic Places
Inventory—Nomination Form

historic The Great Bridge

street & number ^{NH} ~~Old Route~~ 25 N/A not for publication

city, town Ossipee N/A vicinity of

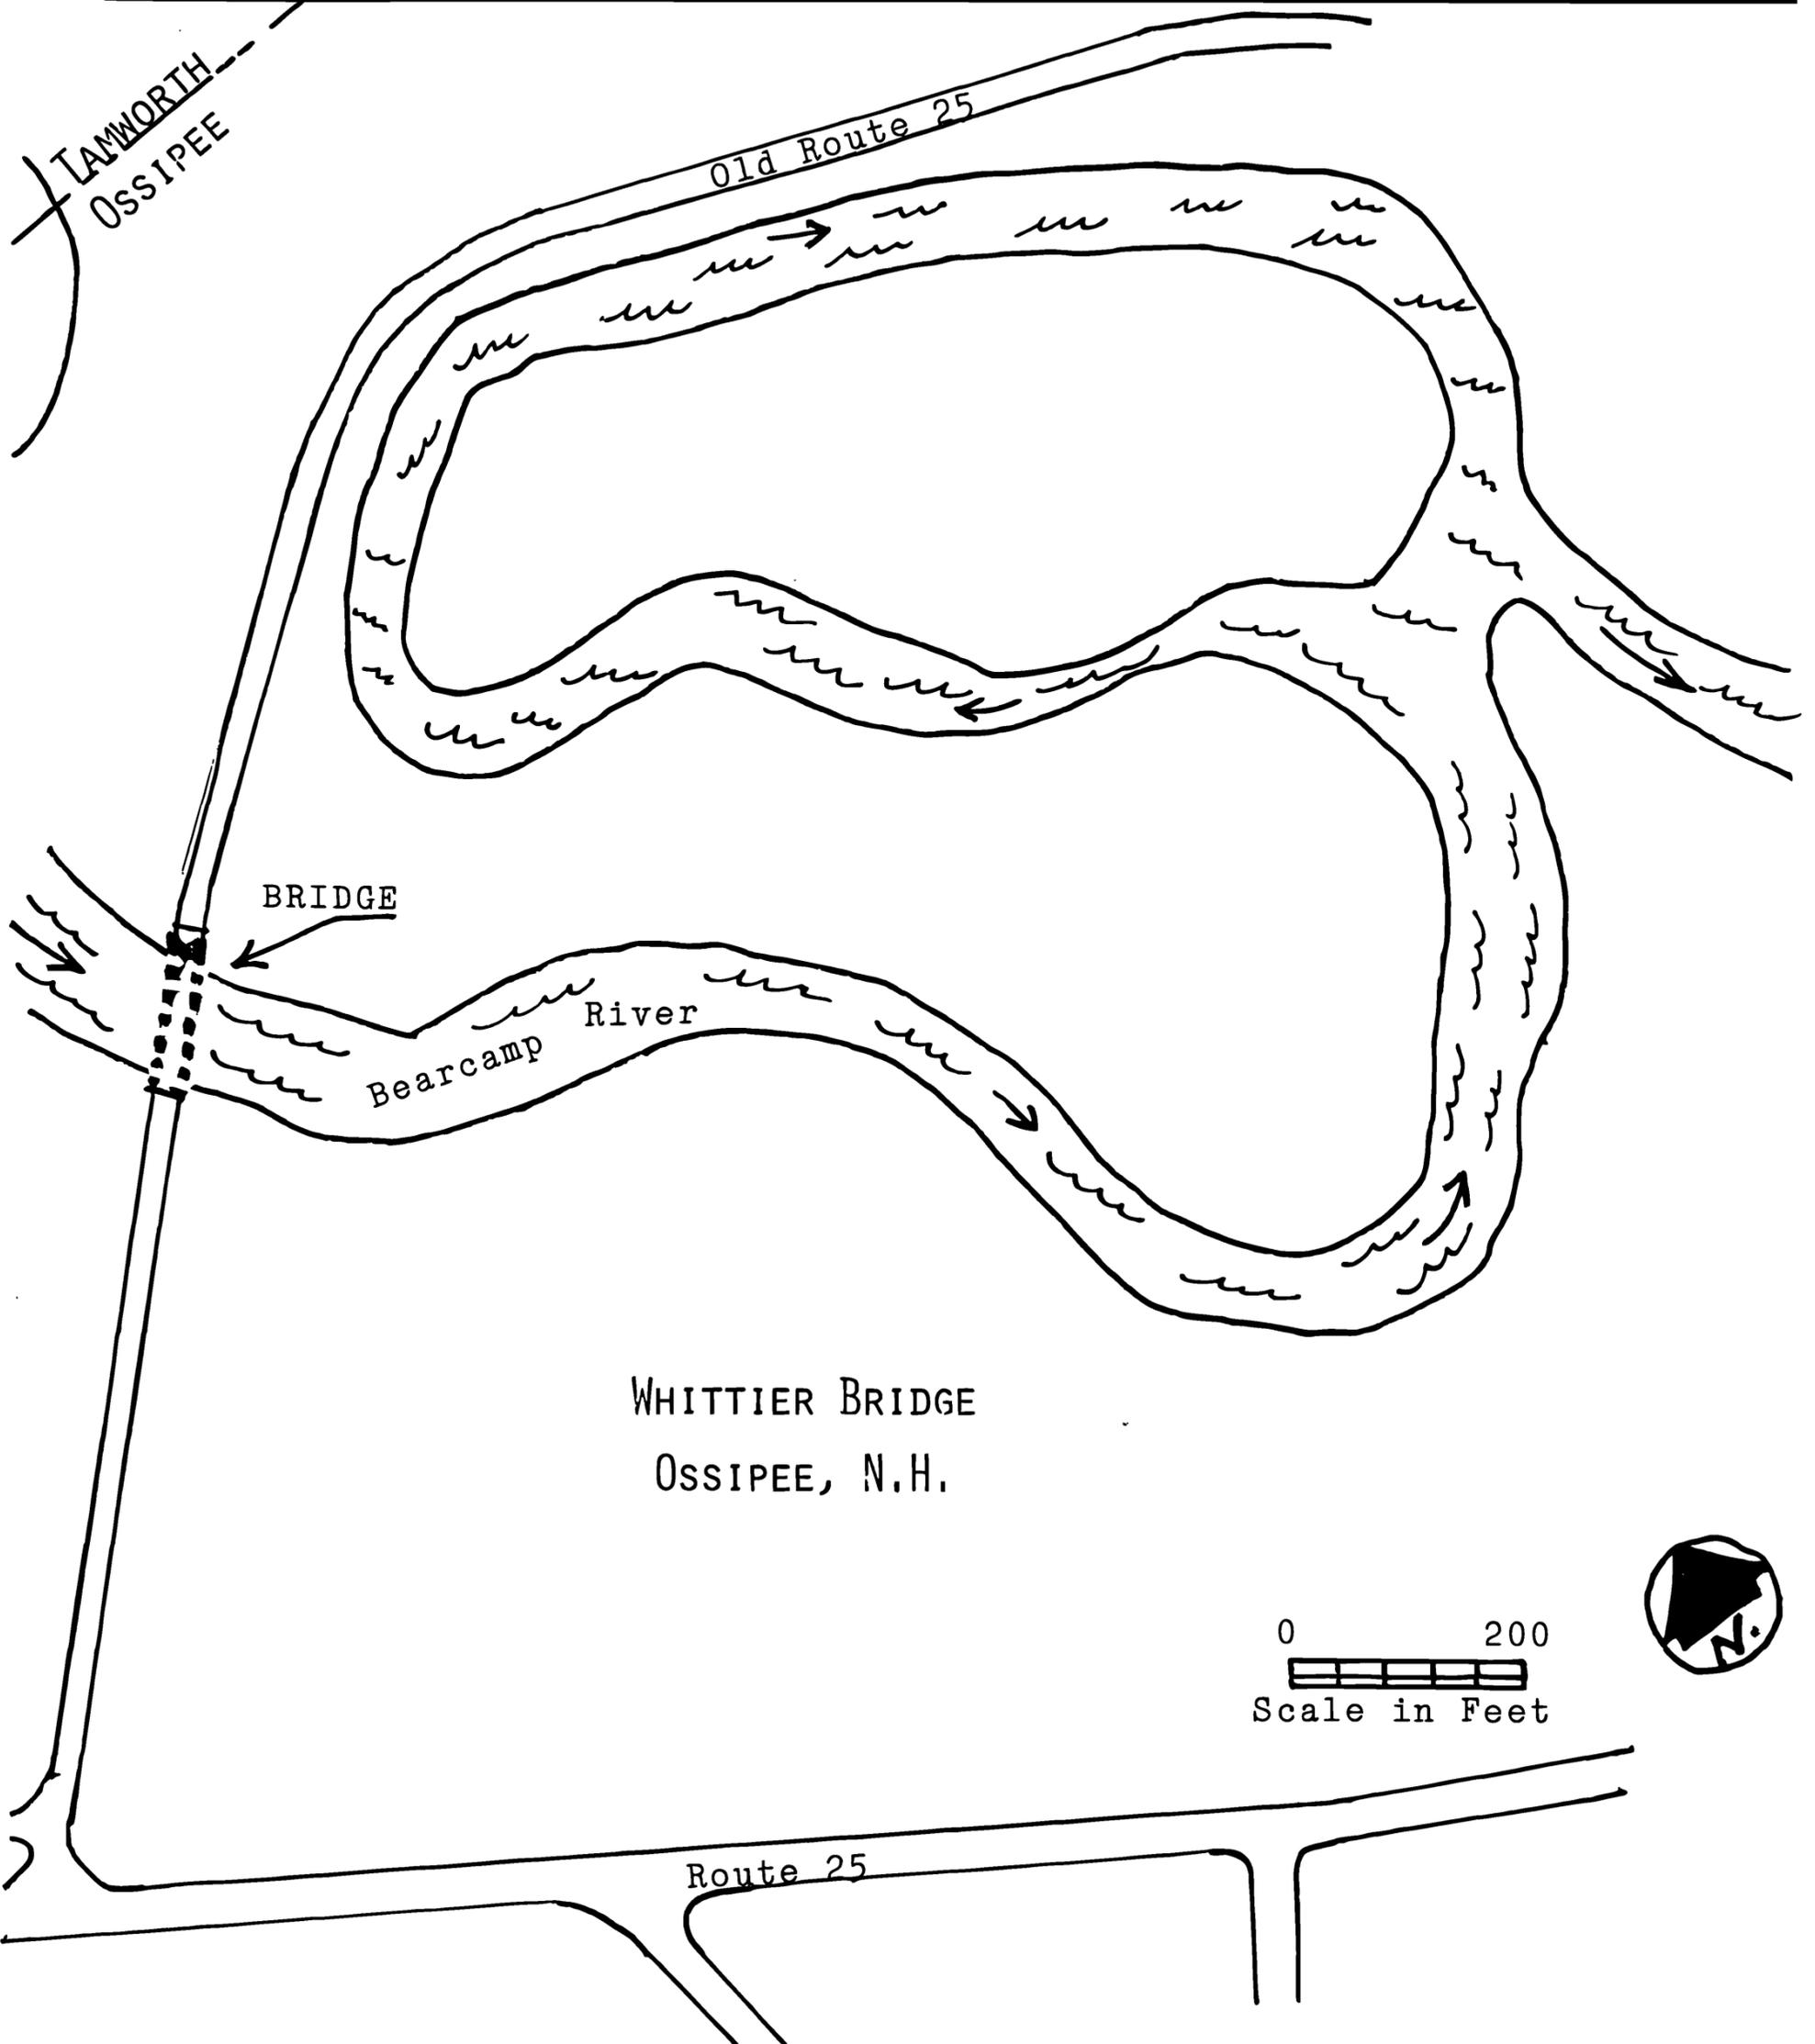
Continuation sheet #6 SKETCH MAP

Verbal boundary description and justification The nominated property consists only of the Whittier Bridge and its abutments. The boundaries of the nominated property are shown by shading and the dashed lines on the enclosed sketch map.
