KENTUCKY HISTORIC RESOURCES INVENTORY

Site No. 4152

1. Historic Name(s) <u>Stone house on Indian Creek</u>		22. ADD/County <u>Bluegrass, Harrison</u>	
Original Owner <u>Haveland?</u>		23. U.S.G.S. Quadrant (15'/75') <u>Cynthiana vic.</u> G.I.S. Mod.

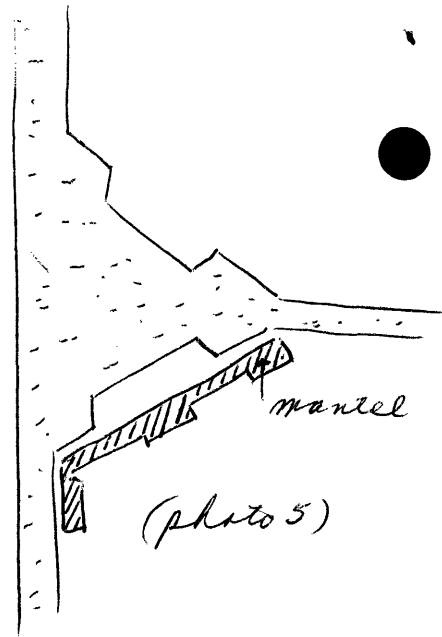
(photo 2)

Enclosed corner stair arises from front of hall, space taken from N.W. room, as at Sc 141. Exterior chimney each end, press in E room beside fireplace. Two rooms on W end both served by the same chimney, corner fireplaces in each room; fine reeded breakfast sunburst mantel in SW room follows the turn of the wall.

A 2 room stone wing was added on the E. end of the house, deeper than the house, and forming an ell. This addition has a hipped roof at the corner, gable on rear; 2 windows in N. front, exterior chimney on S rear. Double faced trim, diagonal trim chair rail, 4 panel doors, diagonal window trim. Cooping fireplace in cellar, entered from N.E. corner. Horizontal bars on cellar w.o. mullions. Wing has superior masonry on front, (photo 4) 9 stone voussiers, typical tooling. No voussiers on cellar windows has allowed wall above to fall out.

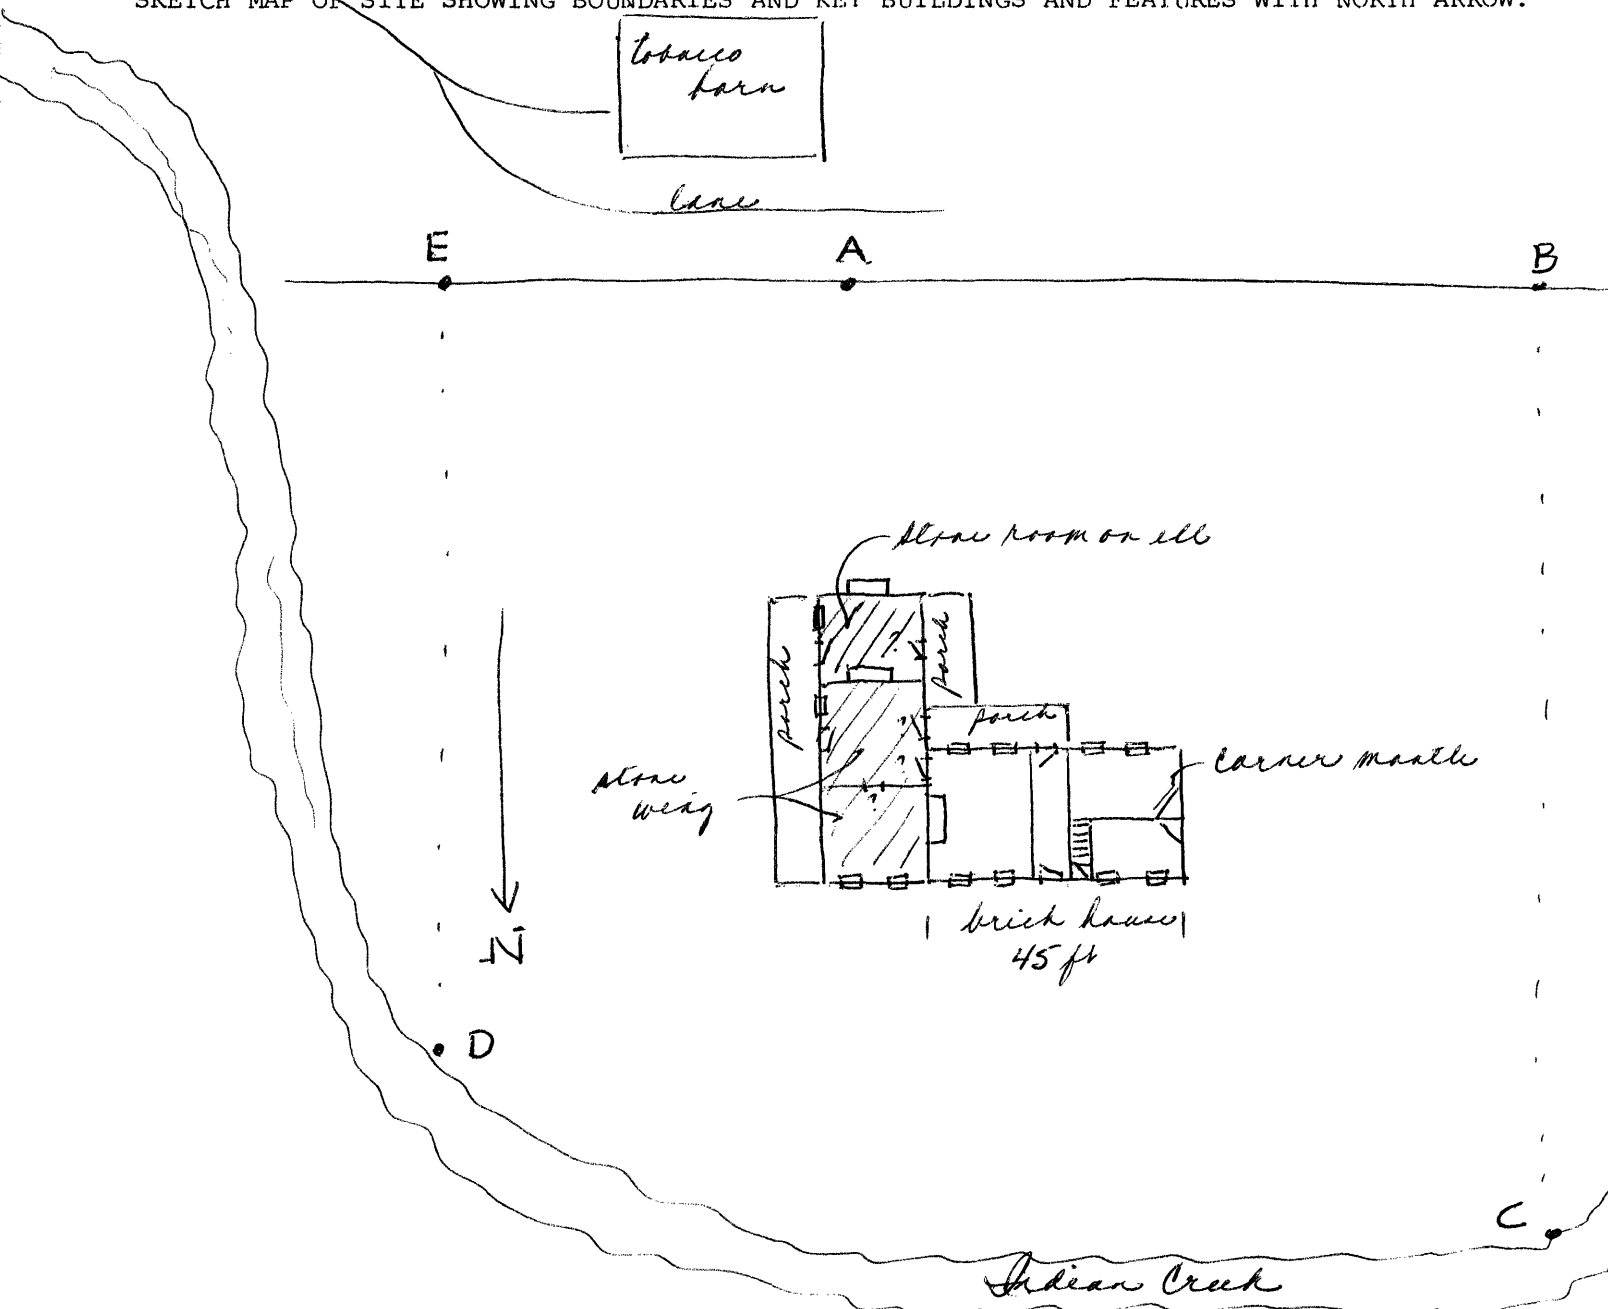
SKETCH MAP OF SITE SHOWING BOUNDARIES AND KEY BUILDINGS AND FEATURES WITH NORTH ARROW.

Beginning at A, at a fence, and at a point directly N of the stone ell, thence parallel to rear wall of house W 150 ft to B, thence at right angle N to the creek bank (C) thence with creek bank E. 250 ft to D, thence parallel to B-C to the fence (E) thence with fence 100 ft W. to the beginning, containing the brick house and stone additional - about 1.4 acre.
