National Register of Historic Places
Inventory—Nomination Form

historic Mount Zion Baptist Church

street & number 900 Cross Street

city, town Little Rock vicinity of

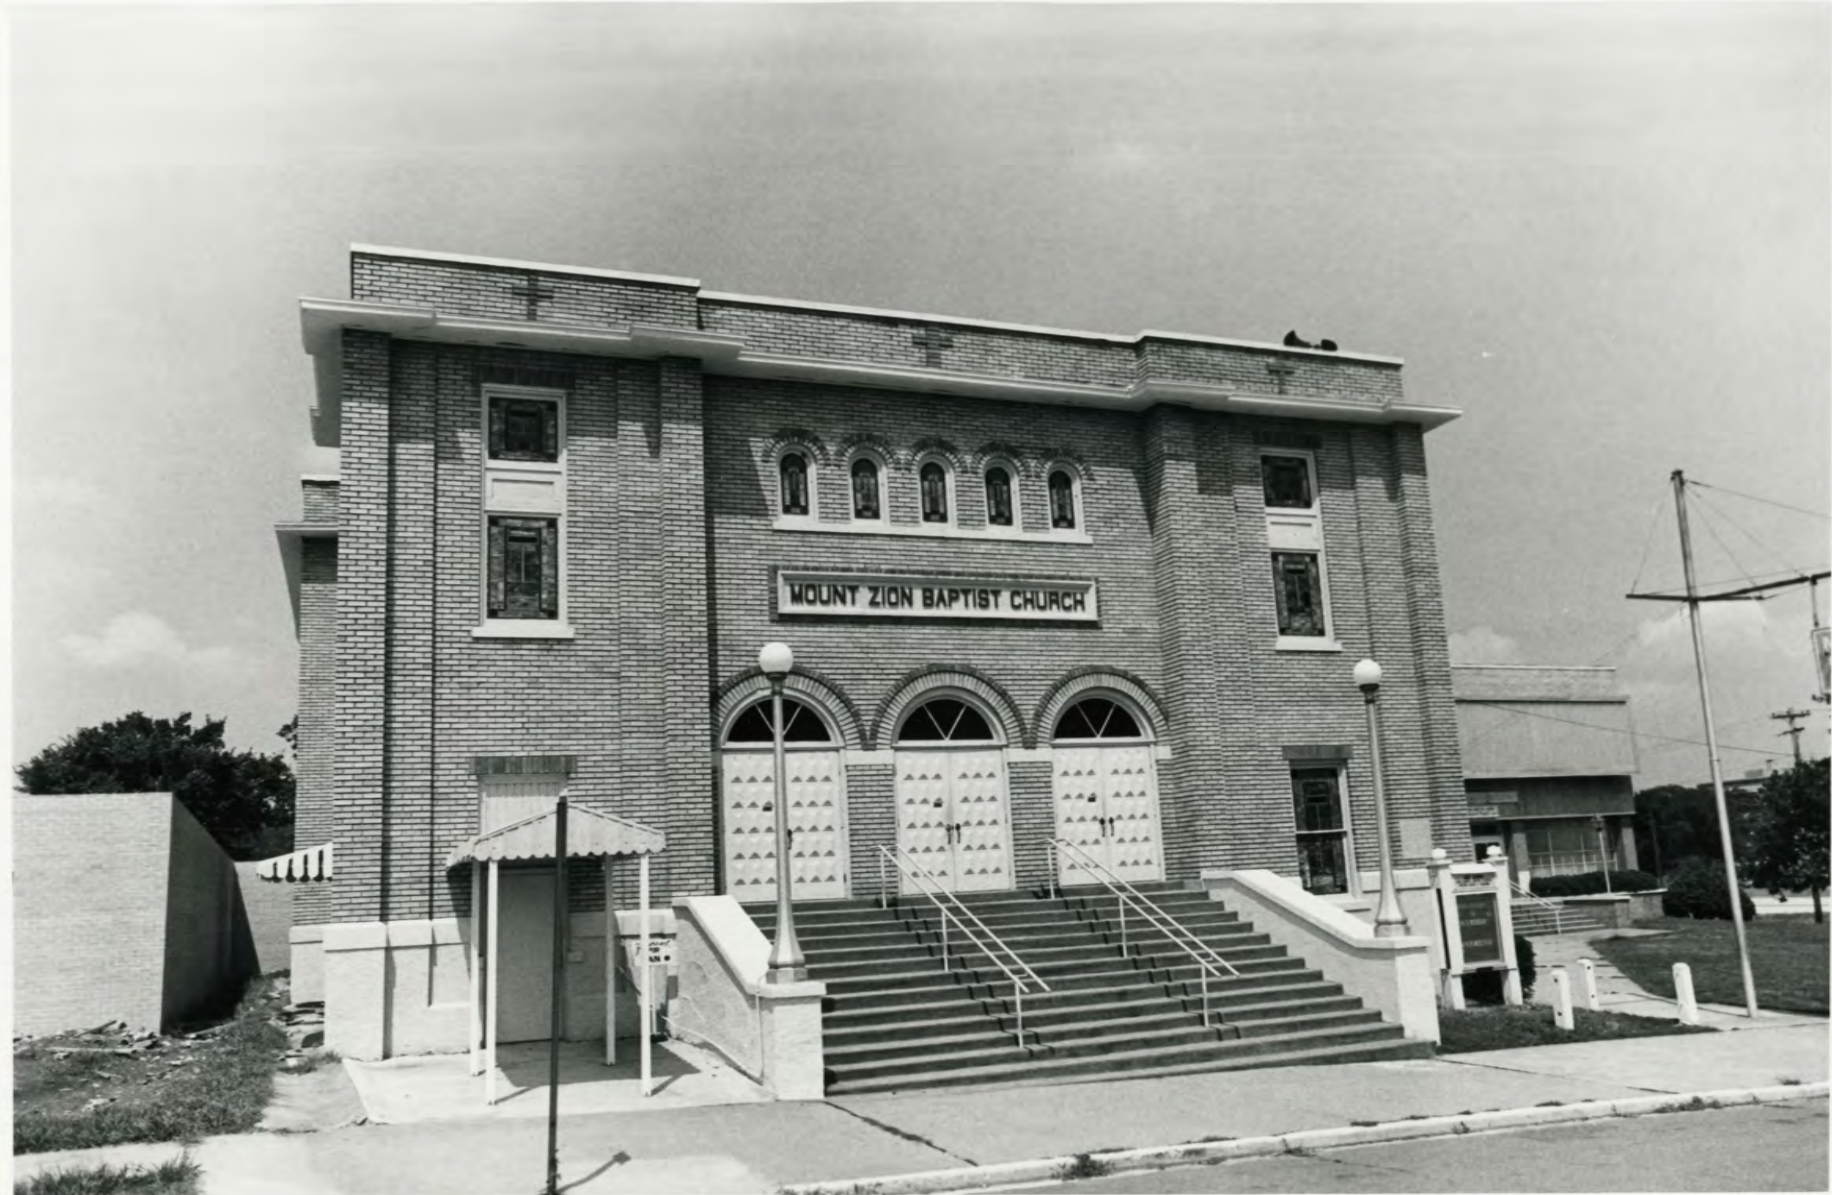
Mt. Zion Baptist Church
Little Rock, Pulaski Co.
East front elevation
Photographed by Mike Swanda
August 1986

The exterior masonry walls are load bearing and are topped with a flat roof surrounded by a parapet wall and an exaggerated cornice. The principal facade is a tripartite composition with a slightly recessed central bay defined by three arched openings adorned with decorative brickwork and surmounted by five arched stained glass windows. A flight of carpeted concrete steps, adjusted to the slope of the site, rises to the arched doorways and extends across the width of the middle bay. The staircase is anchored by iron fixtures with splayed bases and frosted globes typical of the 1920's.

The flanking bays are accentuated by stepped corners on both sides. The second story of these side bays has a pair of Art Glass windows, one mounted atop the other with a wood panel between the two. Previously, the first level of both end bays also had Art Glass windows, but the window on the south bay has been replaced by an aluminum awning and door which provides access to an elevator added ten years ago. Concrete defines the basement level of the structure while an exaggerated wooden overhang accents the base of the parapet wall which acts as the building's cornice. Three crosses, of a slightly darker brick than the walls but laid flush with the wall's surface, adorn the cornice.

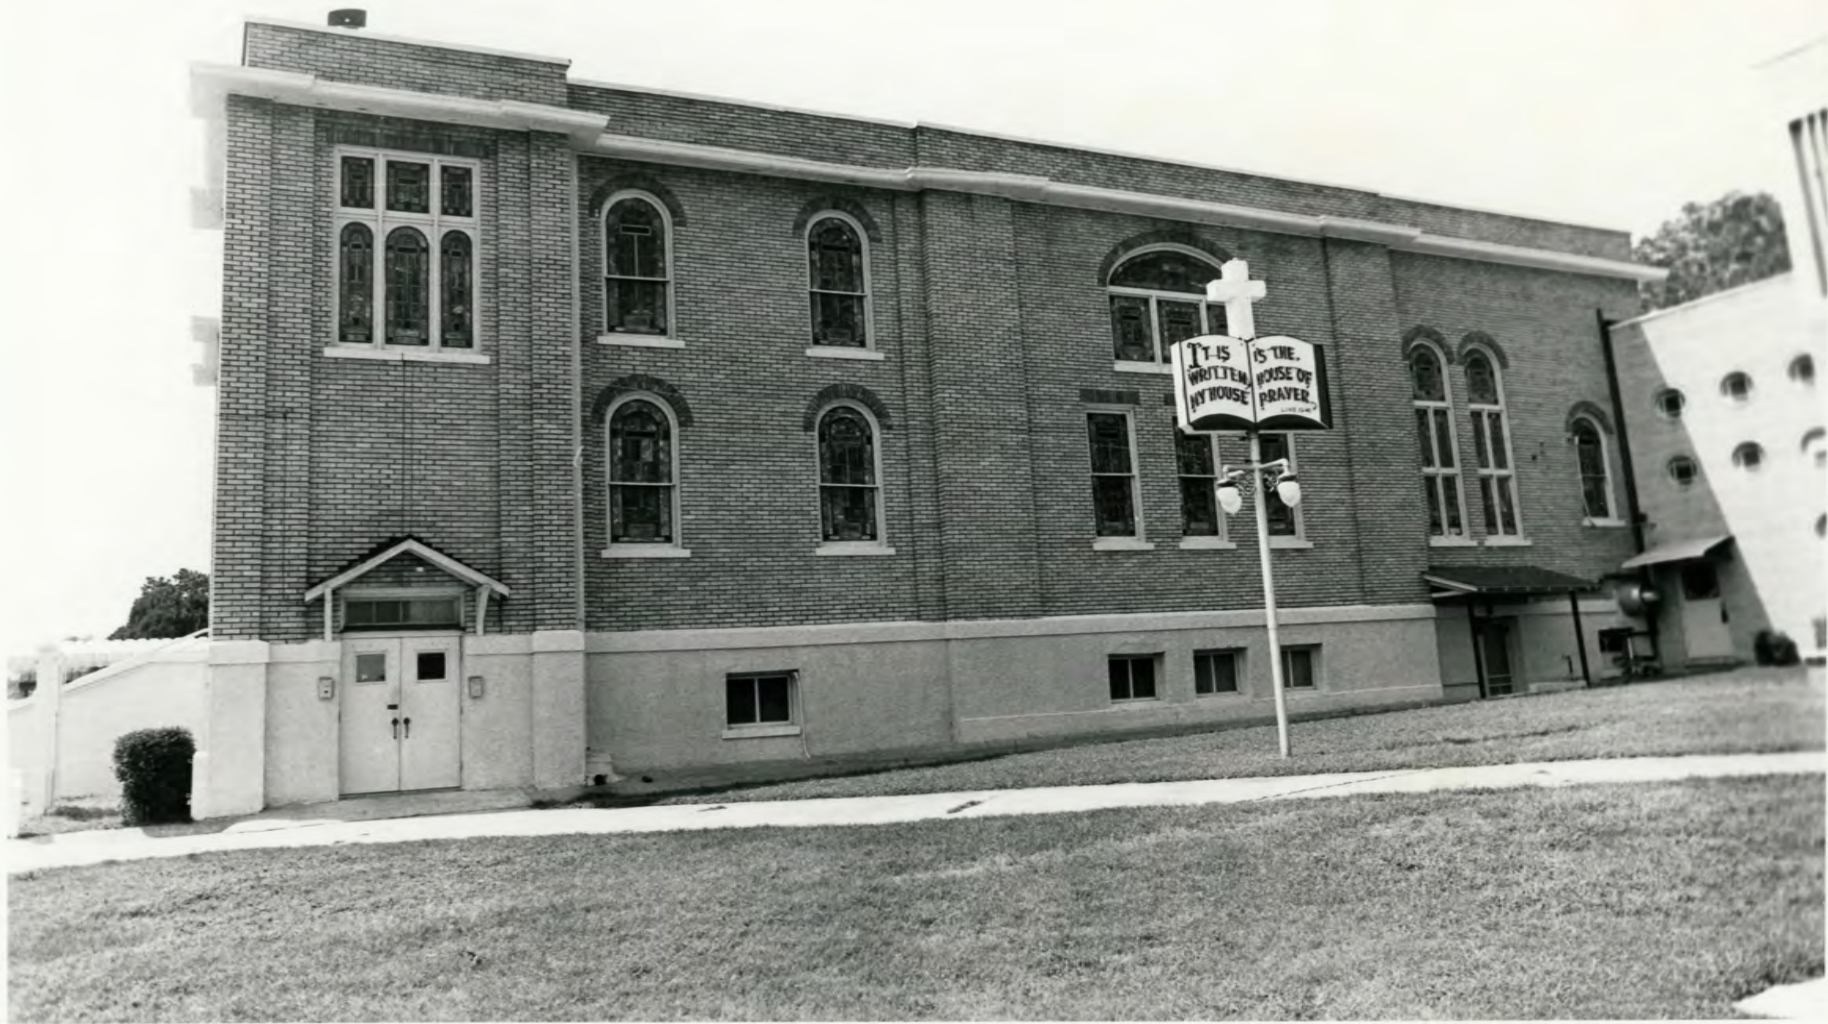
Mt. Zion Baptist Church
Little Rock, Pulaski Co.
North side elevation
Photographed by Robert Gunnels
August 1986

The south and north elevations are similarly ordered, each with five bays. The former has a center bay which extends beyond the essentially rectangular body of the structure.

The north elevation has access to the basement through a door in the bay of the east end at grade and another entry below grade with a short stair on the opposite end. The window placement along these elevations provides a pleasing rhythmic pattern of a group of three windows, a pair of windows then single window. Varied window shapes include rectangular, square, arched and oculus. Pilasters for structural strength appear along both side elevations.

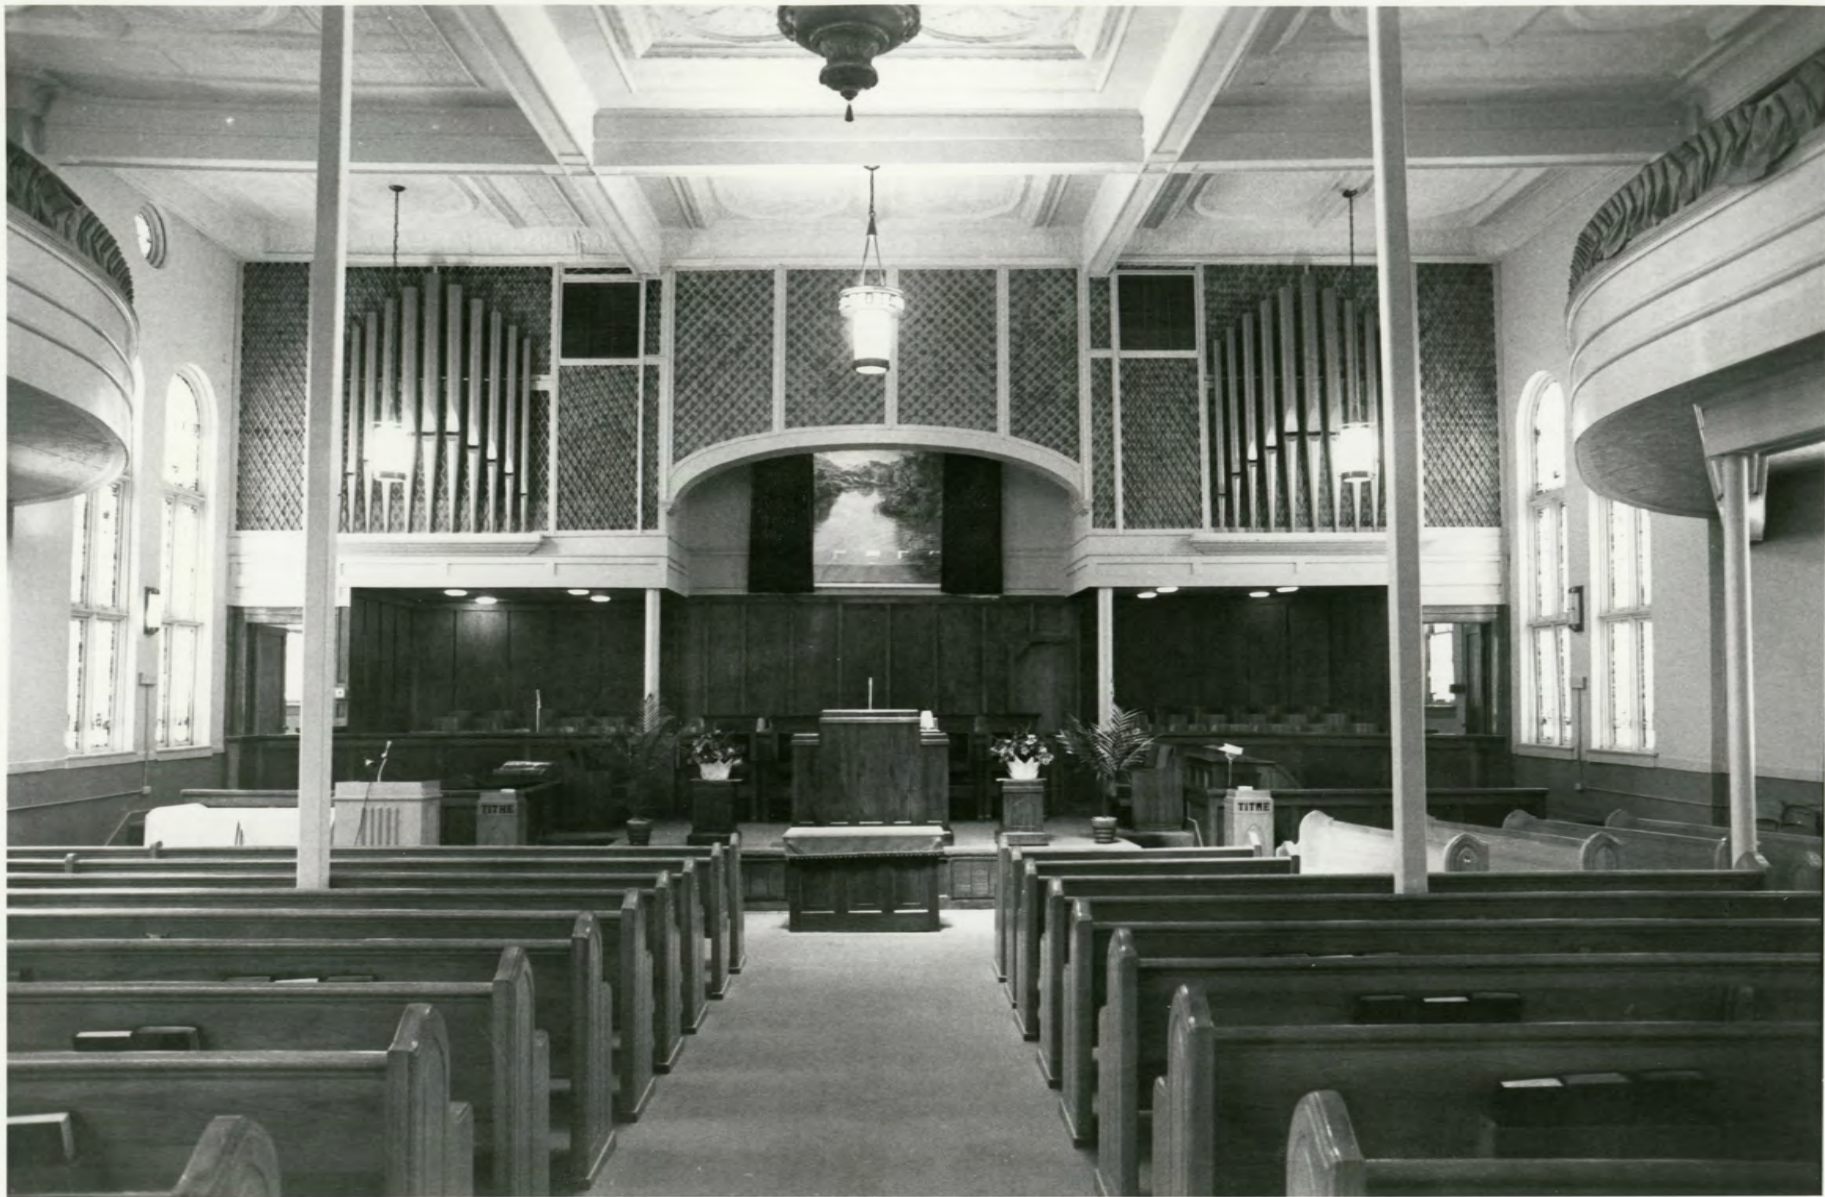
Mt. Zion Baptist Church
Little Rock, Pulaski Co.
Interior of sanctuary
Photographed by Mike Swanda
August 1986

The church's raised first story houses a large sanctuary with a U-shaped balcony. Symmetrical in plan, the interior is defined by an aisle down the center of the gently sloping floor flanked by two side aisles. The former is emphasized further by the placement of three chandeliers down this central axis. Two of these fixtures are recent additions in 1965; the middle chandelier, however, is an ornate copper-clad fixture suspended from an elliptically shaped skylight of multi-paned frosted glass. Organ pipes placed on both sides of the baptistry niche and mounted on a trellis-like grill adorned with decorative bosses also accentuate the structure's symmetry.

The visual terminus of the entrance axis, the center aisle, is the baptistry niche with a colorful mural. The pulpit and choir seating is located in front of the baptistry. The panelling along the curved wall at the rear of the choir seating as well as the panelled handrail behind the pulpit were added in 1950. The choir seats, like those in the balcony, have molded plywood seatbacks, hardwood arm rests, and upholstered seats and are original to the structure. Similar seats were removed from the sanctuary about twenty years ago because they were heavily worn and were replaced by wooden pews.

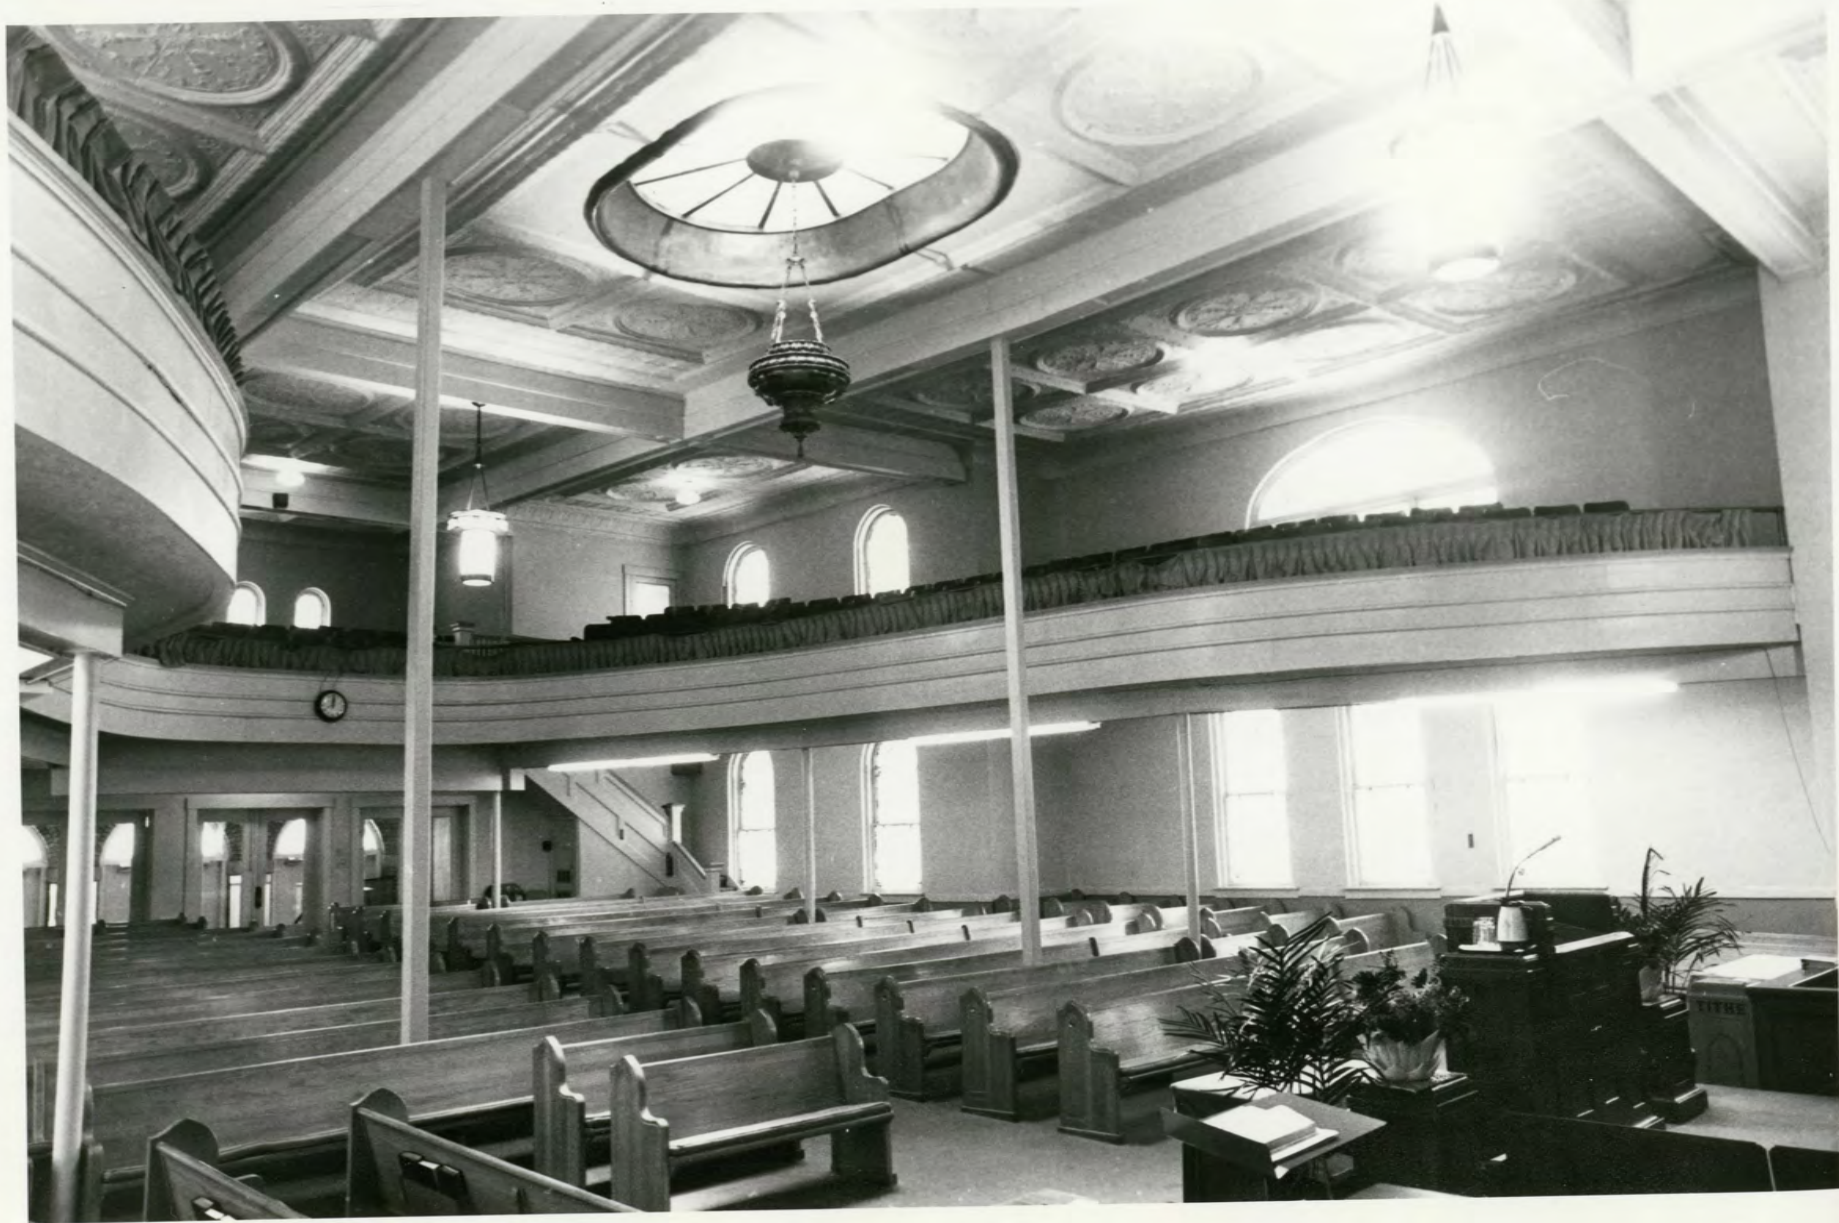
Mt. Zion Baptist Church
Little Rock, Pulaski Co.
Interior of sanctuary
Photographed by Mike Swanda
August 1986

Large stained glass windows dominate the interior of the sanctuary. Along the north and south elevations, these handsome, rectilinear compositions of gold with accents of blue, brown, and purple are executed in the rhythmic pattern.

As noted earlier, the balcony seating dates to the church's construction. A brass railing follows the interior contours of the balcony. The ceiling of the sanctuary is an ornate composition of pressed-metal decoration installed between a network of structural beams. Less ornate, yet still decorative metal ceilings are used in the vestibule, the baptistry and the basement. The decorative treatment of the metal cornice is classically derived and includes a dentil course and egg and dart motif.
