The Folger Coffee Company
SAN FRANCISCO, CALIFORNIA

Folger Coffee Company Building
San Francisco, California

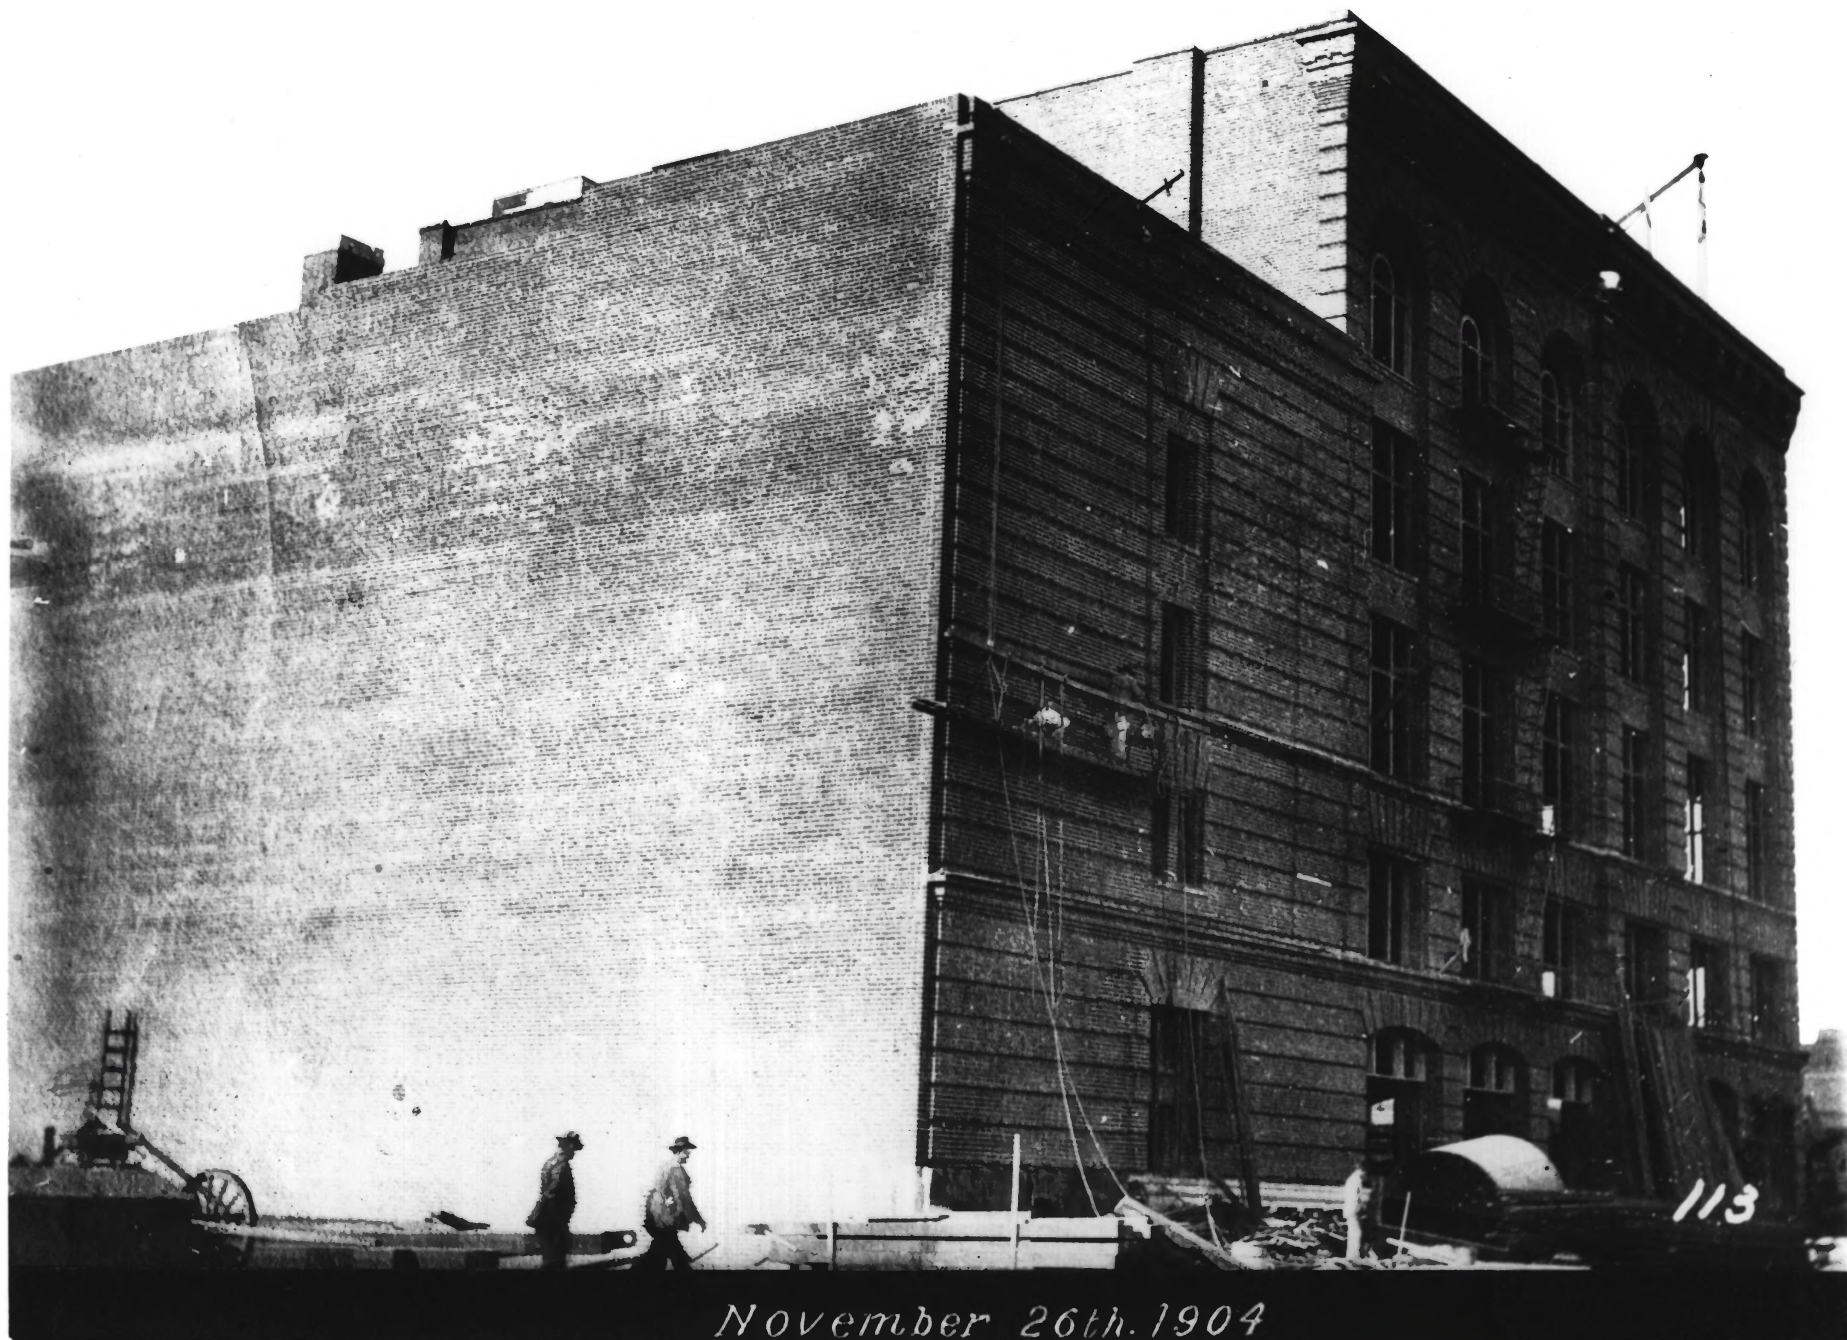
Photo TWO

Looking Northwest At the Spear Street
Facades of the Warehouse and Office/Manufacture
While Building is under Construction.

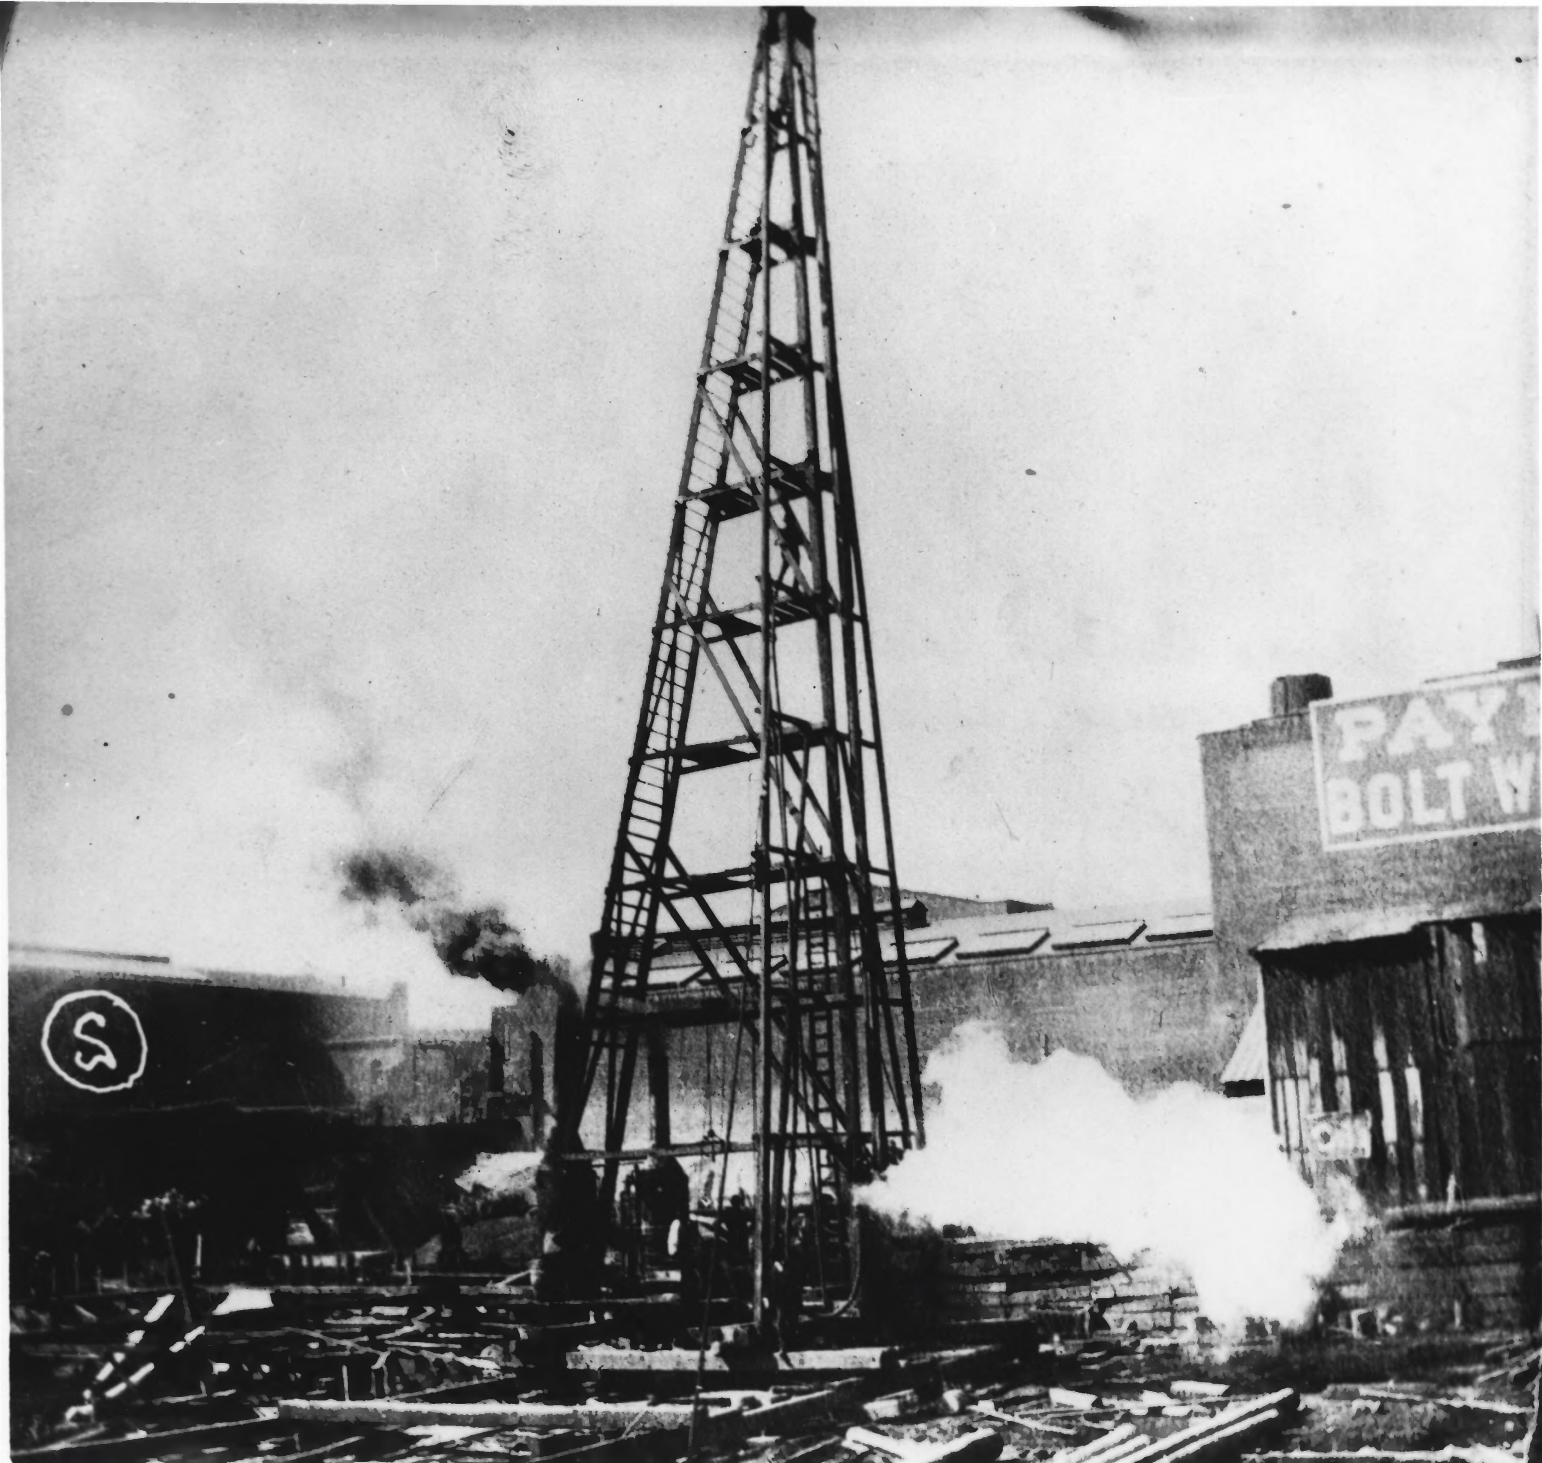
Photo Three.

STEAM driven pile driver, driving wood
pilings approximately 40 feet into BAY FILL.

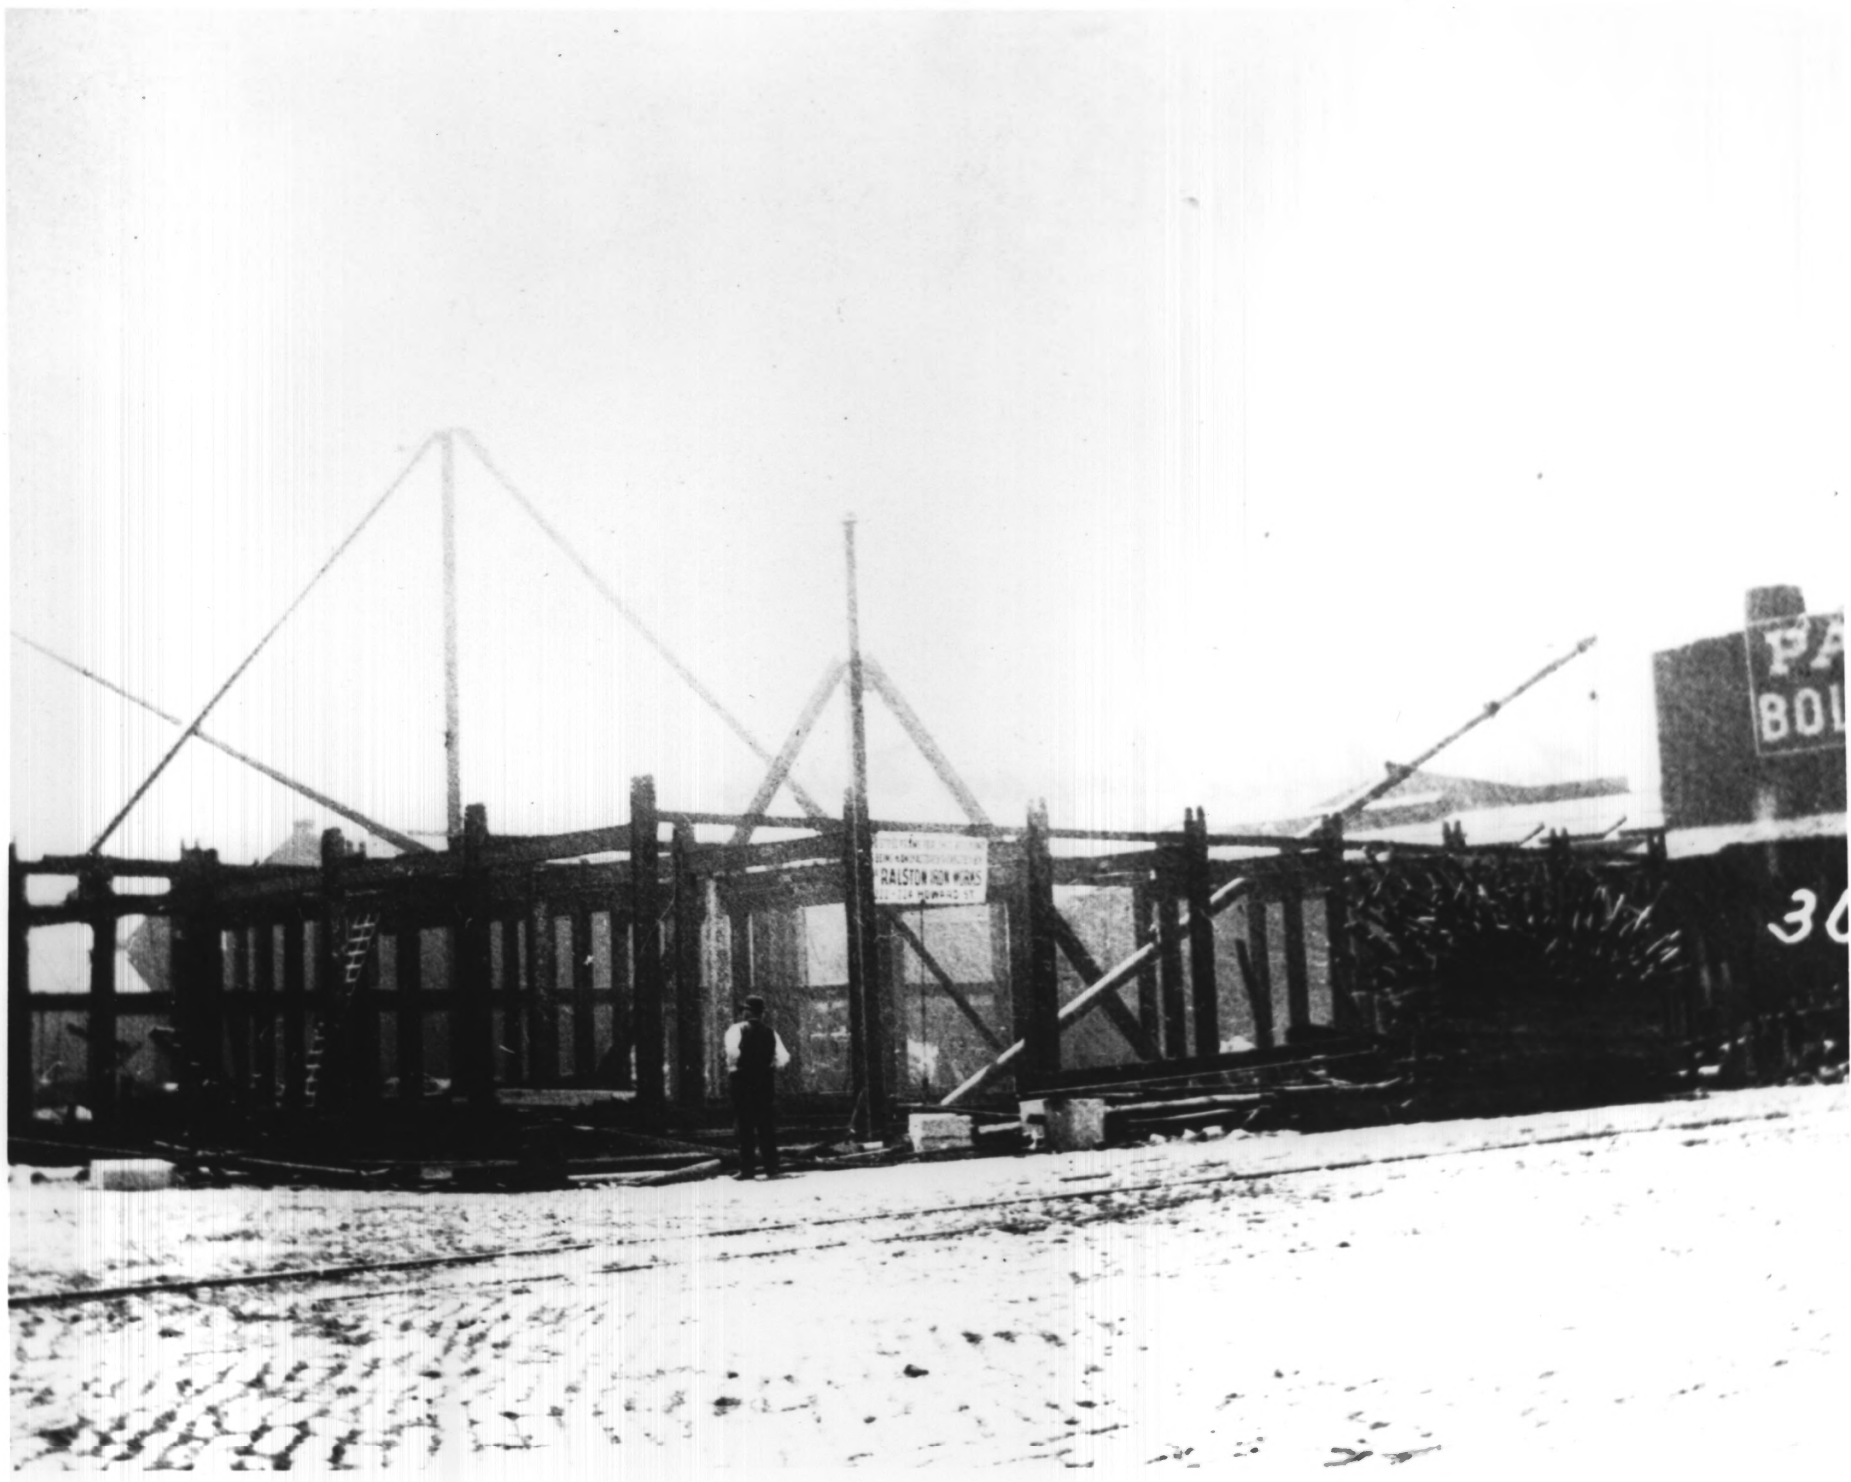
Photo Four.

Looking Southwest at ground floor
STRUCTURAL FRAMING.

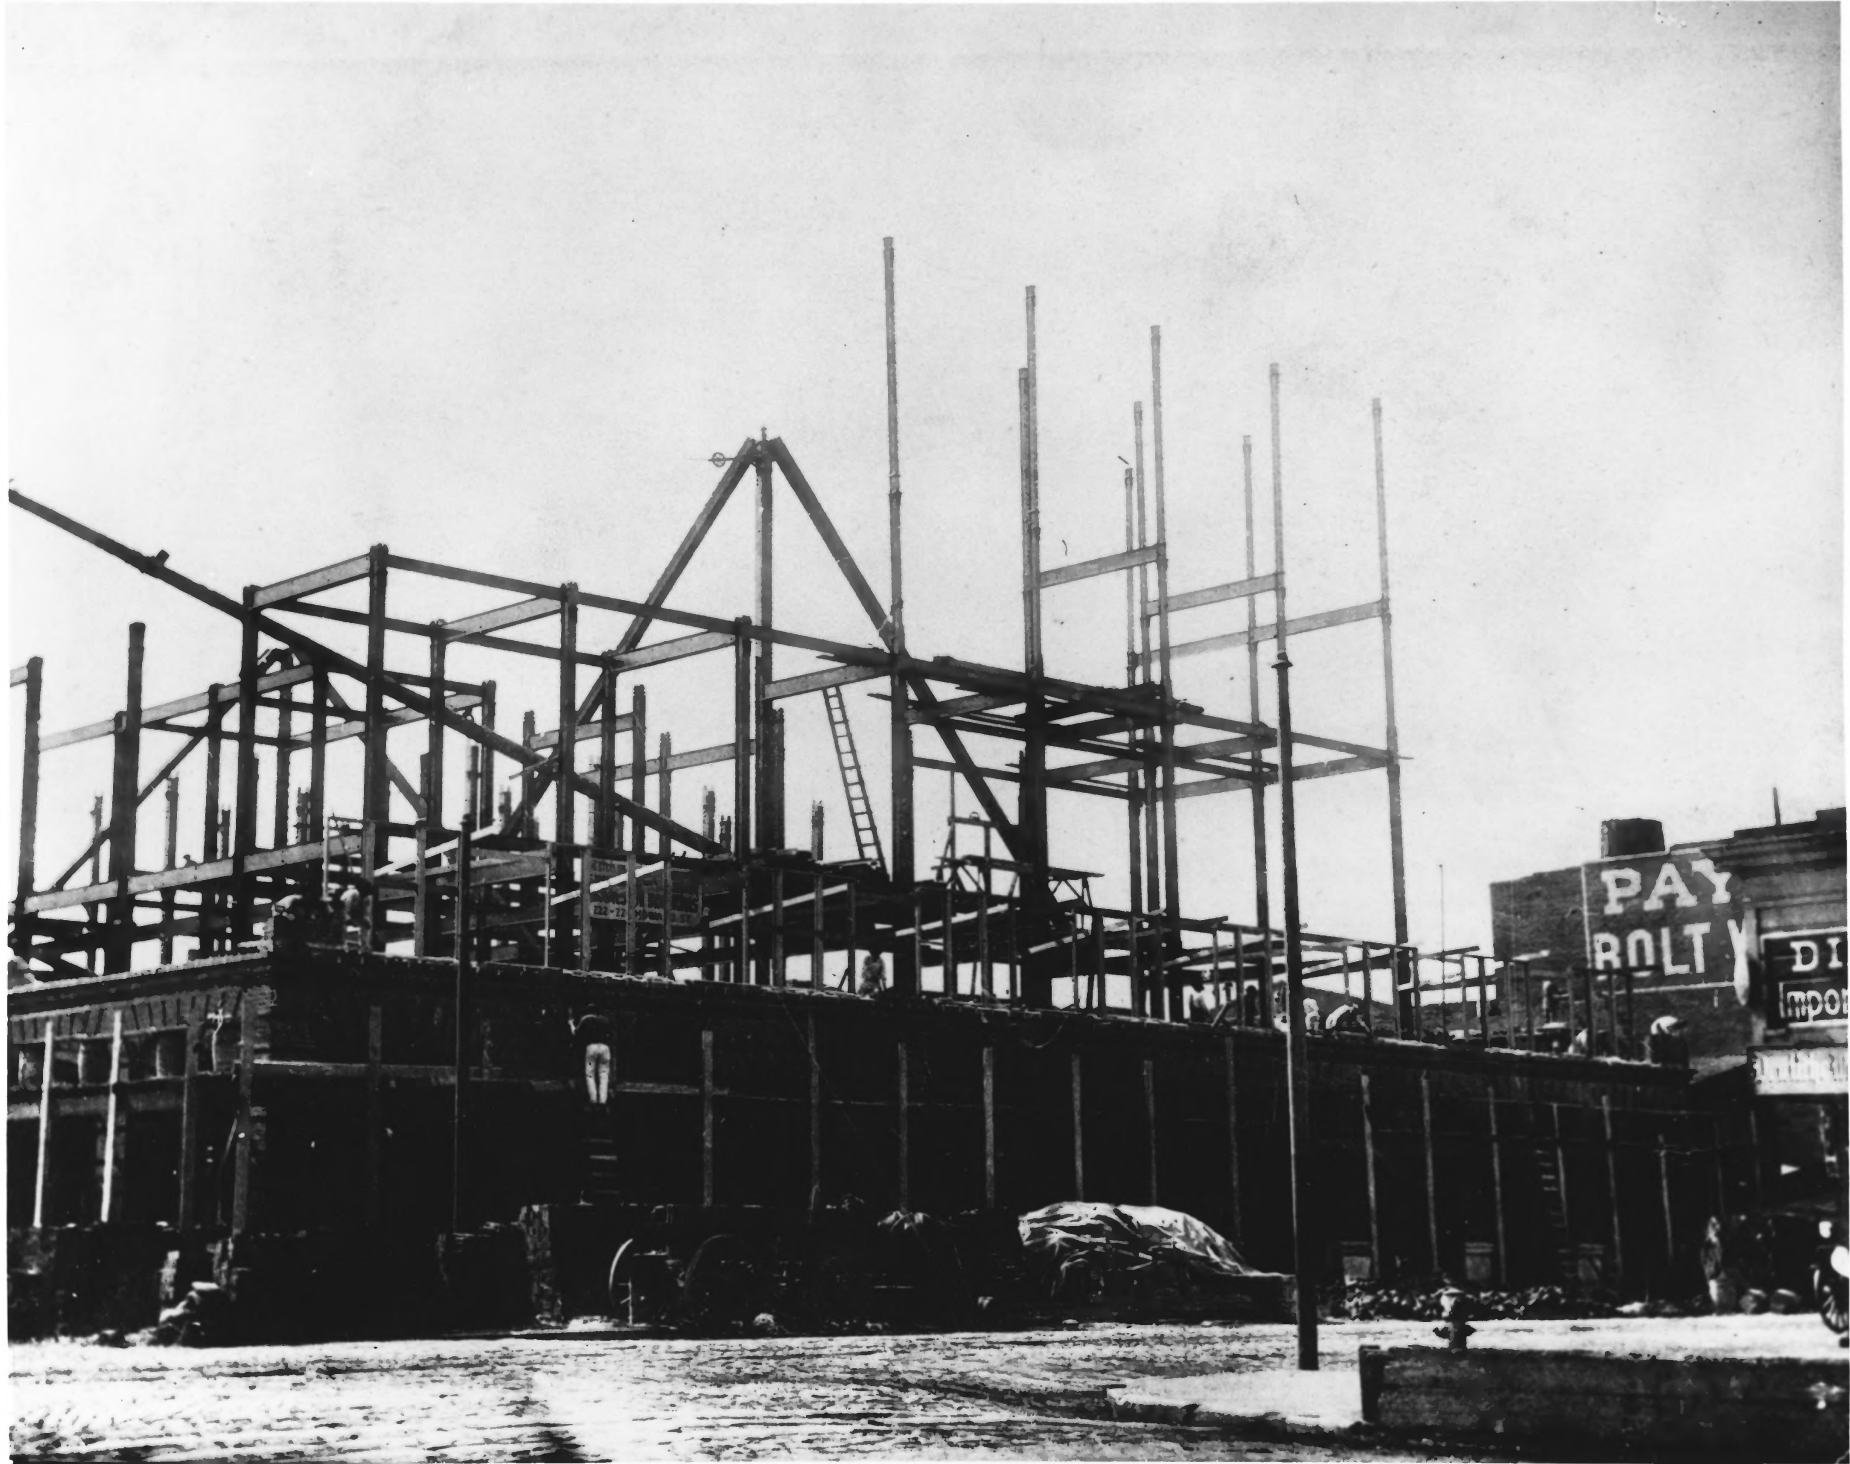
Photo Five.

Looking Southwest, SECOND FLOOR STRUCTURAL
FRAMING IS PROGRESSING; GROUND FLOOR BRICK
IS BEING LAID.

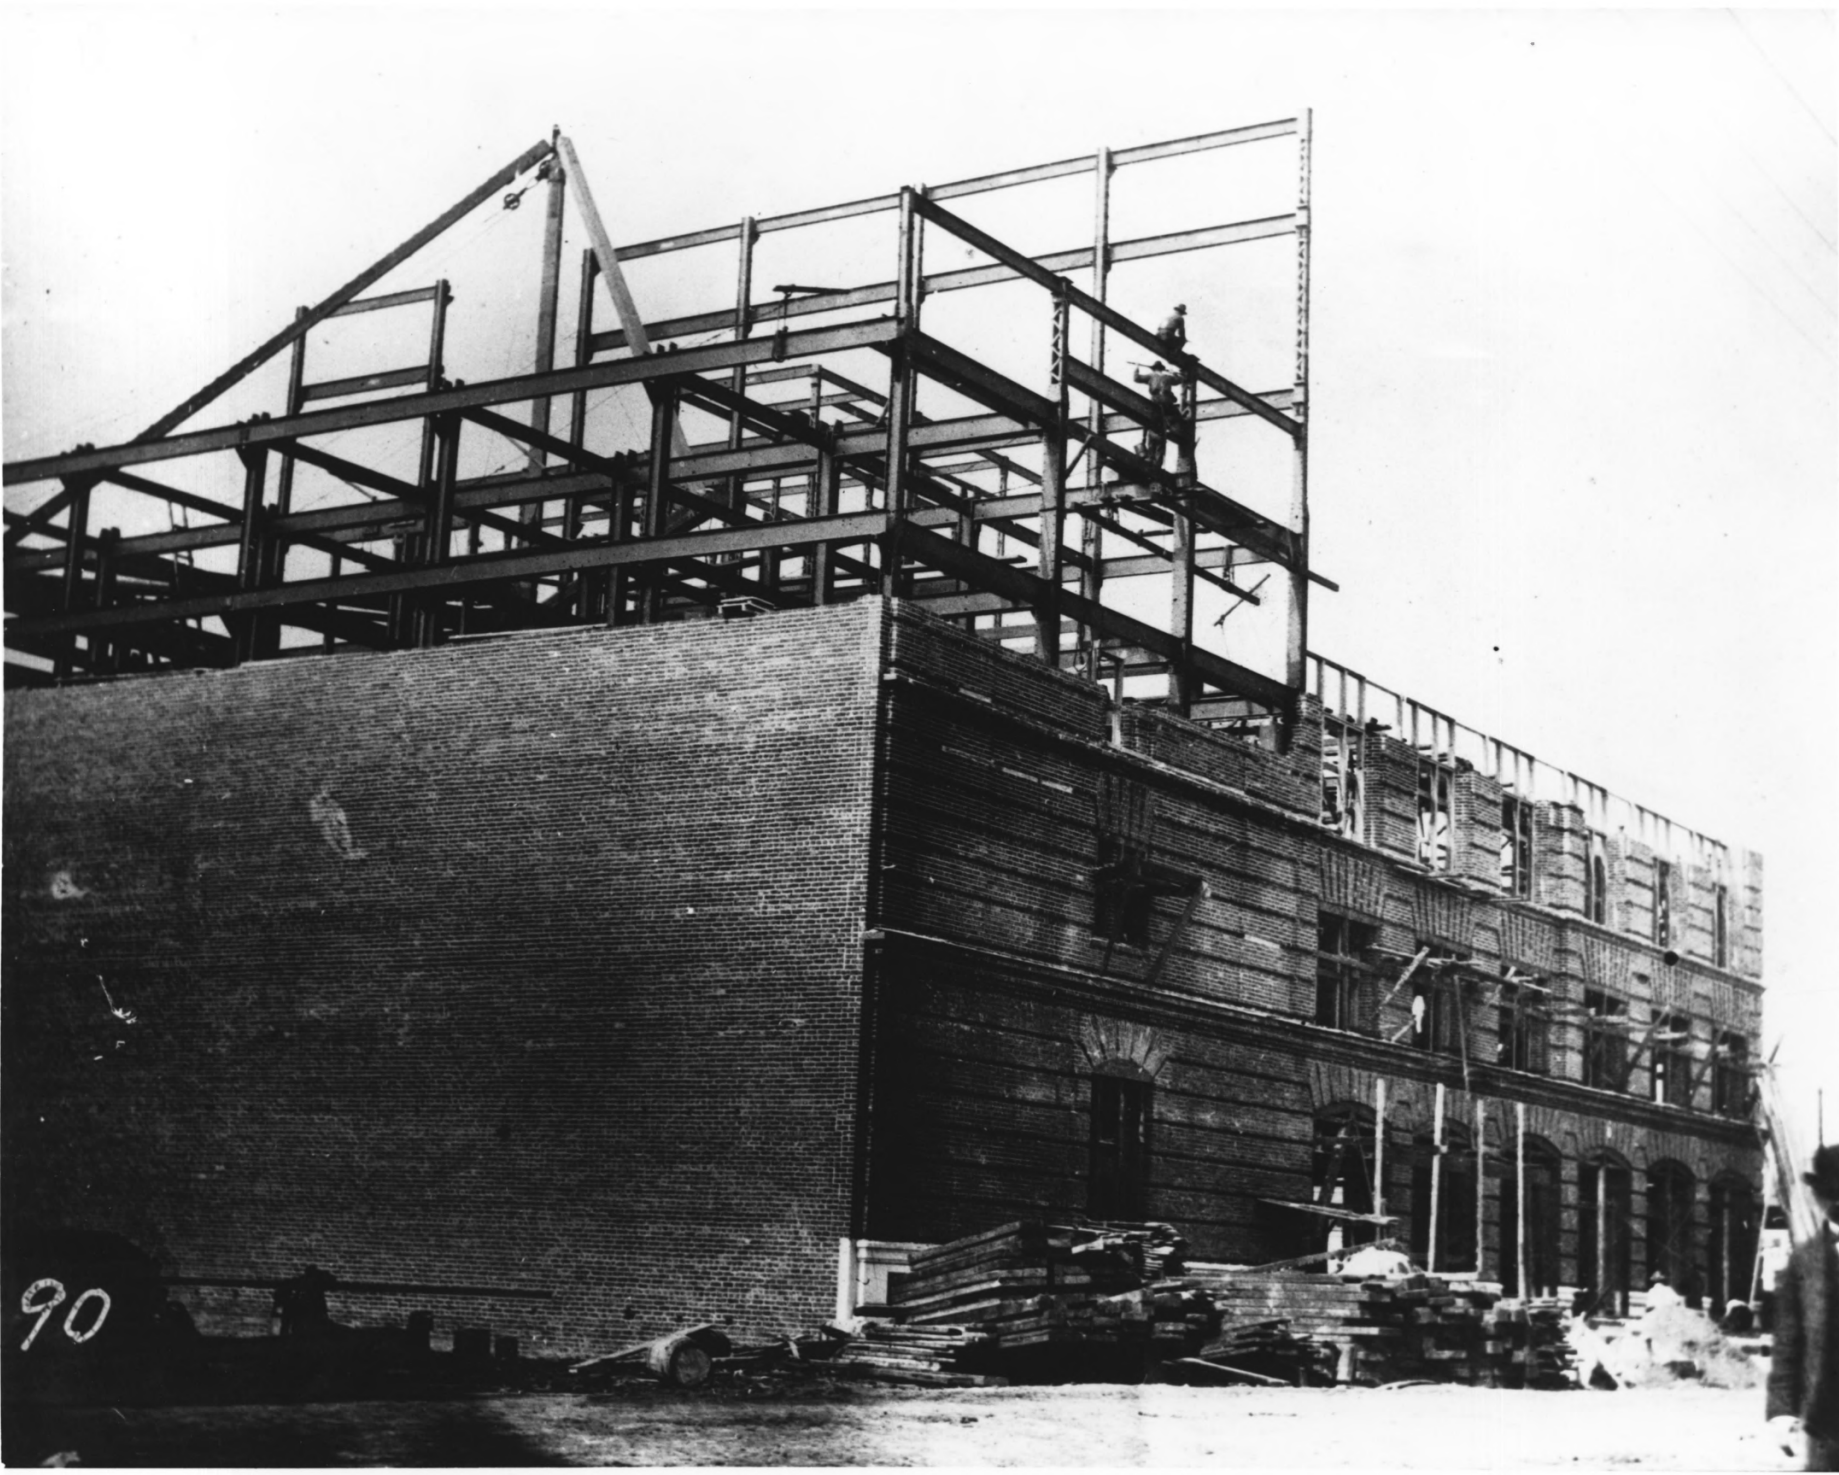
Photo 6.

Looking Northwest along Spear Street, the
STRUCTURAL Steel for the warehouse is
Rising. MASONRY has been LAID through the
SECOND FLOOR AND is almost complete at
the THIRD FLOOR level.

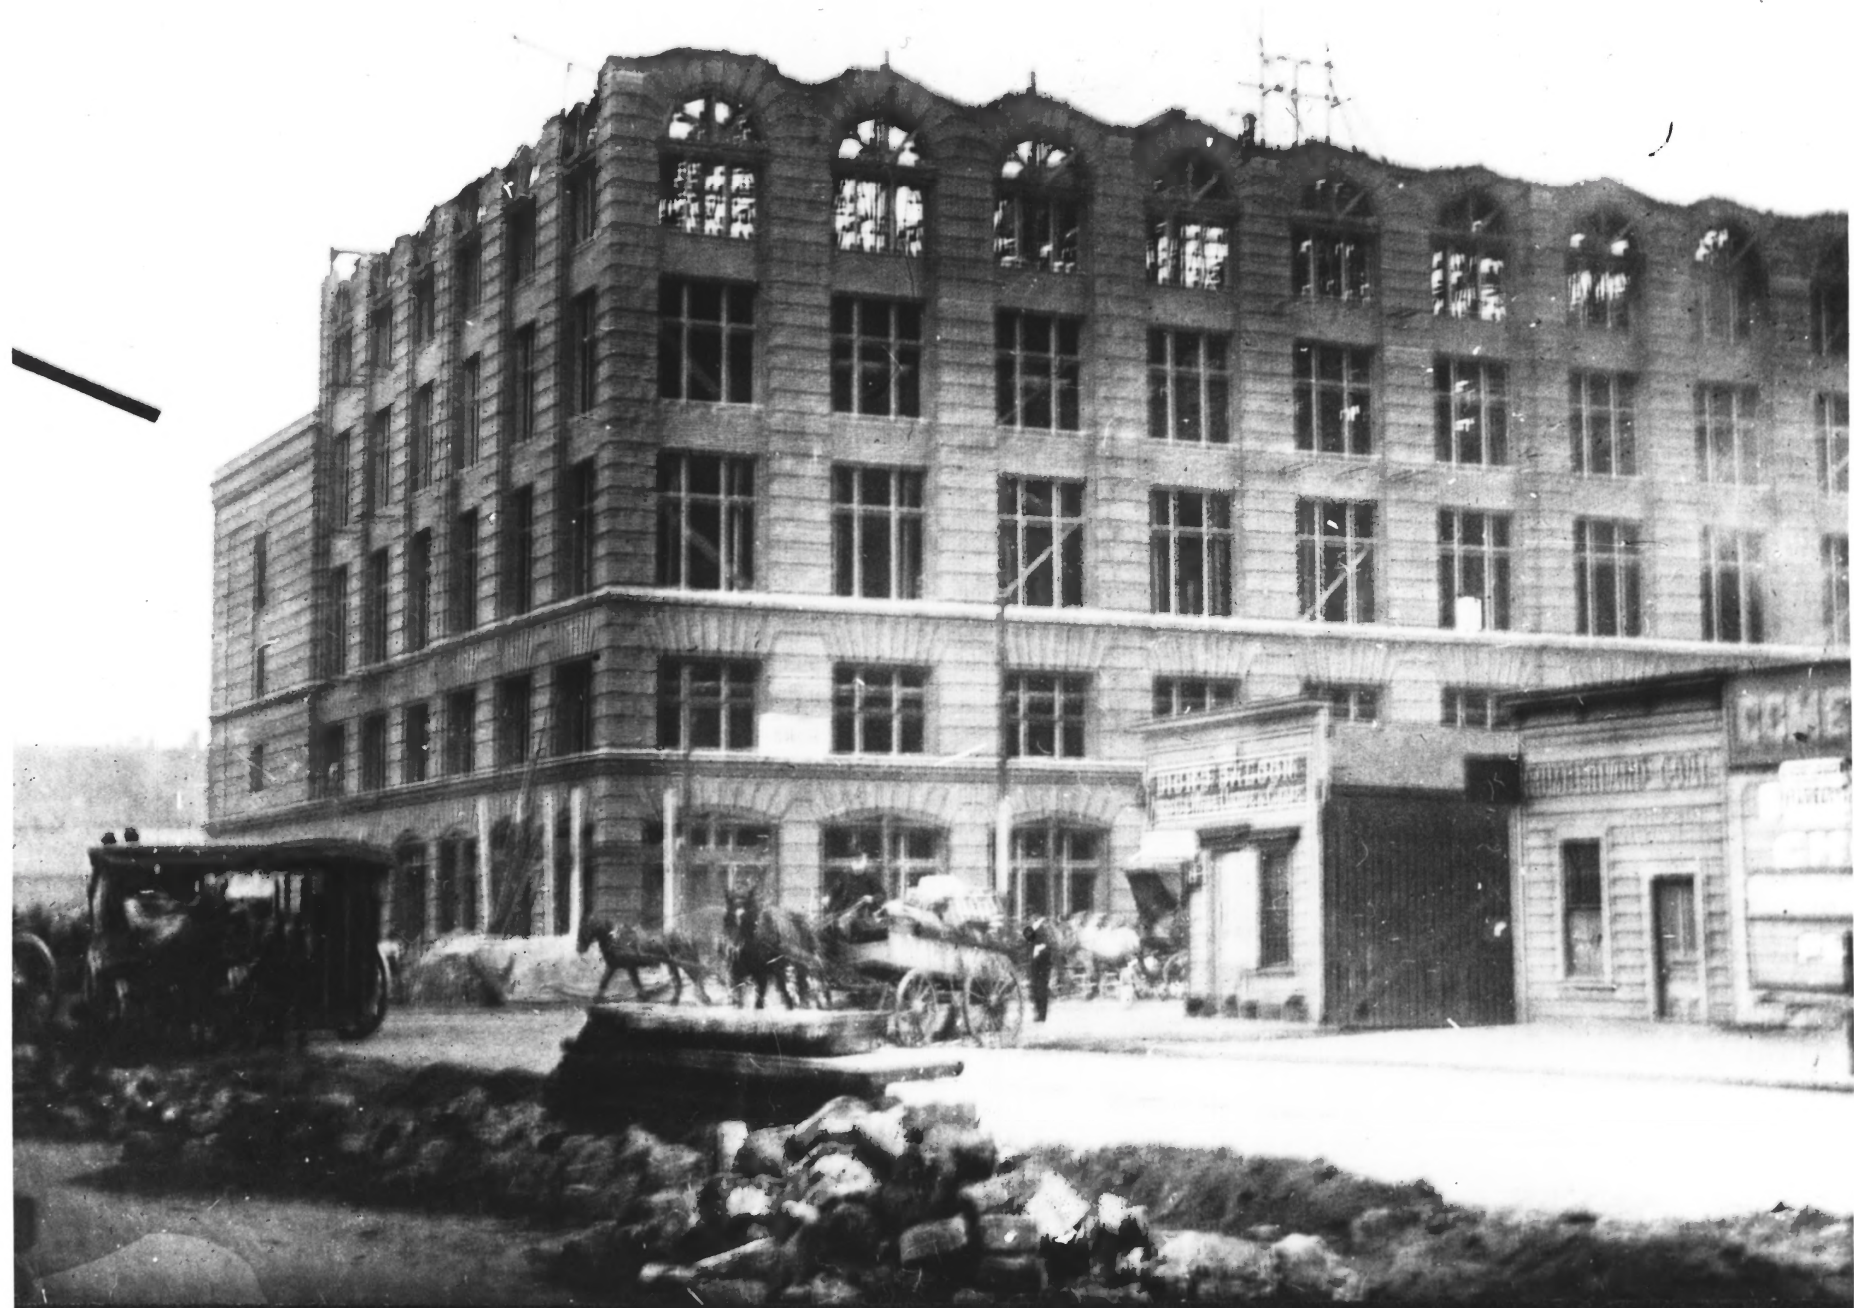
Photo 7.

Looking Southwest, the Warehouse portion on Spear Street appears complete. The office and manufactory are complete to the fifth floor and appears to be awaiting a roof. Note one-story wood structures in foreground.

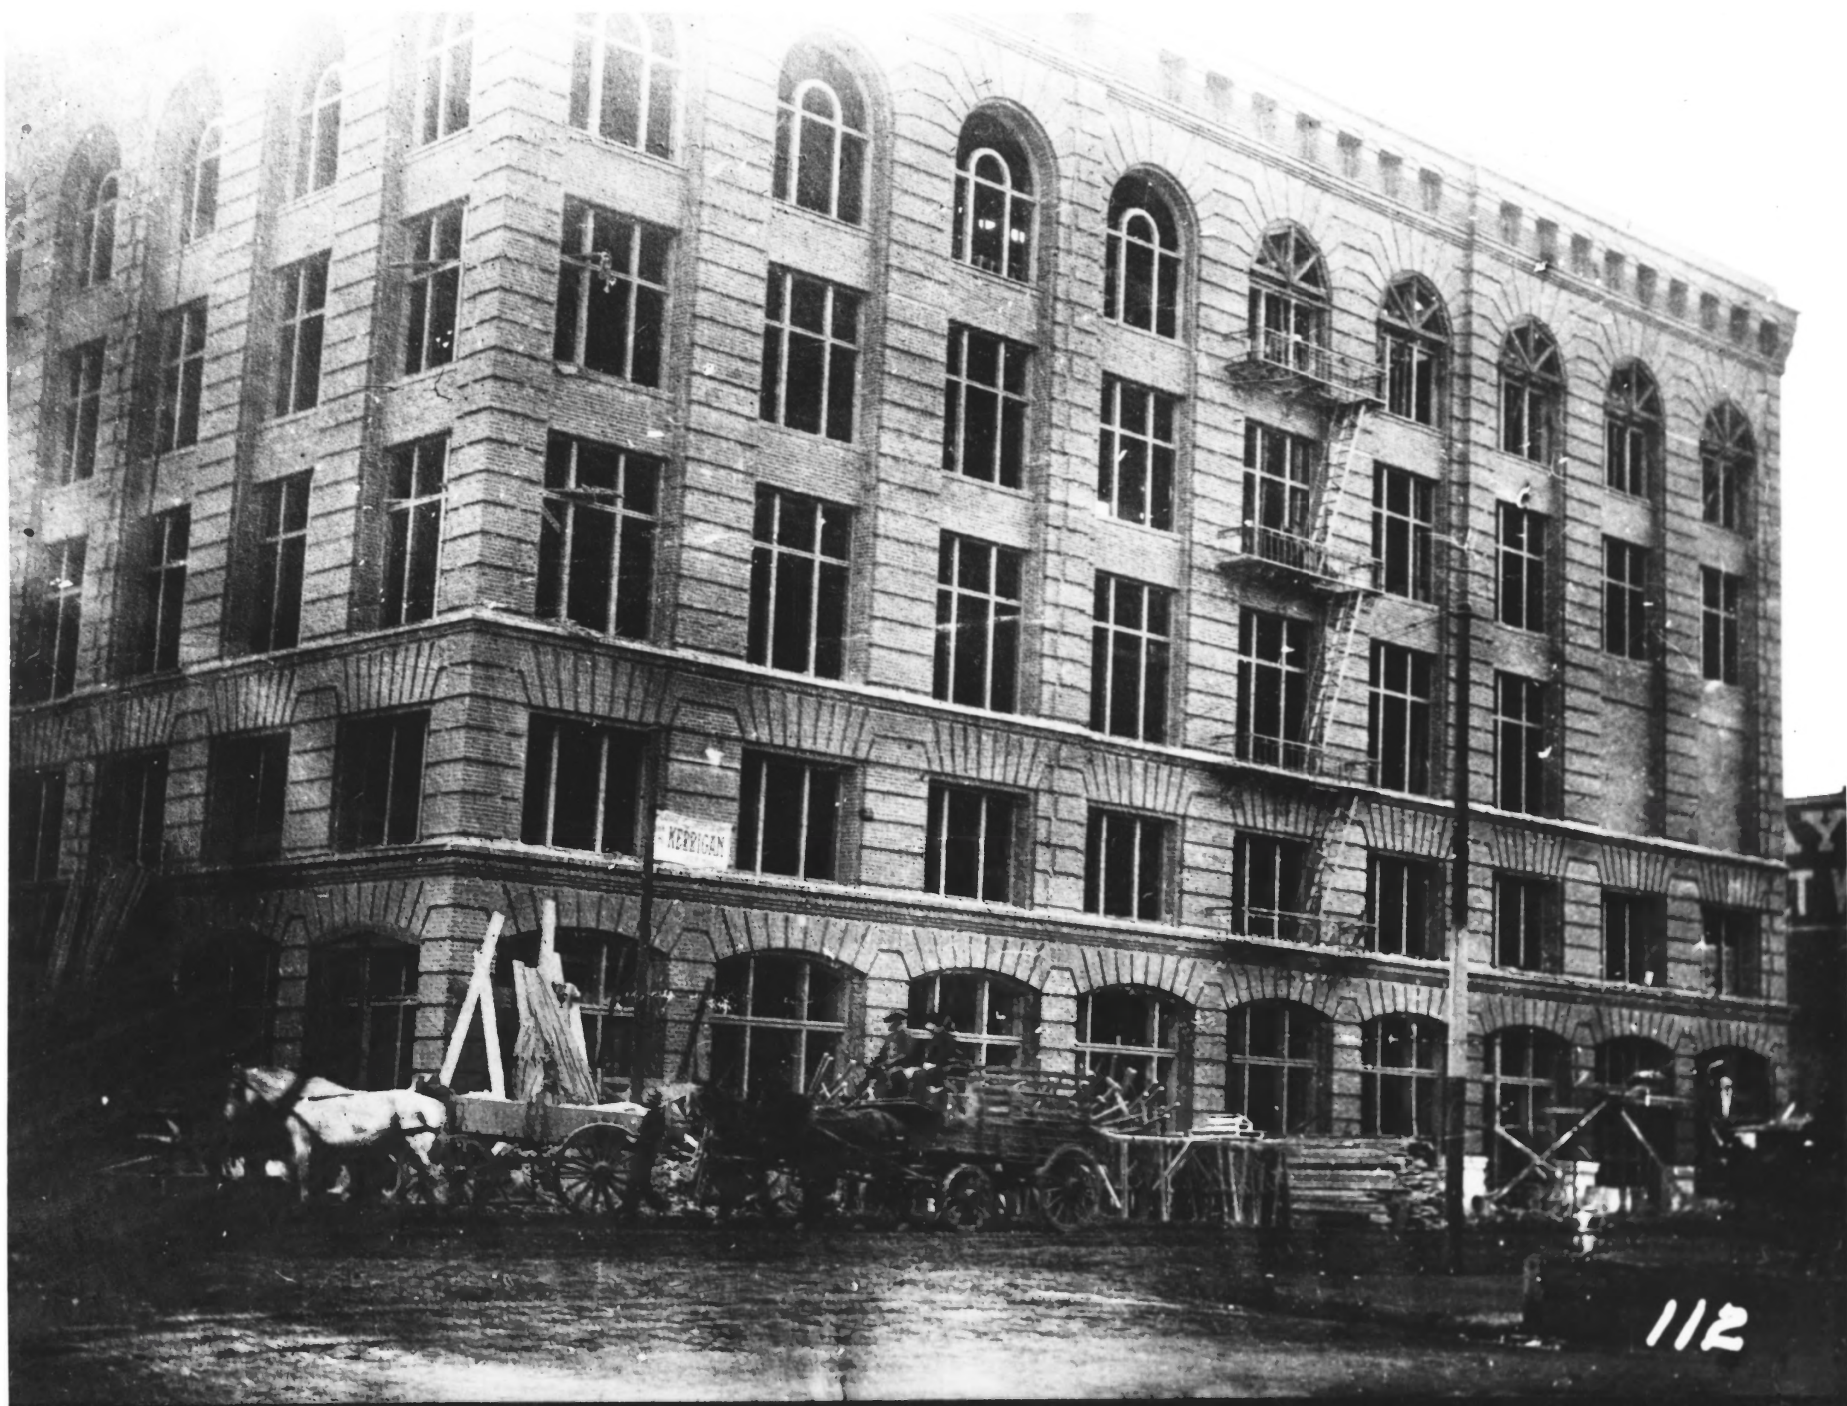
Photo 8.

Looking Southwest with HOWARD Street
elevation in foreground, Corbelled Cornice
IS IN PLACE.

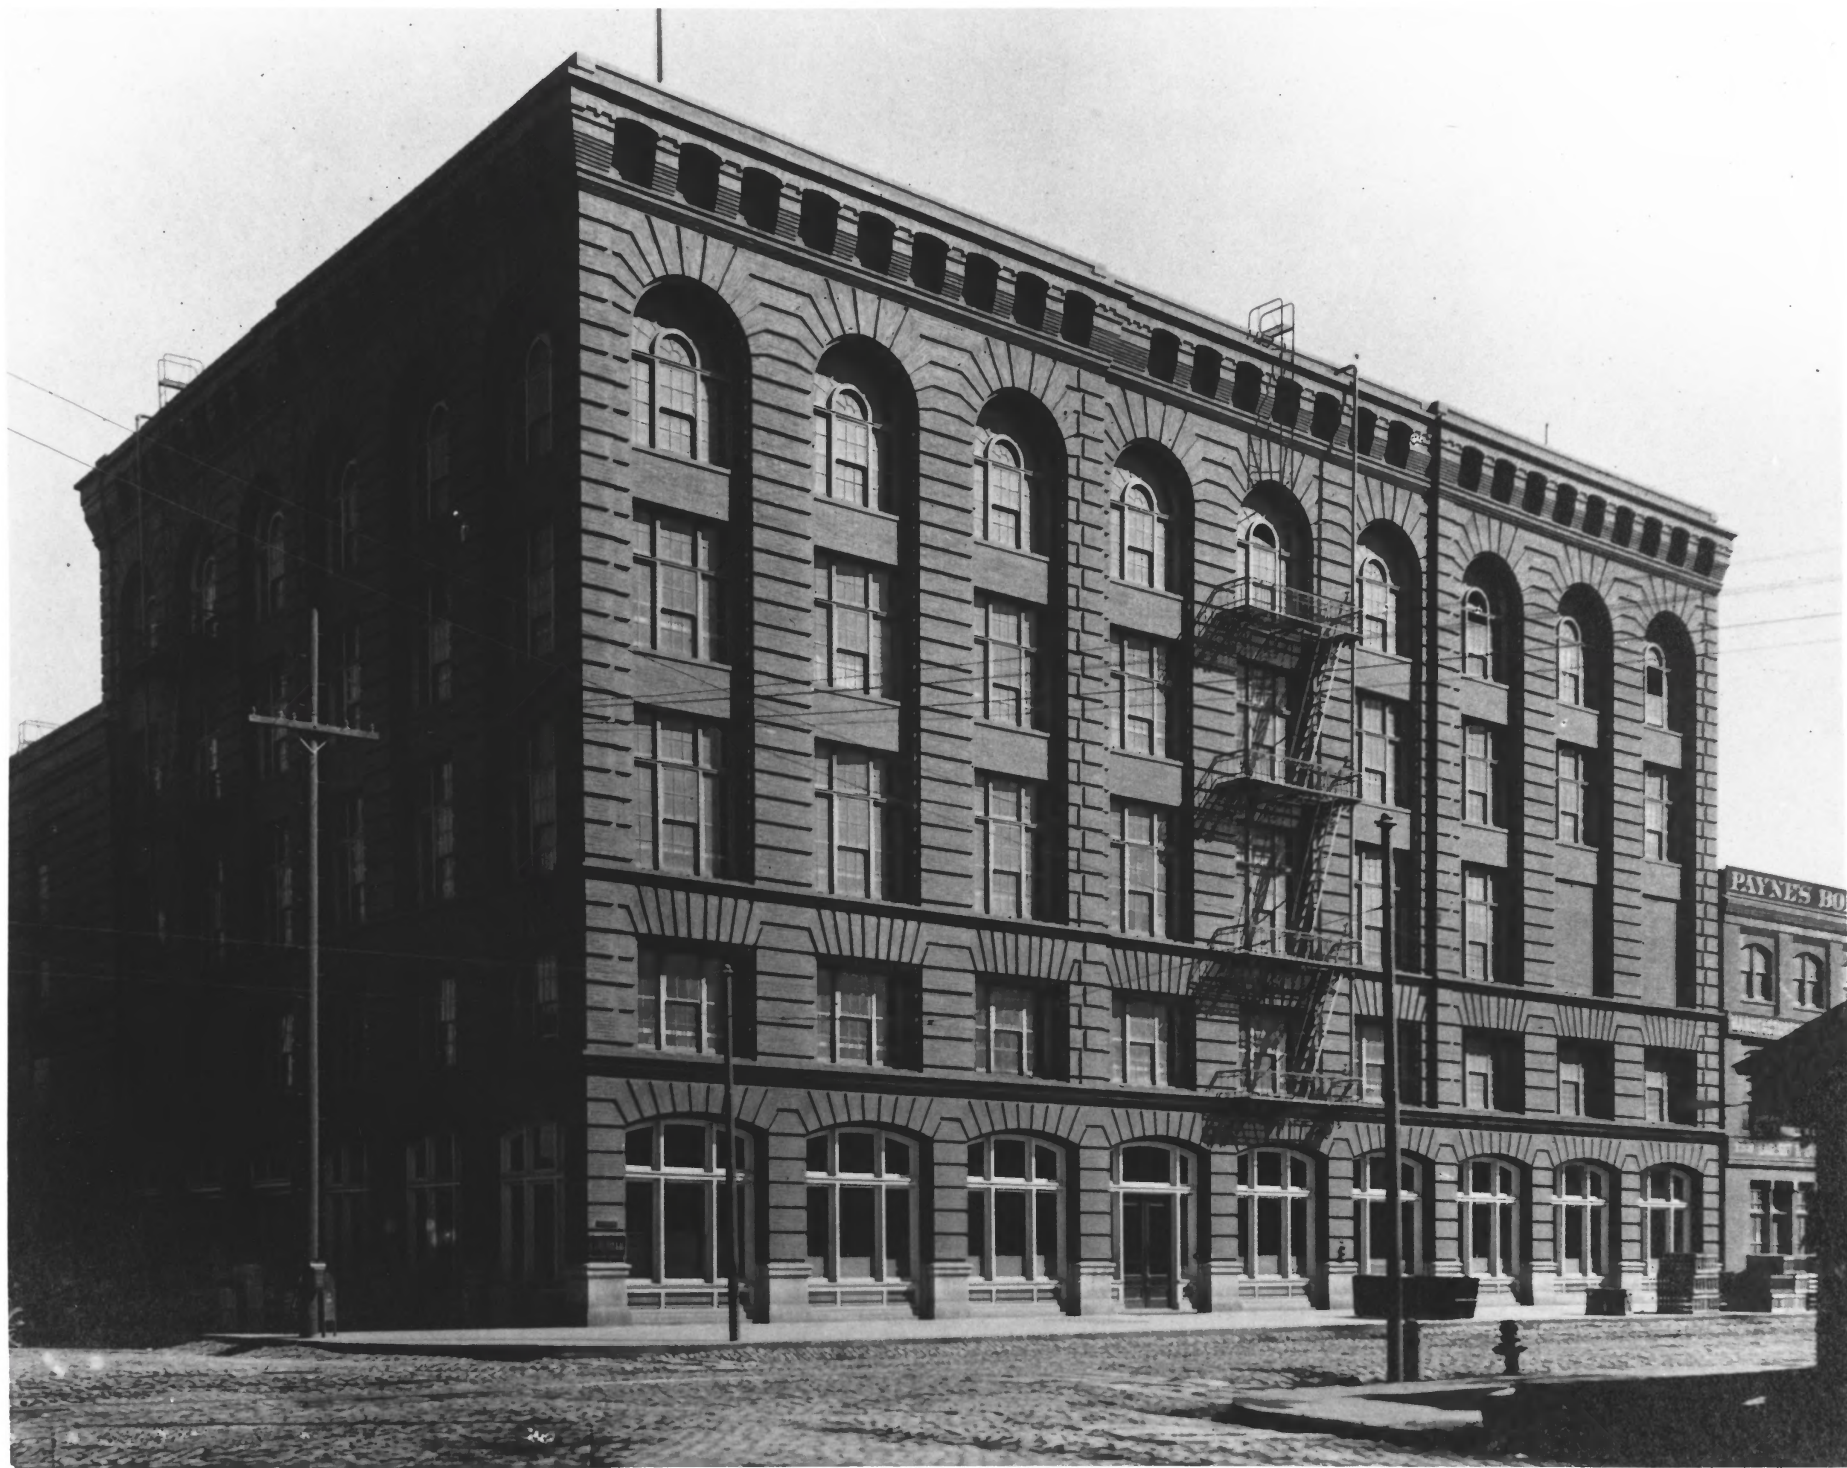
Photo 9.

Looking Southwest, building is complete.
Sun on North or Howard Street facade
shows brick work very clearly.
