The Folger Coffee Company
SAN FRANCISCO, CALIFORNIA

Folger Coffee Company Building
San Francisco, California

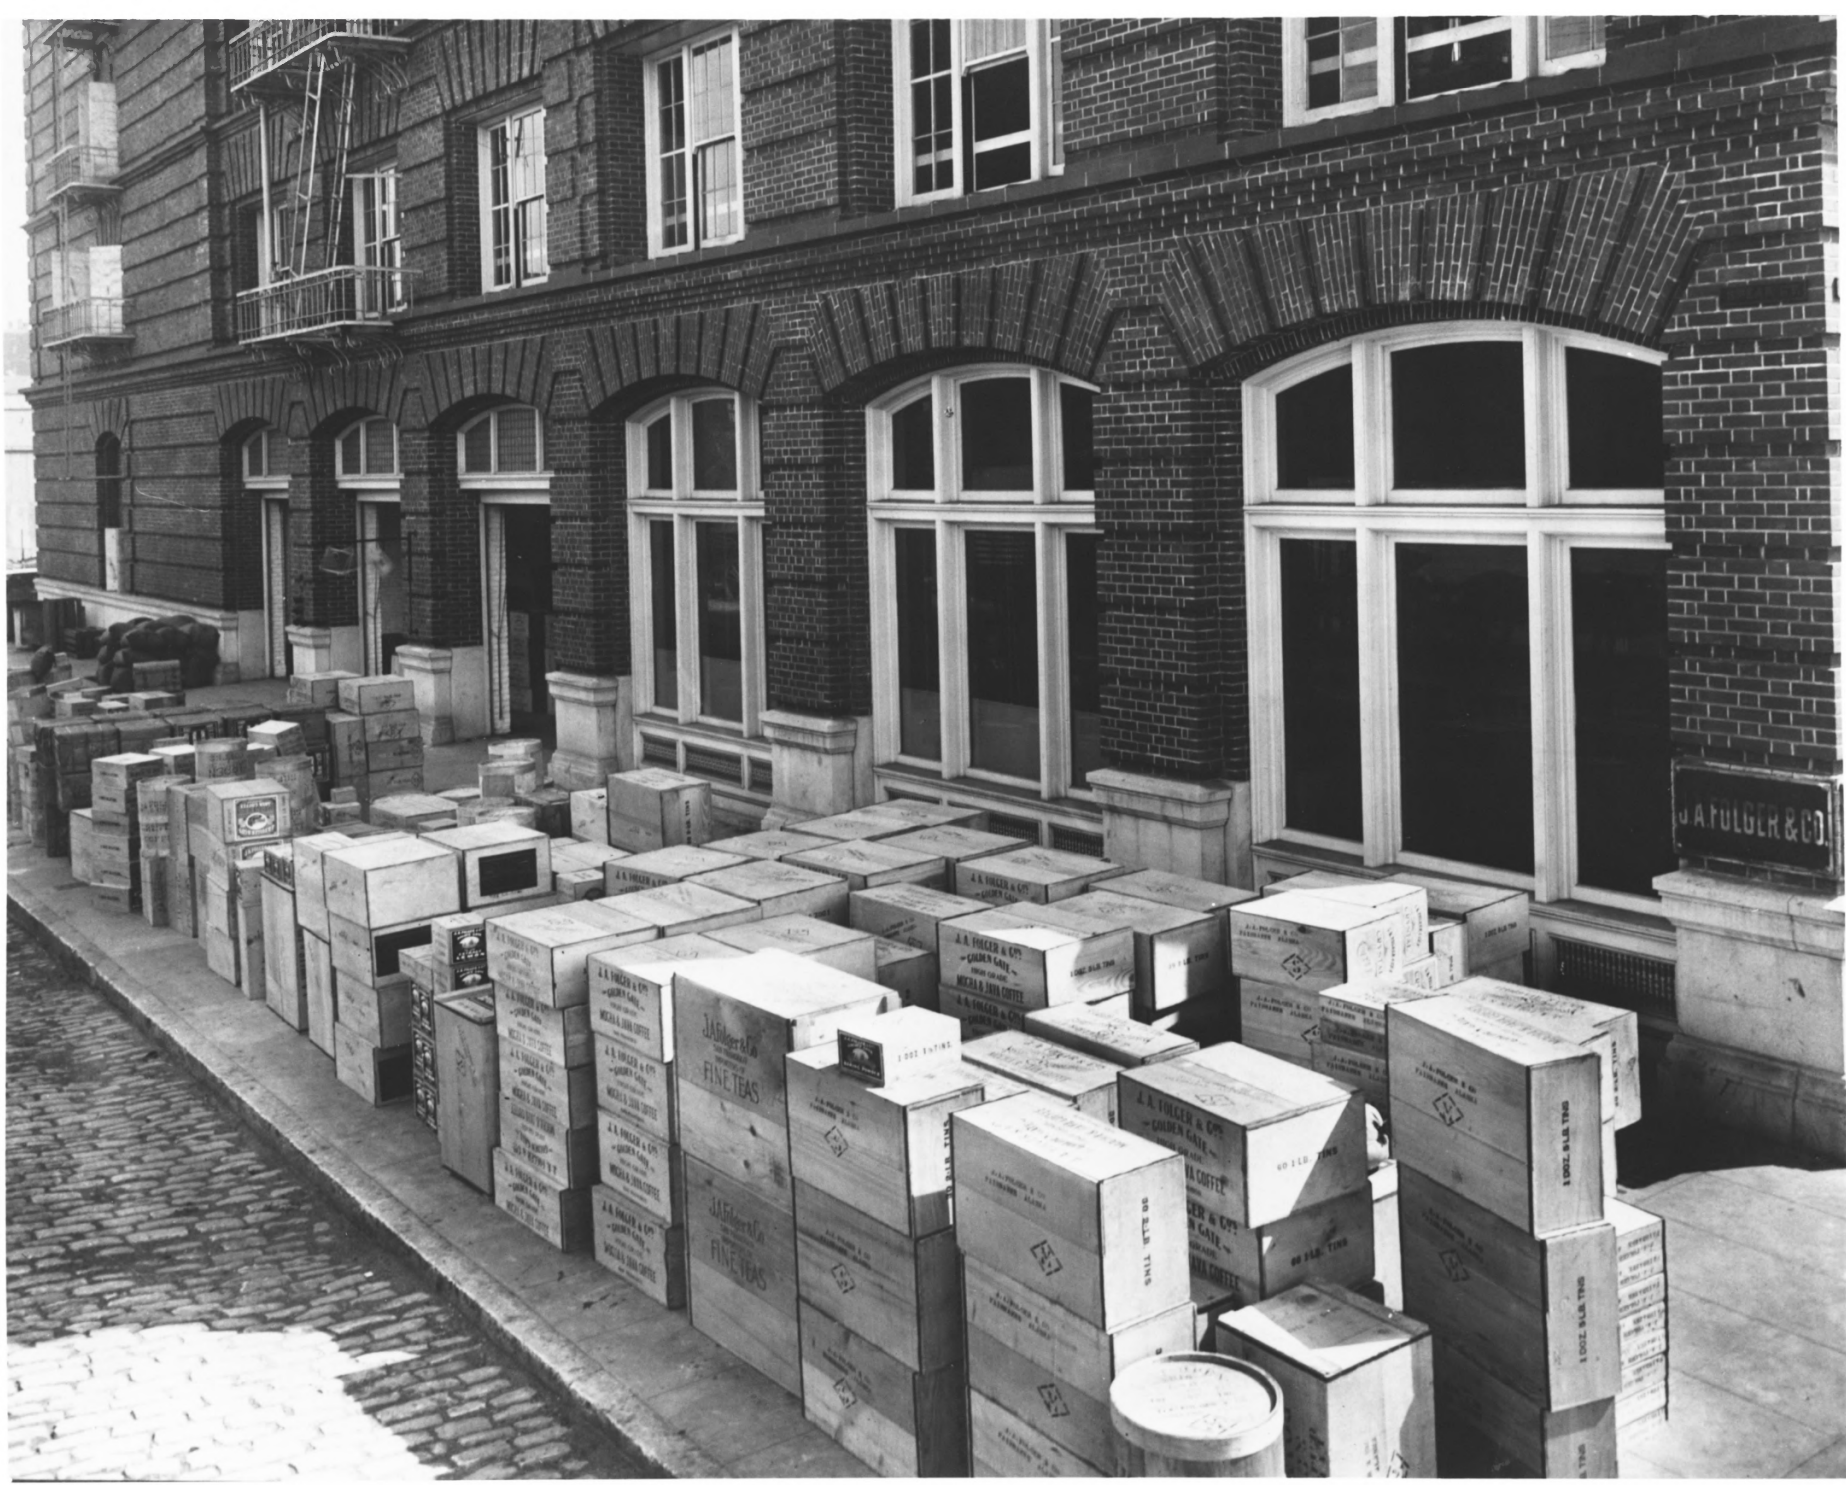
Photo 10.

Looking Southwest at lower floors of
Spear Street facade. Note COMPANY SIGN,
GRANITE BASE WITH ORNAMENTAL GRILLES, AND
NO GROUND FLOOR DOOR INTO WAREHOUSE.
