**National Register of Historic Places
Inventory—Nomination Form**

historic Church of Christ

and/or common Revere Masonic Temple

street & number 265 Beach Street N/A not for publication

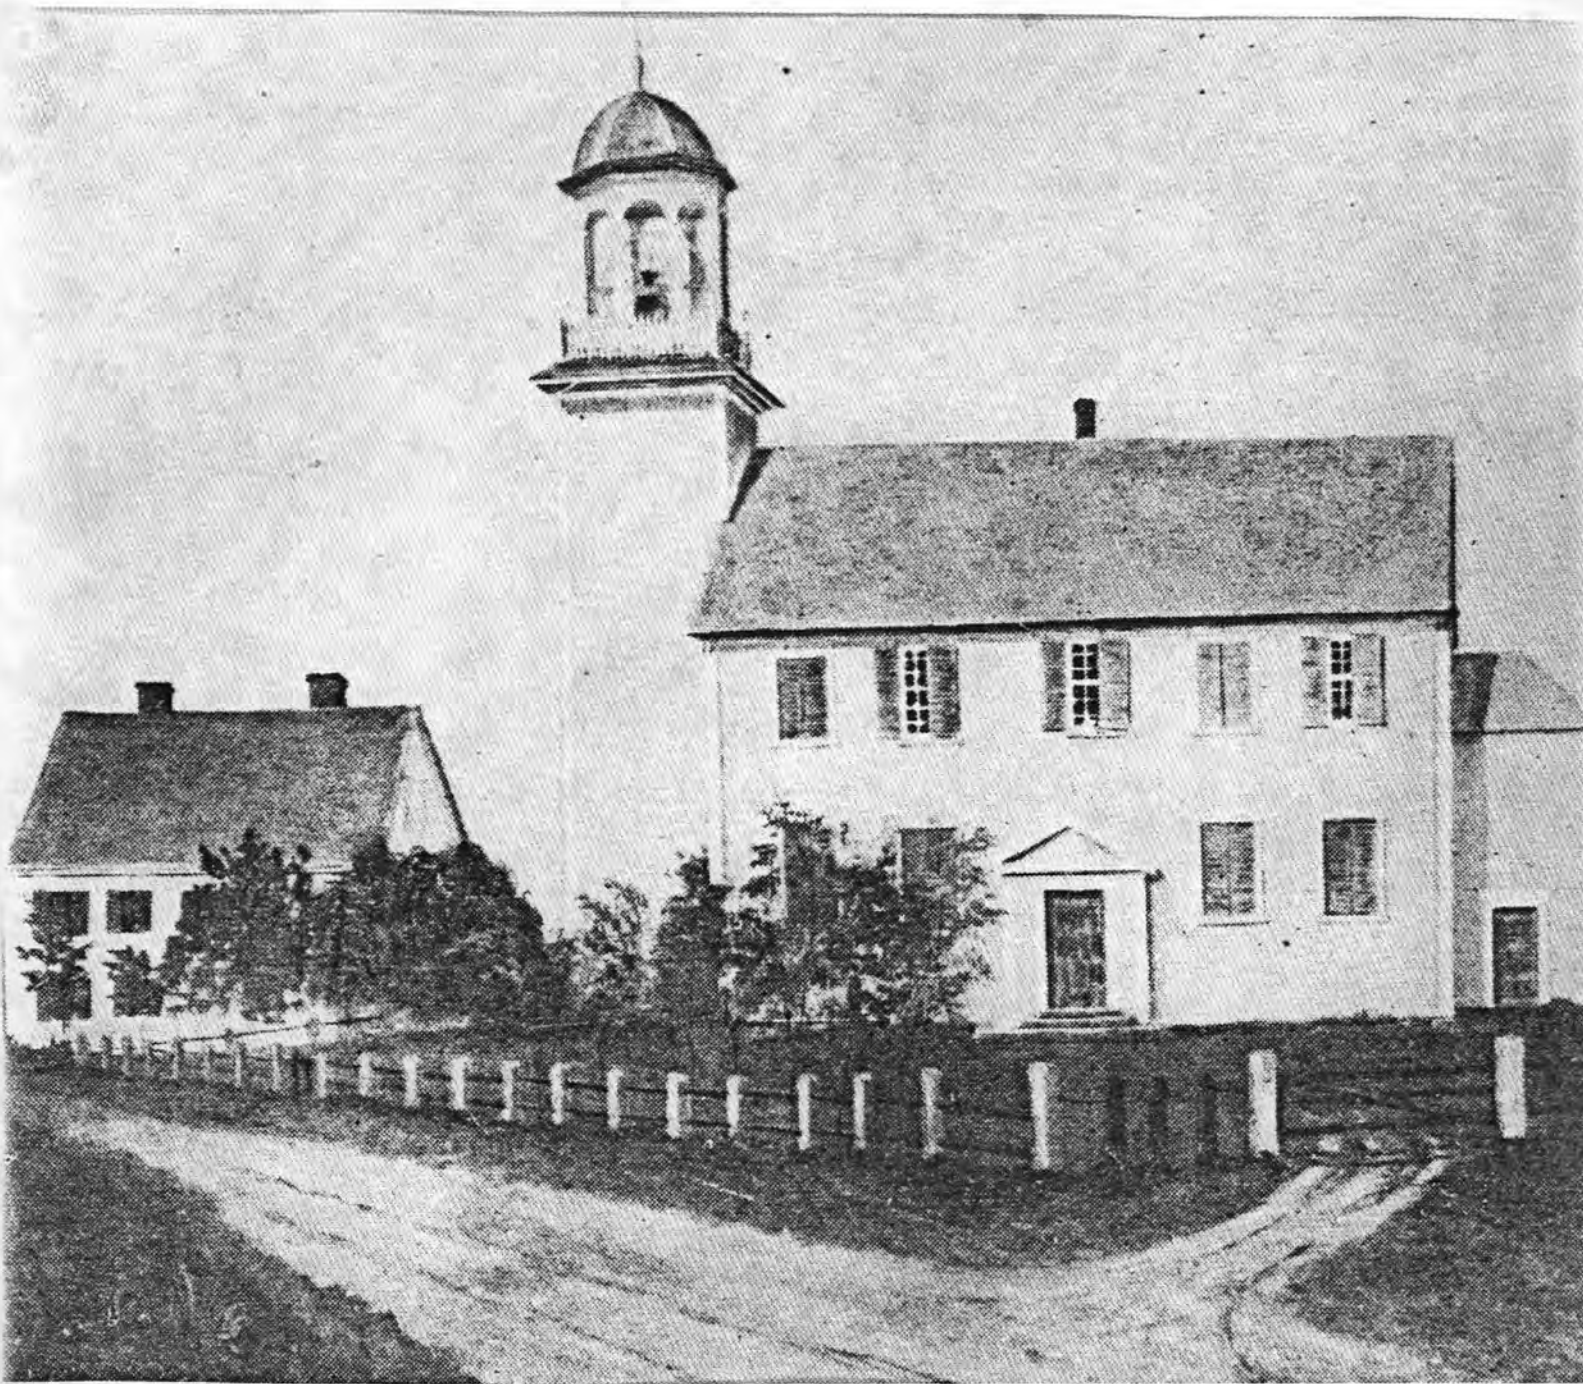
Figure 1. Appearance of Church of Christ Building between 1823 and 1856.

When constructed, in 1710, the Rumney Marsh meetinghouse (as the Church of Christ was then known) stood two stories tall, measured 43' x 35', and featured a gable roof and simple rectangular plan. An 1823 painting of the meetinghouse (Figure 1) shows a structure with five bays, a double tier of symmetrically arranged windows and a central entrance with pediment on the facade. While the entrance pediment may have been a later Georgian addition, the five bay plan and double-tier windows can be presumed to be that of 1710. A porch and tower and spire were added sometime in the 18th century, perhaps in conjunction with the purchase of a bell proposed in 1748. In 1823, the badly deteriorated spire was replaced by an octagonal domed cupola, which surmounted its tower until the 1888 renovations.

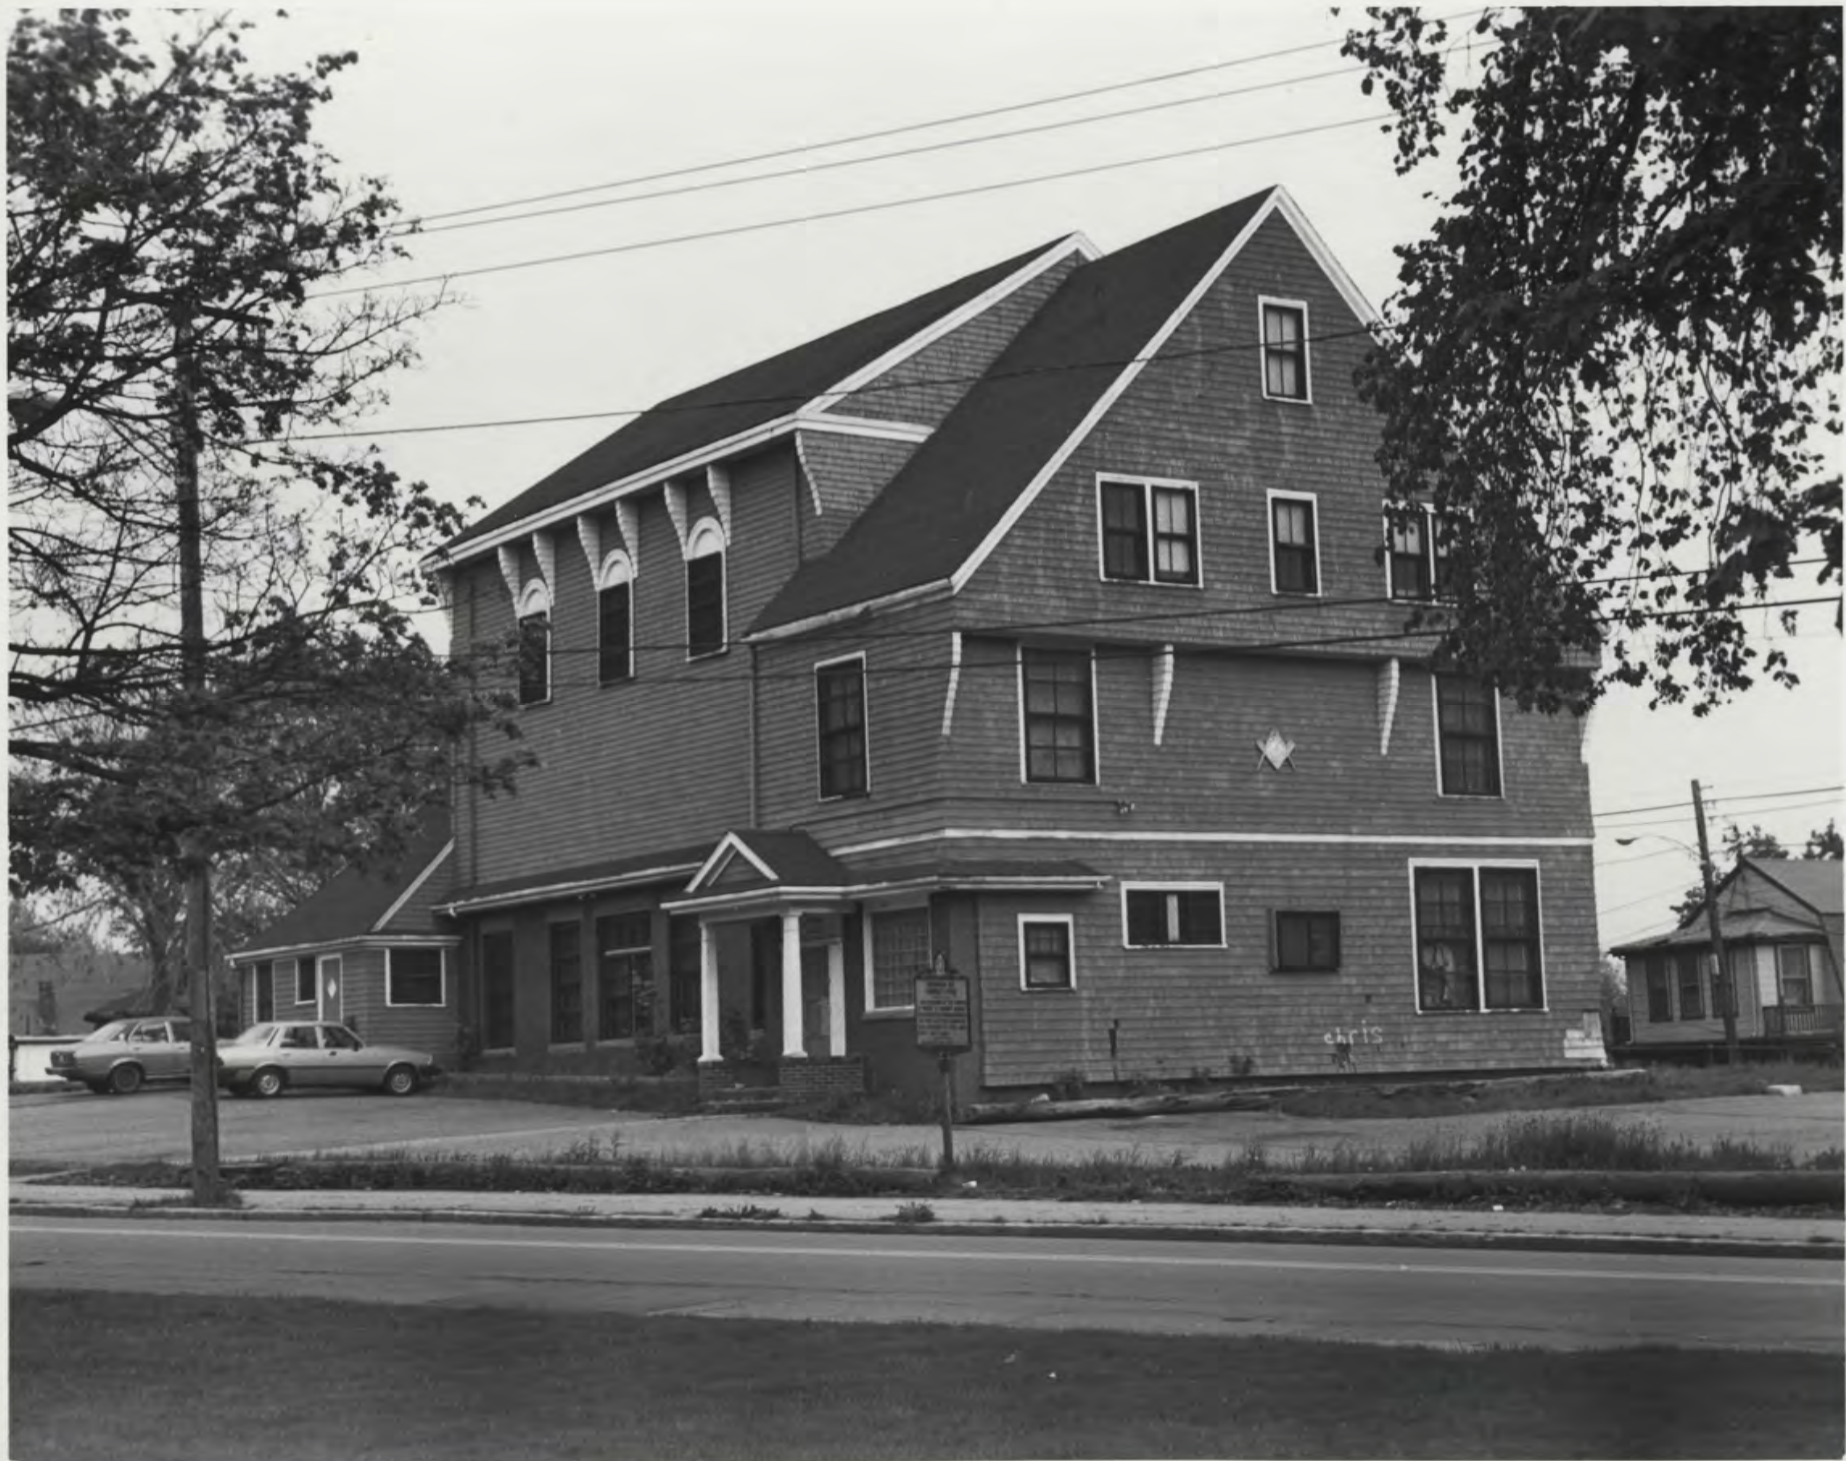
Photograph Number 1 of 7

View of building looking
southeast •

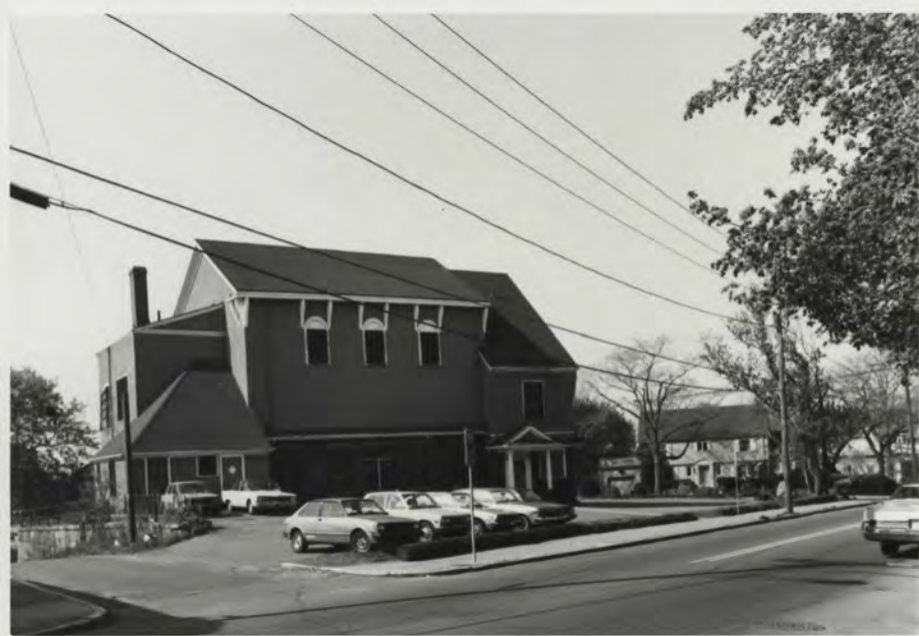
Photograph Number 2 of 7

View of building looking
southwest.

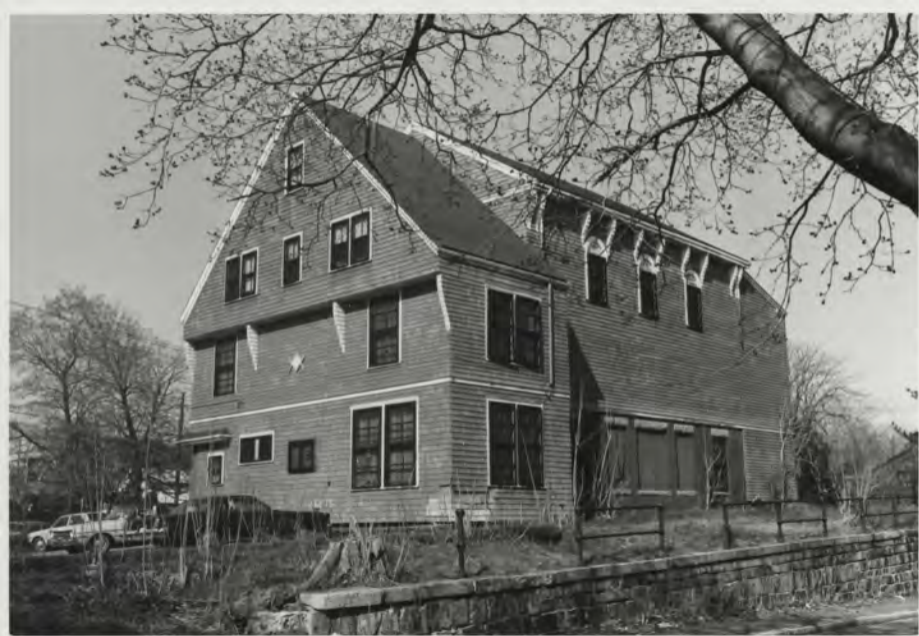
Photograph Number 3 of 7

View of building looking
northeast.

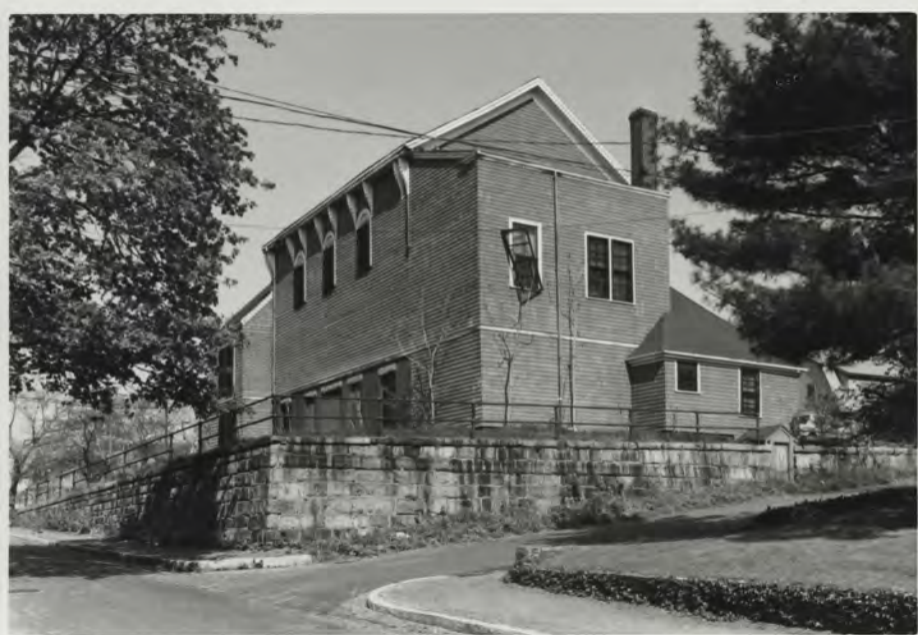
Photograph Number 4 of 7

View of building looking
northwest.

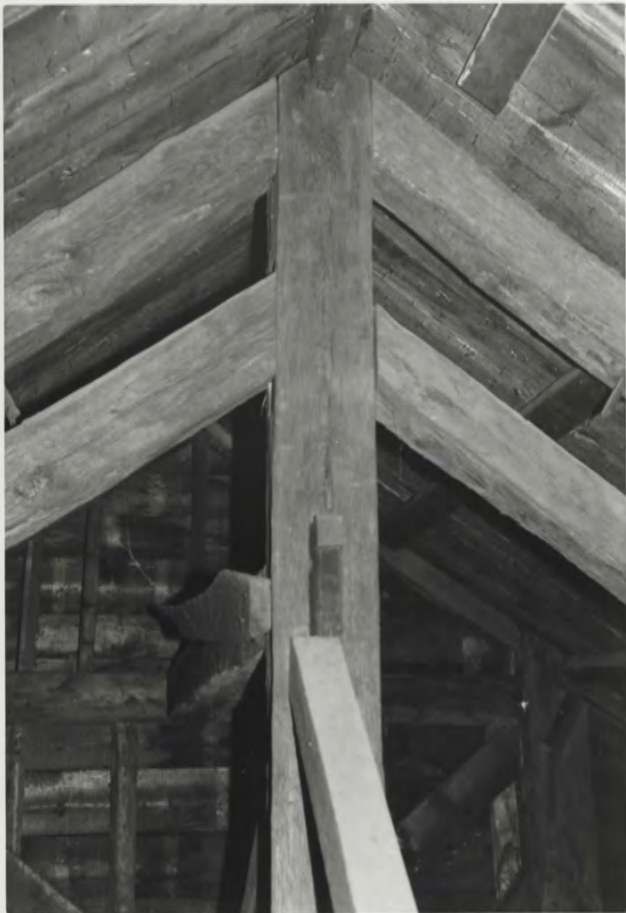
Photograph Number 5 of 7

View of king post with
double rafters framed into it
in meetinghouse roof.

The most notable feature of the building's interior is the timber frame of the 1710 meetinghouse which is enclosed within the present structure. Encompassing the central auditorium space and the attic above, the frame is covered over except in the attic. The structural frame includes: corner posts, four intermediate posts on each long side, north and south plates, and two distinct roof truss systems--one to frame the end walls and one to span the auditorium. The end walls are framed with single principal rafters, tie beams and studding. The four intermediate roof trusses consist of double principal rafters, one placed approximately six inches below the other, a king post and tie beam. The double rafters are mortised into both the king post and tie beam as shown in Photographs 5 and 6, and Diagram 1. Between most sets of rafters are medially placed struts. The spanning tie beams are hewn into a gentle upward bow (see Photograph 7 and Diagram 1). Six common purlins are set into the top of the uppermost rafters.

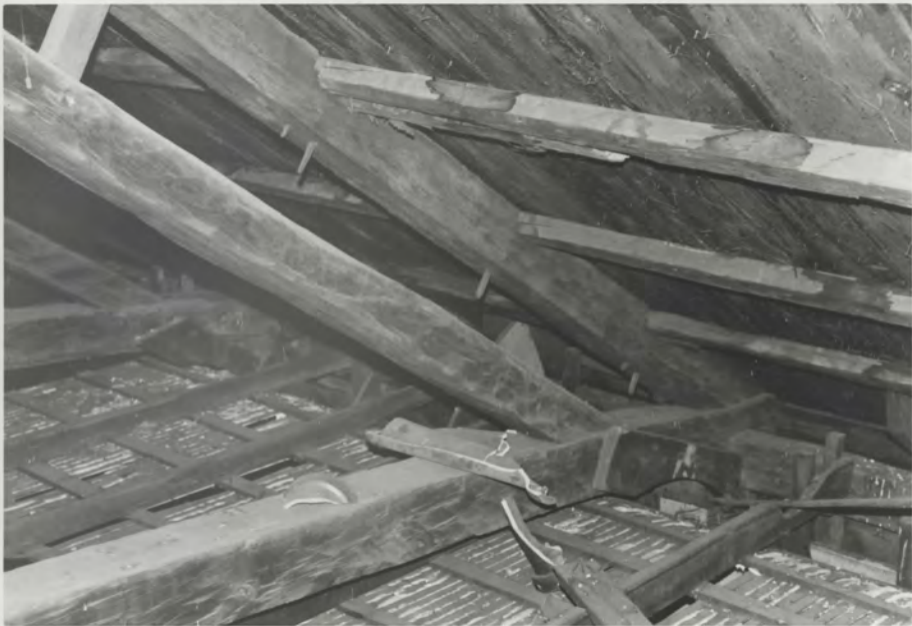
Photograph Number 6 of 7

View of double rafters
framed into tie beam in
meetinghouse roof.

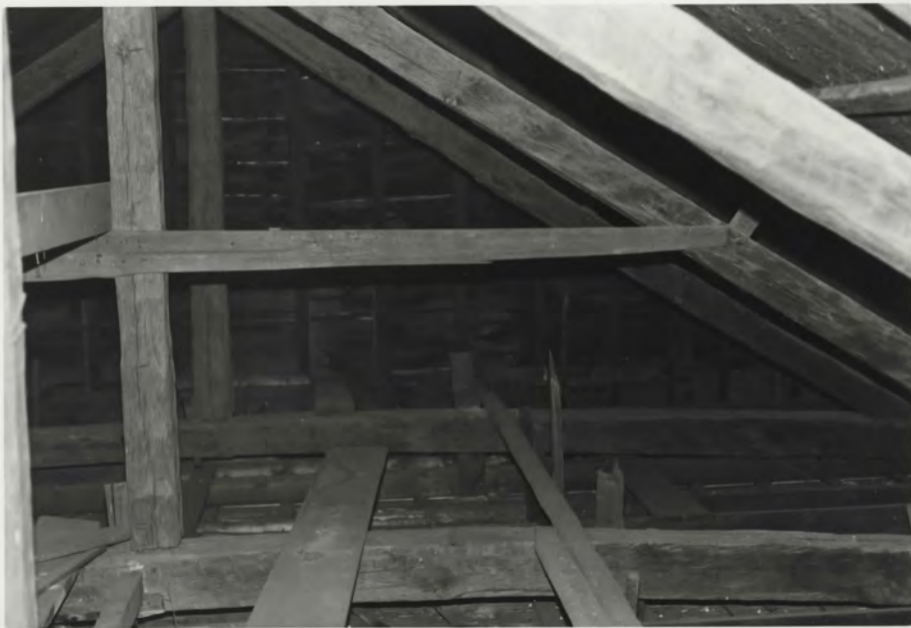
Photograph Number 7 of 7

View of bowed tie beams in
meetinghouse roof.
