**National Register of Historic Places
Continuation Sheet**

Portal Ranger Station
Property Name

Depression-Era USDA Forest Service Administrative Complexes in
Arizona MPS
Multiple Name

historic name Portal Ranger Station
other names/site number Portal Work Station

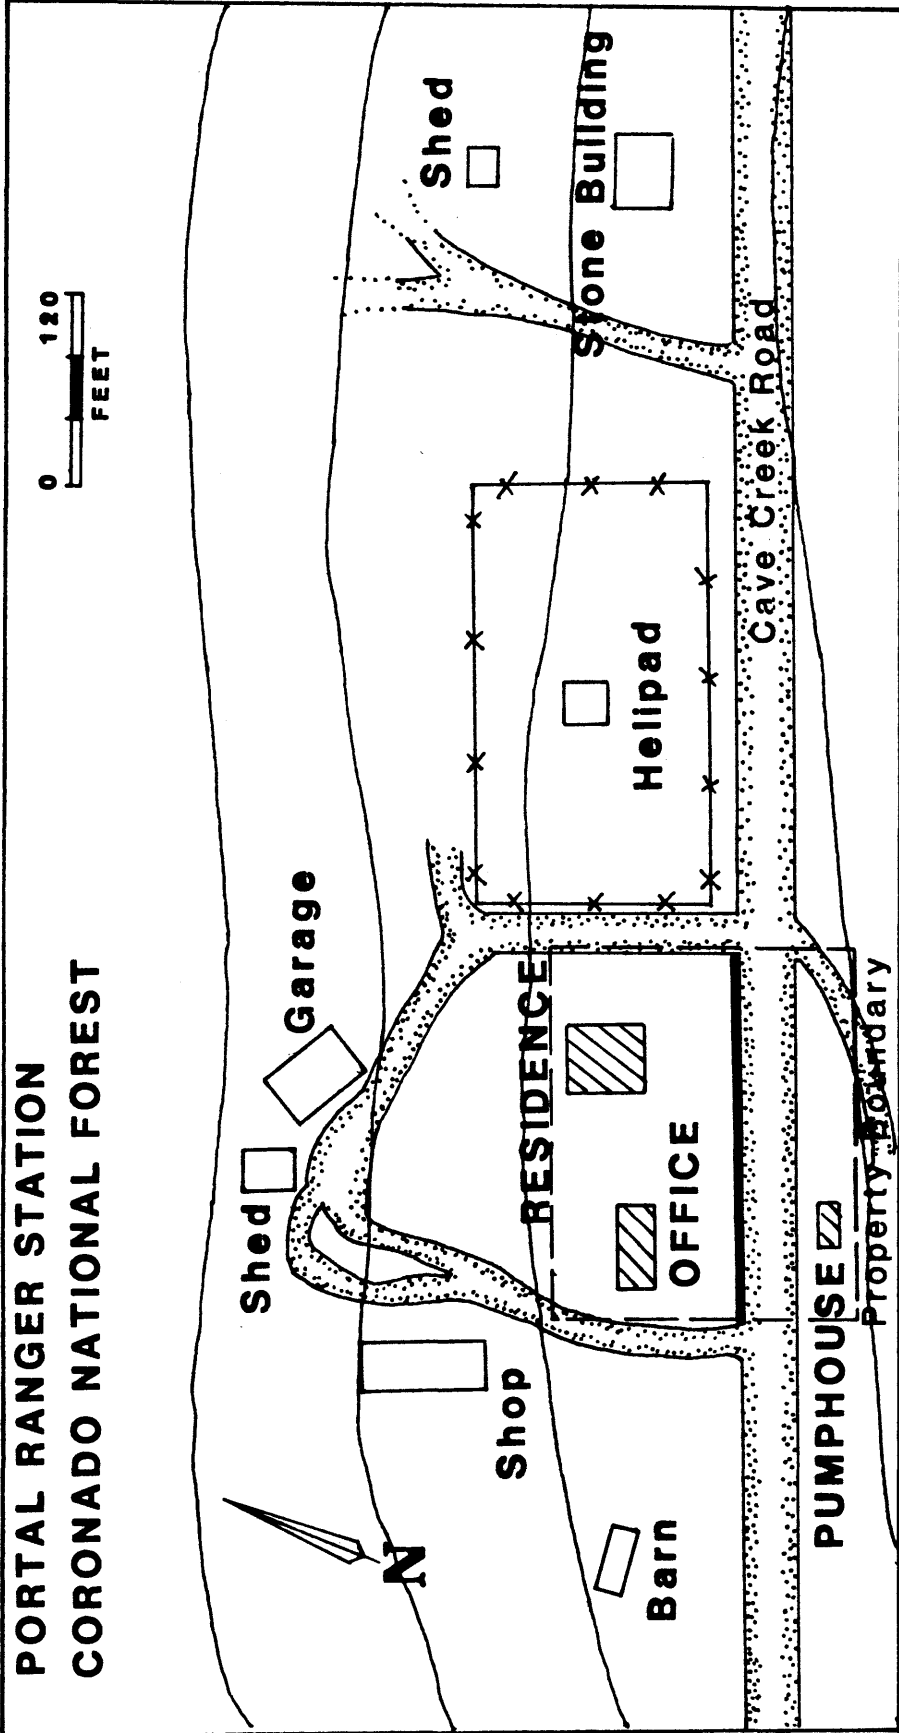
**PORTAL RANGER STATION
CORONADO NATIONAL FOREST**

The residence is situated 100 feet to the northeast of the office. Both face southeast toward Forest Route 42A. The office and pumphouse face each other on opposite sides of paved Forest Route 42A. The pumphouse is in an area of heavy vegetation; a number of trees grow around the office and the residence. Carefully constructed masonry walls and walkways, installed by CCC crews, surround the office and residence. The office currently functions as a bunkhouse for seasonal fire crews, the residence is still used as a residence as well as an office, and the pumphouse is a storage building for inflammable material.
