Robert Mills DAIRY BARN, HALF MOON BAY, CA 94019

CALIFORNIA STATE PARKS, SAN MATEO DIST. 95 KELLY AVE.
HALF MOON BAY, CA. 94019

KENT L. SEAVEY, 1989

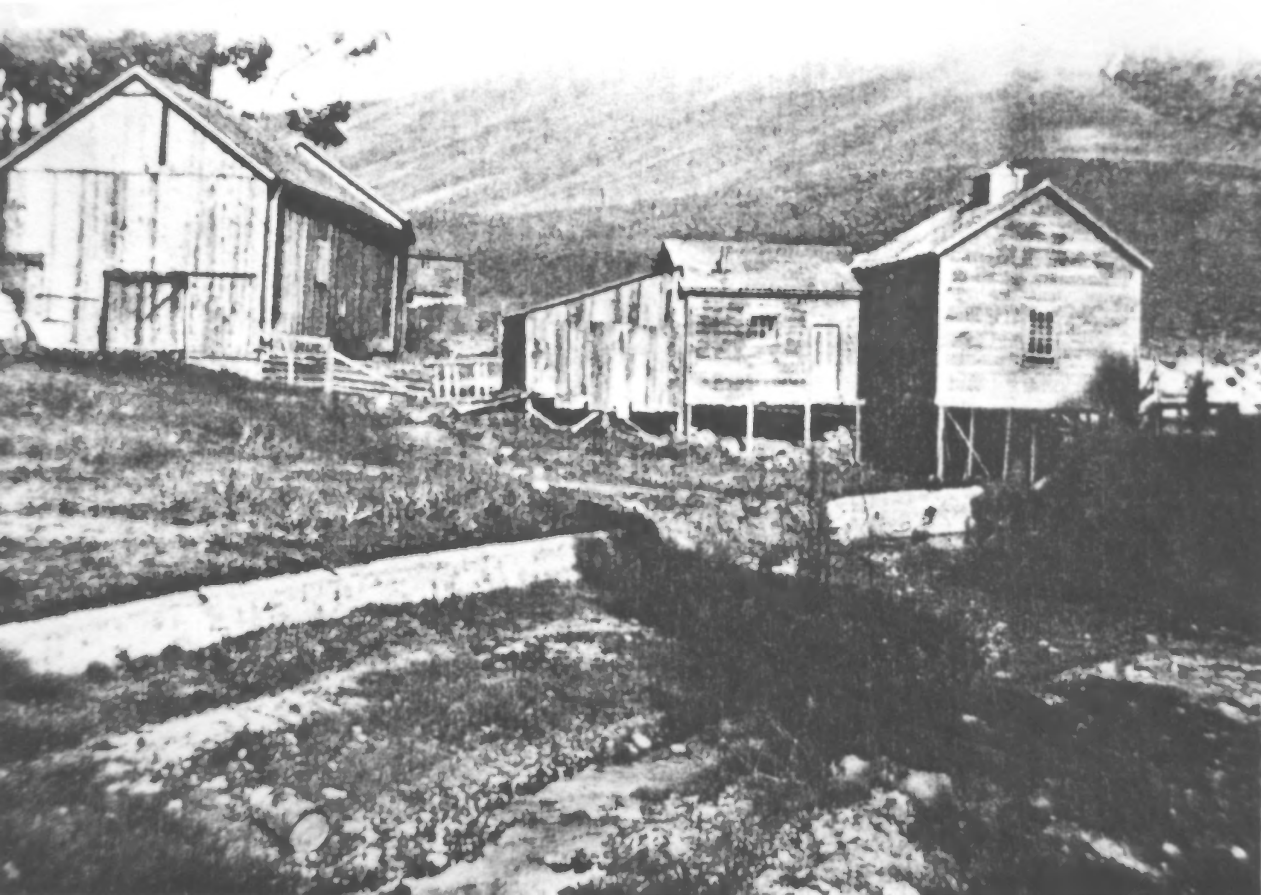
Looking north with Mills Creek and stone retaining wall in foreground. First building on right was grain mill, second building with side shed was blacksmith shop and milk house (both no longer extant). Mills DAIRY BARN ON LEFT with "red grainery" to rear (only root cellar now exists). Note wheat field on hill MASS to rear.

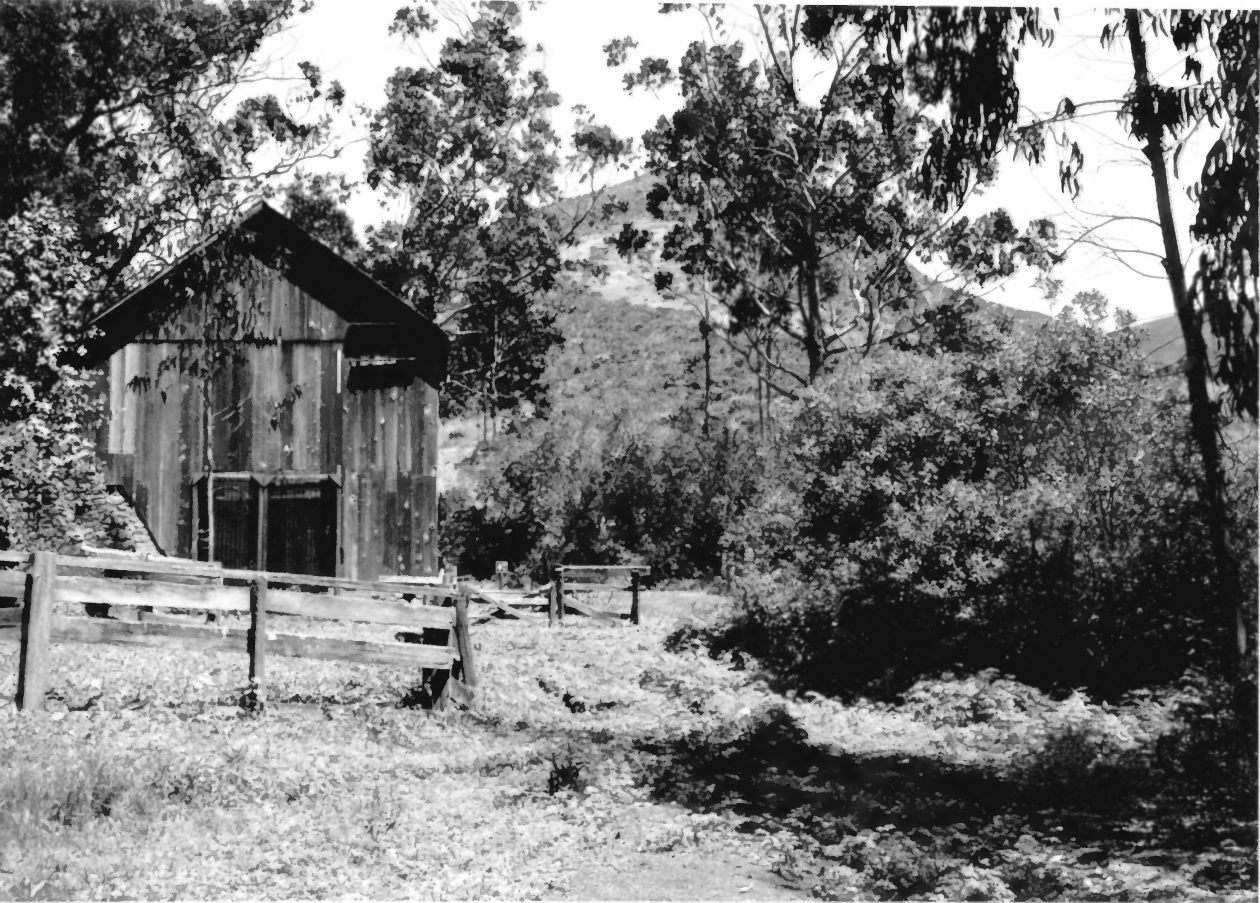
LOOKING GENERALLY NORTH WITH MILLS DAIRY BANK
ON LEFT (SOUTH END ELEVATION). NOTE VEGETATION
ALONG MILLS CREEK TO RIGHT.

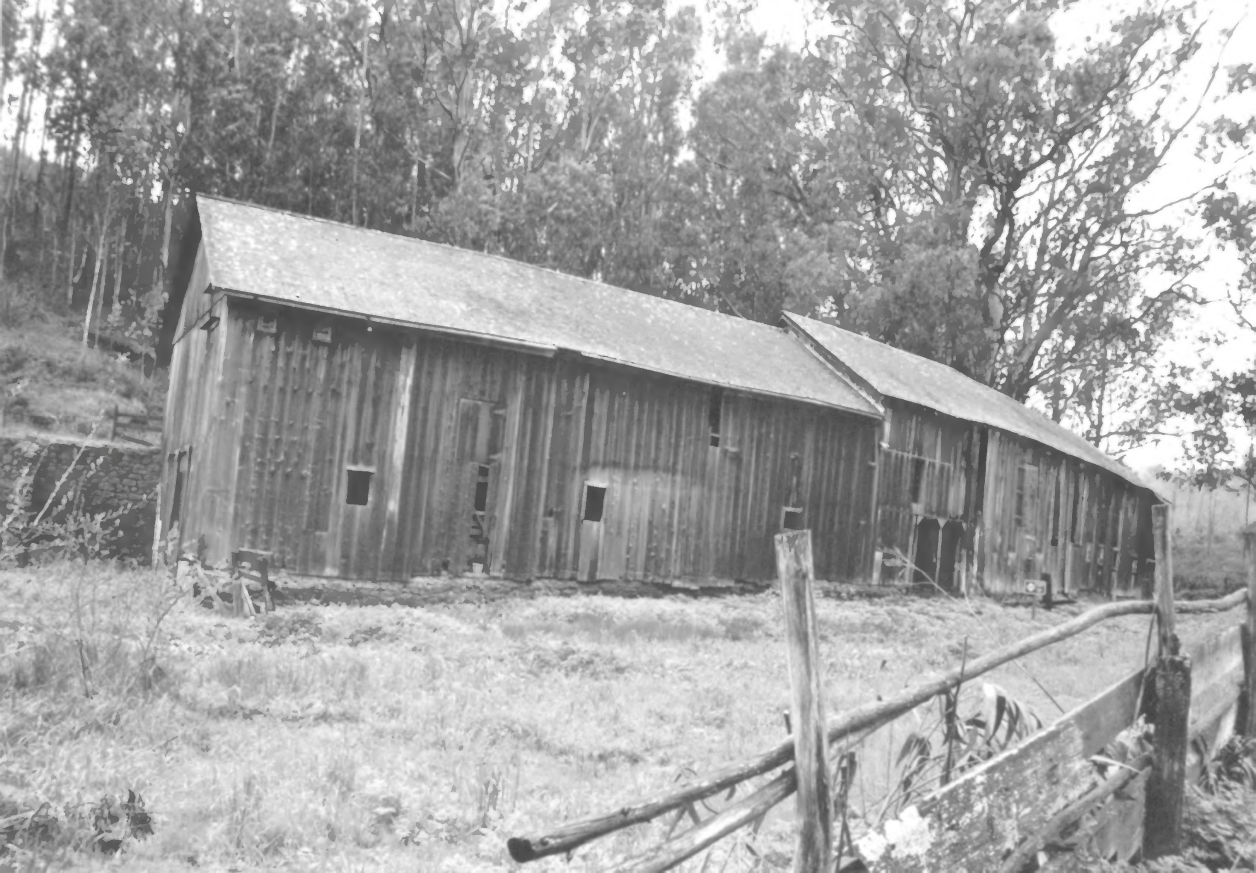
LOOKING NORTH WEST AT SIDE ELEVATION (EAST) OF MILLS
DAIRY BARN.

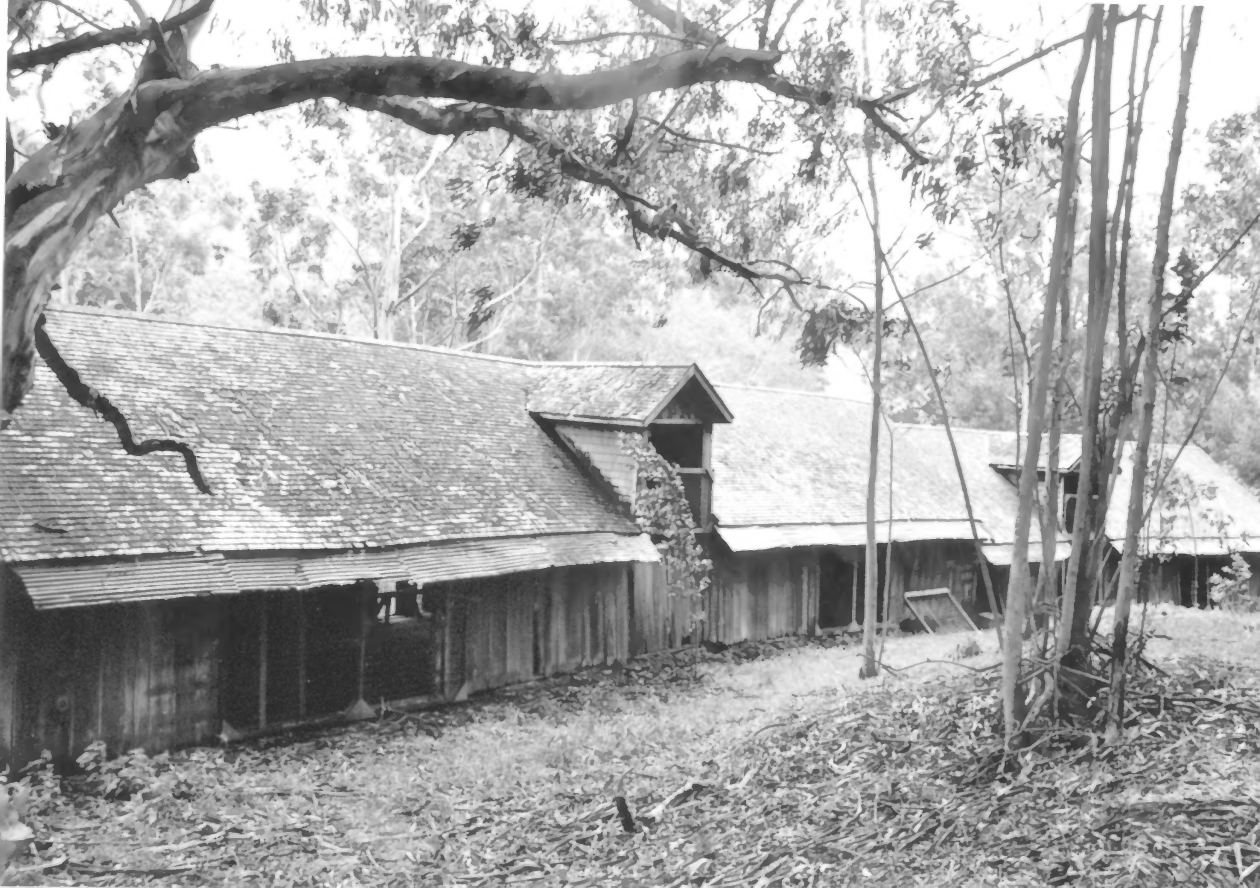
Looking south east AT uphill side ELEVATION (west)
of MILLS DAIRY BARN, NOTE Loading BAYS AND
TWO ROOF DORMERS.

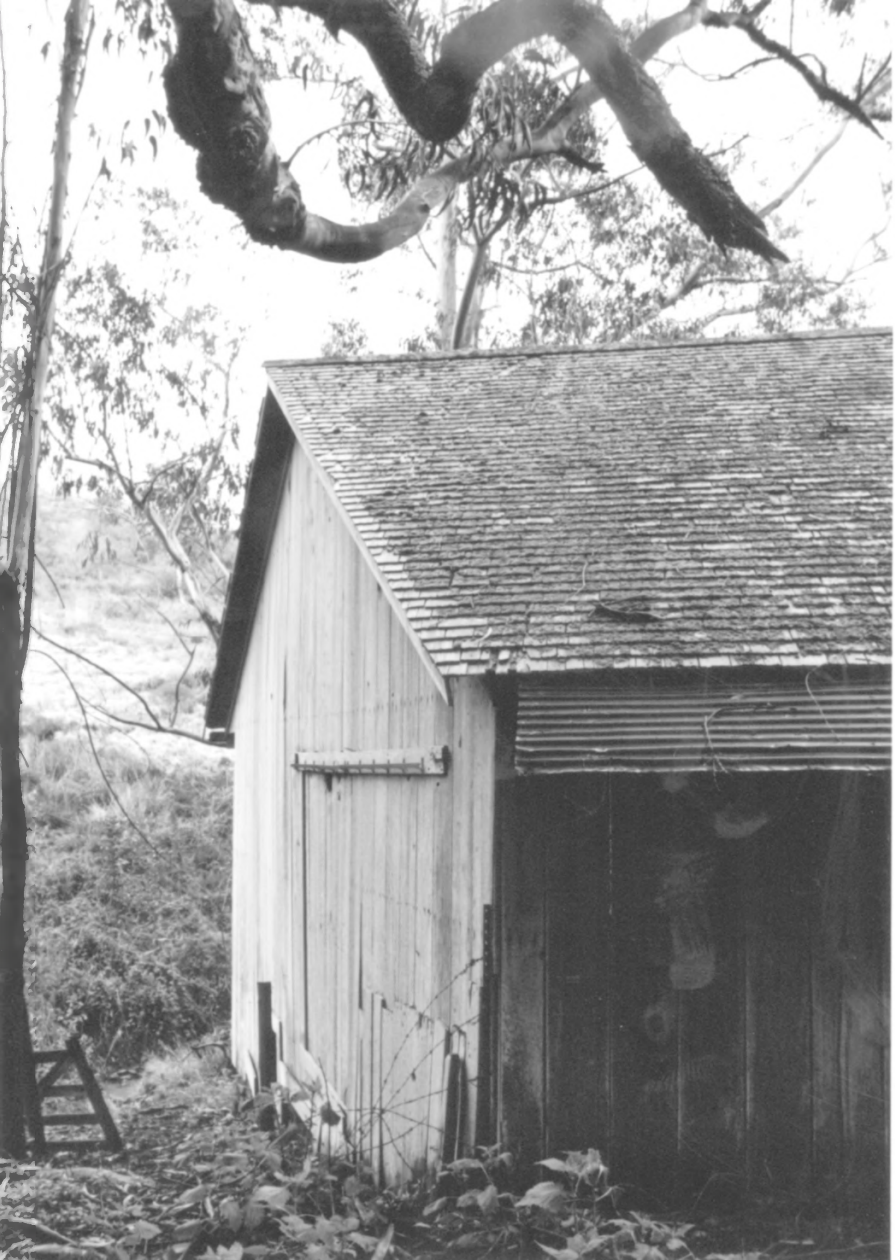
Looking EAST AT THE NORTH END ELEVATION
OF THE ROBERT MILLS DAIRY BARN, NOTE
RAIL FOR SLIDING DOOR (NO LONGER EXTANT)

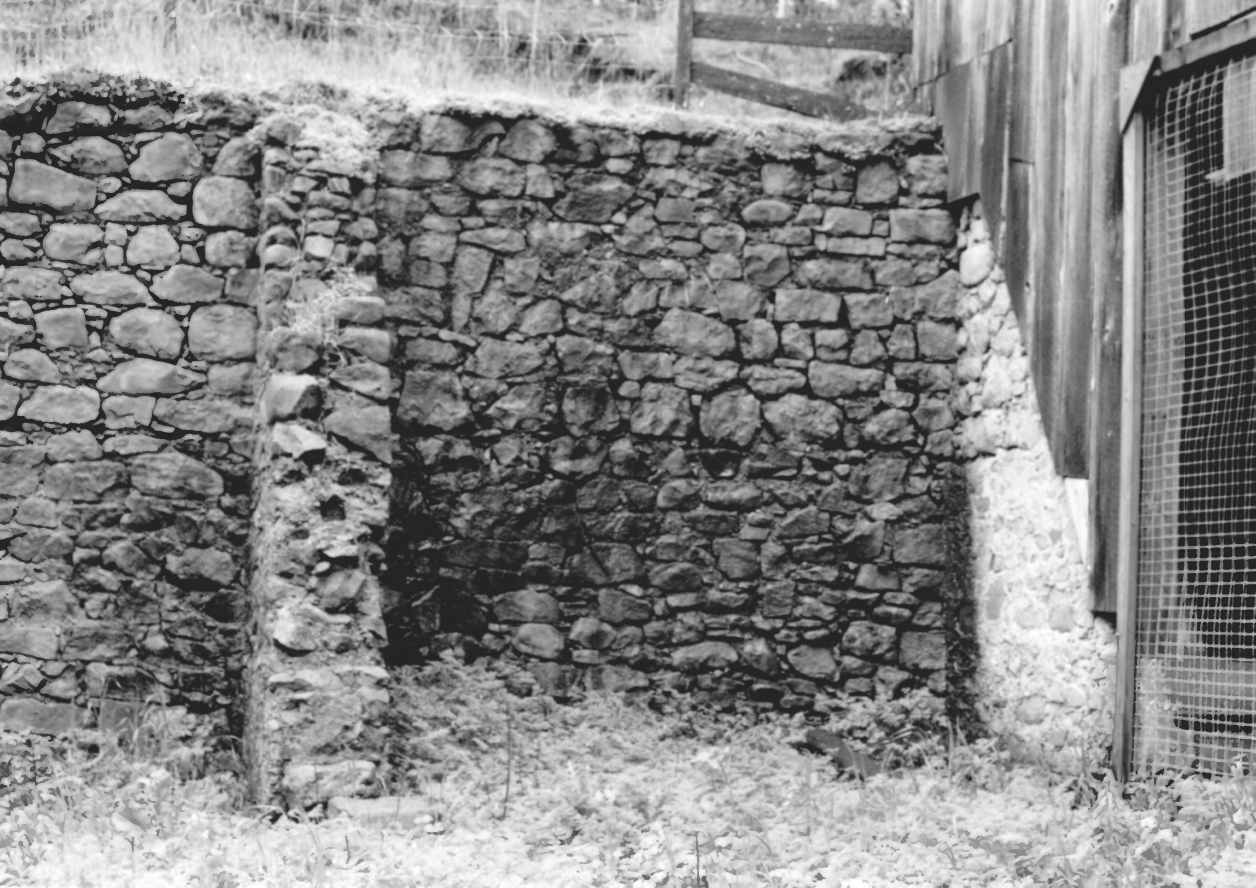
Looking west toward foundation work (stone) of
MASTERMASON G. B. MARTINI. Note horizontal line in wall
ABOUT HALF WAY UP WALL SUGGESTING UPPER PARTS MAY
HAVE BEEN INFILLED BEHIND FOR ROADBED.

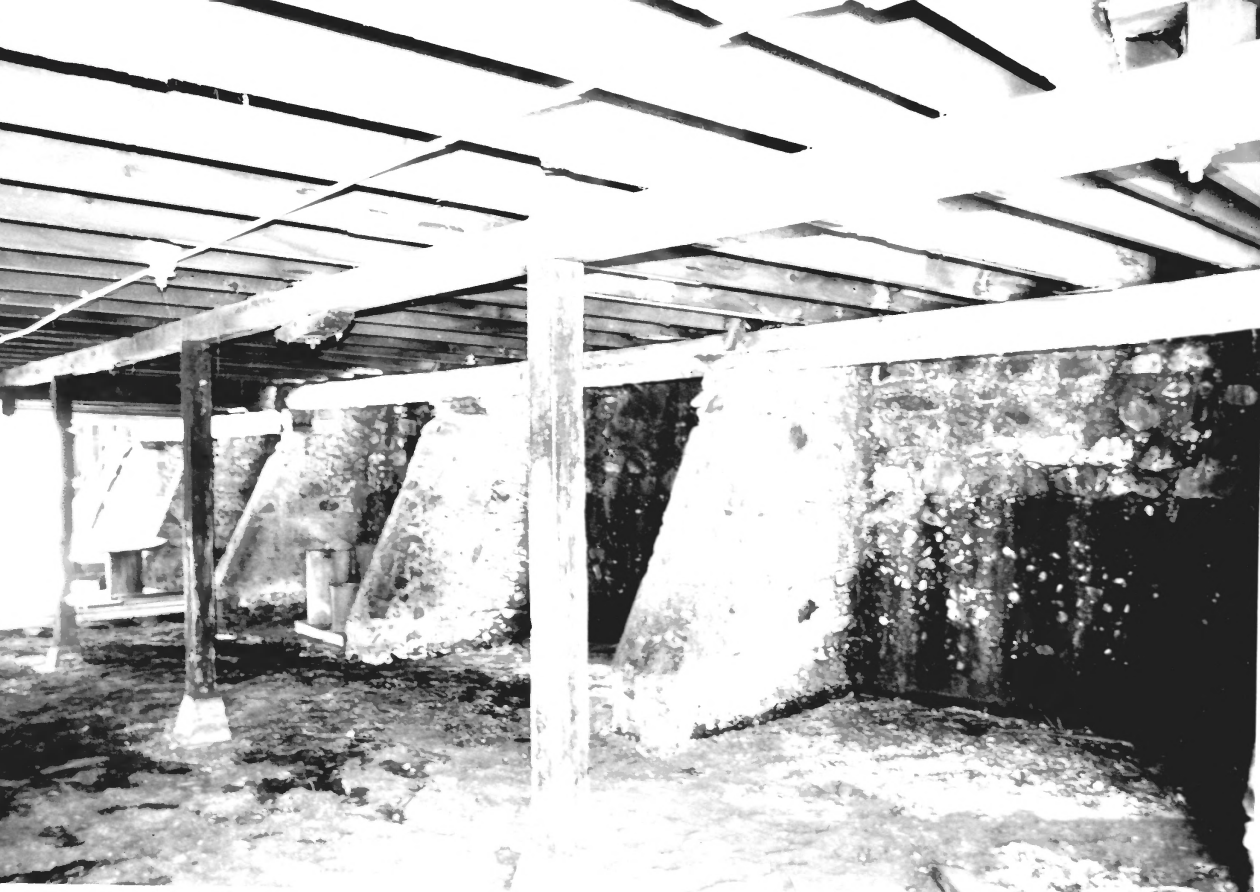
LOOKING SOUTHWEST - AT THE FORMER CATTLE STALLS
BUILT INTO THE BUTTRESSES OF THE STONE RETAINING
WALL. NOTE HEAVY BEAMS ON TOP OF BUTTRESSES
SUPPORTING FLOOR JOISTS.

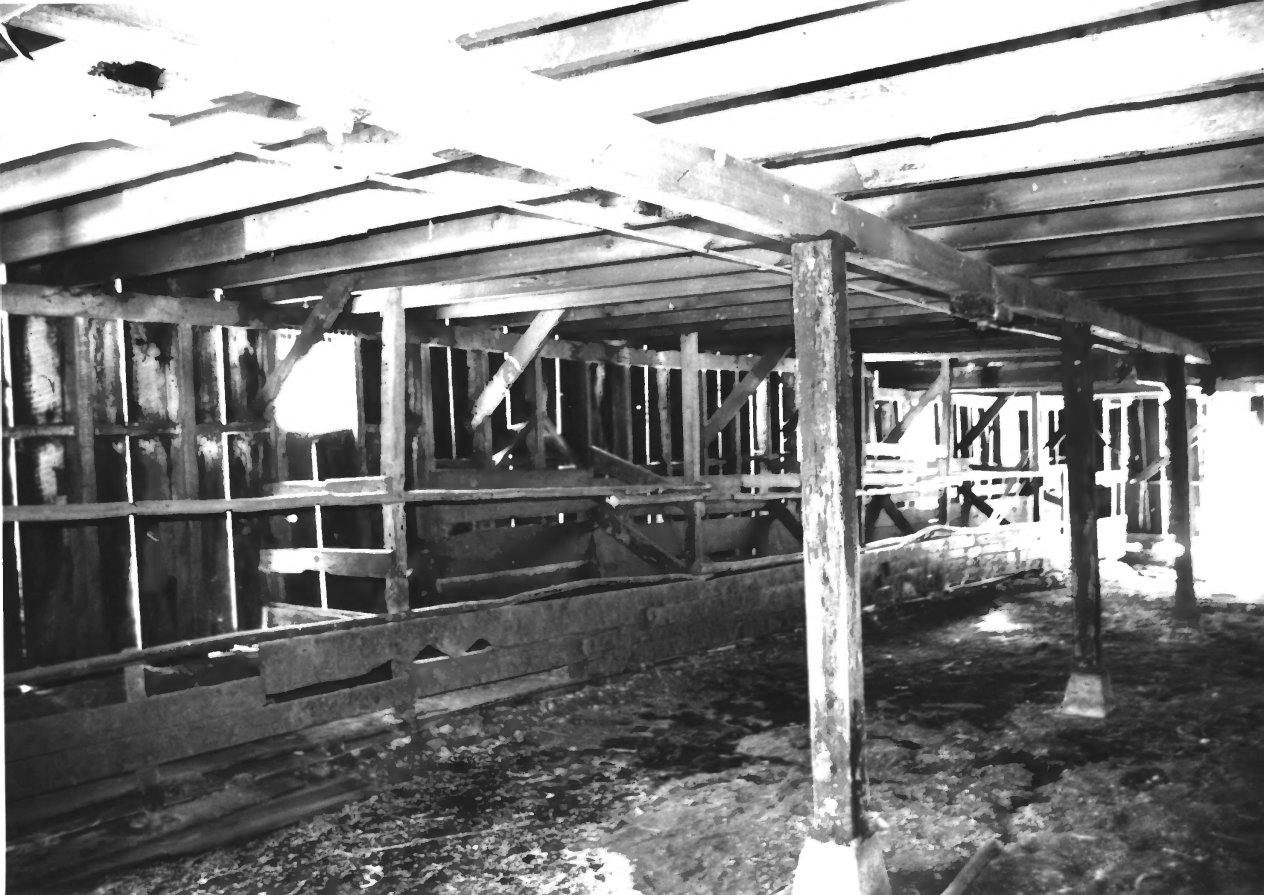
LOOKING SOUTHEAST AT THE CATILE TROUGHs AND STRUCTURAL
SUPPORTS OF THE MILLS DAIRY BARN. DROP BOXES ARE
LOCATED ABOVE WHERE HAY AND OTHER FEED WAS DROPPED
THROUGH FROM THE LOFT.

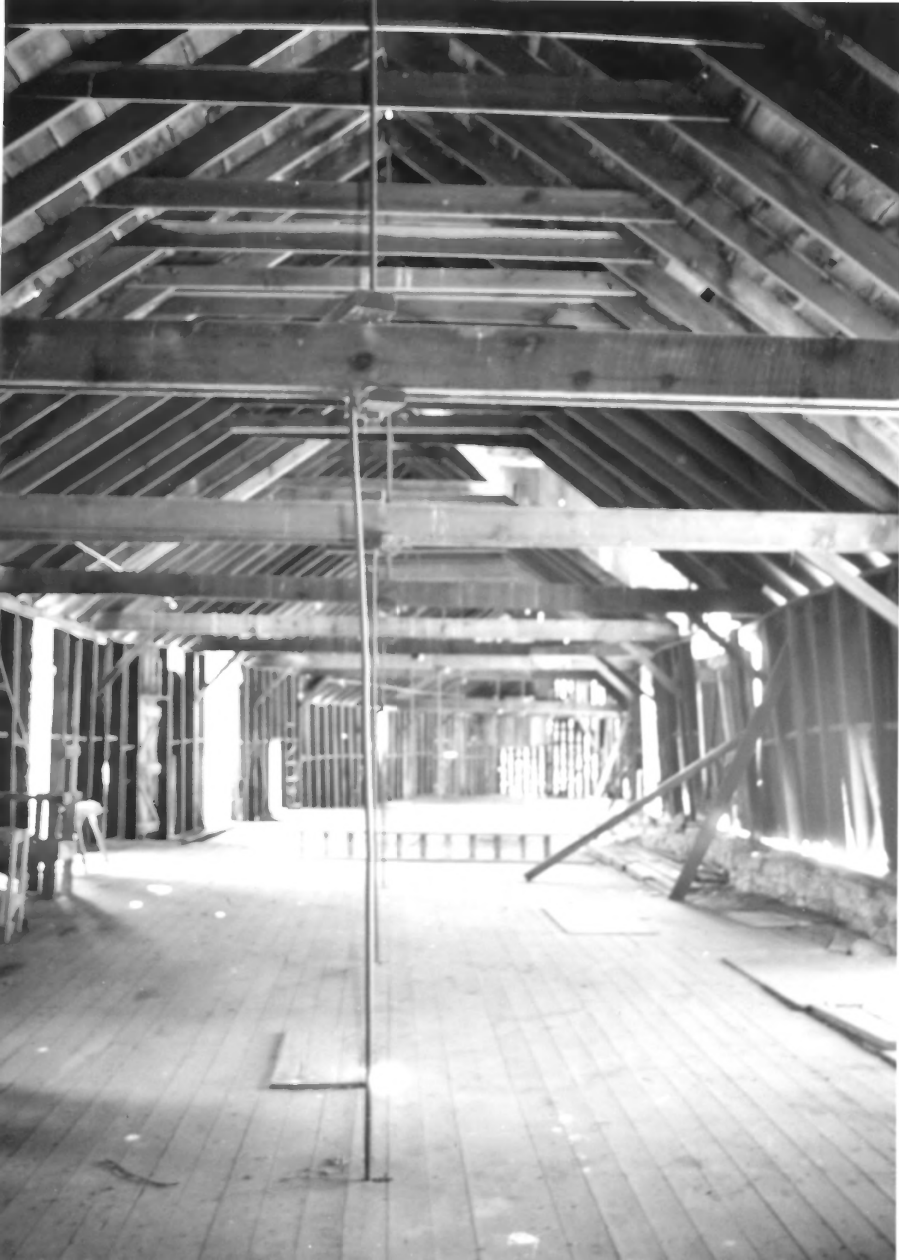
LOOKING GENERALLY SOUTH ALONG
THE INTERIOR OF THE MILLS DAIRY BARN
LOFT. NOTE THE SYSTEM OF VERTICAL
IRON RODS HOLDING THE STRUCTURE IN
TENSION.
