# National Register of Historic Places Registration Form

historic name John Lucas House

street & number 10 Clementon Road East

city or town Borough of Gibbsboro

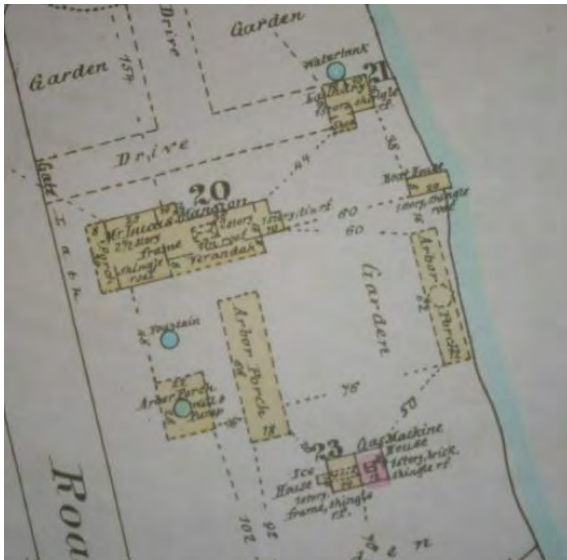
Figure 9: 1875 plan of the house note full porch and five different building campaigns<sup>5</sup>

Between 1870 and 1875, the two rooms at the northern intersection between the front section and rear ell were constructed. This is supported by the footprint of the house on an 1875 map (Figure 9). These rooms may have been bathrooms and likely contained a bathtub and possibly a toilet. John Lucas was a wealthy man; these luxuries were available to the wealthy by the 1860s. Elements including separate foundation walls, seams in the masonry and siding and the differing roof line indicate that this block was an addition.

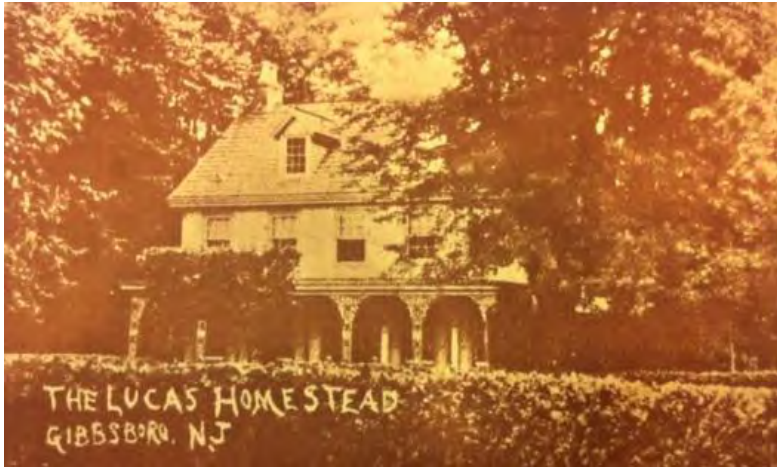
Figure 11: Undated photograph of house. Note: full porch and window sills of the first floor windows. This photo was taken before the windows were turned into full-length casements

Finally, by 1931, the full porch across the west façade was removed (Figures 11 and 12) and the existing smaller porch constructed. Colonial Revival details support an early twentieth century construction date. The oversized casement doors on the west and east elevations probably also date to this period. They replaced original double hung, sash windows, most likely six-over-six. On the interior, changes to the main block from this period include the removal of an interior partition and the conversion of stacked parlors into one large space to the south, the large brick south and north fireplaces, the changes to the front stair and the overlaying of the narrow-gauge wood floor found on both the first and second floors. Some of the plain interior trim also likely dates to this period.

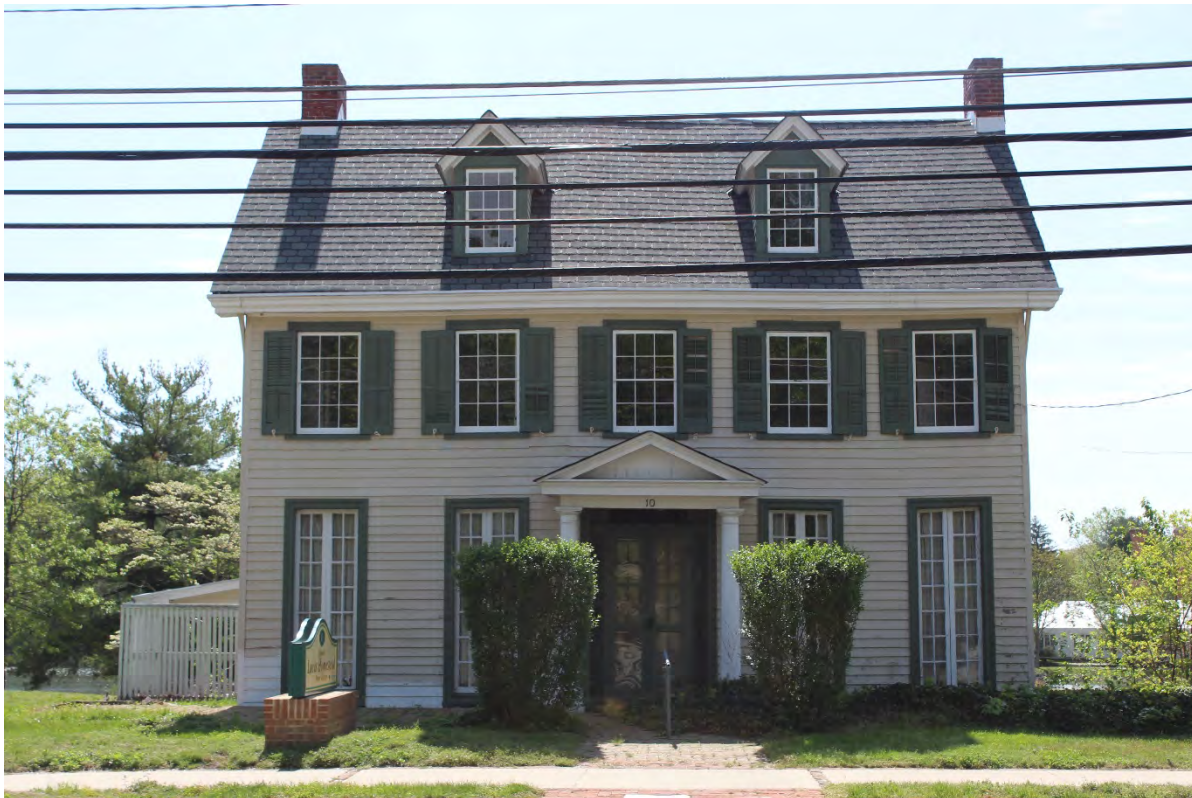
Photo 5: The west façade represents two phases of construction. The south (right) three bays are original ca. 1852 while the two north bays followed ca. 1856. The Colonial Revival entrance porch was added in the twentieth century

molded cornice. The dormers are fenestrated with six-over-six, double hung, sash windows. The side clapboards have a narrow reveal. The dormers likely date to ca. 1856. End chimneys bracket this façade. The south is a later exterior chimney; the interior north chimney dates to ca. 1856 (Photo 5).

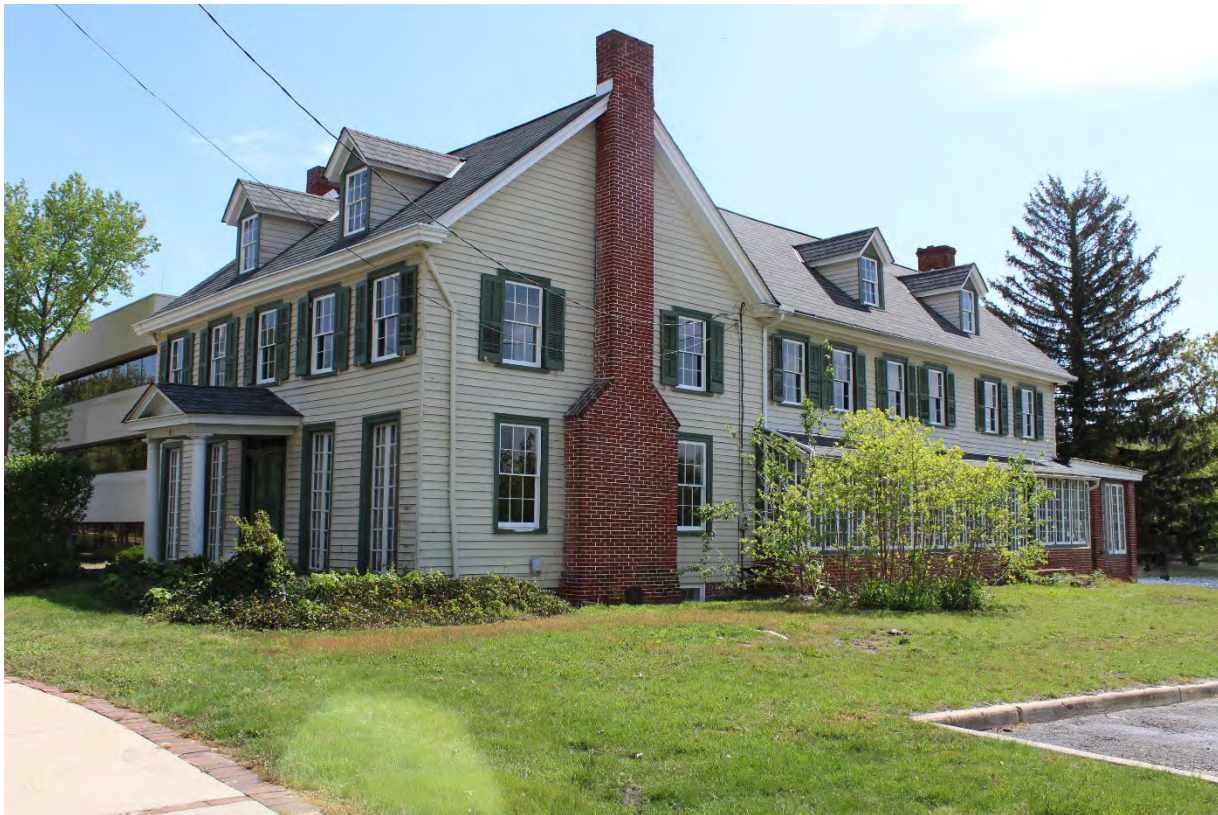
Photo 6: The south elevation represents the original house with four phases behind it.

The south elevation displays four phases of construction: the original main block followed by a two-addition ell to the east. In the fourth phase, brick porches were added to the south and east sides of the house. The main block was built ca. 1852 and includes two, three-light, basement hopper sash windows in the brick foundation and four, six-over-six, double hung, sash windows with louvered shutters on the upper floors with star cast iron shutter dogs. The frames are pegged at the top and sill, as on the front elevation. All appear original. As on the front elevation, the clapboards are five inches in width, and the cornice employs the same profile as that of the façade. This cornice features returns in the east and west gable ends. A later twentieth century exterior brick chimney bisects this elevation.

A six-bay, perpendicular ell with appended glass-enclosed porches adjoins the rear wall of the main block. The ell was built in two campaigns. The first four bays were built between 1856 and 1870. The eastern two bays were constructed by 1875. The porch enclosure and rear porch were added in the twentieth century. The ell is sheathed in five-inch wide clapboards with a narrow corner board at the eastern end; a seam indicates the junction of the two construction campaigns. There are three sets of paired six-over-six, double hung, sash windows on the upper story with louvered shutters with rounded cast iron shutter dogs matching those on the front. The frames are not pegged on the walls of the ell. The ell walls are topped by a cornice with a wide molding and hung gutters. Two narrow, gabled dormers, shorter than those on the facade, rise from the asphalt-clad roof. The dormers feature flush siding in the tympanum, six-over-six, double hung, sash windows and molded cornices. The dormers represent later additions, likely in the twentieth century. A glass-enclosed sun porch with twelve pairs of twelve-by-twelve casement windows on a brick foundation projects from the south wall of the ell. Paired modern replacement doors lead from brick steps up into the porch. The sun porch likely dates to the first quarter of the twentieth century and extends to the rear where it wraps around the east elevation and becomes a one-story flat-roofed enclosed porch addition (Photo 6).

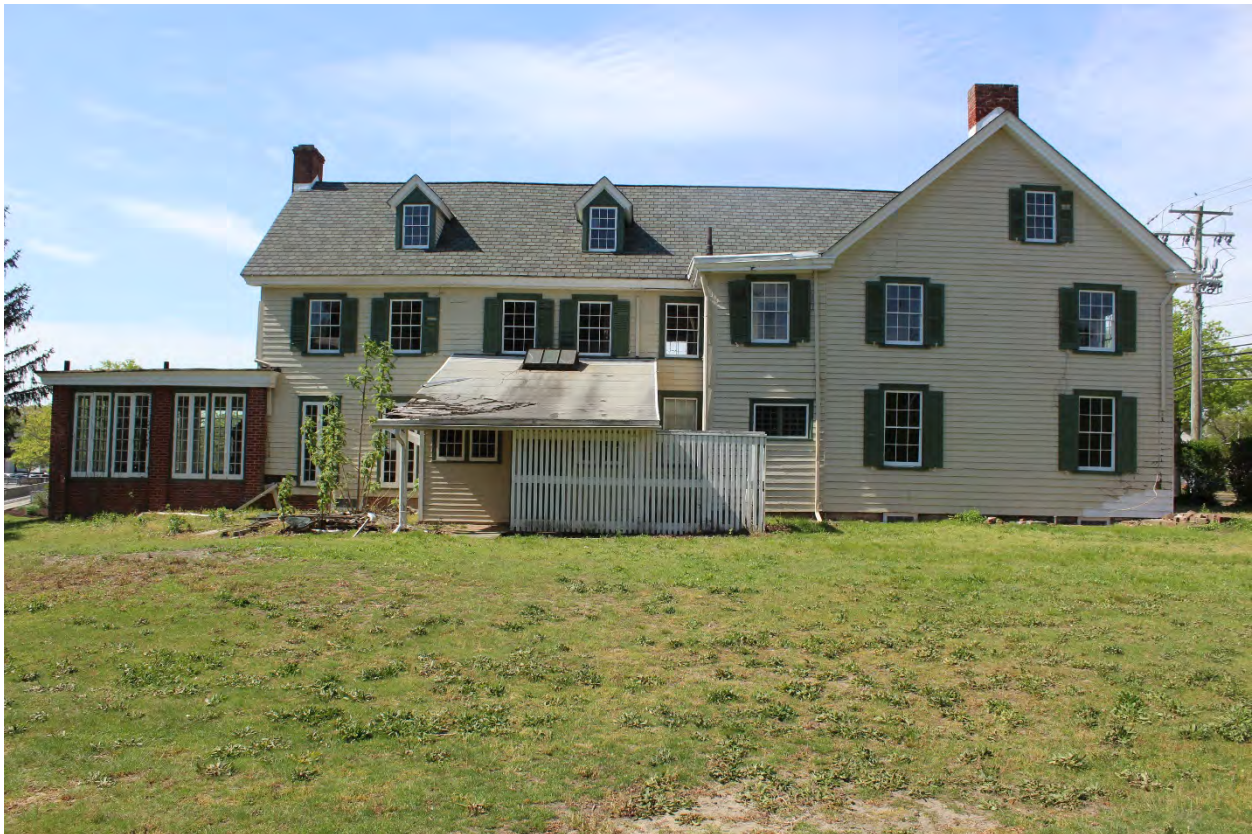
Photo 8: The north elevation represents several phases of construction from ca. 1856-1931

The north elevation illustrates the many phases of construction on the house. At the west end is the ca. 1856 main block. To its east is a corner addition, constructed by 1875. Further east is a section built between 1856 and 1870. A shed-roofed addition likely constructed in the twentieth century projects from this wall. Further east are two bays added by 1875, anchored by the twentieth century enclosed brick porch (Photo 8).

A shed addition stands in front of the rear ell. It has a long, sloping, built-up roof with a skylight at its south peak and an unornamented cornice. The addition is sheathed in five-inch wide clapboards with paired four-light and six-light hopper windows and six- and eight-light casements. These windows have plain frames with a heavy lintel. An open full porch sits beneath the extended shed roof and is supported by simple square columns. It has an open ceiling, brick floor and wooden-slatted enclosure on its western end. Within the porch enclosure, a wood, twelve-light, two panel door opens into the addition. It features an elaborated casing head matching that of the window frames (Photo 8).

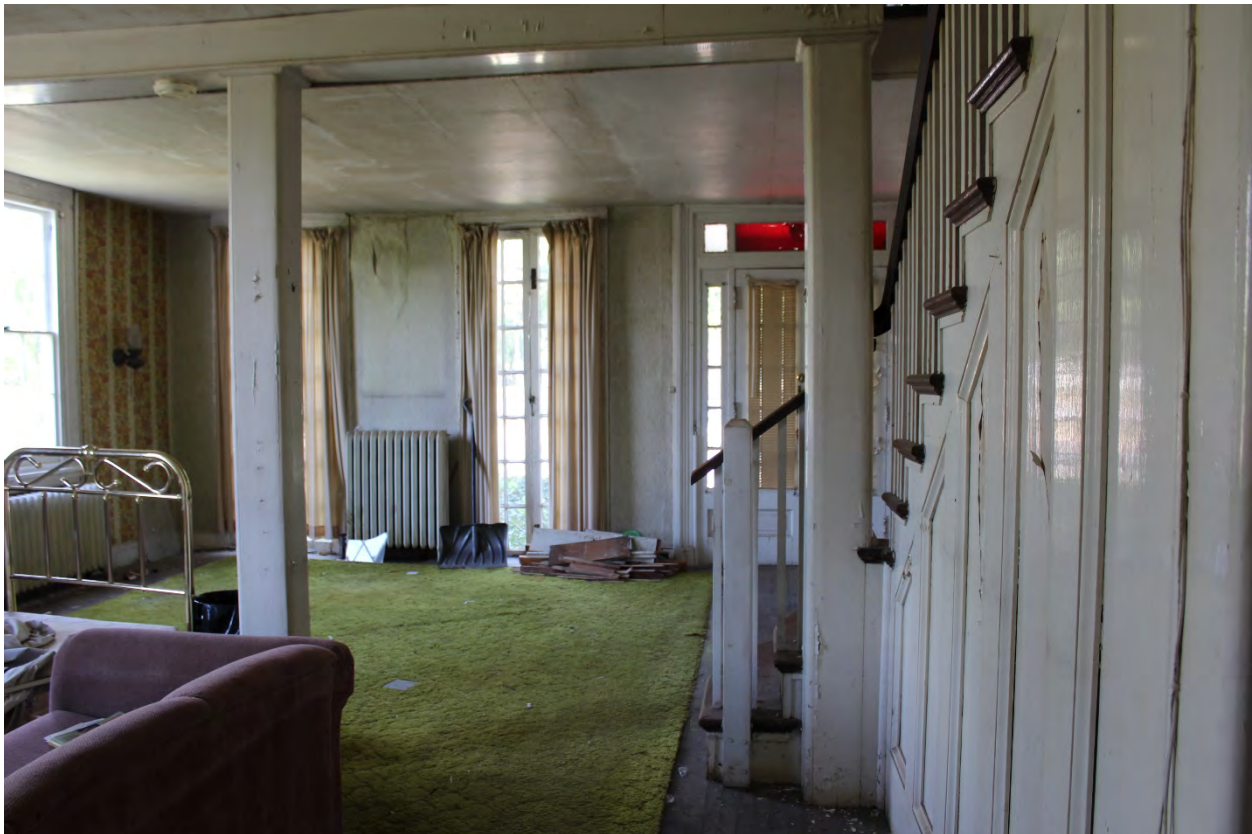
Photo 10: Room 101 looking west is a combination of original fabric (ca. 1852) including most of the stairs, the stair paneling, the doors and window trim with twentieth century upgrades including the narrow-gauge floors, the turn in the stair and the columns and ceiling beam added when an original partition was removed

The main block of the house is now two rooms deep. Originally, it employed a side hall with two stacked parlors at the south end with the north addition always a single room with a fireplace centered on its north wall. Today, this main section is a mix of nineteenth century original fabric and first quarter of the twentieth century renovations. Original nineteenth century features include the floors in the northern room (Room 102) (Photo 9), the trim in both rooms including the baseboards, the sash, the elaborate window frames and aprons, the matching door casings and four-panel doors and the plaster walls and ceilings. The upper portions of the staircase and the stair paneling also likely date to the original house construction. Twentieth century changes include the open layout of Room 101, its narrow-gauge floors and its ceiling beam which marks the location of the original partition wall between the stacked parlors. Other twentieth century alterations are the curved and broad steps at the bottom of the stairs and both fireplaces (Photo 10).

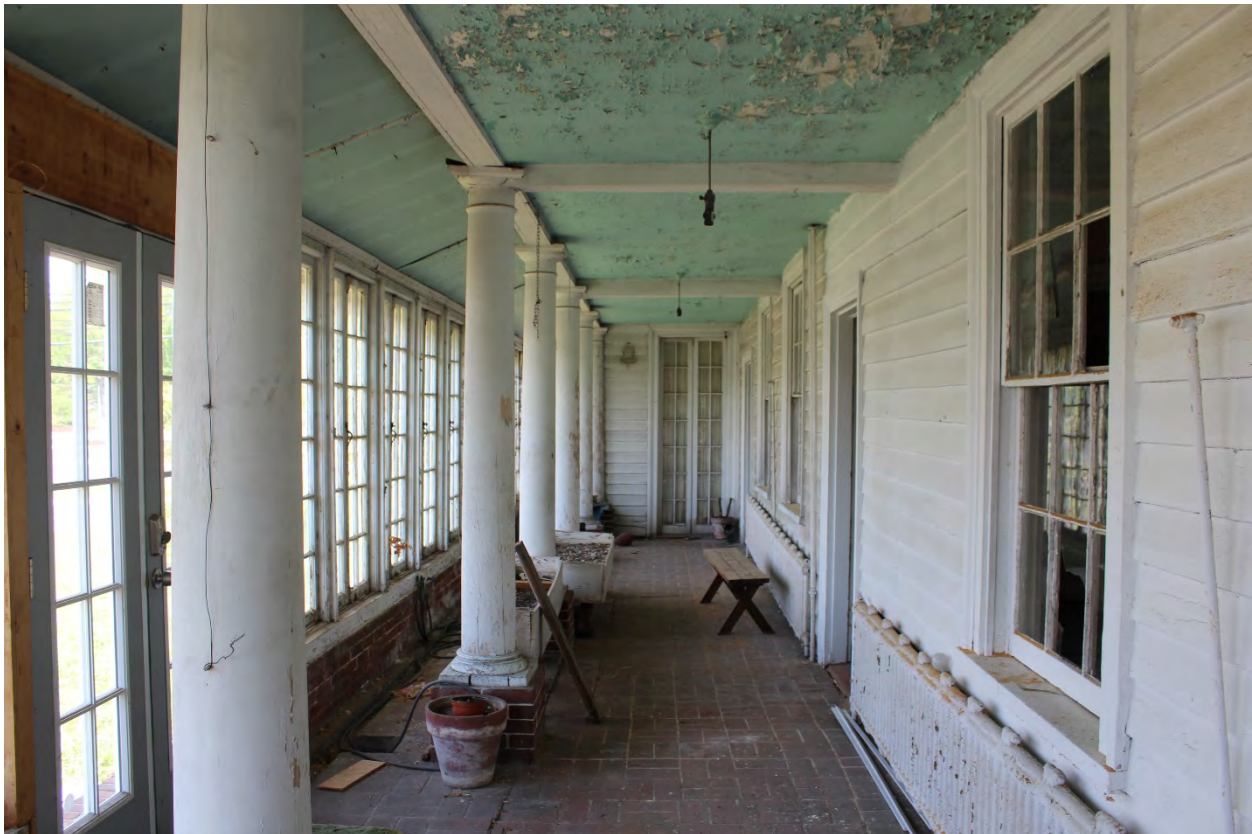
Photo 11: Room 110, on the south elevation of the rear ell, is a nineteenth century porch that was enclosed in the twentieth century

including one with arched top panels, are original as is the back staircase. The glass casement doors on the north wall represent twentieth century alterations evidenced by their plain block casings. At the rear of the ell is an enclosed porch with casement windows, brick walls and floors, beaded board ceiling and oversized brick fireplace. This porch was added during the first quarter of the twentieth century. The glass-enclosed side porch (Room 110) is of the same vintage with brick floor, exterior clapboard walls, and round columns supporting the beaded board ceiling (Photo 11).

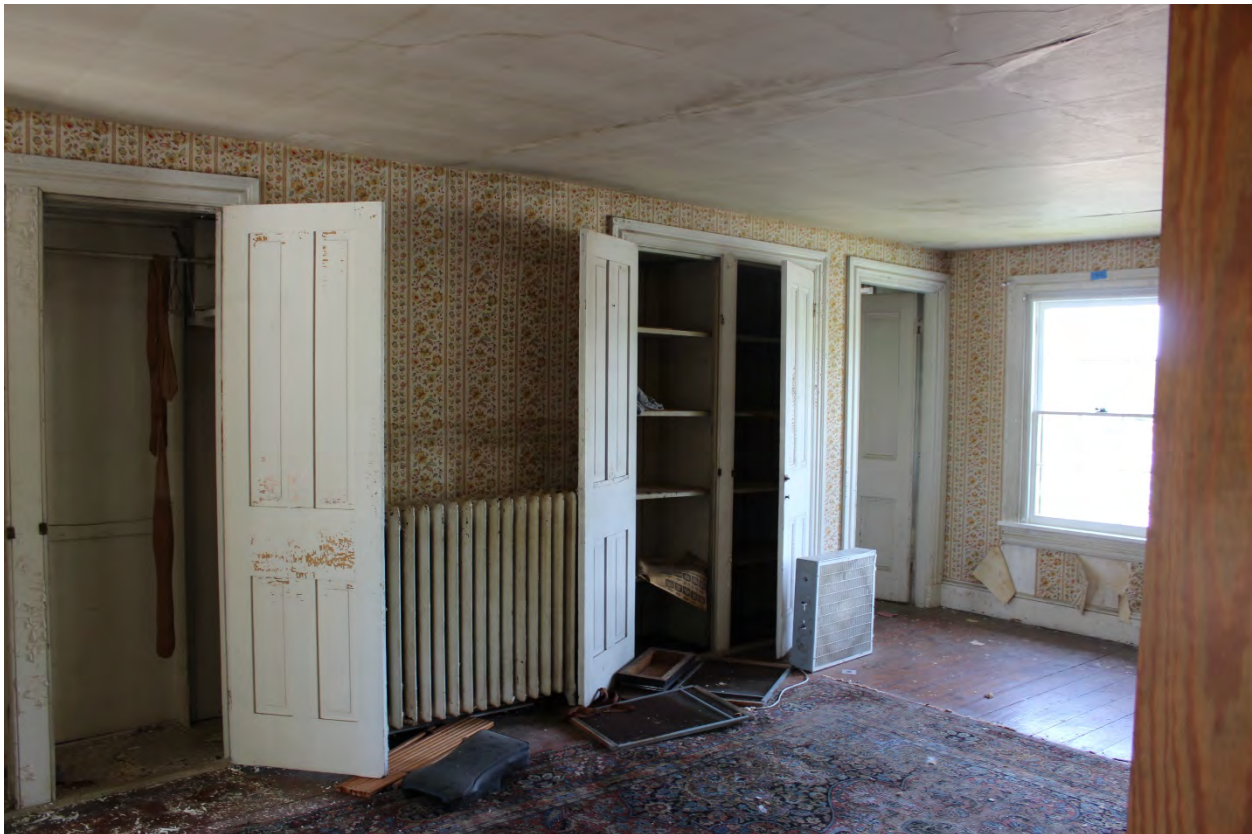
Photo 12: Room 206 dates to the second half of the nineteenth century and retains most of its original fabric

The second story contains a series of bedrooms with a bathroom in the corner addition above the first-floor bathroom. The rooms retain their nineteenth century wood floors, plaster walls and ceilings, molded trim and baseboards and four-panel doors. For the most part, these rooms are original to their construction periods (Photos 12-13).

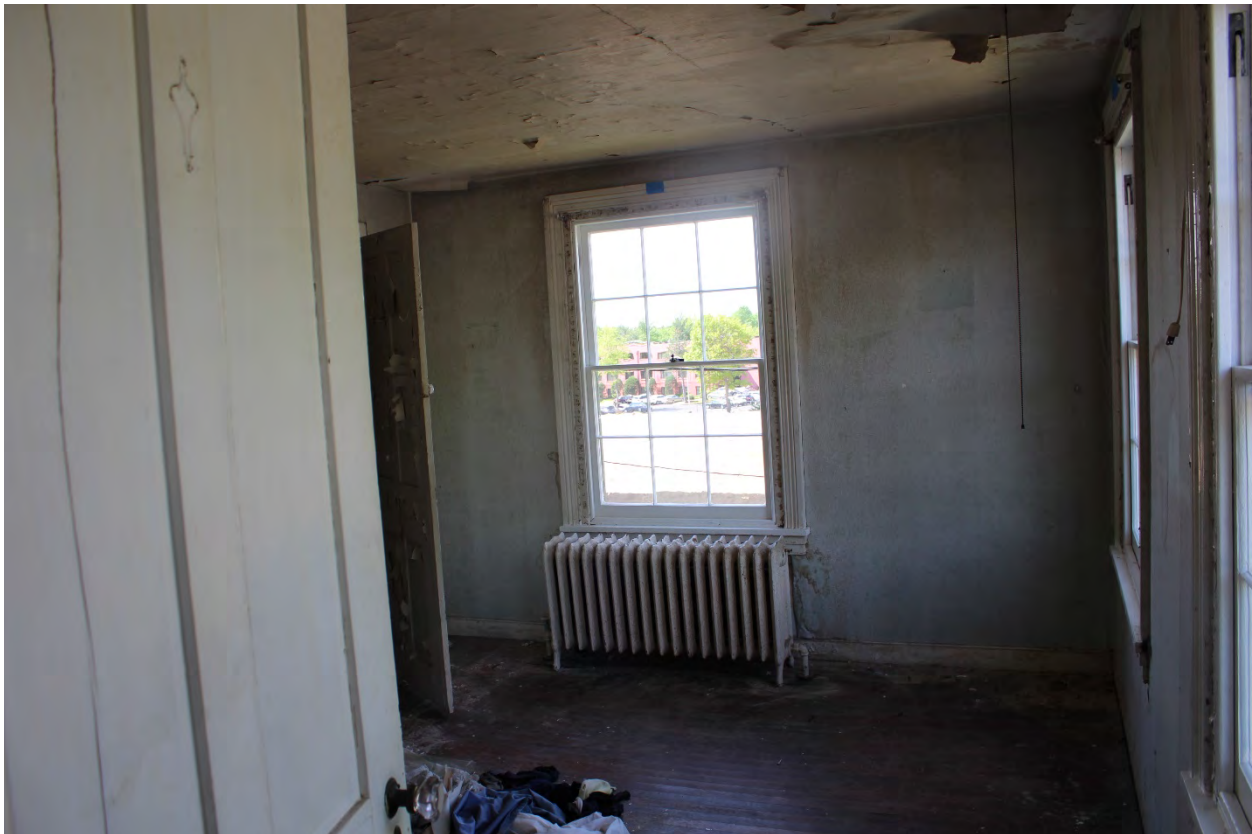
Photo 13: Room 202 is an original bedroom, dating to ca. 1852. It retains its original fabric
