National Register of Historic Places
Inventory—Nomination Form

historic THOMAS THRELKELD HOUSE
and/or common

street & number Benson Pike not for publication
city, town Shelbyville vic. vicinity of congressional district
state Kentucky code county Shelby code

HISTORIC AMERICAN BUILDINGS SURVEY SHEET 1 OF 12 SHEETS

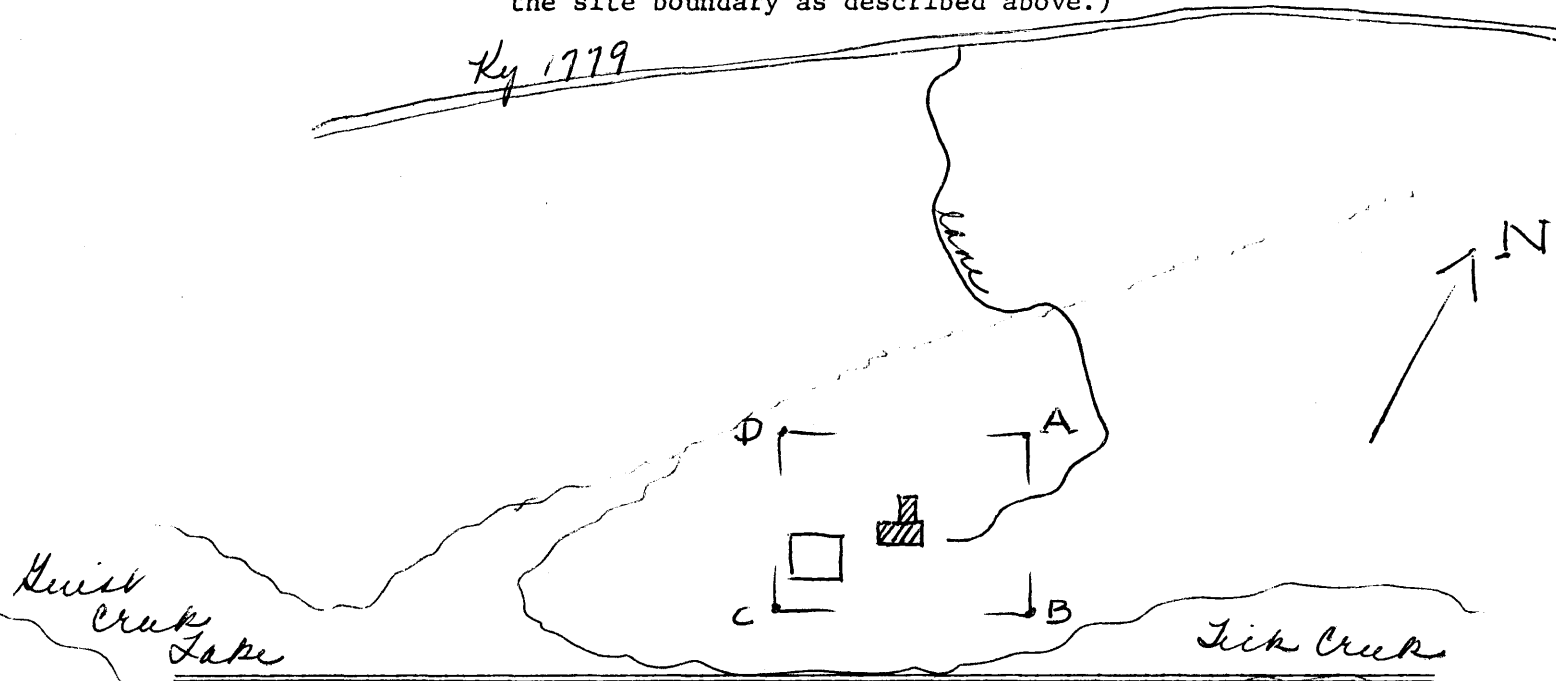
Sketch of Site Plan (Showing outbuildings, structures, landscape features and the site boundary as described above.)

Beginning N.E. of the house at A, thence S 656 ft to B, thence W 656 ft to C, thence N 656 ft to D, thence E 656 ft to the beginning; containing the house, spring, and dependency foundations.

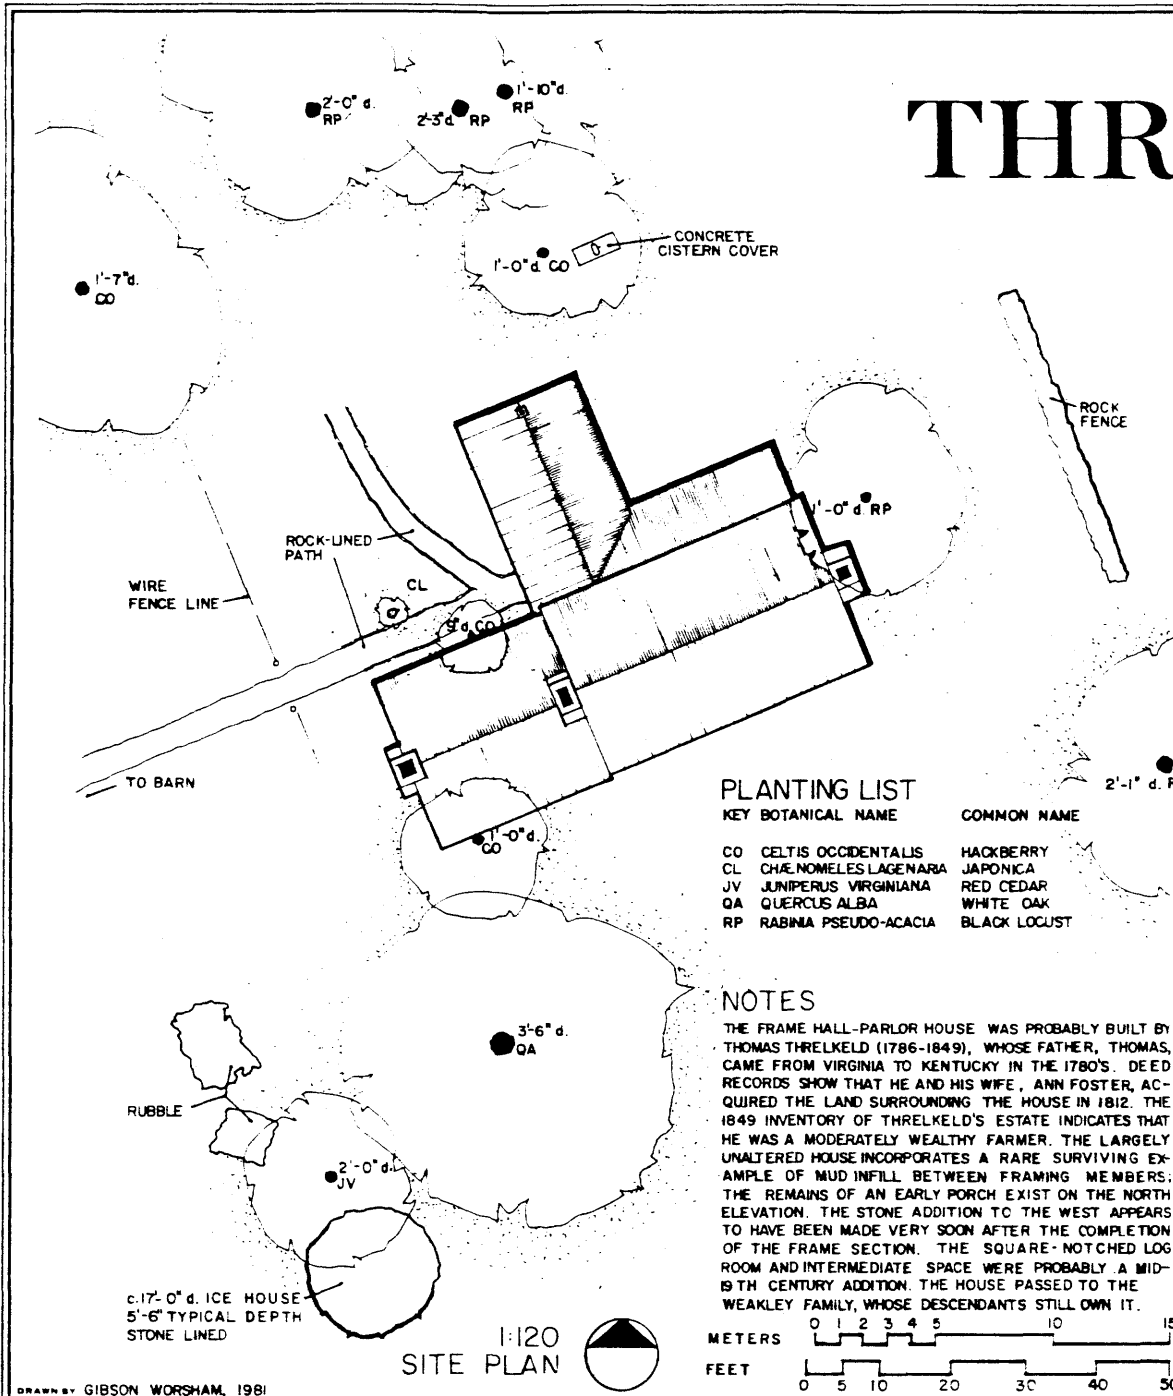
THE FRAME HALL-PARLOR HOUSE WAS PROBABLY BUILT BY THOMAS THRELKELD (1786-1849), WHOSE FATHER, THOMAS, CAME FROM VIRGINIA TO KENTUCKY IN THE 1780'S. DEED RECORDS SHOW THAT HE AND HIS WIFE, ANN FOSTER, ACQUIRED THE LAND SURROUNDING THE HOUSE IN 1812. THE 1849 INVENTORY OF THRELKELD'S ESTATE INDICATES THAT HE WAS A MODERATELY WEALTHY FARMER. THE LARGELY UNALTERED HOUSE INCORPORATES A RARE SURVIVING EXAMPLE OF MUD INFILL BETWEEN FRAMING MEMBERS. THE REMAINS OF AN EARLY PORCH EXIST ON THE NORTH ELEVATION. THE STONE ADDITION TO THE WEST APPEARS TO HAVE BEEN MADE VERY SOON AFTER THE COMPLETION OF THE FRAME SECTION. THE SQUARE-NOTCHED LOG ROOM AND INTERMEDIATE SPACE WERE PROBABLY A MID-19TH CENTURY ADDITION. THE HOUSE PASSED TO THE WEAKLEY FAMILY, WHOSE DESCENDANTS STILL OWN IT.

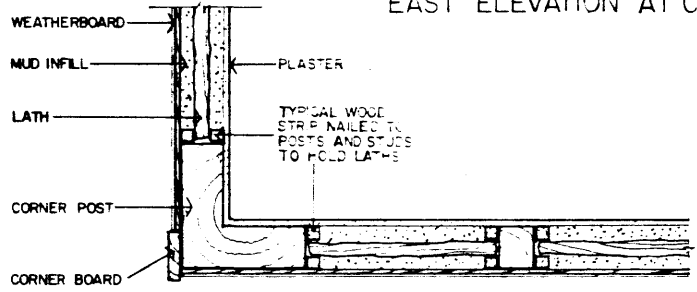
SECTION AT A

1 1/2" FRAMING DETAILS AT SOUTHEAST CORNER

The house is made up of three sections, all of which are of one story: a two-room frame section with garret and basement, built first; a stone wing to the west, built very soon after; and a log ell to the north, built at a considerably later date (see photos 1 & 2 and plans & elevations). The frame section is a three-bay hall-parlor house with a central door symmetrically placed in the principal (south) facade fronting the creek. The foundation is constructed of coursed, squared rubble. A barred vent below each of the two windows on the south front flanks the location of a now vanished wooden stoop. The frame section is sheathed with tapered weatherboard with a six inch weather incorporating a 1/2" bead. The fenestration and siding on the north facade indicate that it originally carried no porch or other appendage. It contains four asymmetrically located openings: two central doors flanked by windows (see photo 3). At each end of the house rise shouldered exterior stone chimneys between two small windows which light each end of the garret. The first floor windows on the north and south are equipped with pintles for exterior blinds. The three exterior doors are hung on butt hinges and bear traces of graining on their outer faces, although the exposed weatherboards and door frames are devoid of paint. The frame is constructed of 3" x 4" studs resting on 12" x 12" sills and augmented by down braces (on the front and probably the rear). One arch brace is known to exist over the door to the stone wing at the south corner of the west gable end (see photo 4). Each corner post is constructed of a 12" x 12" section hollowed to form an L shape, thereby preventing the inner corner of the post from protruding into any of the rooms.

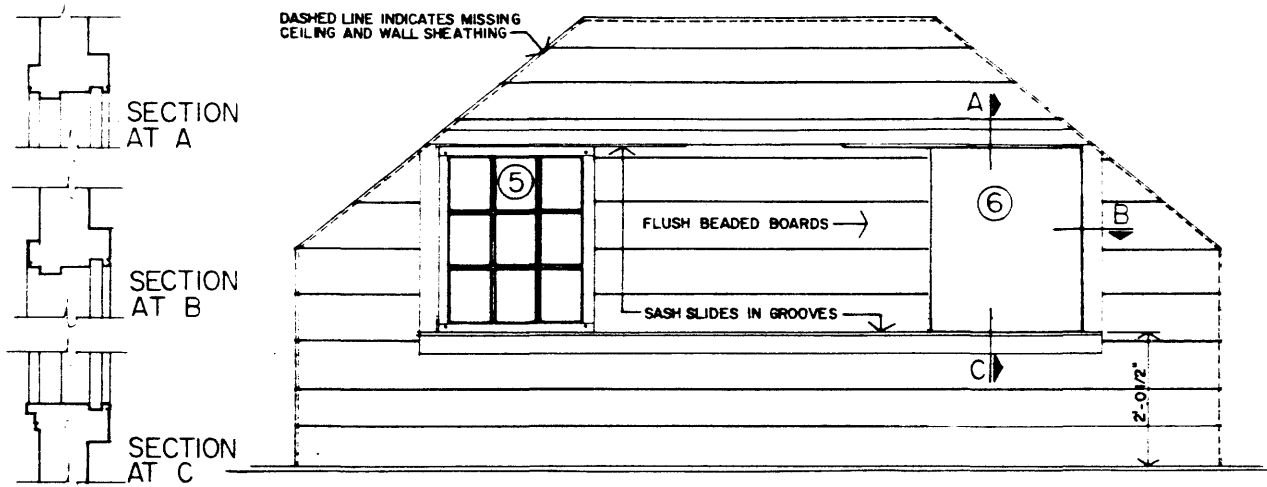
1 1/2" EAST GARRET WINDOWS 5 & 6 DETAILS

3/4" EAST GARRET WINDOWS 5 & 6 INTERIOR ELEVATION

sash slides horizontally in rails articulated above and below with beading along their grooved edges, and the distance between the windows is such that the two corresponding sashes, when open, occupy exactly the space between the window openings and behind the chimney. The bead on the underside of the top guide rail was left off in the center of the space between the windows for a distance equal to the width of one sash, so that when the sash is moved to the center it can fall forward and be entirely removed.

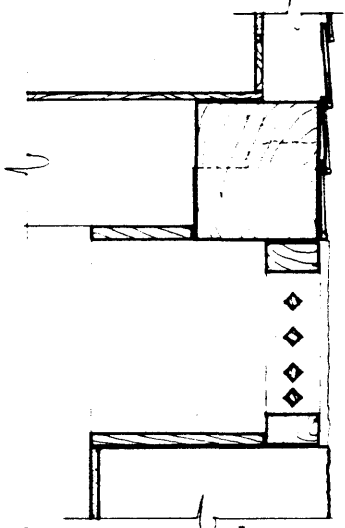
NORTH BASEMENT VENT ① JAMB FULL SCALE PROFILE AT B

3/4" NORTH BASEMENT VENT ① DETAILS

1 1/2" BASEMENT VENT ① SECTION AT A

The cellar consists of a single space under the east room of the frame section. It is reached by an exterior flight of stone steps at the south corner of the east gable wall. The stone walls are plastered and a barred vent is located in both north and south walls. No cooking or heating fireplace was provided in the basement; the hearth above is carried on a corbelled stone arch vaulting out to the first joist in front of the chimney.

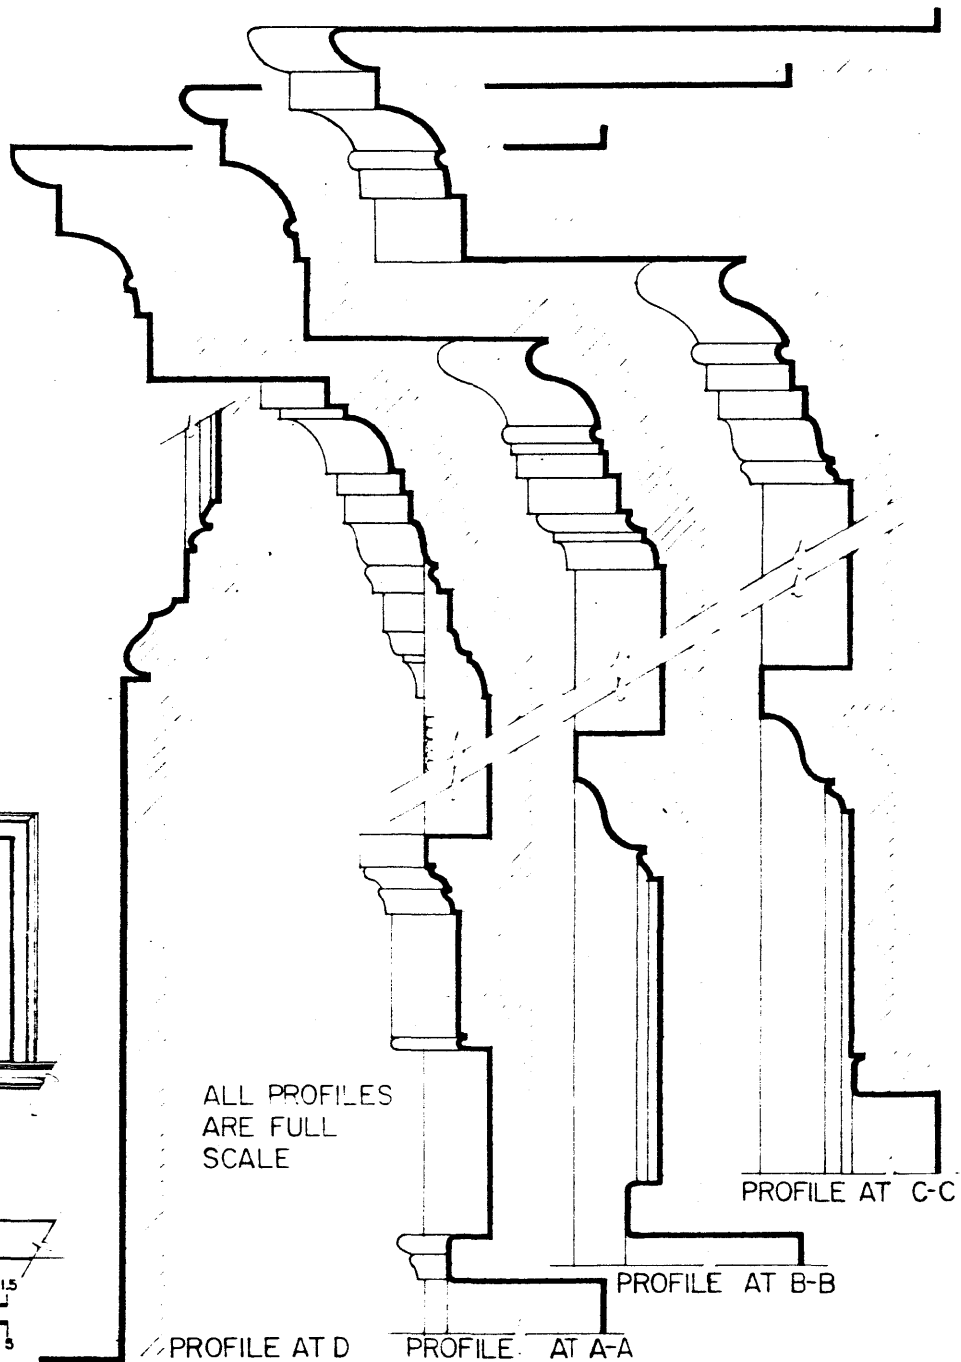
ALL PROFILES ARE FULL SCALE

PROFILE AT D

PROFILE AT A-A

PROFILE AT B-B

PROFILE AT C-C
