AMERICA STREET SCHOOL
22 America Street
Providence, Rhode Island

View: Front elevation (West) on America Street.

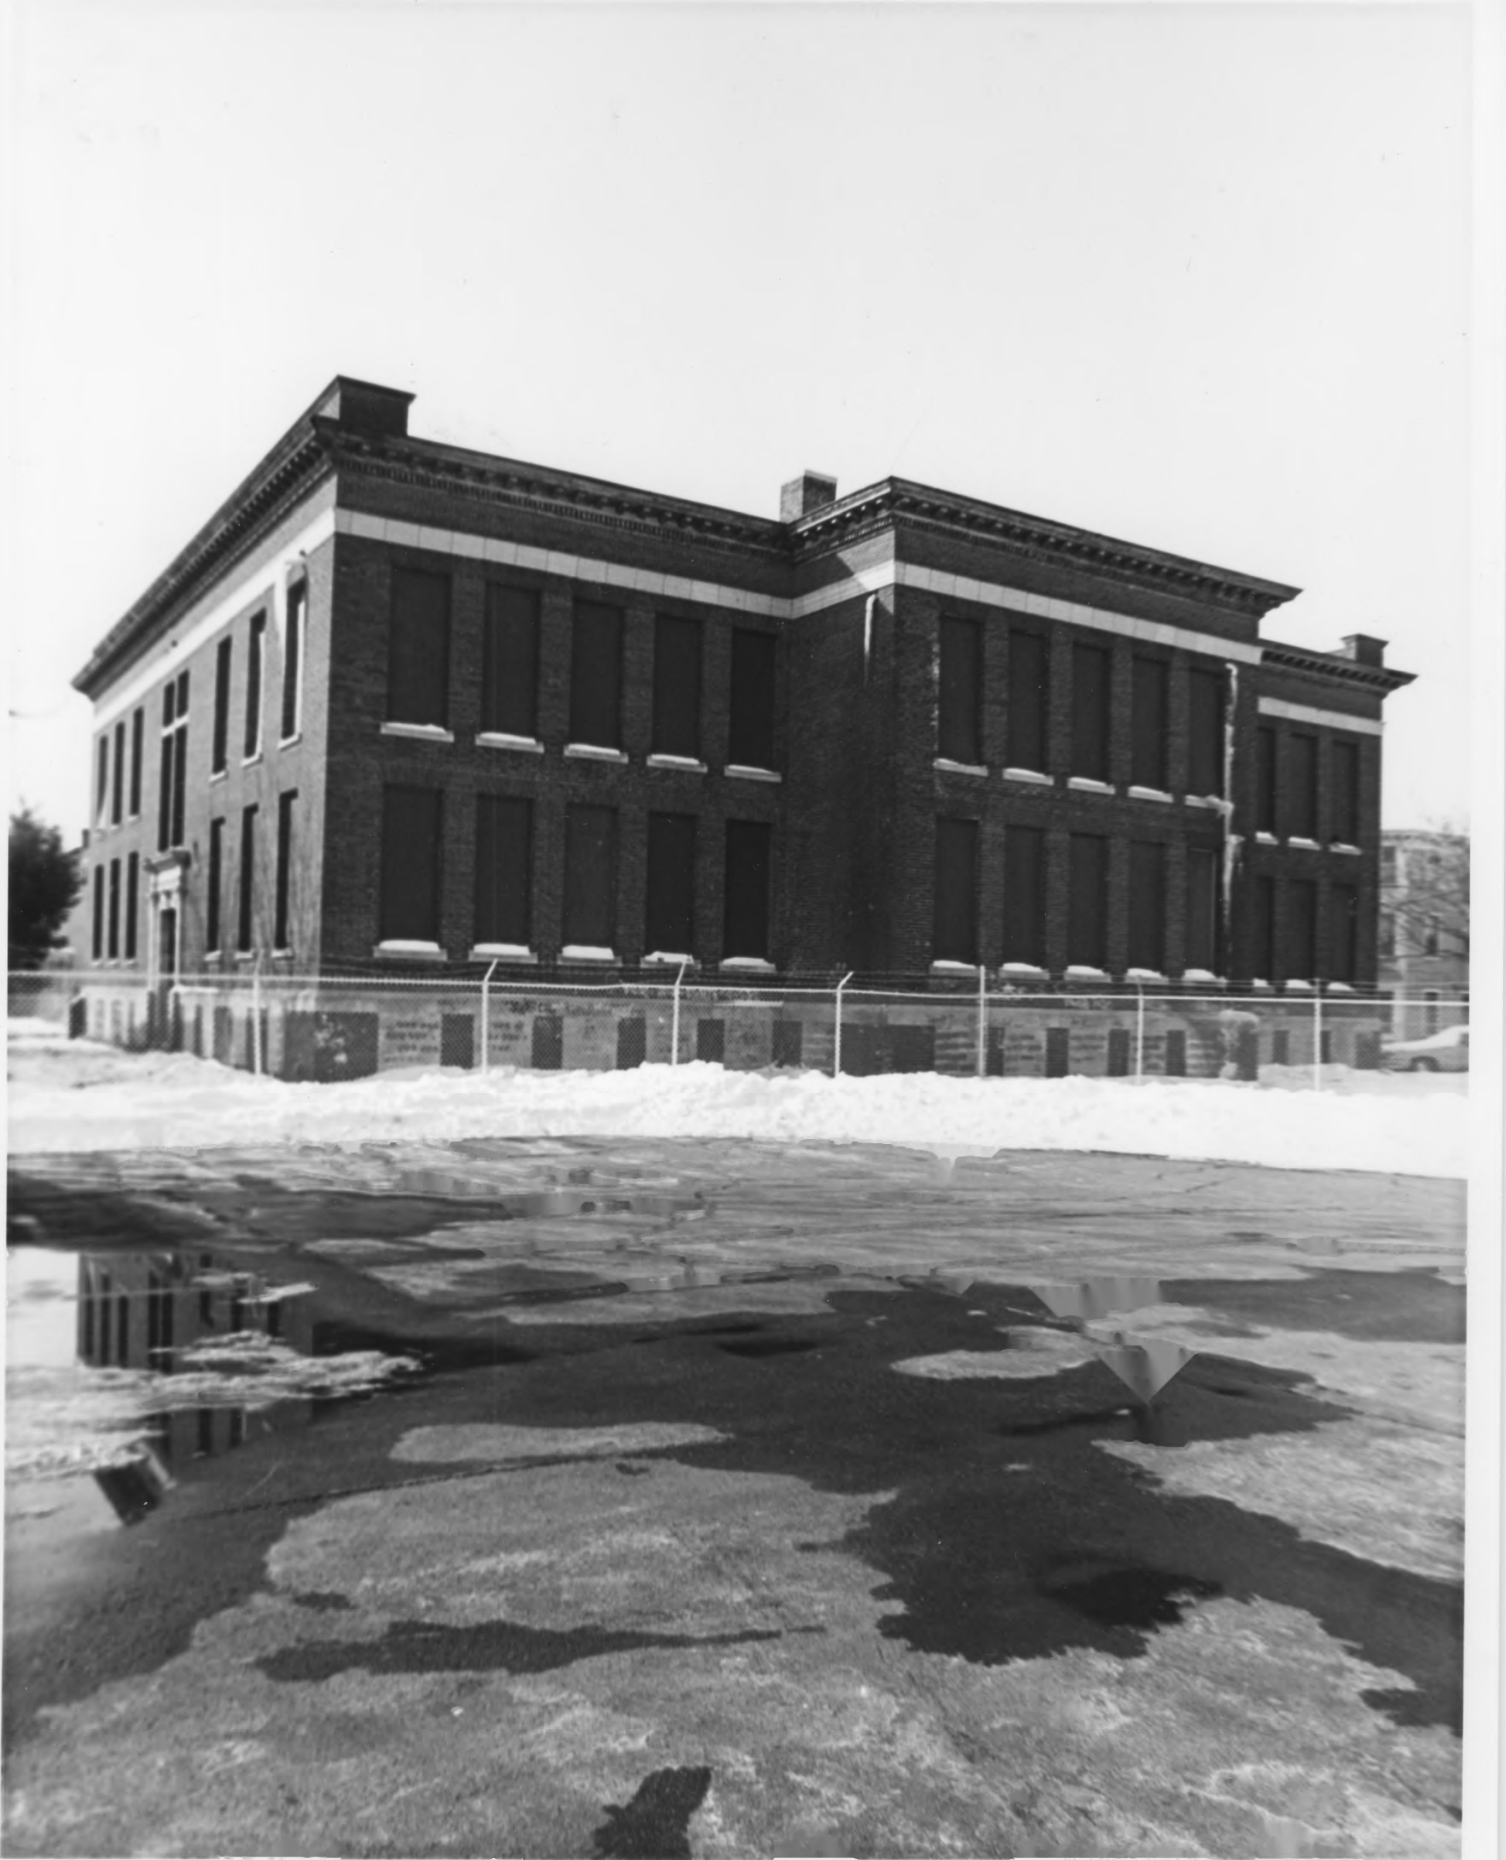
Photo #3

View: Rear and side elevations (East and North).

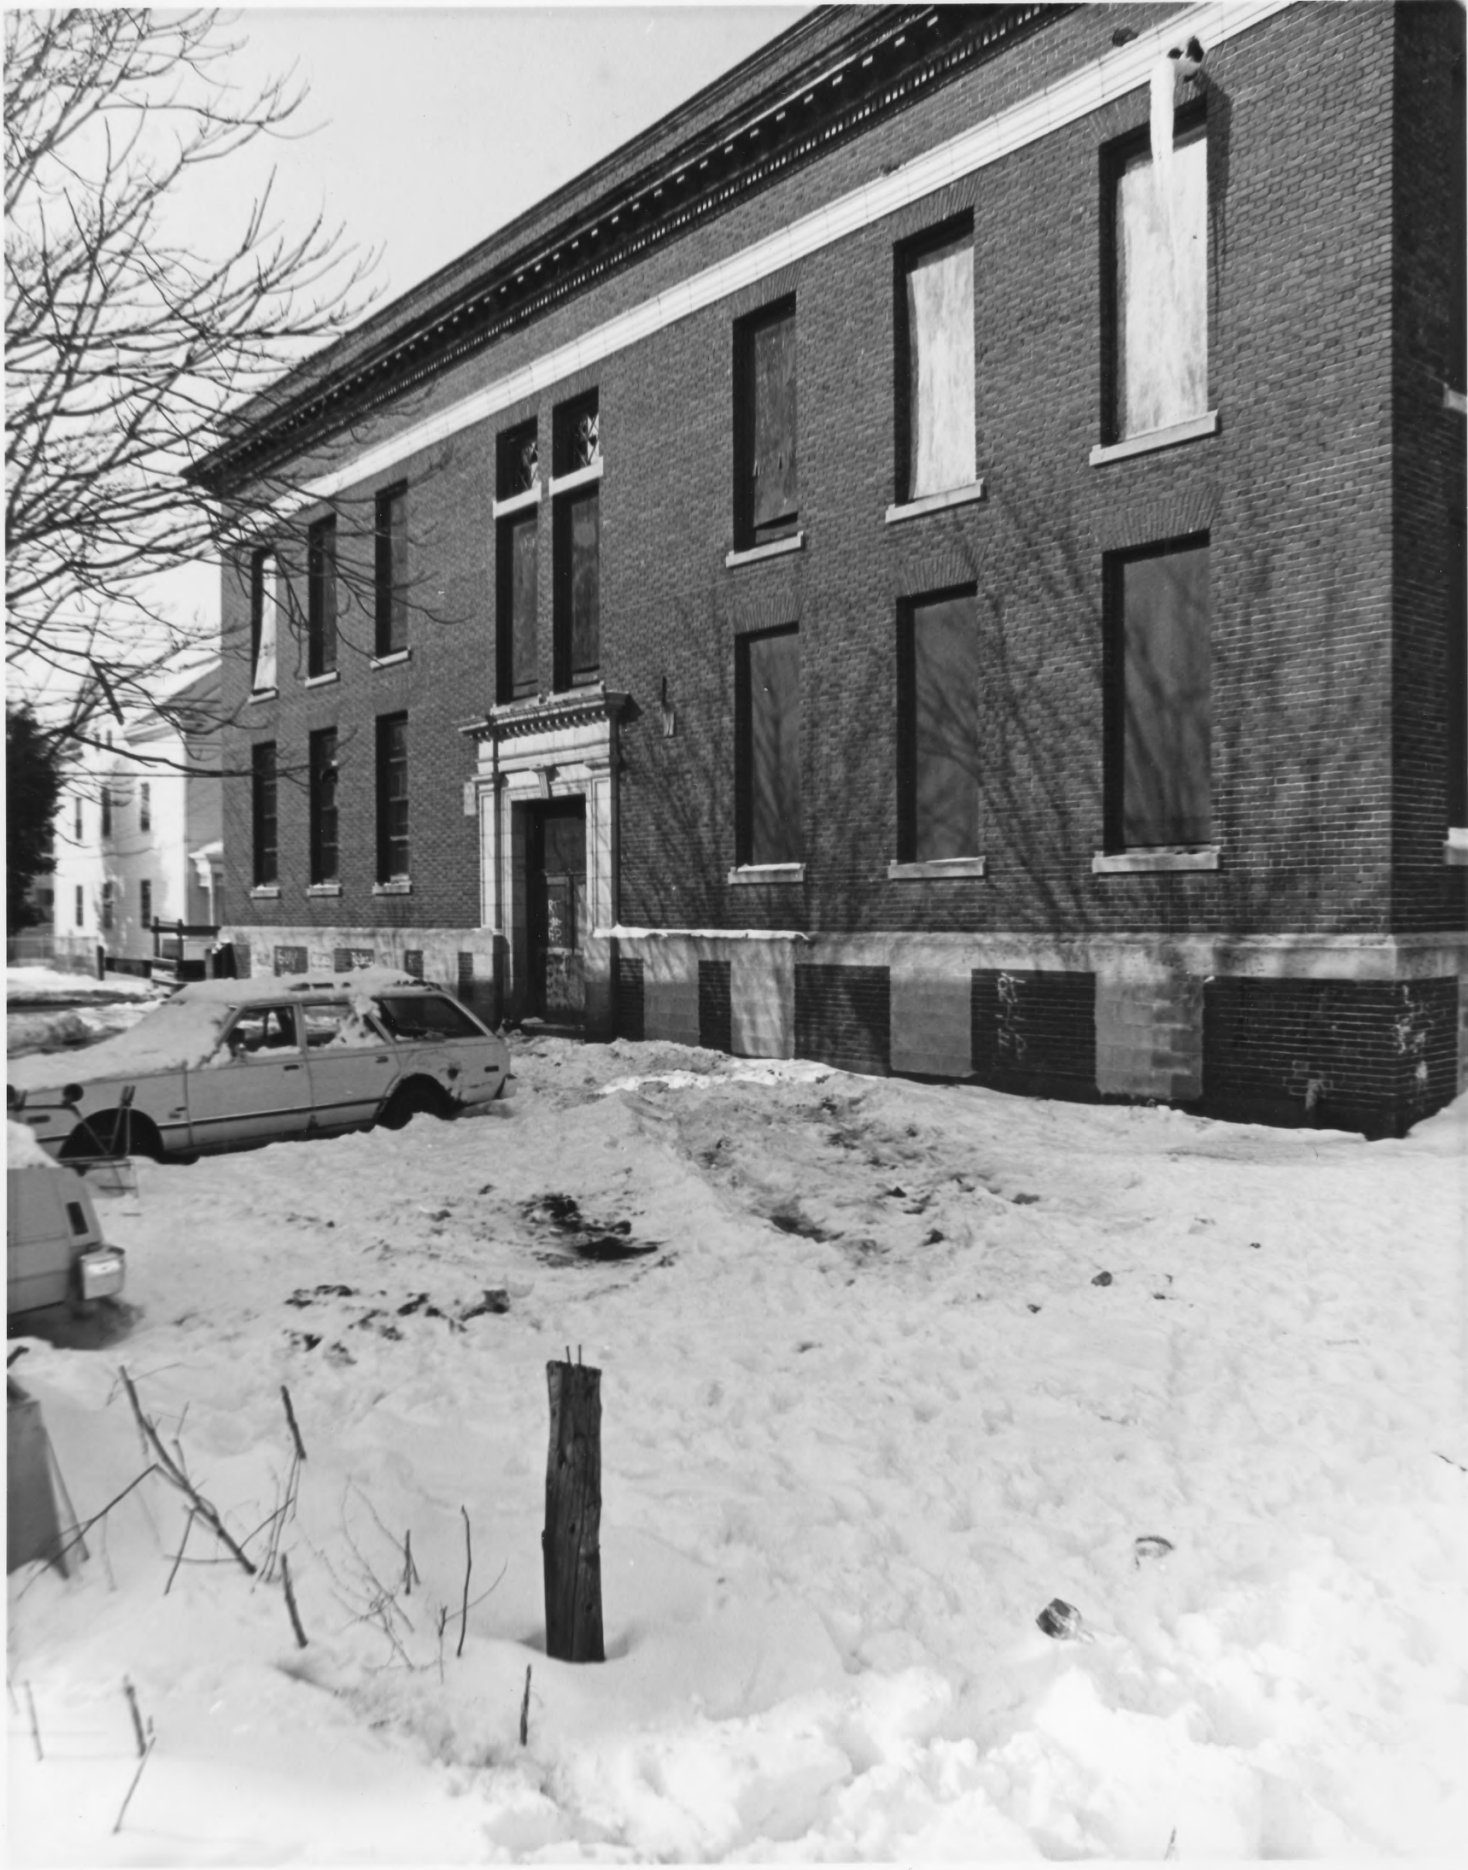
Photo #55

View: Side elevation((North)).

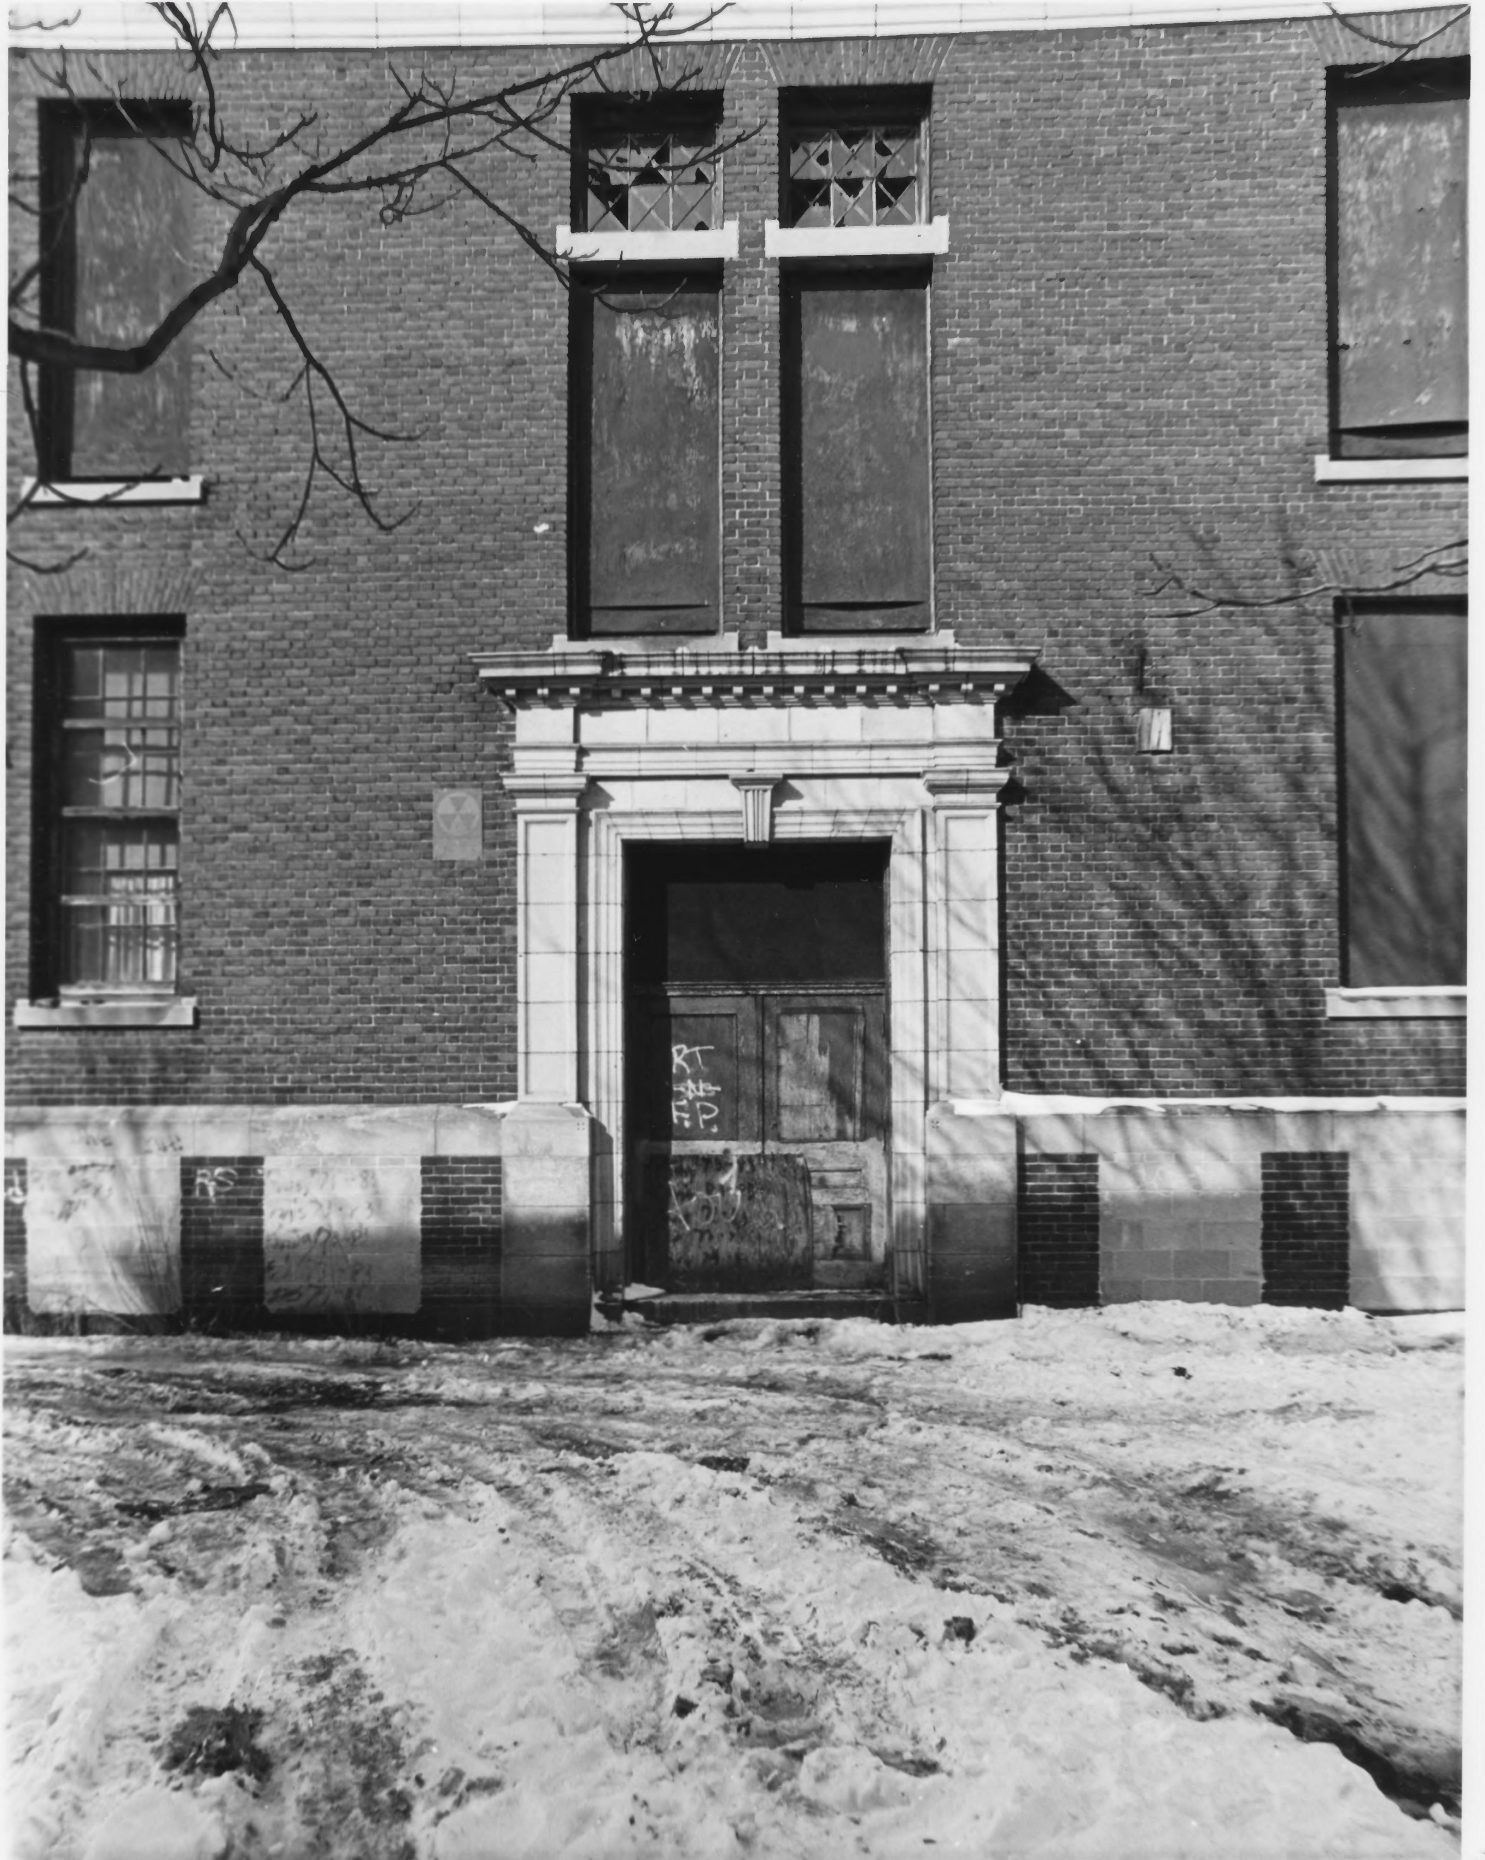
Photo #6

View: Side entrance on the South elevation which is
identical to the North, side elevation.
There are double doors framed by squat pilaster
strips and capped by a vaguely Ionic entab-
lature.

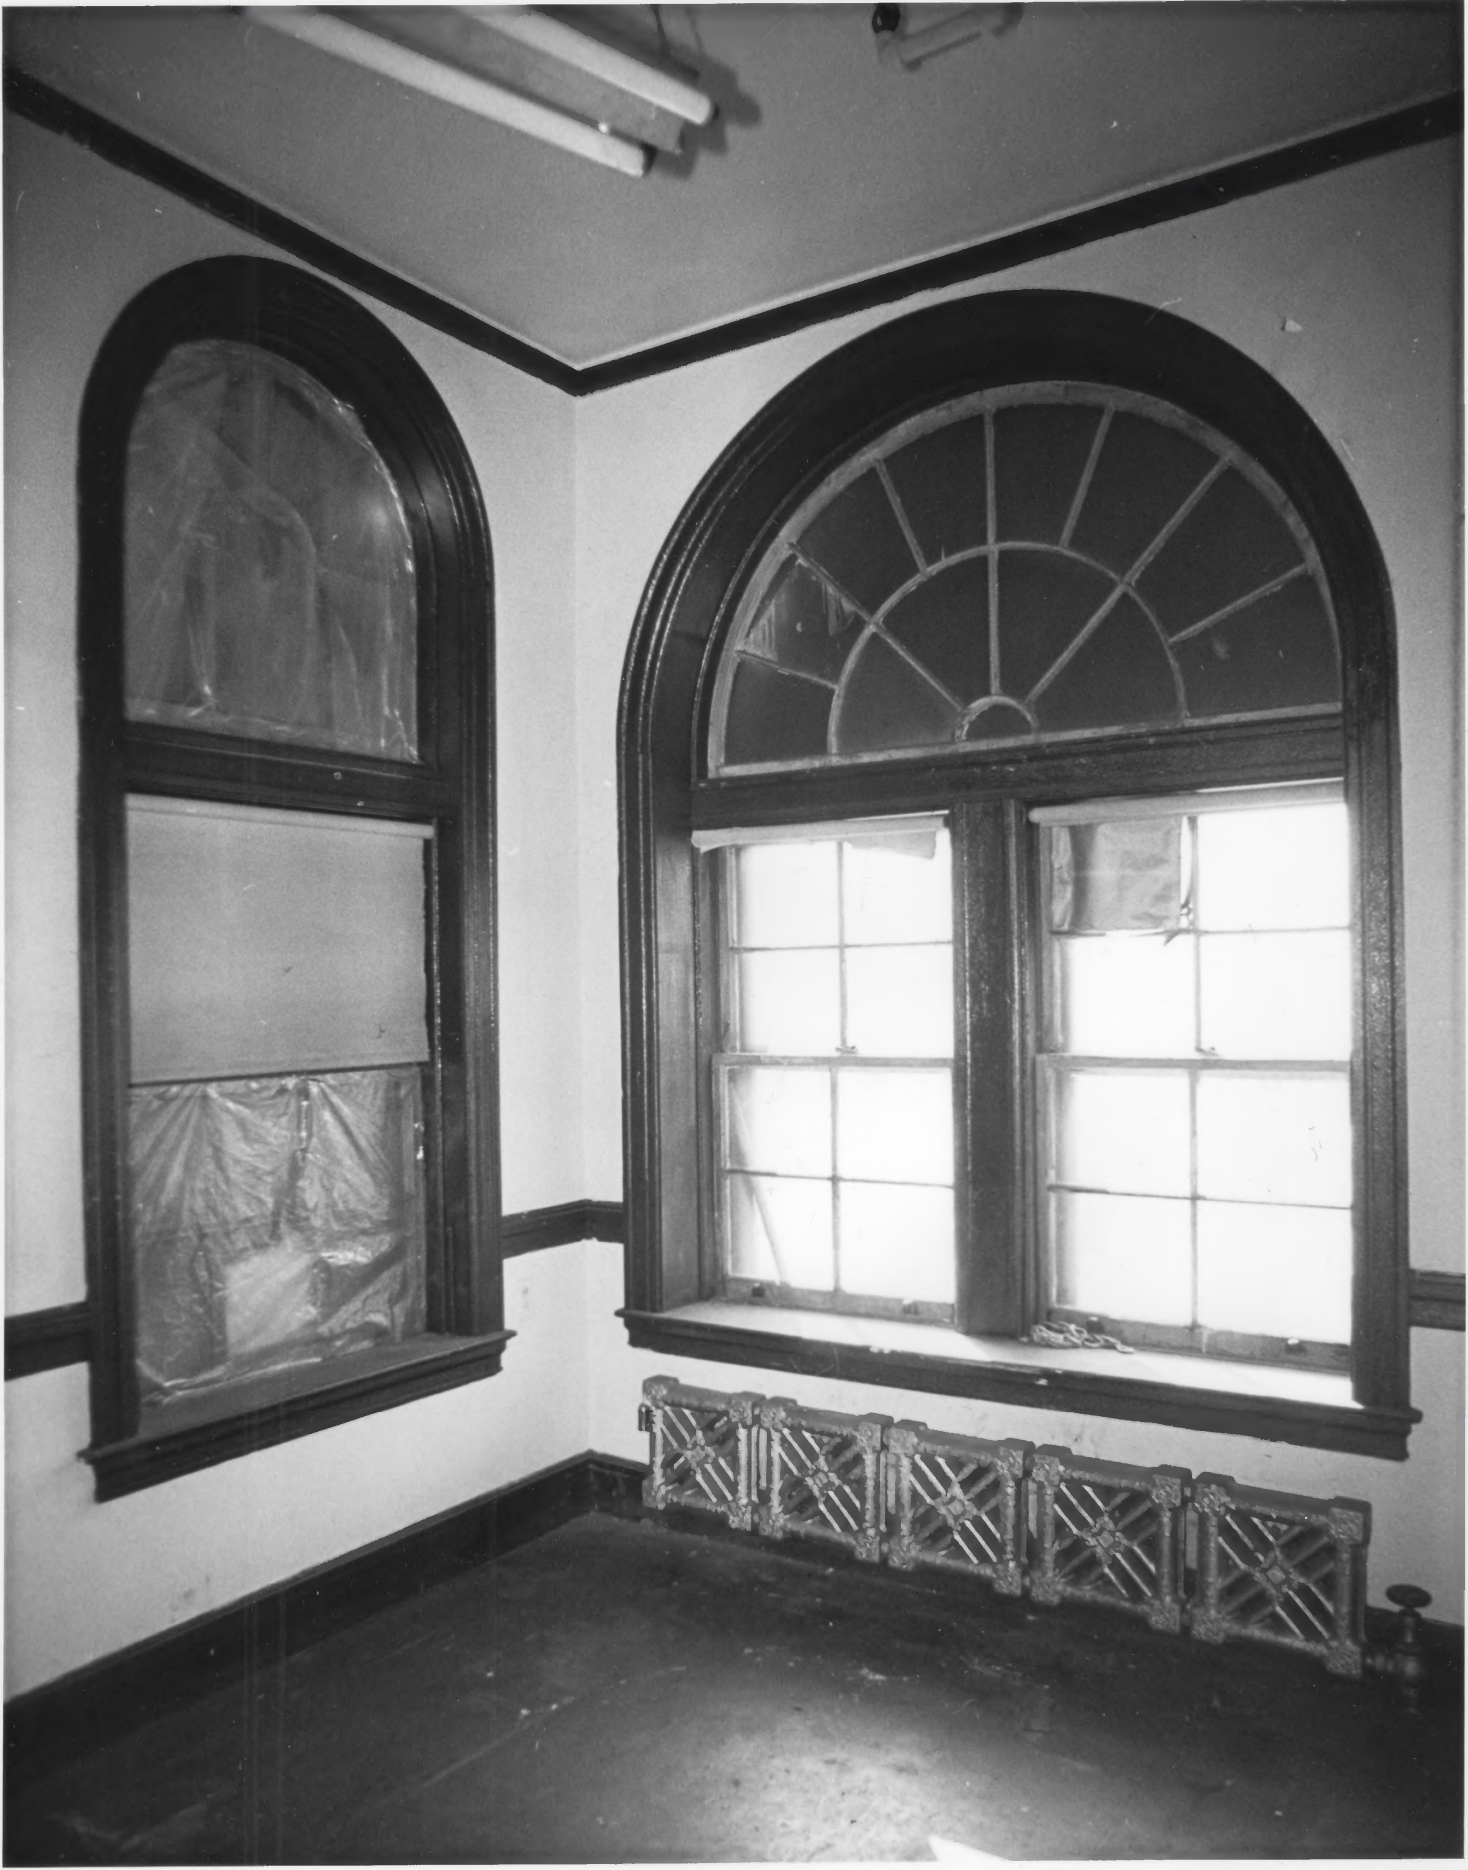
Photo #7

View: Multi-Light, half-round fanlights in the
Principal's room adjacent to the main entrance;
identical detail in the teachers' room on
the other of the entrance.

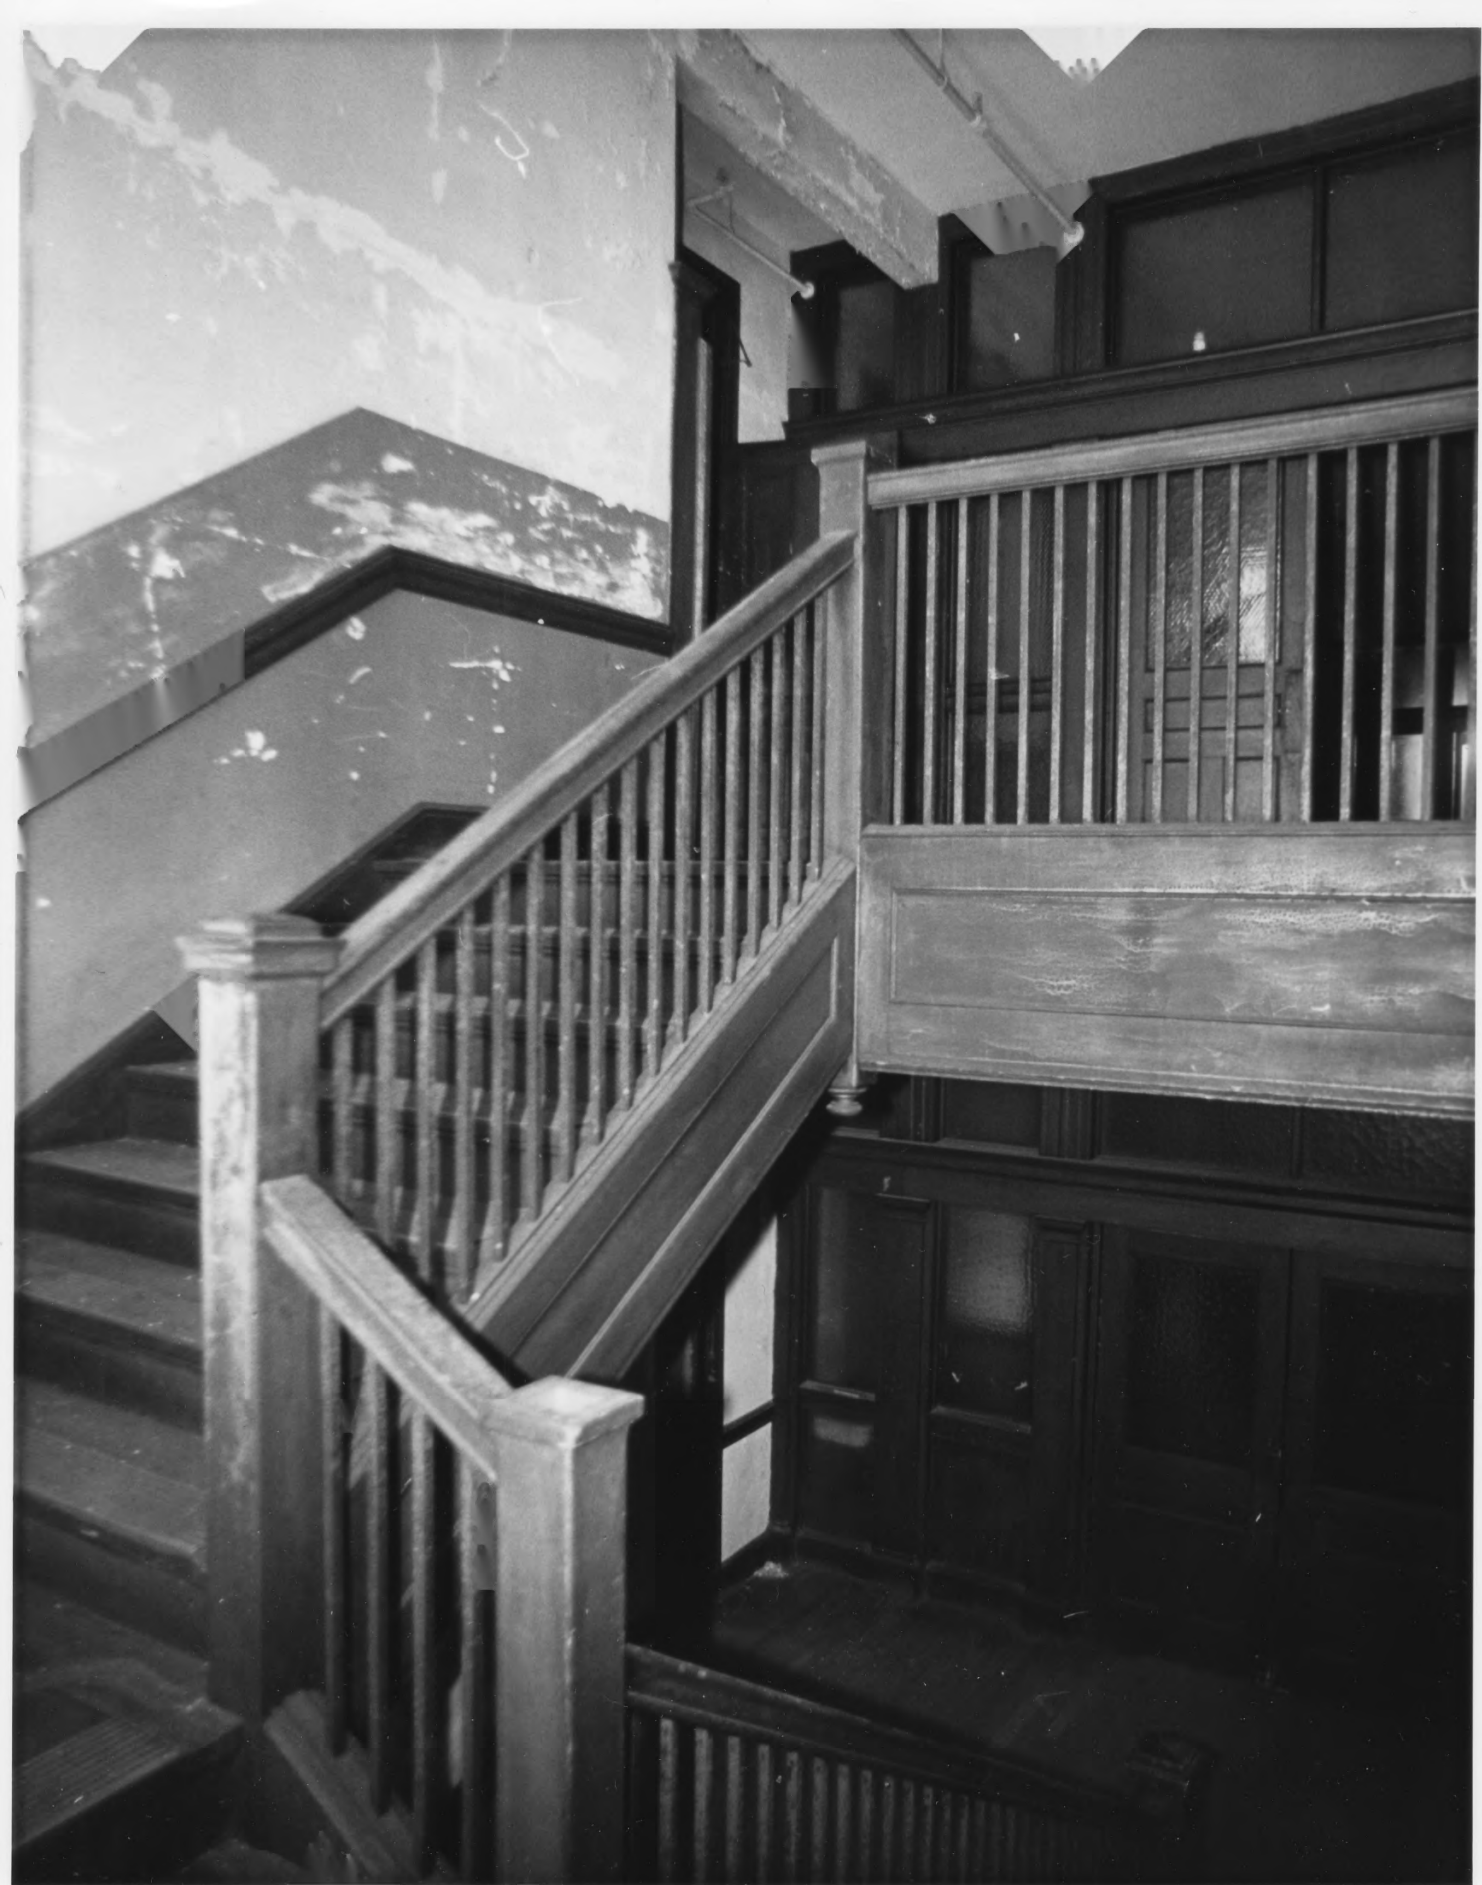
Photo #8

View: Stairwell on the North end of the building
which is identical to the South stairwell.
Oak and glass partitions separate the stair-
halls from the central corridor.

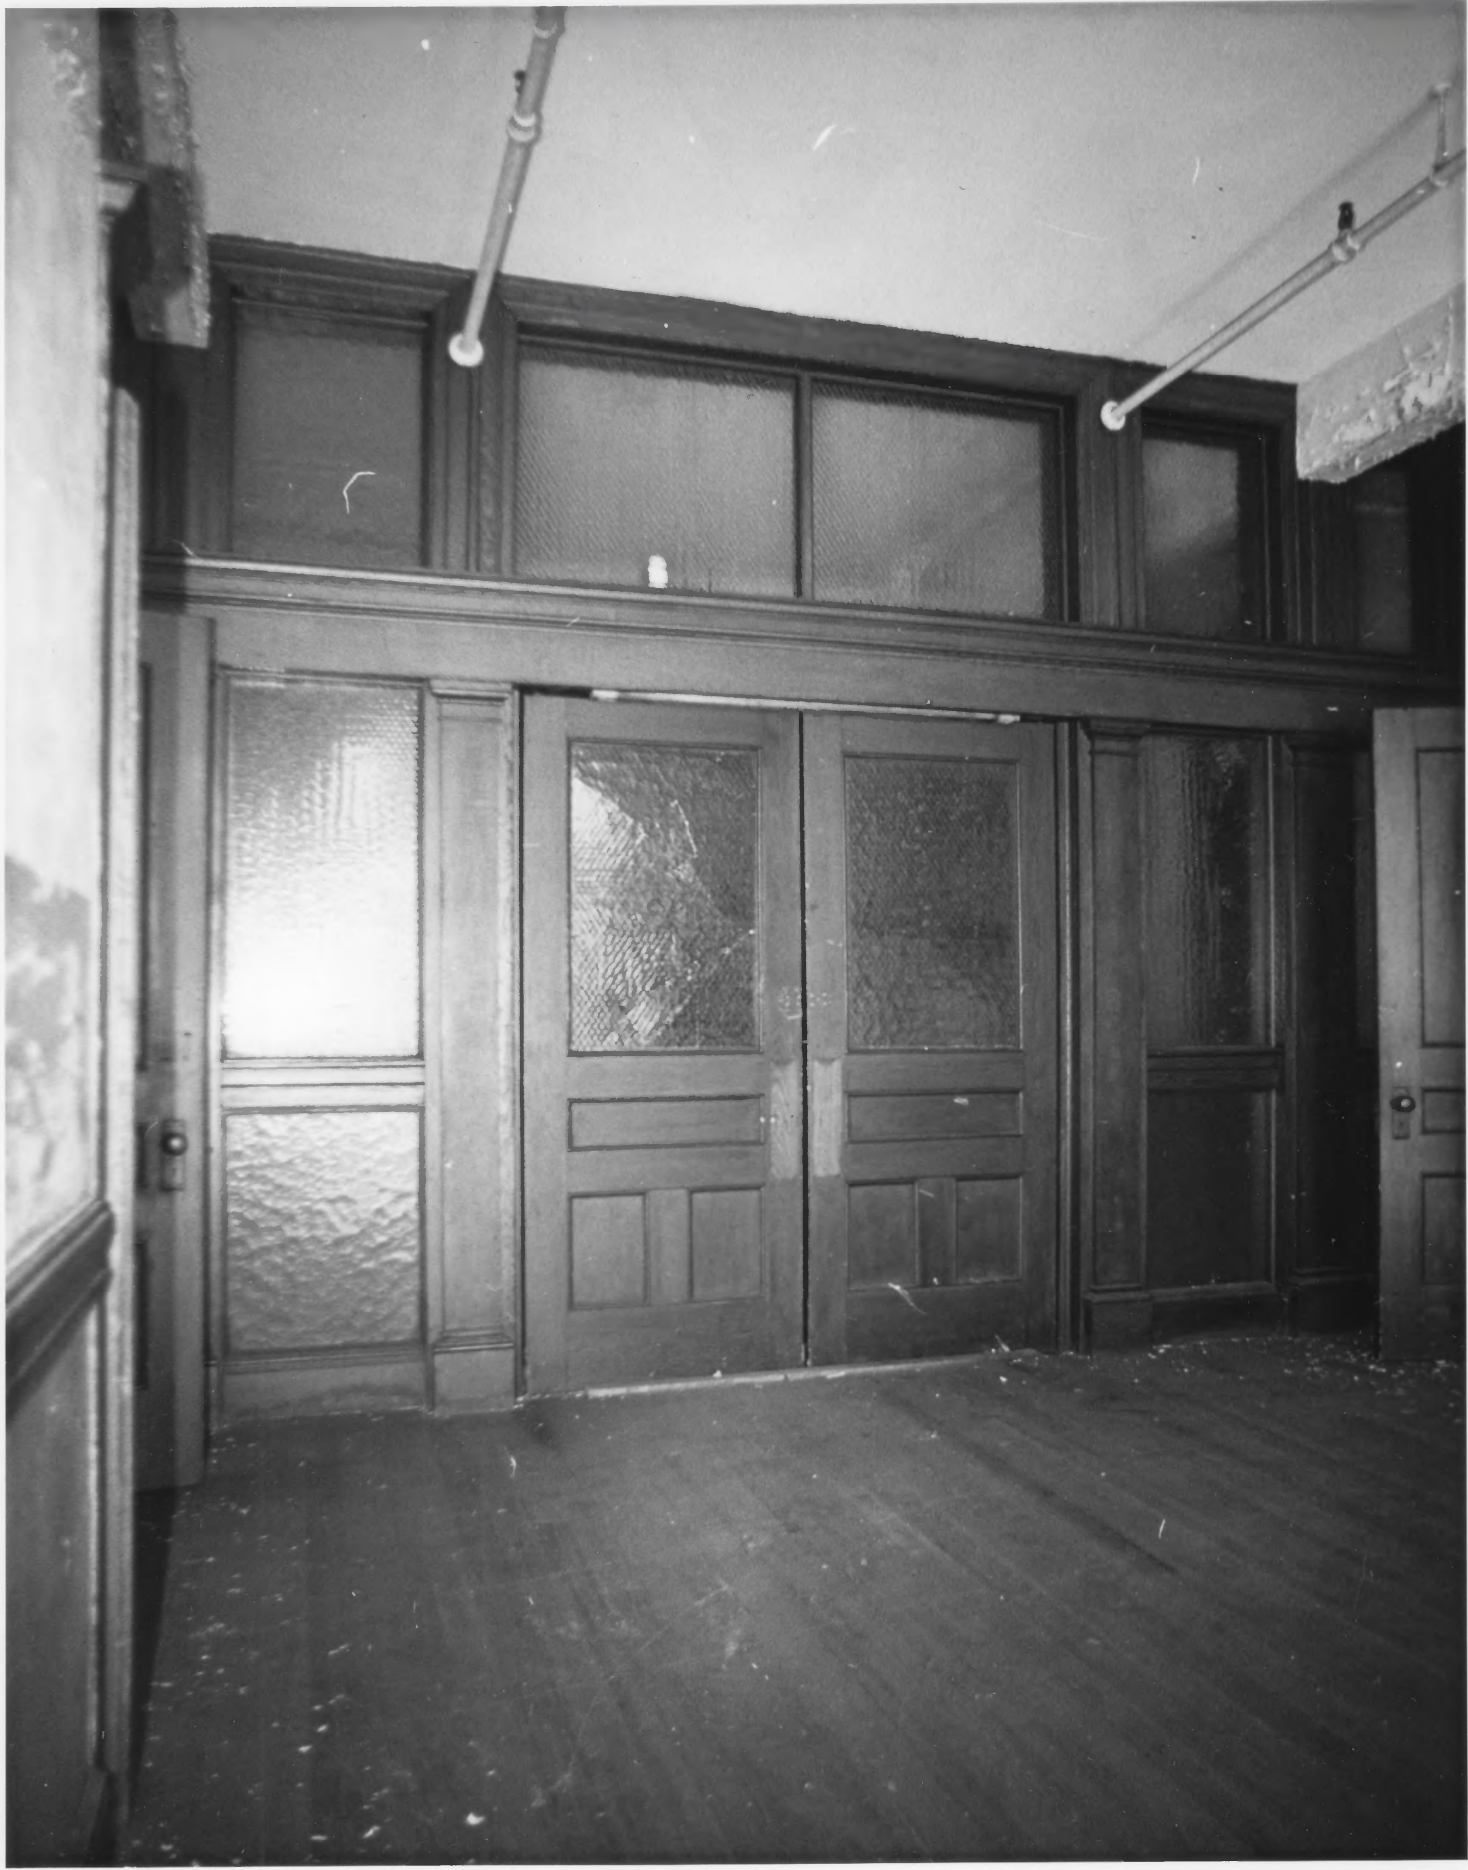
Photo #9

View: Detail of the oak and glass partition separating
the stairhall and corridor at the north end of
the building.

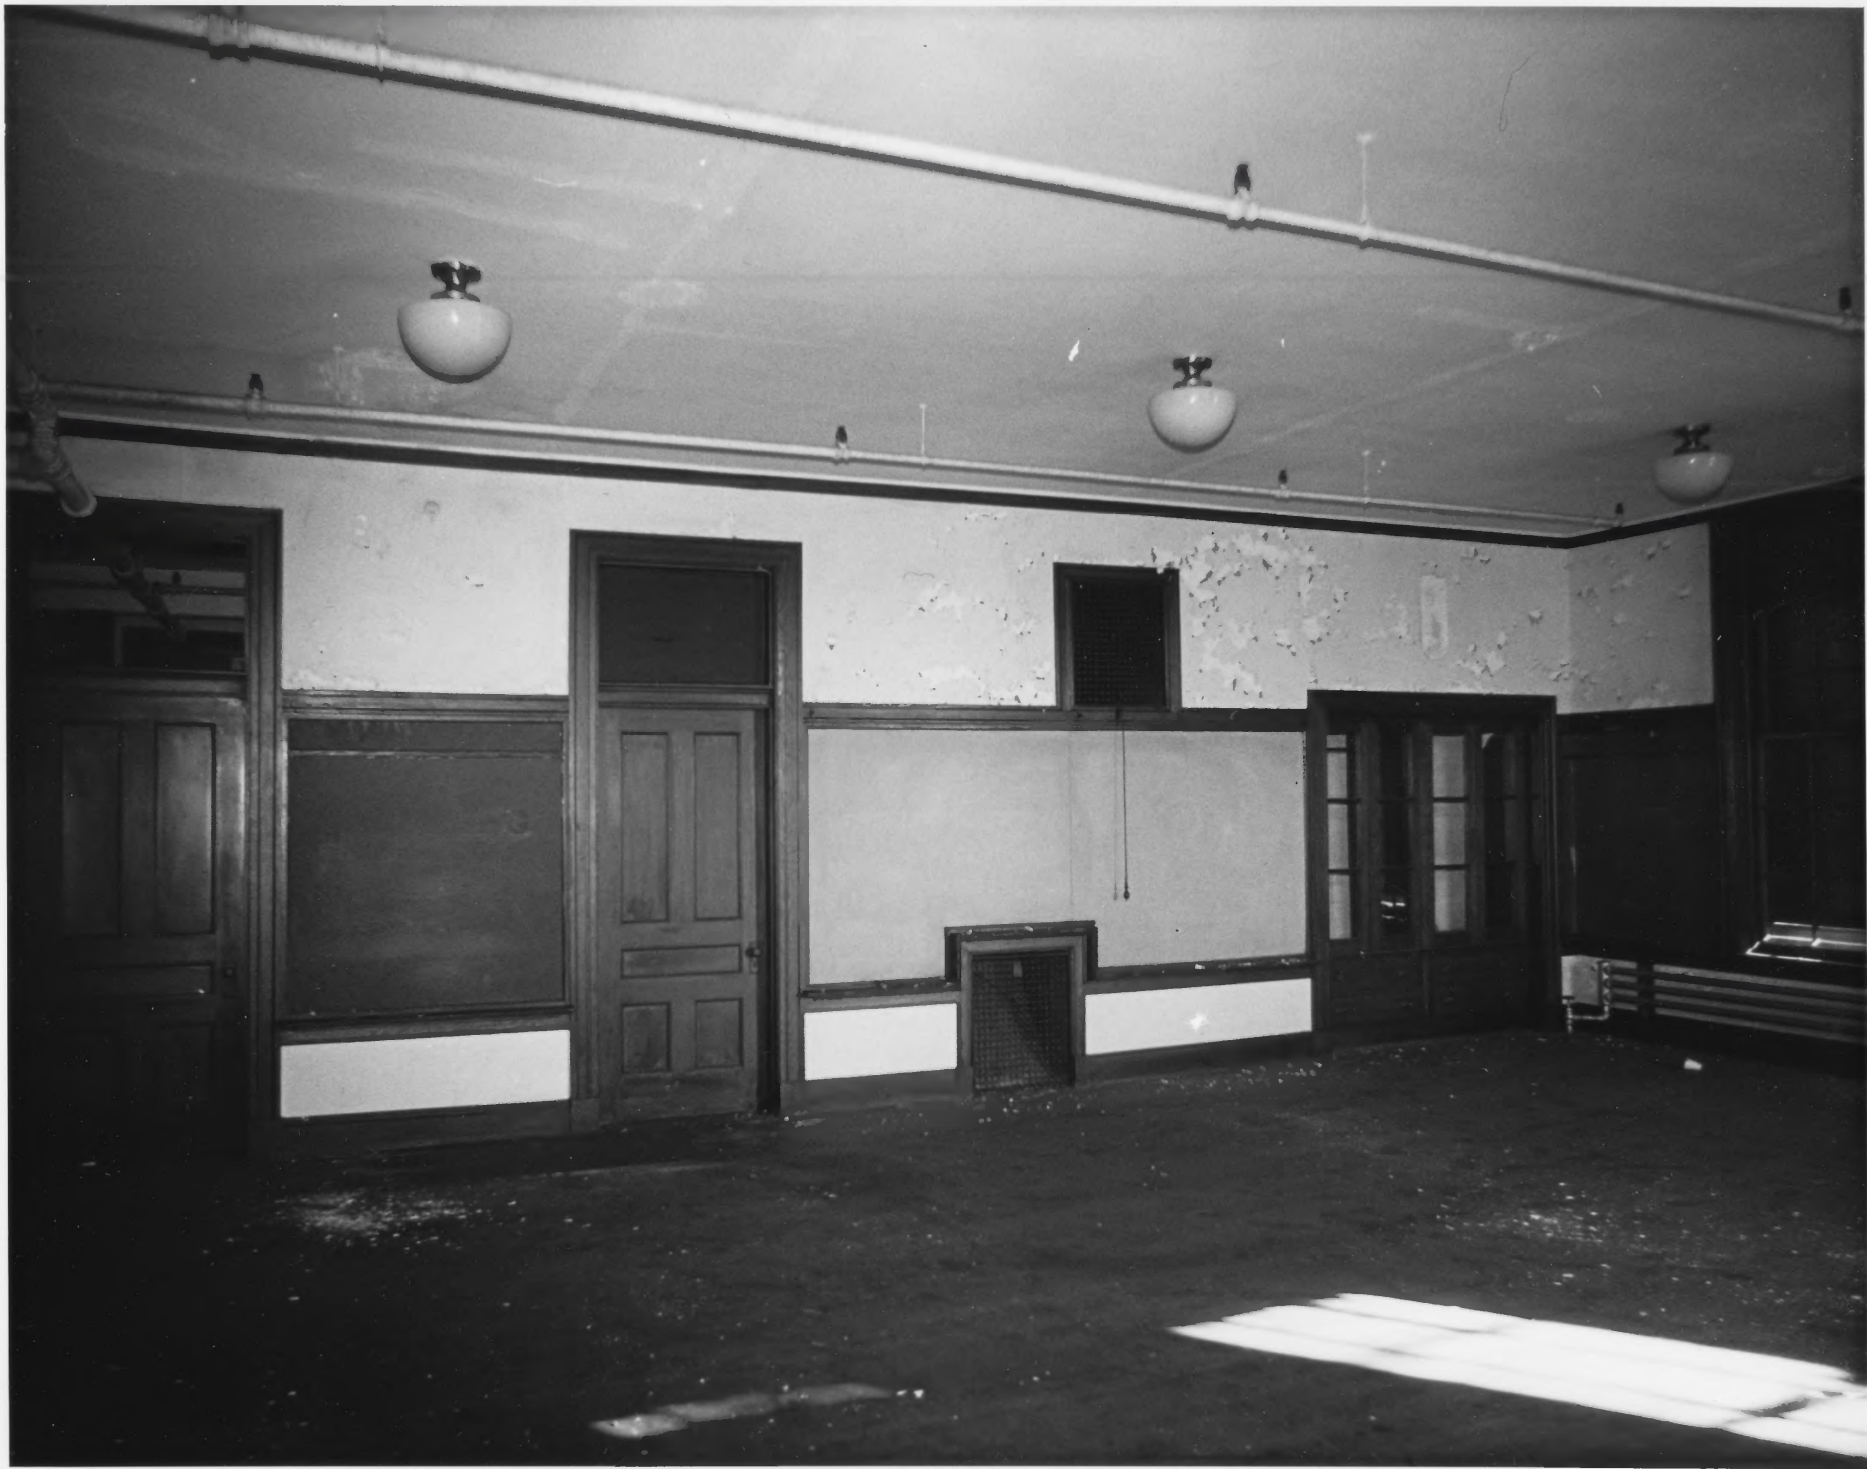
Photo #10

View: Typical interior wall elevation at the front
of the classroom. View off the east wall of the
the second floor, Southwest classroom.
