National Register of Historic Places Registration Form

| Elmer Baker Barn Name of Property | | | Texas Cou County and S | inty, Oklahoma state |

The Elmer Baker Barn is a tall, two-story, Transverse-crib barn located one mile east of Hooker, Texas County, Oklahoma. The barn is located on a farmstead south of the intersection of U.S. Highway 64 and Mile 47 Road in the NW4 of the NW4 of the NW4 of Section 25, T5N, R17E of the Cimarron Meridian. The barn is accessible from Mile 47 Road. The barn has a symmetrical, rectangular shape and measures thirty-five feet wide by forty feet long. It has a steeply-pitched gambrel roof and a large bonnet-type hay hood. The walls are clad in wooden shiplap. The foundation is a concrete slab. The floor plan conforms to the Transverse-crib plan that originated in the southern Appalachians during the early nineteenth century. This specimen was constructed by an unknown builder ca. 1900 and moved to its present location in 1906. To a remarkable degree, the interior and exterior of the barn retain their original appearance.

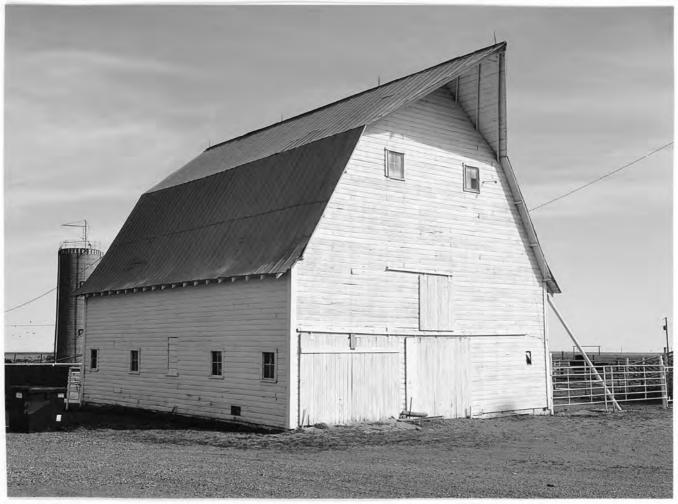
OL- Texas County- Elmer Baker Barn - 0001

The west elevation of the barn faces Mile 47 Road and is the gambrel end containing the bonnet-style hay hood. Despite the large hay hood, the barn does not contain a large haymow door or ridgeline pulley system for loading loose hay. According to the present owner, the barn has never contained a haymow door or pulley system, and no evidence of such could be detected from the interior. Purlins are exposed along the eaves. High in the west gable wall are two fixed two-over-two windows. Just below the middle of the gable wall is a sliding hayloft door centered above the loft floor level that provided ventilation and movement of fodder in and out of the haymow. At ground level is a large sliding door covering the central aisle as well as a sliding door on the left (north eave side) aisle, where Elmer Baker kept a truck. On the far right side of the west elevation is an augur hole allowing access to a grain bin on the ground floor of the southwest corner of the barn where feed grains (oats and barley) were stored.

The north elevation features exposed rafter tails and a symmetrical fenestration of four fixed, two-over-two windows. An access door to a feed bin is centered between the second and third windows. The north elevation fenestration originally contained wood windows for ventilation and lighting. These were replaced in 2004 with aluminum windows since the originals had been broken, but the new ones are indistinguishable from the original windows. All other windows on the barn are original and appear identical to the new ones on the north elevation. A manual feed grain loading door is centered at ground level on the north elevation.

| No. | Subject | Dir. |
|---|---|---|
| 0001 | north eave side and west gable end | southeast |

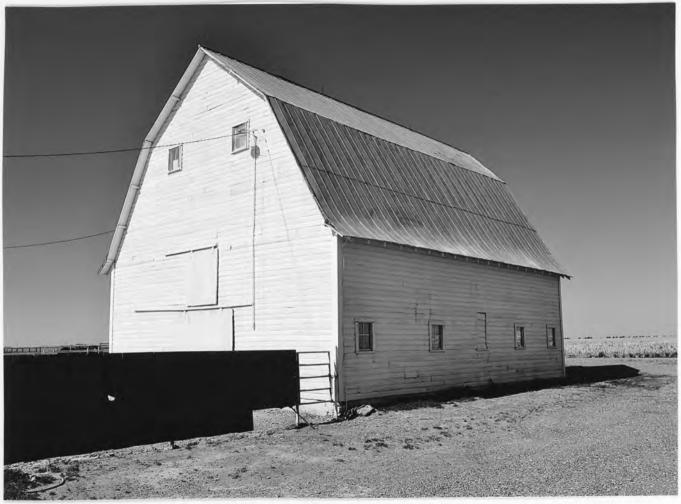
OK_Texas County_ Elmer Baker Barn - 0002

The east elevation contains the gable end facing the fields. Purlins are exposed along the eaves. As with the opposite end, two fixed two-over-two windows are located high in the gable wall, a sliding hayloft door is centered just above the level of the loft floor, and a large sliding door covers the central aisle.

| No. | Subject | Dir. |
|---|---|---|
| 0002 | north eave side and east gable end | southwest |

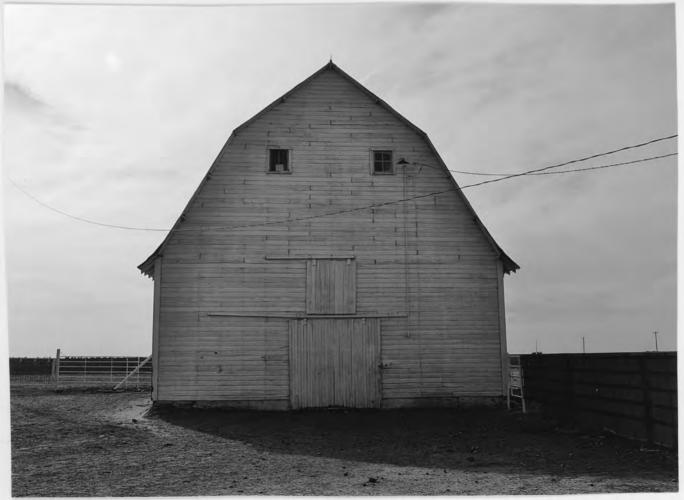
OK_Texas County_ Elmer Baker Barn - 0003

| No. | Subject | Dir. |
|---|---|---|
| 0003 | east gable end | west |

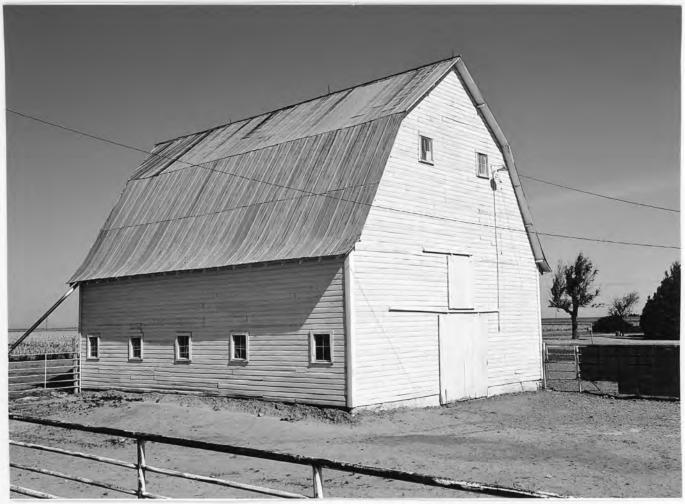
OK-Texas County-Elmer Baker Barn-0004

The south elevation features exposed rafter tails and a symmetrical fenestration of five fixed two-over-two windows. A four-inch steel pipe buttresses the southwest corner of the barn and is visible from this elevation.

| No. | Subject | Dir. |
|---|---|---|
| 0004 | south eave side and east gable end | northwest |

This barn has been through many severe storms and high wind events during its history. The most damaging event in Carroll Baker's memory was a storm in 1954 that produced 100 mph winds. The winds inflicted serious damage to the barn. After that storm, Elmer Baker hired Wayne Thompson, a contractor in Hooker, to structurally brace the barn. Thompson installed steel braces sunken into concrete along the interior south eave-side and connected these to a single four-inch steel pipe buttress connected to a sunken concrete pier on the west corner of the south eave wall. Thomson's system has anchored this tall barn against the battering winds of the High Plains for 58 years. It proved to work through later storms, including comparable storms in the late 1970s and another in 1989. After these storms, additional structural reinforcement (2" x 6" and 2" x 12" lumber on the south wall) was added to the interior. Thompson's 1954 steel brace is the only modification visible from the exterior of the building.

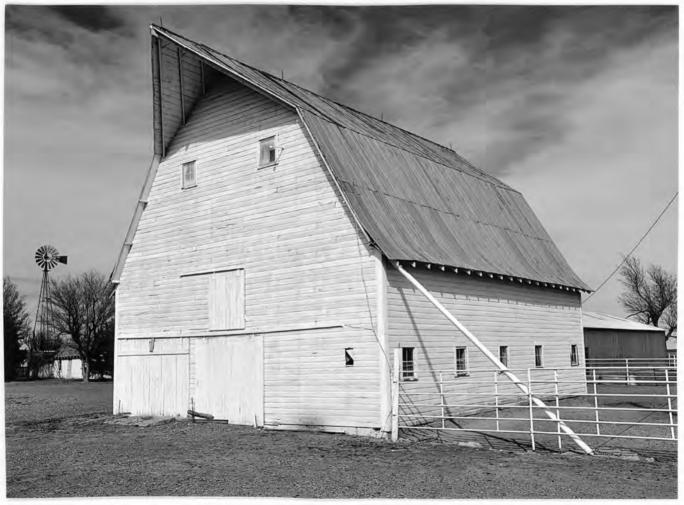
OK_Texas County- Elmer Baker Barn - 0005

| No. | Subject | Dir. |
|---|---|---|
| 0005 | south eave side and west gable end | northeast |
