National Register of Historic Places Registration Form

Historic name: Rock Creek Ranger Station Historic District

Street & number: Custer Gallatin National Forest, Beartooth Ranger District

City or town: Red Lodge State: Montana County: Carbon

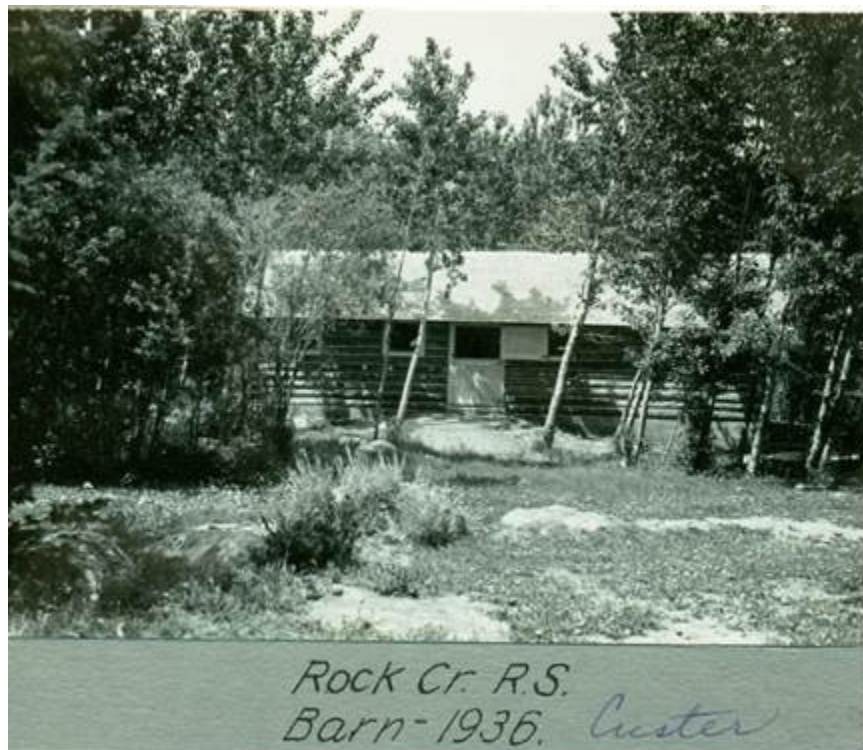
Figure 1. Barn within the Rock Creek Ranger Station complex, ca. 1936 (Image courtesy of CGNF Billings Office).

The barn (Building #2401) is a one story, log building with a rectangular floor plan. The building rests on a concrete foundation. The log walls are joined with square notches. The exterior walls are chinked with lath and daubed with mortar, and the interior walls have split pole chinking. The fenestration on the main (southern) façade consists of a Dutch door flanked by two pairs of six-lite hopper windows. An additional Dutch door is present on the eastern gable elevation and a three-panel wood door is located in the southern façade. A concrete pad leads to the main southern entry while the eastern door is accessed via a wooden staircase. The wood staircase at the southern entry has been removed. The building has a saltbox roof covered with wooden shingles. The roof displays exposed rafter ends and the apex has a galvanized ridge cap with end balls. The interior floor plan consists of three stalls and a tack room. A 1990 draft NRHP nomination form and the 2001 inspection form state the barn was constructed in 1938; however, a 1936 photograph indicates the building sat at this location at that time (Figure 1).

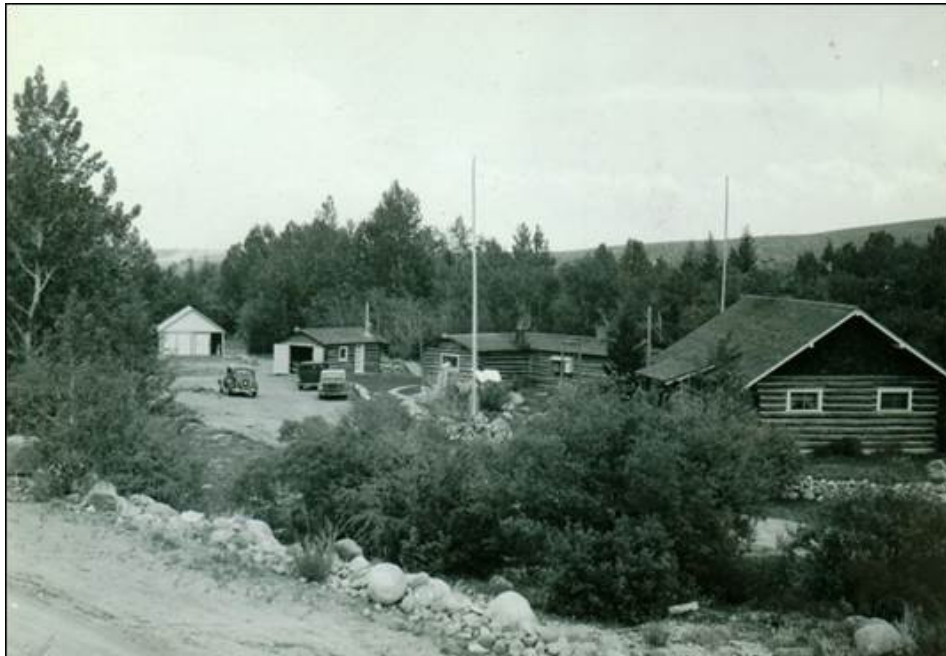
Figure 2. Rock Creek Ranger Station complex, ca. 1936, showing the original L-shaped cabin at center with the new dwelling (Building #1010) located at right and the garage and “barn” (now the two stall garage [Building #2200]) at left (Image courtesy of CGNF Billings Office).

The two stall garage (Building #2200) is a one-and-a-half story, wood frame building with a rectangular floor plan. It sits on a raised concrete foundation. Exterior walls of the 460 square foot building are clad with drop siding with quarter board trim. The front-gabled roof is covered with corrugated metal, has exposed rafter ends, and an interior slope brick chimney. The western (main) façade contains two large sliding wooden garage doors; the southern elevation contains a single five-panel wood mandoor. A small hinged loft door is present in the gable end. Windows consist of three-lite, four-lite, and six-lite fixed, and paired six-by-six-lite sliding. All windows have wood frame surrounds and sills. A small wooden storage box for a fire extinguisher is located adjacent to the garage doors on the northern facade. Although a facility inventory completed by the Forest Service in 1983 for the Rock Creek Ranger Station complex indicates that the garage was constructed in 1938, the building appears in a 1936 photograph of the complex in its current location, indicating its construction at least two years prior to this date (Figure 2). At the time of the inventory, the building was being used as a “sign shop”⁵.

One of these buildings is shown in an overview photograph of the property as located along the circular drive east of the original L-shaped log cabin and garage (see Figure 2). The area presently occupied by the two-stall garage, is labeled as a “barn” on the 1931 improvement plan. The memorandum accompanying the 1931 plan notes that “the minimum amount of effort has been expended on this barn because it is planned, when funds are available, to replace this building with a new log structure.” It further describes the barn as a wood frame, hipped roof building with no foundation. As this description does not conform to the architectural style of the building in the photograph, it is presumed that the two-stall garage was constructed on site after the original barn was razed and reconstructed.

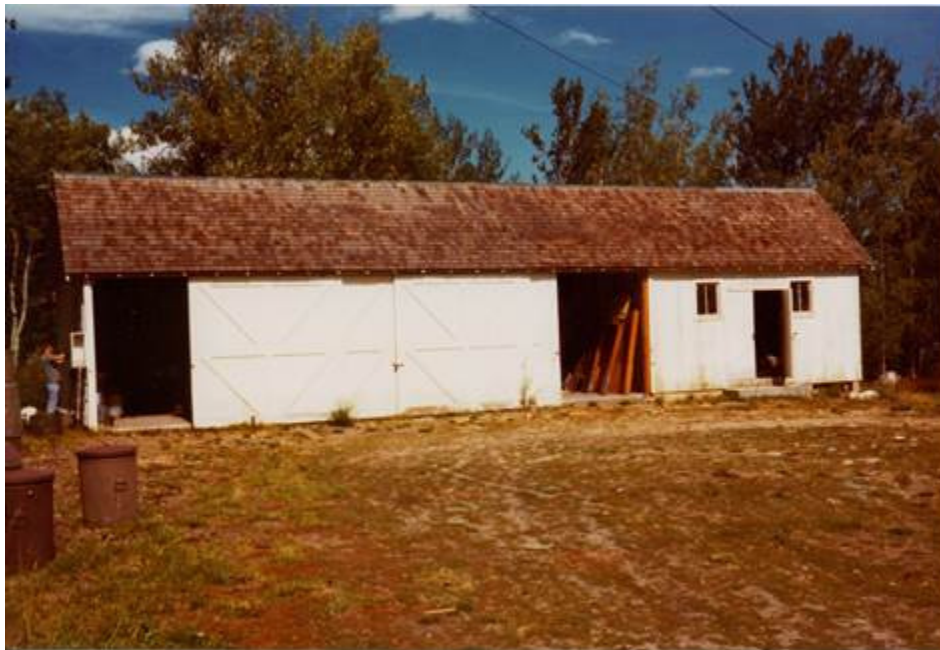
Figure 3. Multi- stall garage building (Building #2302), ca. 1976, facing northeast (Image courtesy of CGNF Billings Office).

the interior floorplan possibly changed since its original construction. A historic photograph of the building confirms that its exterior has not changed since 1976 (Figure 3).

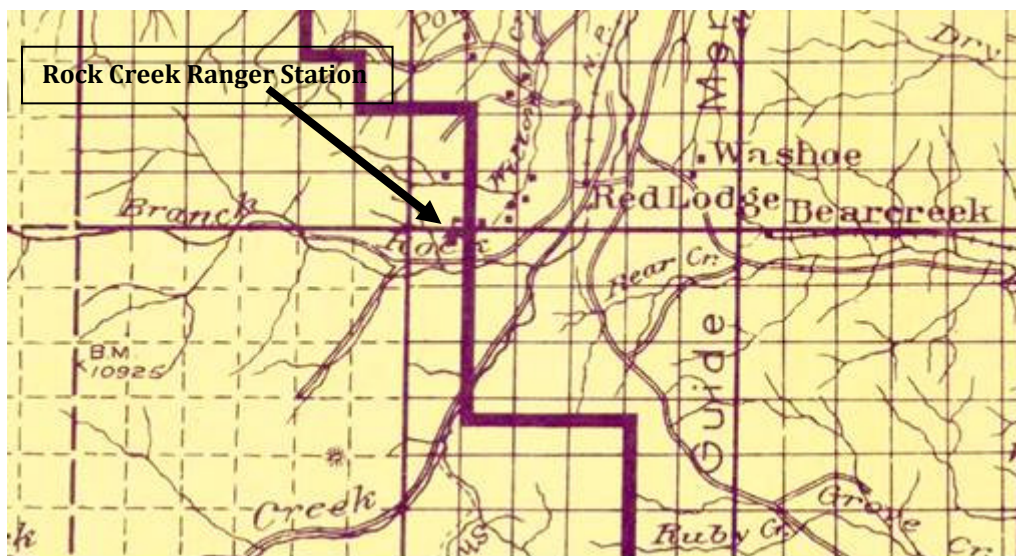
Figure 4. Beartooth National Forest, 1912. Forest Service map showing the road leading to the Rock Creek Ranger Station (Image courtesy of CGNF Billings Office).

A Forest Service map of the Beartooth National Forest confirms that the Rock Creek Ranger Station was accessible by road as early as 1912.⁹ Interestingly, this road is shown on the map as extending to the south of the ranger station, rather than to the north, as it is currently runs (Figure 4). This road, which is assumed to be the precursor to the West Fork of Rock Creek Road, continues past the ranger station to the west, where it eventually terminates at a creek crossing. Another map, dating to 1918, shows the road as following the same general alignment.

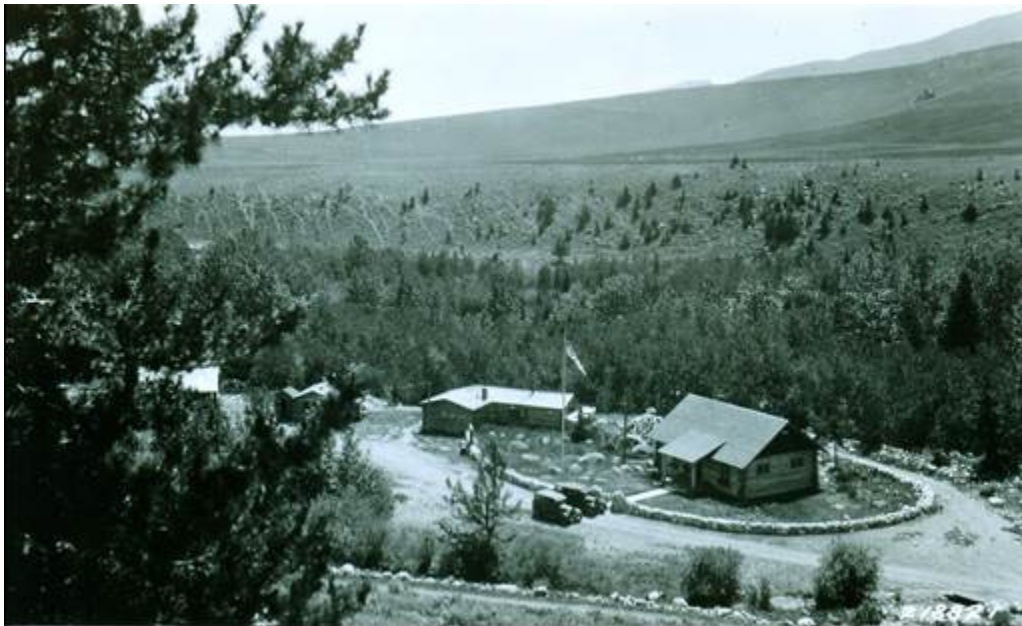
Figure 5. Overview of the Rock Creek Ranger Station, ca. 1927, showing the looped access road in the headquarters area (Image courtesy of CGNF Billings Office).

An historic overview photograph of the ranger station that dates to 1927 shows the road. Its existence in the photograph around the Main Cabin strongly suggests its construction occurred in the mid-1920, likely around the same time as the construction as the Main Cabin. In the photograph, the road is surfaced with gravel and wide enough to accommodate two cars (Figure 5). The 1931 improvement plan map for the Rock Creek Ranger Station depicts the road originating off the historic West Fork Road (West Fork of Rock Creek Road) following the same alignment to the southwest as at present. As it approaches the southwest end of the ranger station complex it turns east toward the building cluster where it again splits with a segment continuing east and running north of the Main Cabin, and a segment continuing south. The south trending segment west of the building complex splits once again with a segment continuing south over the West Fork Ditch Company Canal (the Green Ditch on the 1931 improvement plan map)

Further improvements were made to the complex in the 1920s. In 1923, the original outhouse and earth root cellar were razed and replaced, and in 1925, a new log dwelling (known today as the “Main Cabin”) was constructed. The newly-constructed outhouse measured 6 feet long by 6 feet wide and had a shingle roof, concrete-lined pit, and automatic lids.³⁴ The cellar was constructed entirely of concrete and measured 10 feet long by 10 feet wide.³⁵ Two years after the dwelling was completed, a coal house was added to the complex. Similar to the other buildings at the site, the 20-foot long by 14-foot wide coal house was of log construction and had a concrete foundation and shingle roof. A historic photograph of the ranger station complex dating to 1927 shows many of these improvements (see Figure 5).

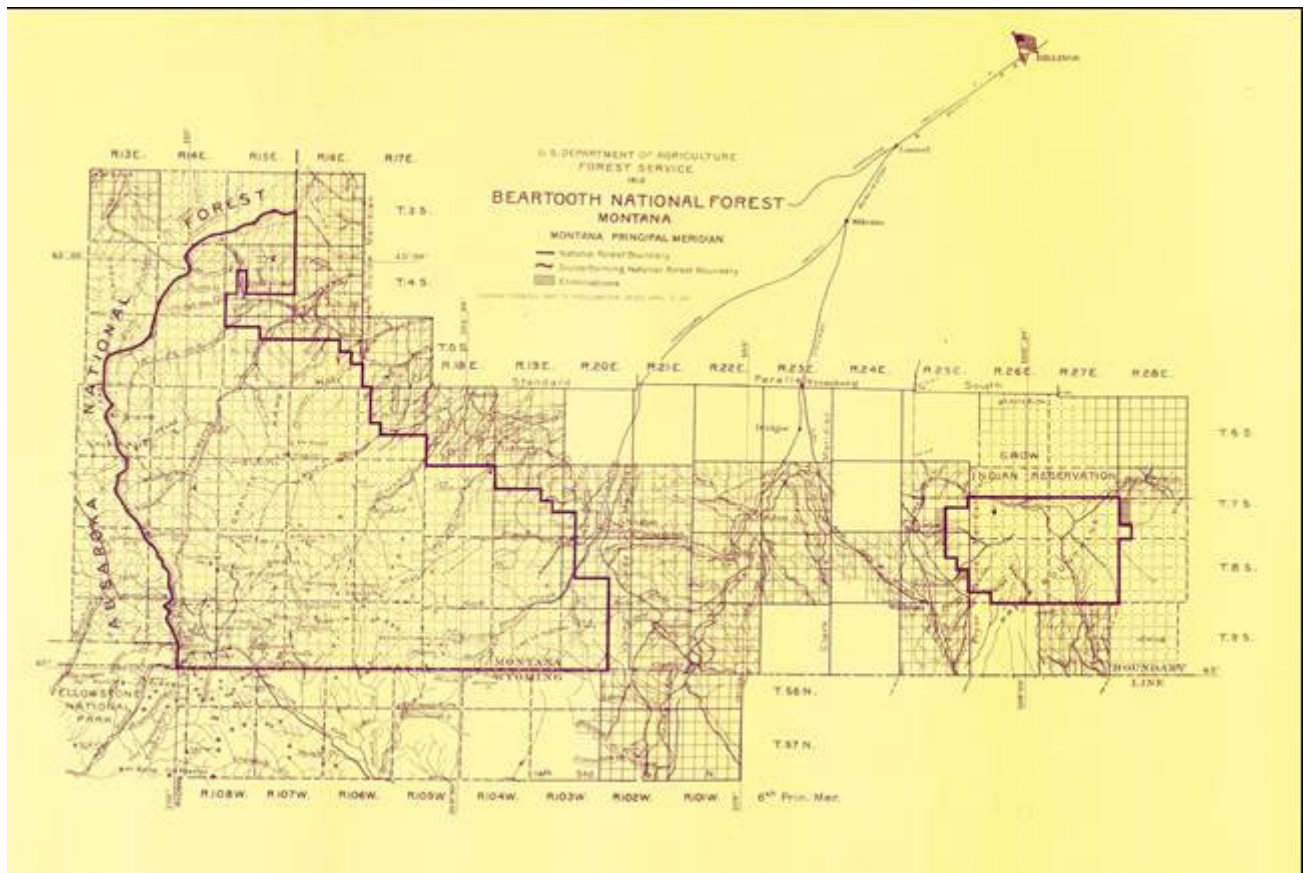
Figure 6. Forest Service map of the Beartooth National Forest, 1912, depicting the forest boundaries with the discontinuous Pryor Mountains boundary located to the east (Image courtesy of CGNF Billings Office).

The new Beartooth National Forest consisted of lands within Montana and included the eastern portion of the former Absaroka Division of the Yellowstone Forest Reserve, as well as the lands of the former Pryor Mountain National Forest, a separate forest 35 miles to the east, created in 1906 (Figure 6).²⁶ The Beartooth National Forest encompassed 685,293 acres of land and included the Beartooth Plateau and West Fork of Rock Creek. The Beartooth Forest was separated into four management districts including the Pryor Mountain District, Rock Creek District, Stillwater District, and Rosebud District.

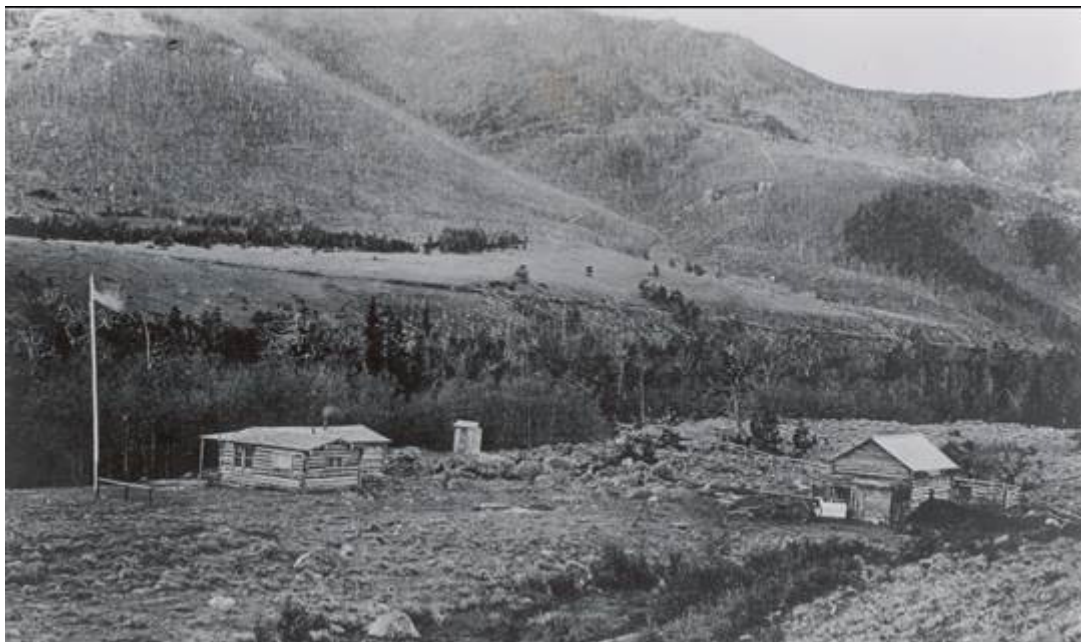
Figure 7. Rock Creek Ranger Station, ca. 1911, showing the L-shaped cabin with office addition (visible at left), barn (visible at right), and outhouse (visible near center) [Image on file at the Beartooth Ranger District Office, Red Lodge].

foot wide “office” was added to the building.³⁰ The photograph also shows a flagpole with an adjacent hitching post east of the L-shaped cabin, a circular corral to the northwest of the barn, and a split rail fence along the western property boundary. As these improvements are not noted on the 1931 memorandum, they were likely added to the ranger station after its initial development.

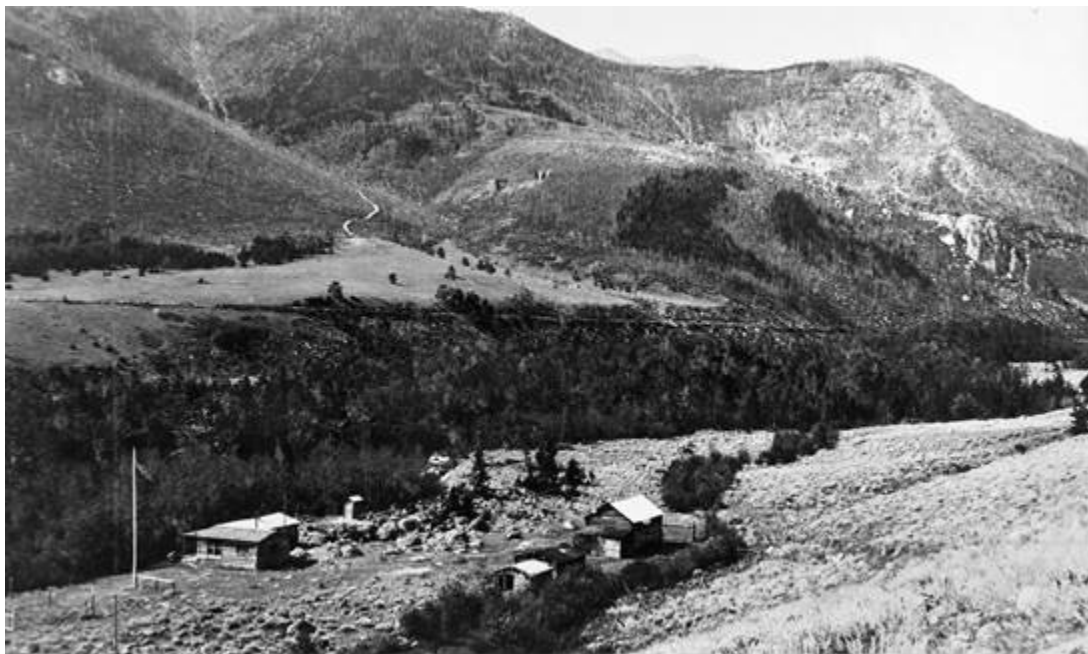
Figure 8. Rock Creek Ranger Station, ca. 1913–1919, showing the tool house (bottom center), reoriented outhouse, and additional fencelines (Image on file at the Beartooth Ranger District Office, Red Lodge).

By 1913, the site expanded to include a “tool house” and several fencelines.³¹ A second historic photograph of the ranger station property shows two side-gabled log buildings to the northeast of the barn and corral (Figure 8). Although the date of the photograph is unknown, one of these buildings is likely the tool house. The function of the second building is unknown. The photograph also indicates that the outhouse had been reoriented so that its entry faced north or south rather than west, and that additional split rail and post-and-wire fencing had been added north of the barn and tool house and west of the hitching post and flagpole. By 1914, the improved facility was described in a Forest Service report as “having the largest amount of work” of the administrative facilities within the Forest, requiring “considerable pasture” in the summer months for forest officers’ horses.³²

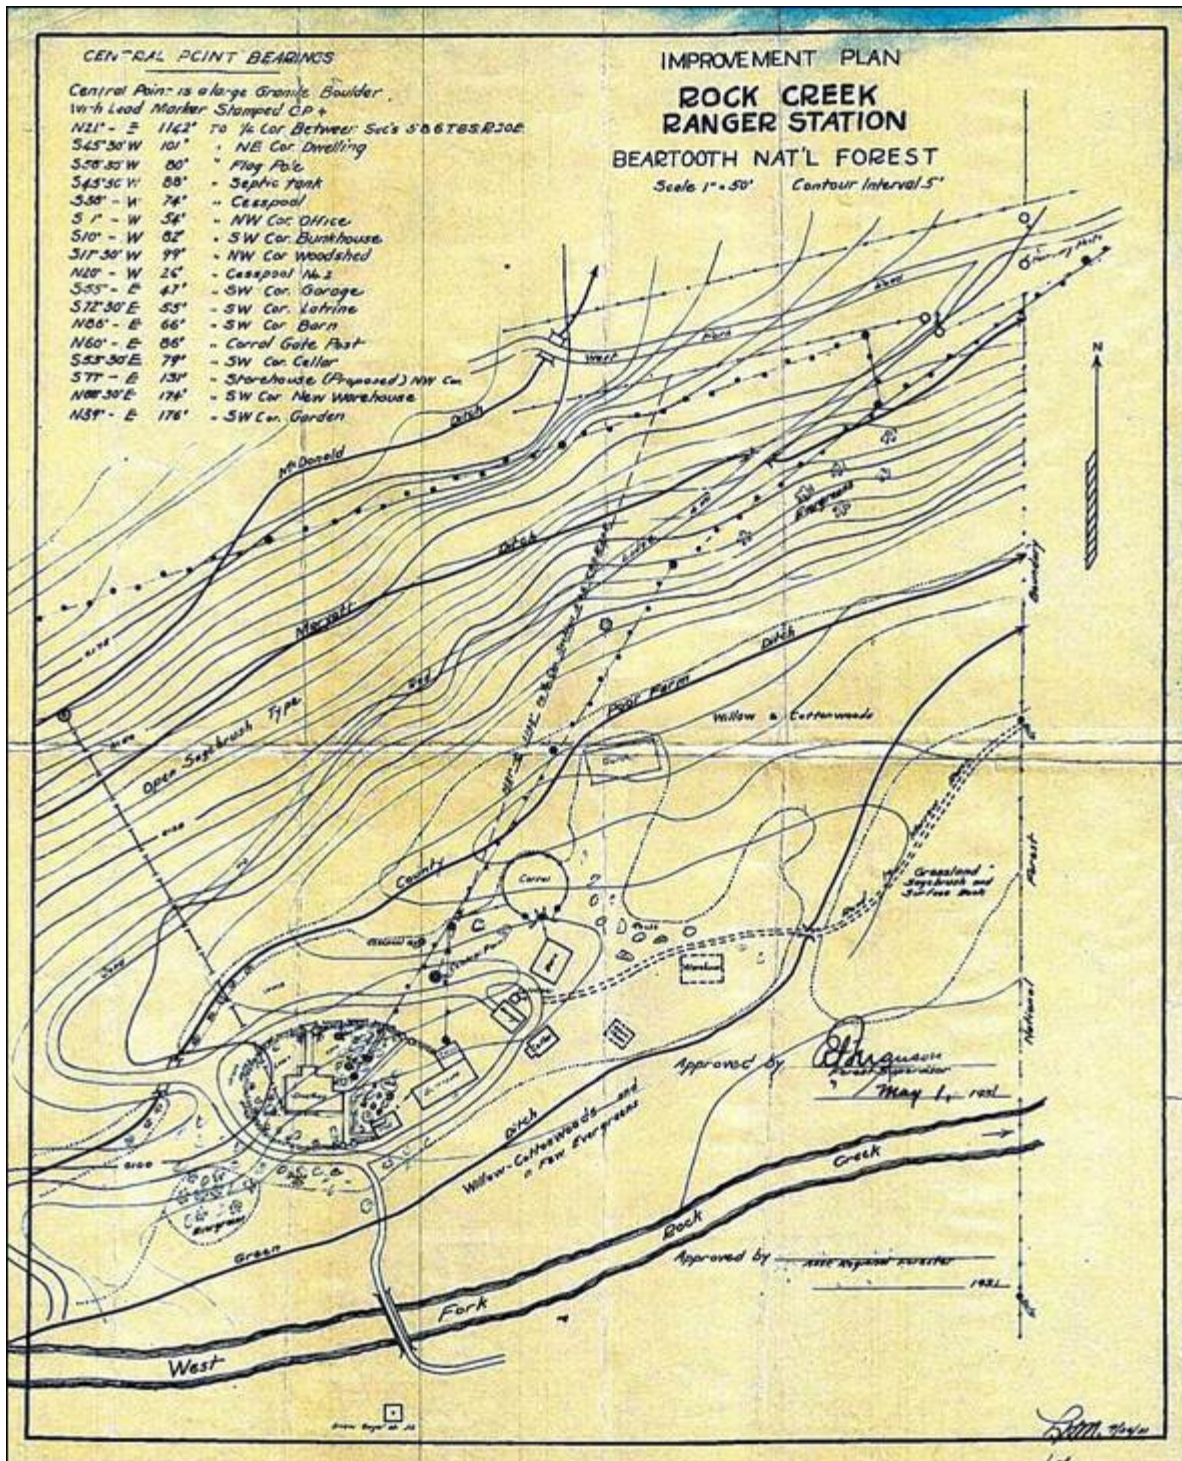
Figure 9. Improvement plan for the Rock Creek Ranger Station drafted by "L.K.M." on April 25, 1931 and approved by Forest Supervisor R.T. Ferguson on May 1, 1931 (Image on file at the Beartooth Ranger District Office, Red Lodge).

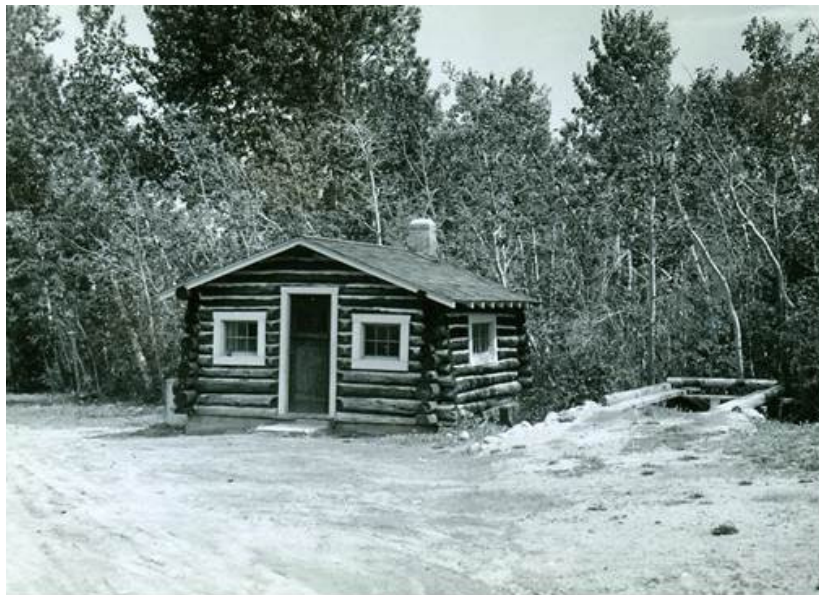
Figure 10. Possible former warehouse building (now the storehouse/fire cache [Building #2301] within the Rock Creek Ranger Station complex, ca. 1936 (Image courtesy of CGNF Billings Office).

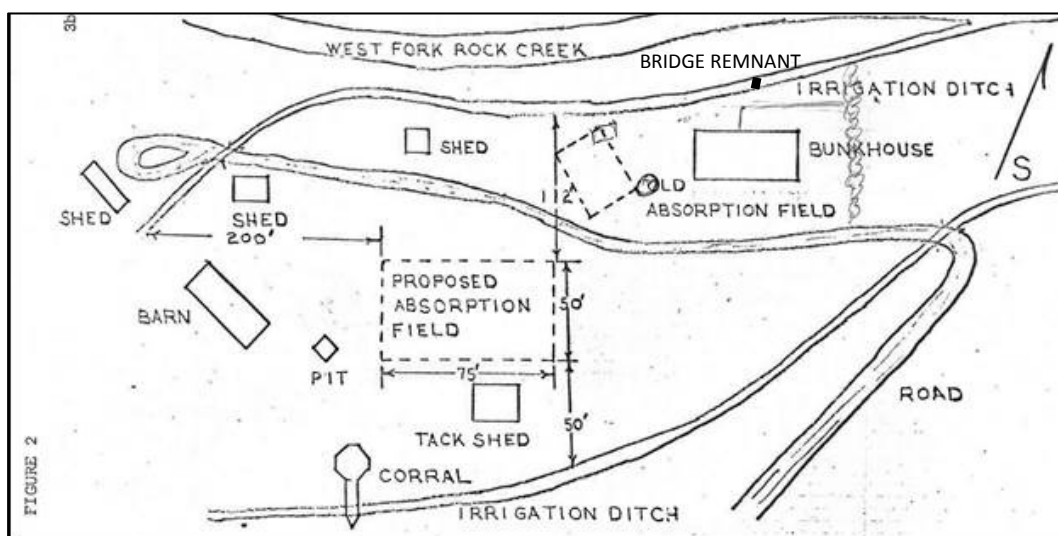
Figure 11. 1971 sketch map of the Rock Creek Work Center, showing buildings and structures within the headquarters area. Note the road does not extend to the maintenance yard at the time this map was drafted (Image on file at the Beartooth Ranger District Office, Red Lodge).

In 1971, the Forest Service published an engineering report for the former administrative facility, now work center, which provided a brief description of buildings and structures situated within the property. The report described the complex as consisting of “one bunkhouse used only in the summer for seasonal help, one pit toilet, a corral for keeping a maximum of 10 horses, and four other buildings used for storage of bulk materials.”⁴⁴ It further noted that the property was “encircled by two irrigation ditches whose points of diversion lie upstream,” and included a sketch map depicting the infrastructure mentioned in the report (Figure 11).

Based on the descriptions provided on the map, the four storage buildings likely represent the two-stall garage (Building #2200), the multi-stall garage (Building #2302), the storehouse/fire cache building (Building #2301), and the tack shed (Building #2308), all which remain on the property today. The map also shows the Main Cabin (Building #1010) and barn (Building #2401) in their present locations. The current locations of the “tack shed” and the corral suggest that both of these facilities were subsequently relocated sometime after the map was produced. In the case of the corral, the report noted that its current location adjacent to the County Poor Farm Ditch, was unsanitary and contributing to contamination of its water supply—an observation that likely prompted its relocation to the southeast of the barn sometime after 1971. The map also suggests that pit toilet was razed following publication of the report. The author noted that at the time of the site visit, the pit toilet was filled with water and recommended that the structure be replaced with a vault toilet.

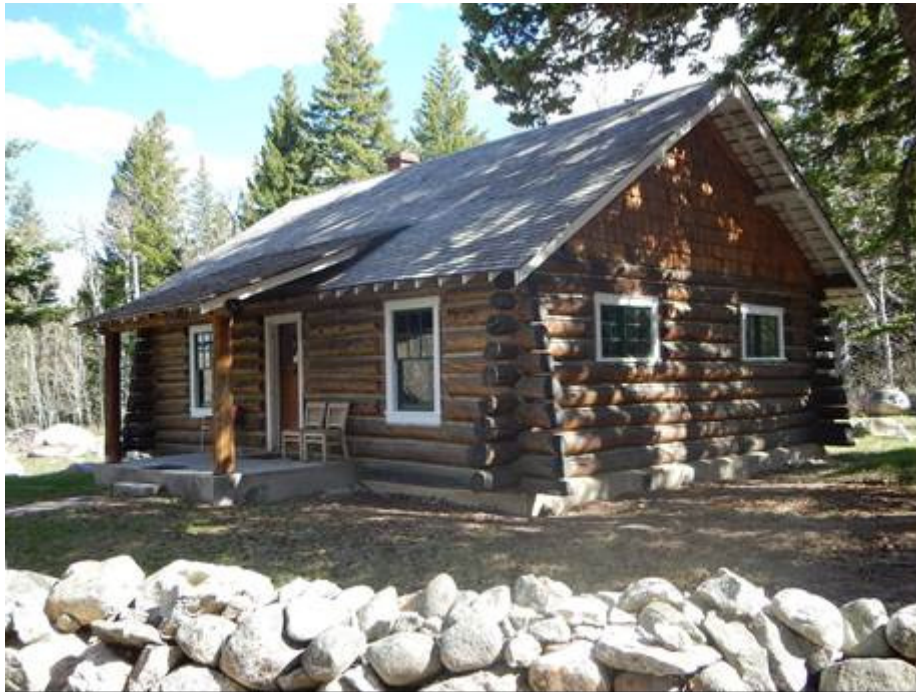
Photograph 1. MT_CarbonCounty_RockCreekRangerStationHD_0001. Northern (main) and western elevations of the Main Cabin (Building #1010), facing southeast (Source: Logan Simpson, 2015).

The Main Cabin (also known as Building #1010) is the earliest building remaining within the Rock Creek Ranger Station Historic District. The one-and-a-half story cabin was built during the summer of 1925 in accordance with plans developed by Thomas W. Buckley of the Regional Office of the Forest Service on August 28, 1924.³ The cabin rests on a raised concrete foundation above a partial basement. Walls are constructed of full logs hauled to the property from Camp Nelson on the West Fork of Rock Creek and Camp Beaver above Basin Creek.⁴ The log ends are cut at an angle, tapering in from bottom to top, and are joined with ventral saddle notches daubed with cement and chinked with lath. The steep, side-gabled roof is covered with wooden shingles and has exposed purlins and rafter ends. Wooden shakes also cover the gable ends of the cabin. An interior slope brick chimney extends from the apex of the roof at the eastern end of the building.

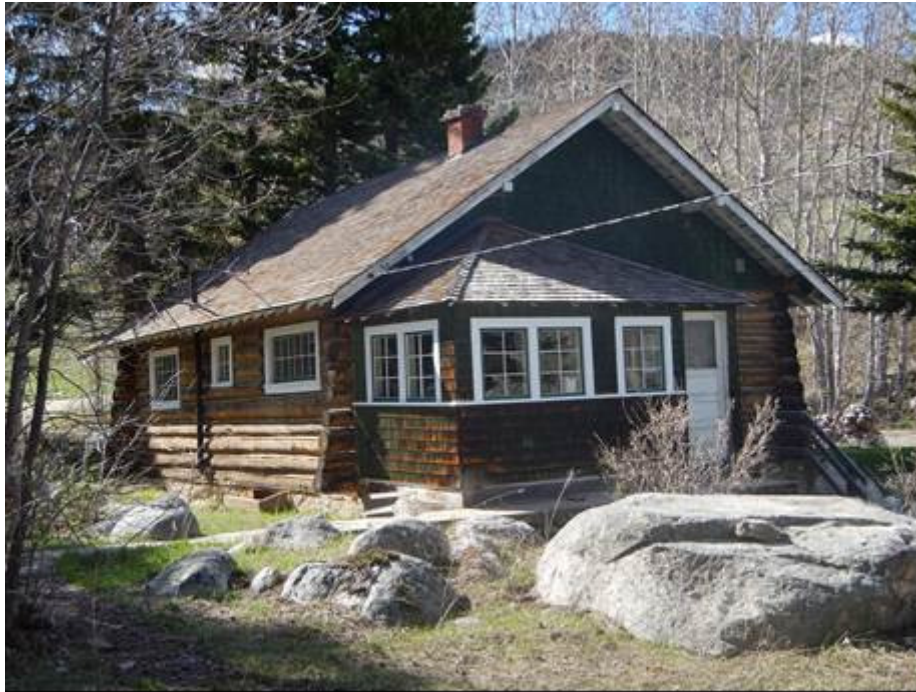
Photograph 2. MT_CarbonCounty_RockCreekRangerStationHD_0002. Southern and eastern elevations of the Main Cabin (Building #1010), facing west-northwest (Source: Logan Simpson, 2015).

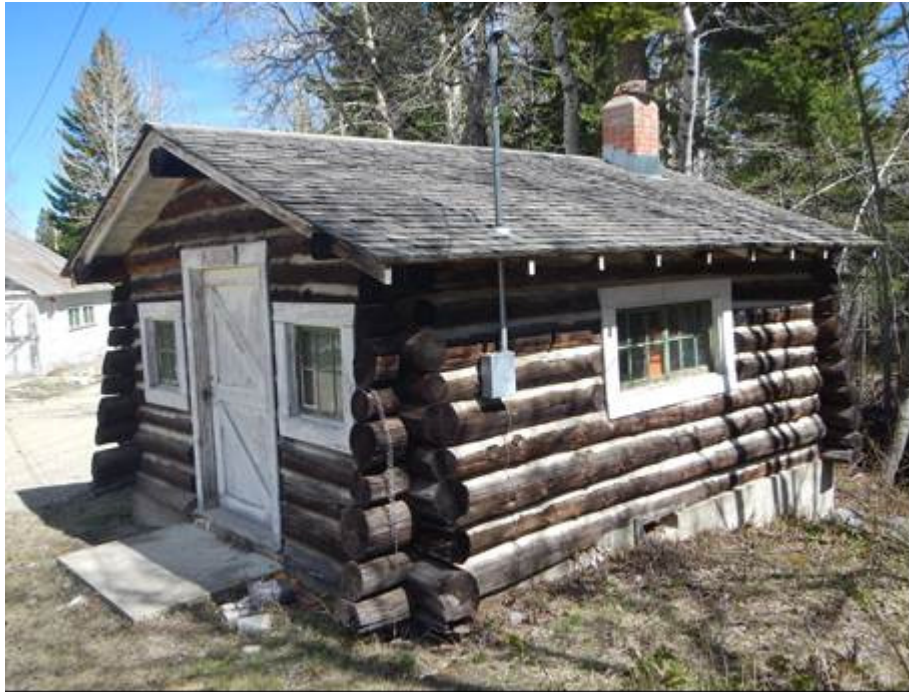
Photograph 3. MT_CarbonCounty_RockCreekRangerStationHD_0003. Storehouse/fire cache building (Building #2301), facing east (Source: Logan Simpson, 2015).

The storehouse/fire cache (Building #2301) consists of a one-story, rectangular plan log building featuring saddle notching. The building measures 16 feet long by 14 feet wide. A shallow front-gabled roof protects the building which rests on a concrete foundation. The log ends are cut at an angle to taper out from top to bottom. The exterior of the walls are daubed with concrete and the interior walls are chinked with split poles. The interior of the building is accessed by a single wood door with two plywood panels sporting diagonal wood strapping or cross-bracing on its main (northern) façade. The centrally-placed entry has a concrete stoop and is flanked by two six-lite fixed windows. Paired six-by-six-lite sliding windows are present on the remaining three elevations. All of the windows have wood surrounds. The roof is covered with wood shingles and features an interior slope brick chimney, and exposed rafter ends and purlins.

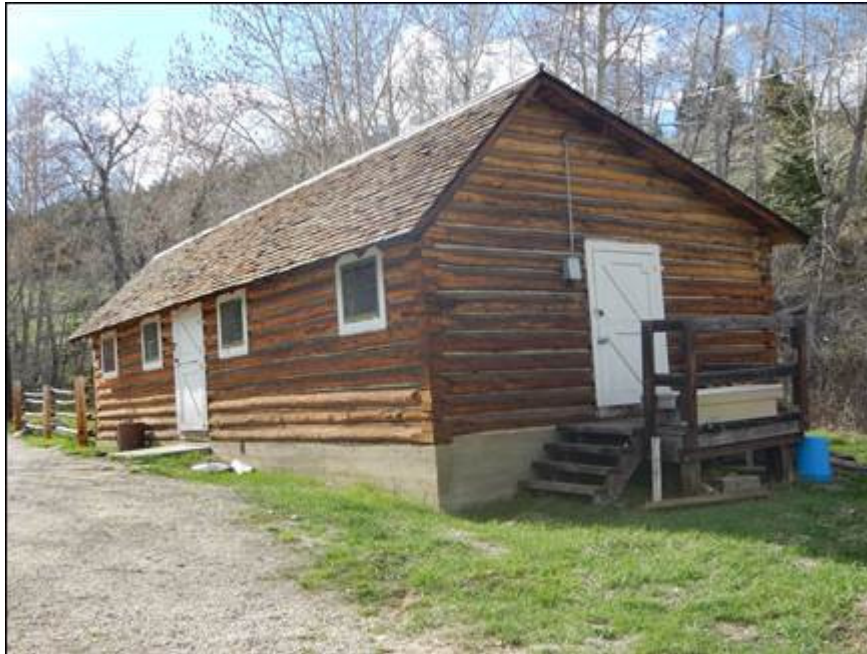
Photograph 4. MT_CarbonCounty_RockCreekRangerStationHD_0004. Barn (Building #2401), facing northwest (Source: Logan Simpson, 2015).

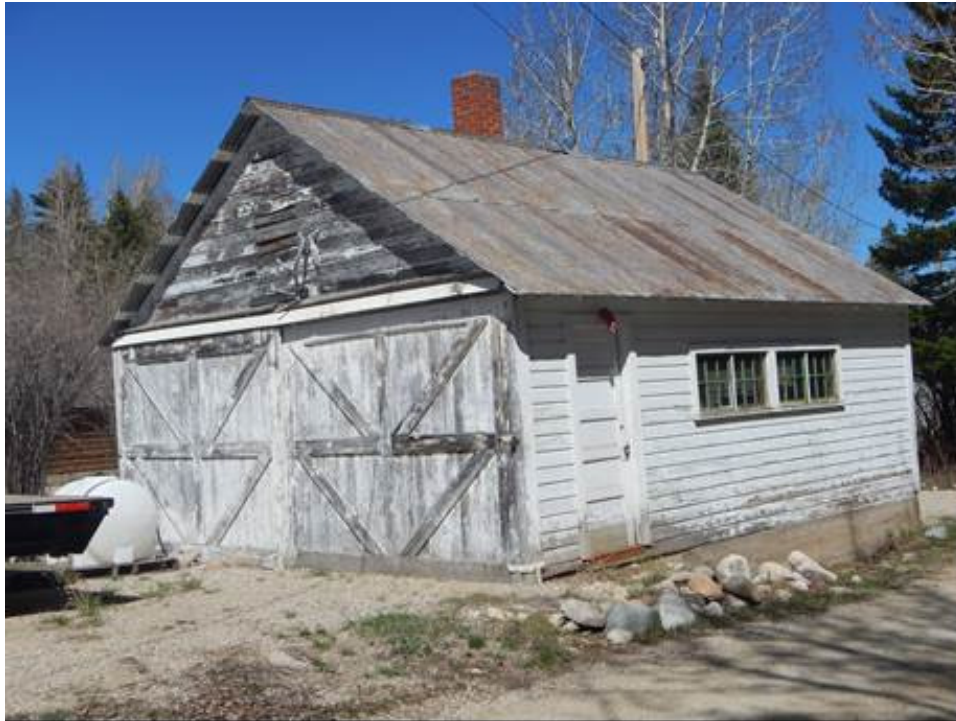
Photograph 5. MT_CarbonCounty_RockCreekRangerStationHD_0005. Two stall garage (Building #2220), facing northeast (Source: Logan Simpson, 2015).

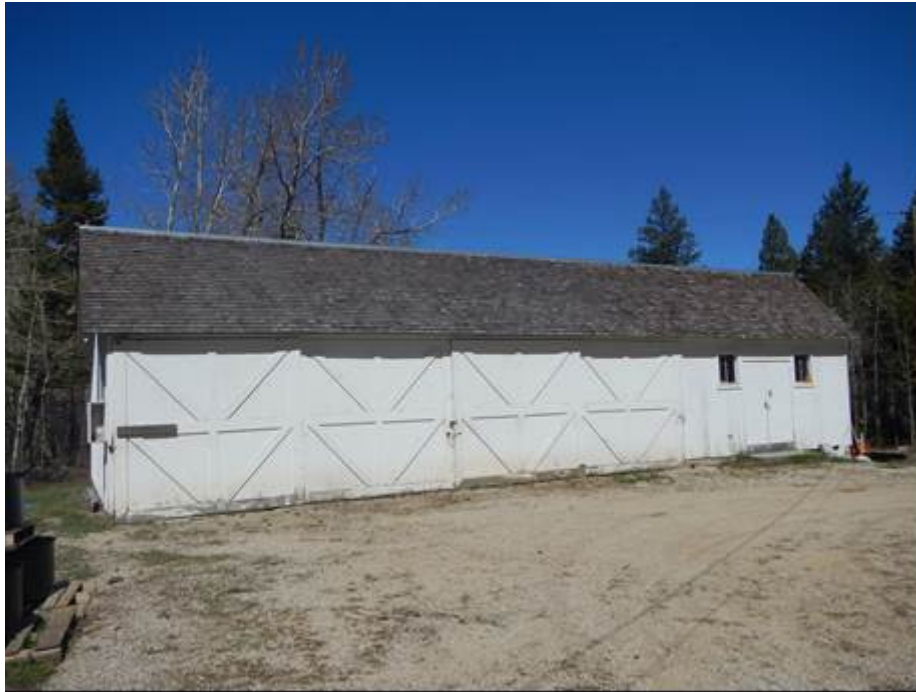
Photograph 6. MT_CarbonCounty_RockCreekRangerStationHD_0006. Multi- stall garage (Building #2302), facing northeast (Source: Logan Simpson, 2015).

The multi-stall garage (Building #2302) consists of a one-story wood frame building with a rectangular floor plan. The building rests on a raised concrete foundation and has a saltbox roof covered with wooden shingles. The roof displays exposed rafter ends and a galvanized ridge cap with end balls. Its exterior walls are clad with board-and-batten painted white. The interior of the building contains four stalls accessed by a series of sliding garage doors on the southern (main) façade; the doors are constructed of vertical boards with cross bracing. Immediately to the east are paired hollow core mandooors accessed from a concrete pad. Two-lite fixed windows flank the double entry, and a row of boarded-over windows are present on the eastern elevation. A small storage box for a fire extinguisher is mounted on the west wall and an electrical box with a pipe is present on the western façade. The 1983 inventory provides a build date of 1938 for this building. The form noted the building contained five rather than six stalls;⁶ a 1978 Forest Service inventory identified the building as a “4-stall garage.”⁷ These documents suggest that

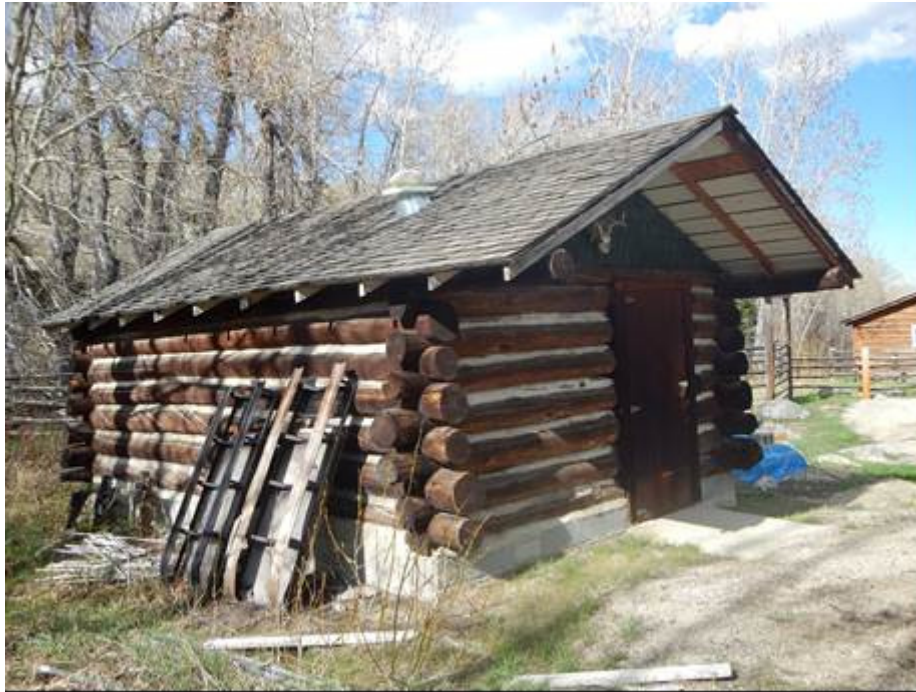
Photograph 7. MT_CarbonCounty_RockCreekRangerStationHD_0007. Tack house (Building #2308), facing northeast (Source: Logan Simpson, 2015).

The tack house (Building #2308) is a one story, log bearing building with a rectangular floor plan. The shallow, front-gabled roof is covered with wood shingles and displays exposed rafter ends. Wood shingles cover the gable ends of the building. The building rests on concrete blocks set on top of a concrete foundation, suggesting that the current building was moved to this location after the original building was razed. Walls are constructed of logs joined with saddle notches and daubed with cement with split pole chinking used in the interior. Log ends are cut at an angle to taper in from the bottom to top. Fenestration consists of a single hollow core door on the main (southern) façade fronted by a small concrete pad, and two window openings on the eastern façade. One window opening is currently covered with plywood, and the second window contains a six-lite awning window. The condition of the extant window suggests recent reconditioning. A facility inventory completed by the Forest Service in 1983 for the Rock Creek Ranger Station complex indicates construction of the tack house occurred in 1969.⁸ Although this date could indicate the year in which the building was moved to its current location within the complex, evidence to corroborate this has not been found; therefore, the building is considered a noncontributing resource.

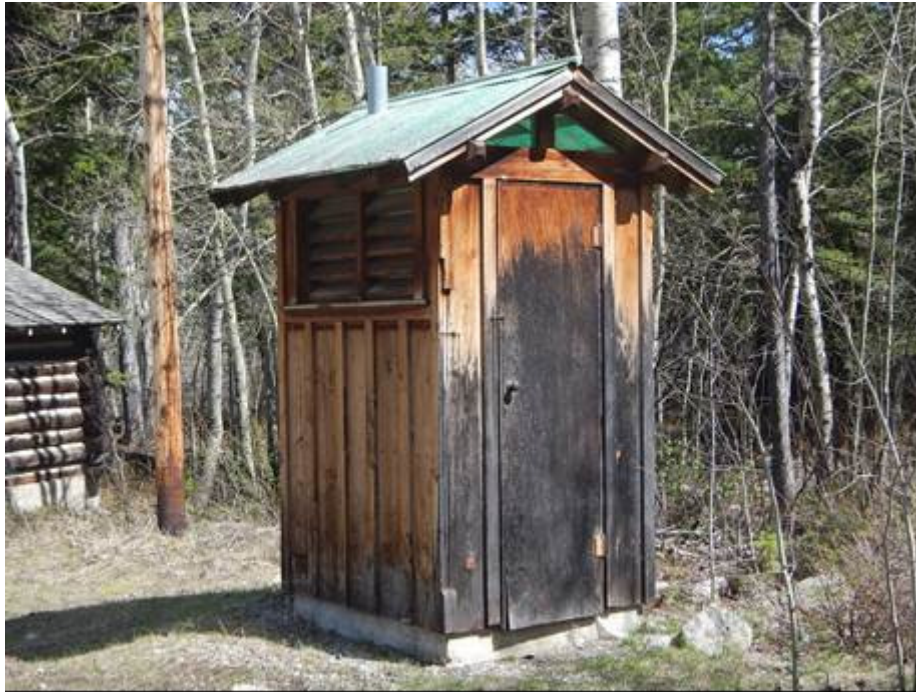
Photograph 8. MT_CarbonCounty_RockCreekRangerStationHD_0008. Outhouse, facing southeast (Source: Logan Simpson, 2015).

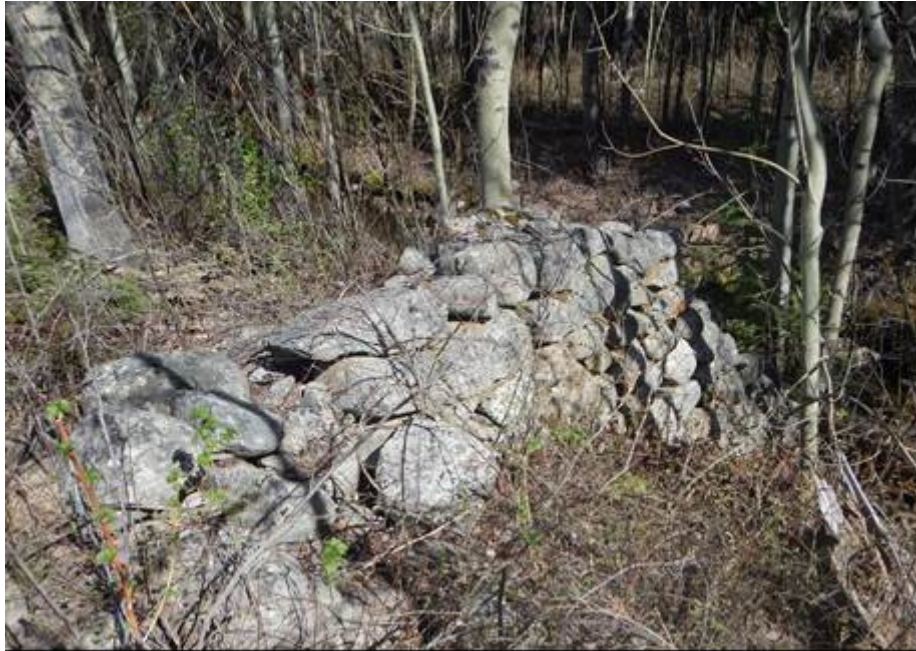
Photograph 9. MT_CarbonCounty_RockCreekRangerStationHD_0009. Stacked stone wall/foundation to the southwest of the storehouse/fire cache (Building #2301), facing southeast (Source: Logan Simpson, 2015).

An L-shaped segment of a dry laid stone wall or foundation stands southwest of the storehouse/fire cache (Building #2301). The feature measures approximately 8 feet long by 1-foot wide. The wall varies from 1-foot to 4 feet in height and displays 4 to 8 courses. The rocks vary in size, with the larger rocks typically placed at or near the bottom of the wall, and smaller rocks used for the top courses. The wall appears to be partially built into the slope as it extends south toward the West Fork Ditch Company Canal.

Two possibilities exist for the function of the feature. Given its size, it may represent the remains of the original earth and rock cellar built on the property around 1908. The cellar remained in use until the 1930s when it was razed and replaced with a new concrete cellar. However, it is also possible that the structure represents remnants of the “storehouse,” a building depicted on the 1931 improvement plan as being “proposed” for construction in the same general area as this feature. A description of the proposed building is not provided in the plan. Either way, the feature dates to the period of significance for the property and undoubtedly served as an ancillary building or structure for the ranger station complex. As such, it is considered to contribute to the overall significance of the district.

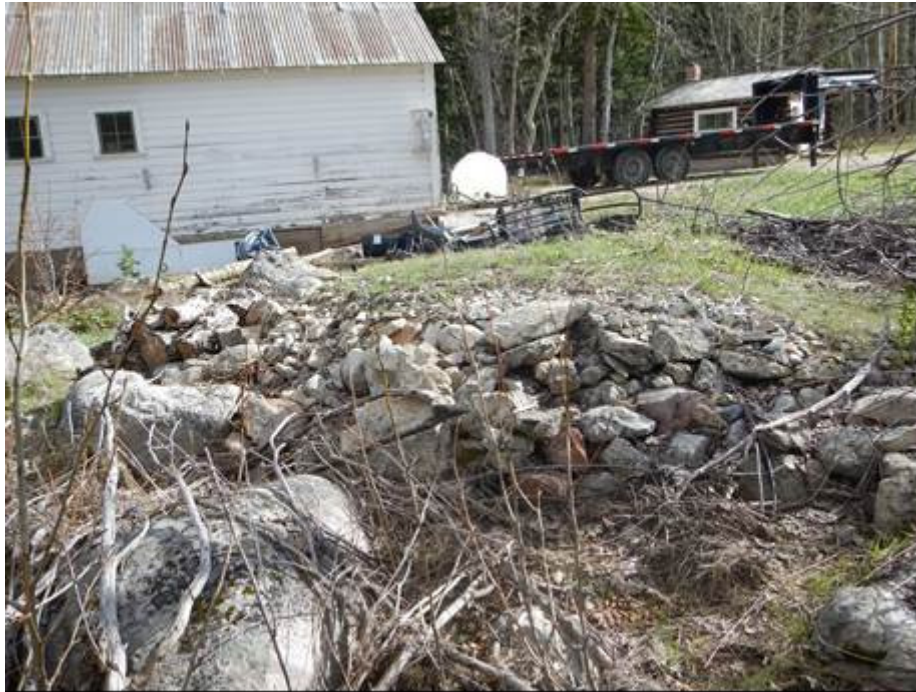
Photograph 10. MT_CarbonCounty_RockCreekRangerStationHD_0010. Possible wall or foundation to the north of the two stall garage (Building #2200), facing southwest (Source: Logan Simpson, 2015).

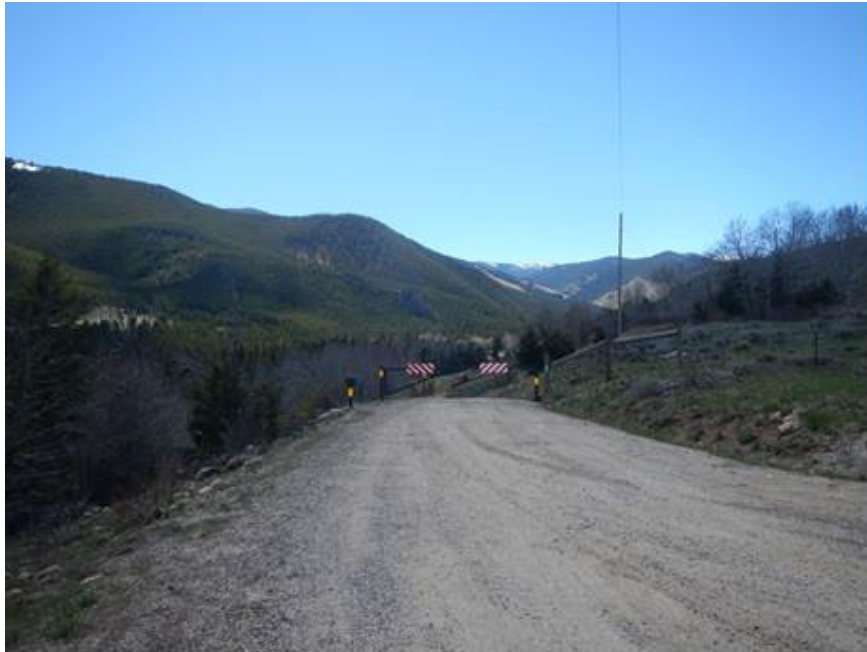
Photograph 11. MT_CarbonCounty_RockCreekRangerStationHD_0011. Rock Creek Ranger Station access road, showing the gate at its northern end, facing southwest (Source: Logan Simpson, 2015).

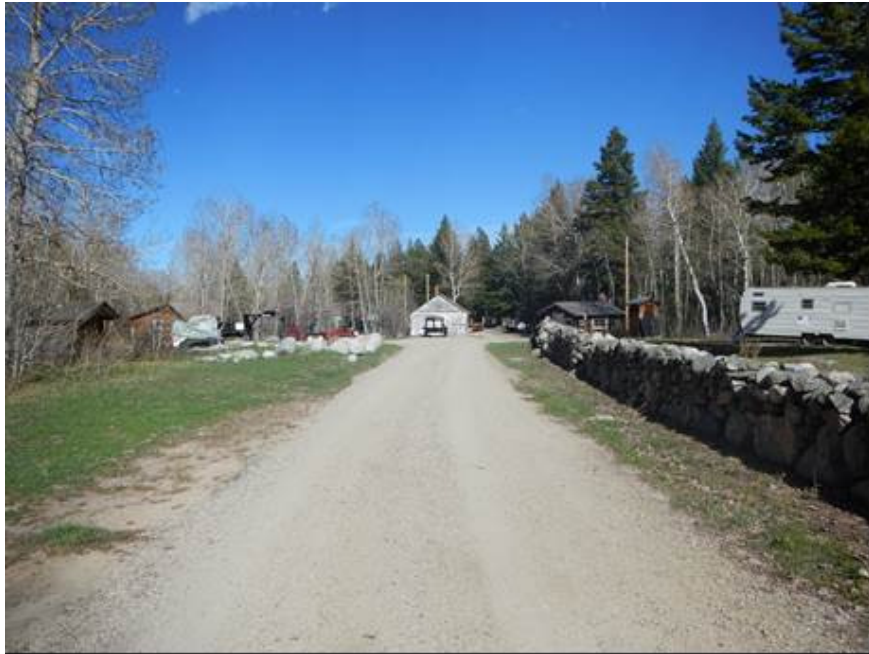
Photograph 12. MT_CarbonCounty_RockCreekRangerStationHD_0012. Rock Creek Ranger Station circulation road, showing the two-stall garage, facing east (Source: Logan Simpson, 2015).

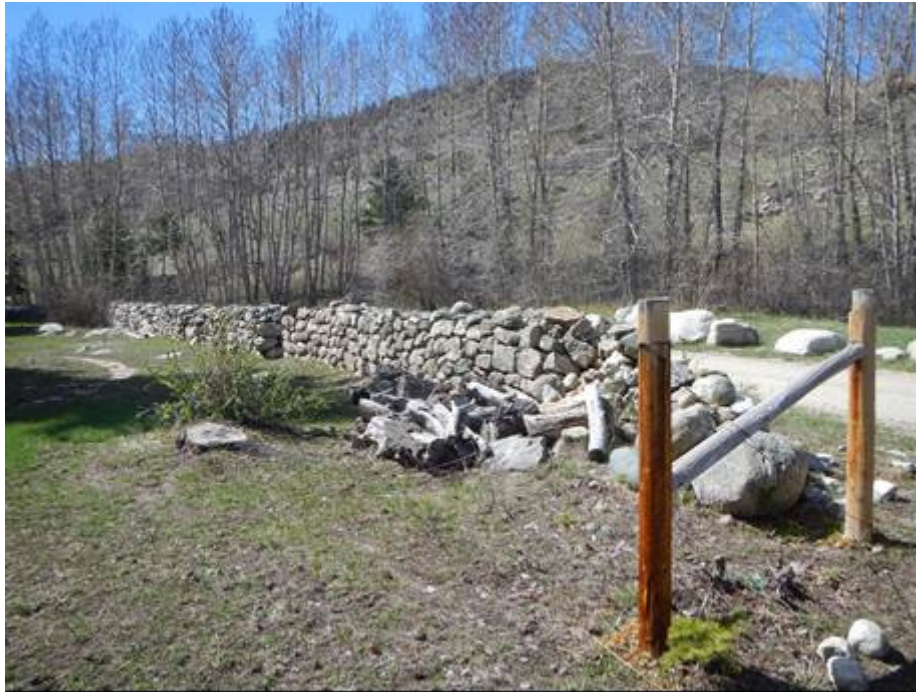
Photograph 13. MT_CarbonCounty_RockCreekRangerStationHD_0013. Stacked stone wall to the north of the main cabin (Building #1010), facing southwest (Source: Logan Simpson, 2015).

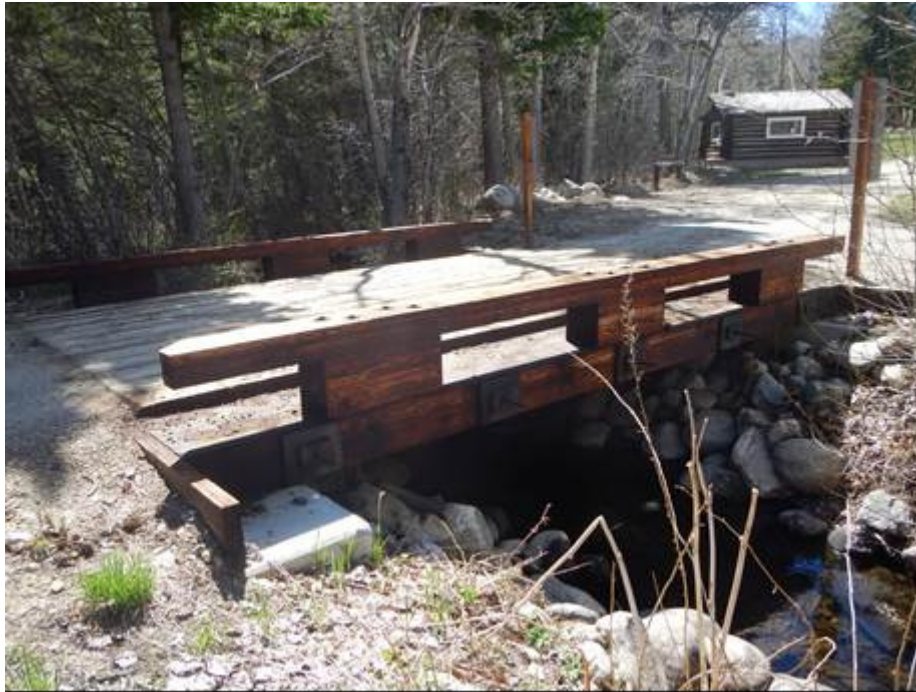
Photograph 14. MT_CarbonCounty_RockCreekRangerStationHD_0014. Bridge, facing southwest (Source: Logan Simpson, 2015).

A wooden deck bridge with low wood guardrails spans the West Fork Ditch Company Canal and provides access to the multi-stall garage (Building #2302). The bridge is 18 feet long by 10 feet wide and rests on simple concrete abutments. The abutments and channel immediately beneath the bridge are reinforced with cobbles. A map of the complex indicates that a bridge was built at this location as early as 1931; however, it was replaced in 1990 and modified in 2009. The feature is a noncontributing resource of the district.
