National Register of Historic Places Registration Form

Historic name: Rock Creek Ranger Station Historic District

Street & number: Custer Gallatin National Forest, Beartooth Ranger District

City or town: Red Lodge State: Montana County: Carbon

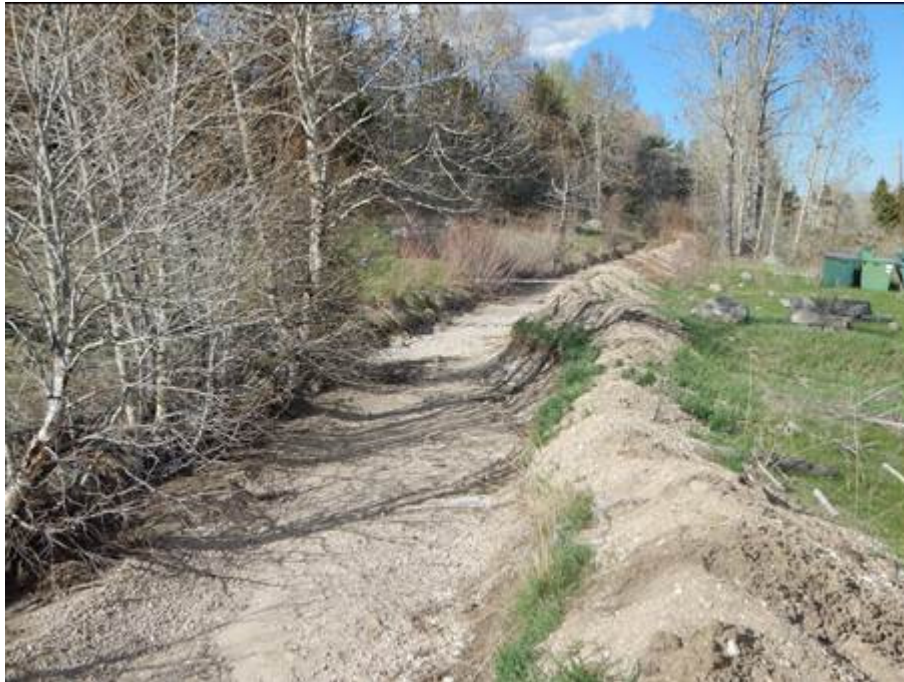
Photograph 15. MT_CarbonCounty_RockCreekRangerStationHD_0015. Maryott Ditch as it appears within the maintenance yard, facing northeast (Source: Logan Simpson, 2015).

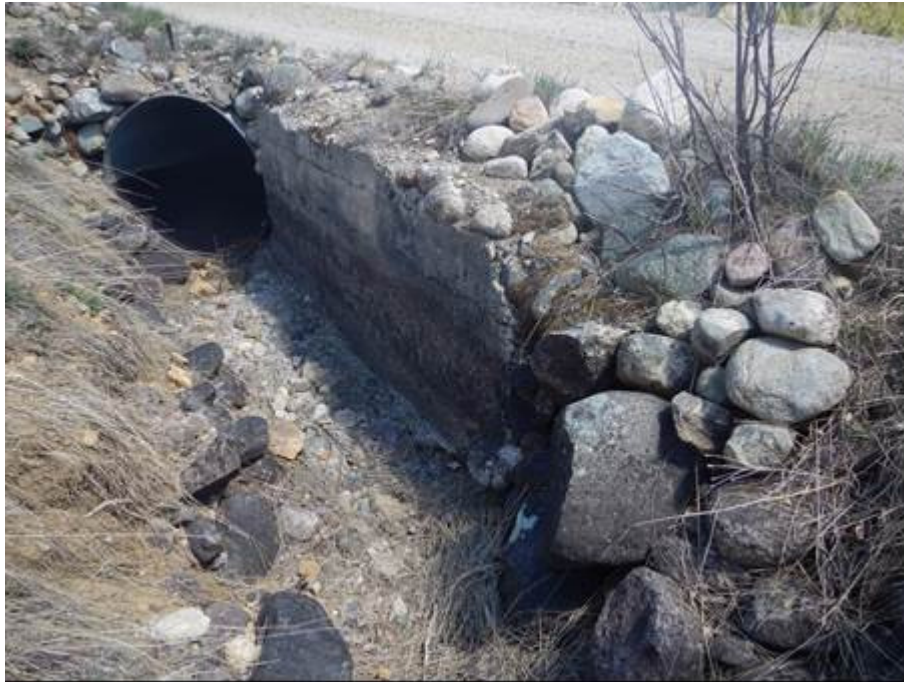
Photograph 16. MT_CarbonCounty_RockCreekRangerStationHD_0016. Maryott Ditch, steel pipe culvert and concrete wall to the west of the District's access road, facing northeast (Source: Logan Simpson, 2015).

ditch flows beneath the current access road near the base of the hill via a corrugated metal pipe culvert. Additional diversion structures or features were not observed.

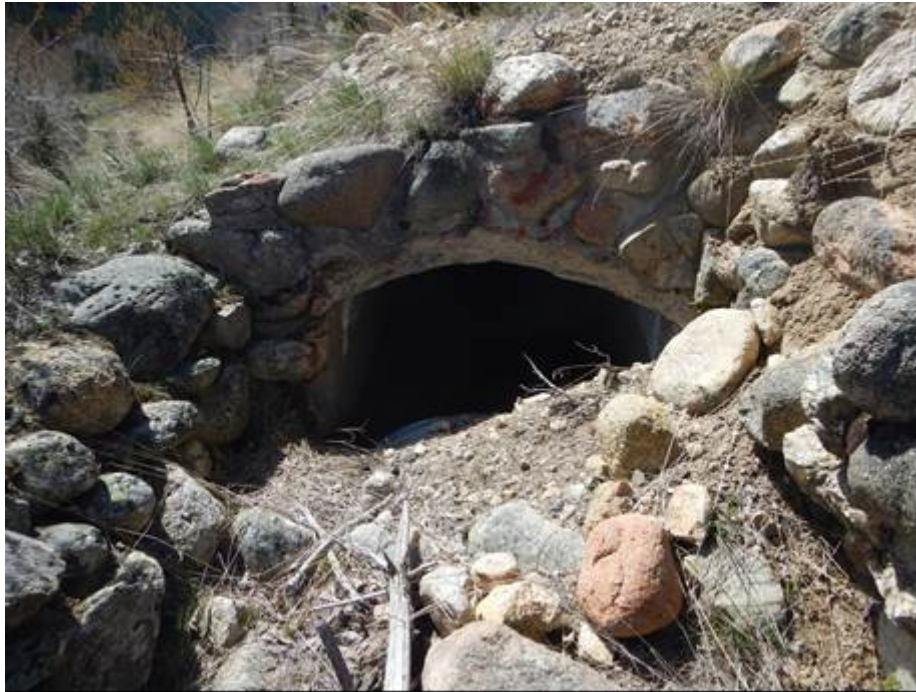
Photograph 17. MT_CarbonCounty_RockCreekRangerStationHD_0017. Maryott Ditch, showing the stone and concrete culvert on the east side of the District's access road, facing west (Source: Logan Simpson, 2015).

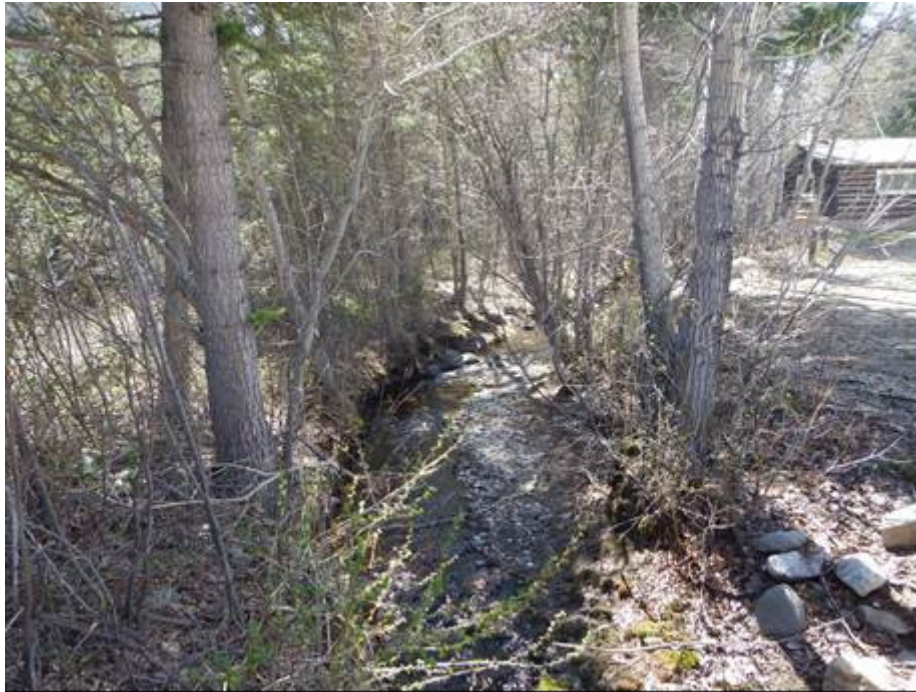
Photograph 18. MT_CarbonCounty_RockCreekRangerStationHD_0018. West Fork Ditch Company Canal, facing southwest (Source: Logan Simpson, 2015).

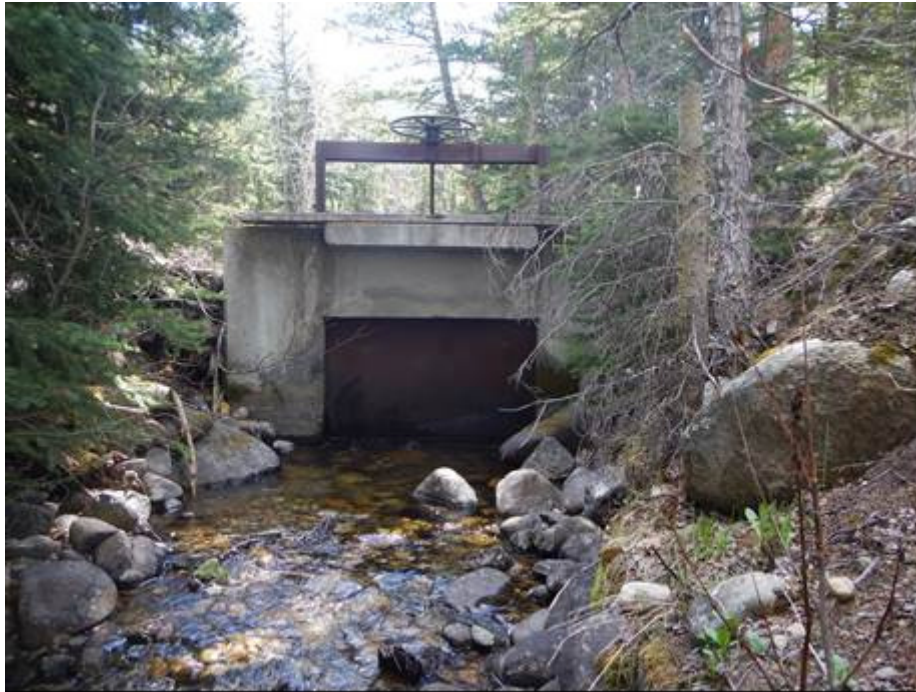
Photograph 19. MT_CarbonCounty_RockCreekRangerStationHD_0019. Headgate associated with the West Fork Ditch Company Canal, facing west-southwest (Source: Logan Simpson, 2015).

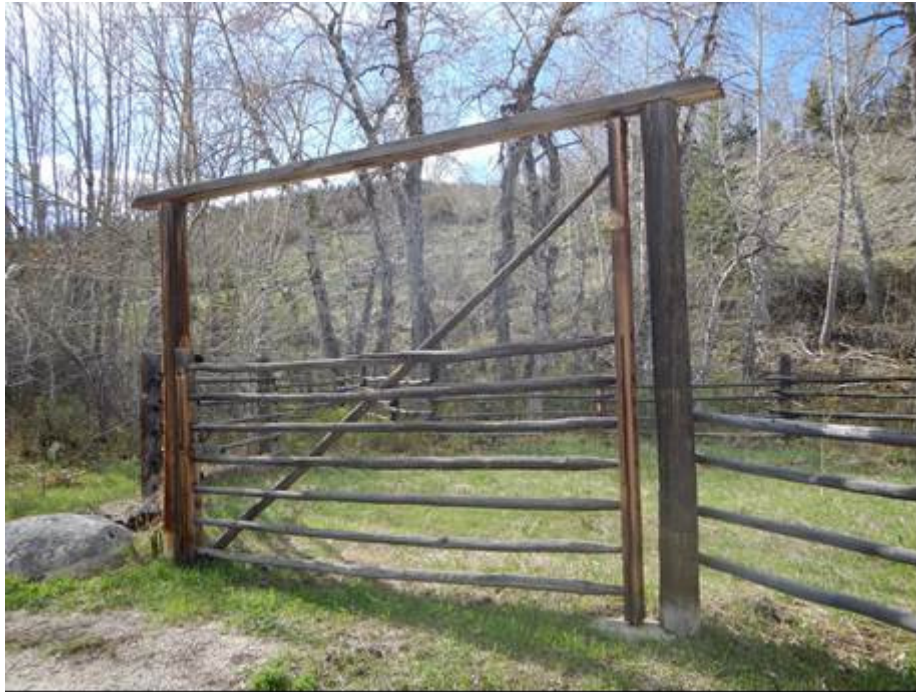
Photograph 20. MT_CarbonCounty_RockCreekRangerStationHD_0020. Post and pole corral, facing northwest (Source: Logan Simpson, 2015).

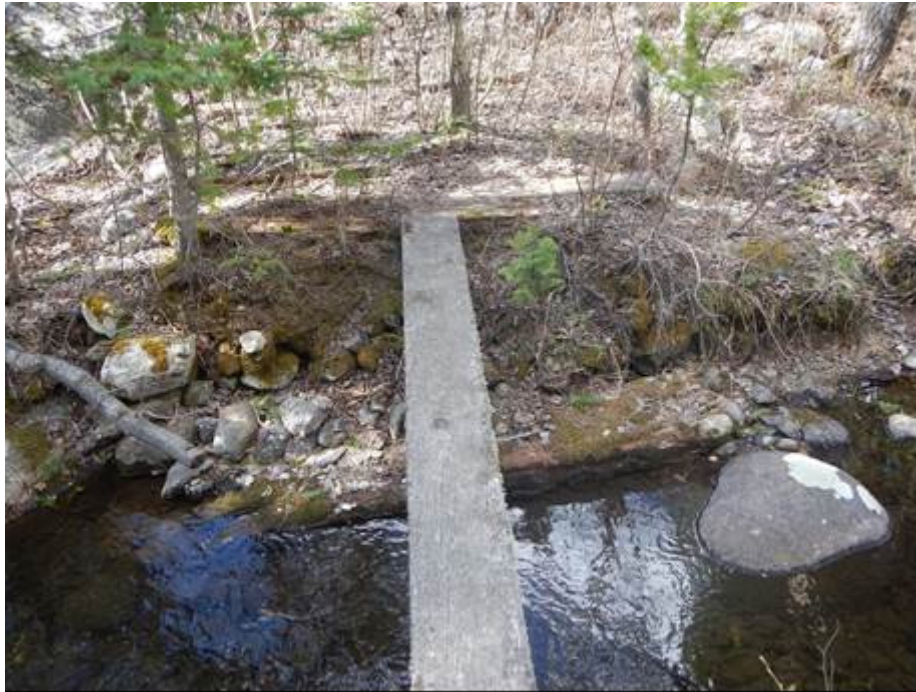
Photograph 21. MT_CarbonCounty_RockCreekRangerStationHD_0021. Remnants of a bridge spanning the West Fork Ditch Company canal, facing north. Note that the former bridge abutments are currently being used to support a wooden plank footbridge.

Remnants of a second bridge spanning the West Fork Ditch Company Ditch are present south of the Main Cabin (Building #1010). The bridge has deteriorated so that only portions of the original wooden abutments remain. Both abutments measure approximately 0.5 feet long by 10 feet wide. The northern abutment is constructed of stacked square timbers; one of the boards was partially buried adjacent to the ditch's channel and the second had fallen into the channel at

the time of the present survey. A single row of cobbles was also visible beneath the in situ abutment. The southern abutment consists of a square timber placed above a rounded log. Both of these logs remain in place. A modern wooden plank has been placed on top of the wooden abutments forming a narrow footbridge across the ditch. The feature retains integrity of location and setting. Prior to its deterioration, the feature, roughly 10 feet wide, would have supported more substantial traffic across the ditch. In addition to the poor integrity of the feature, the fact that no road or trail alignment is visible near the resource indicates its use as a bridge ended years ago and no longer retains integrity of association. The structure has also lost integrity of materials, design, workmanship, and feeling. In addition, the date of construction remains unknown. The feature is considered a noncontributing resource.
