Riley- Cutler House  
11510 Pedee Creek Road  
Monmouth, Polk County, Oregon

1 of 19  
View of site before relocation

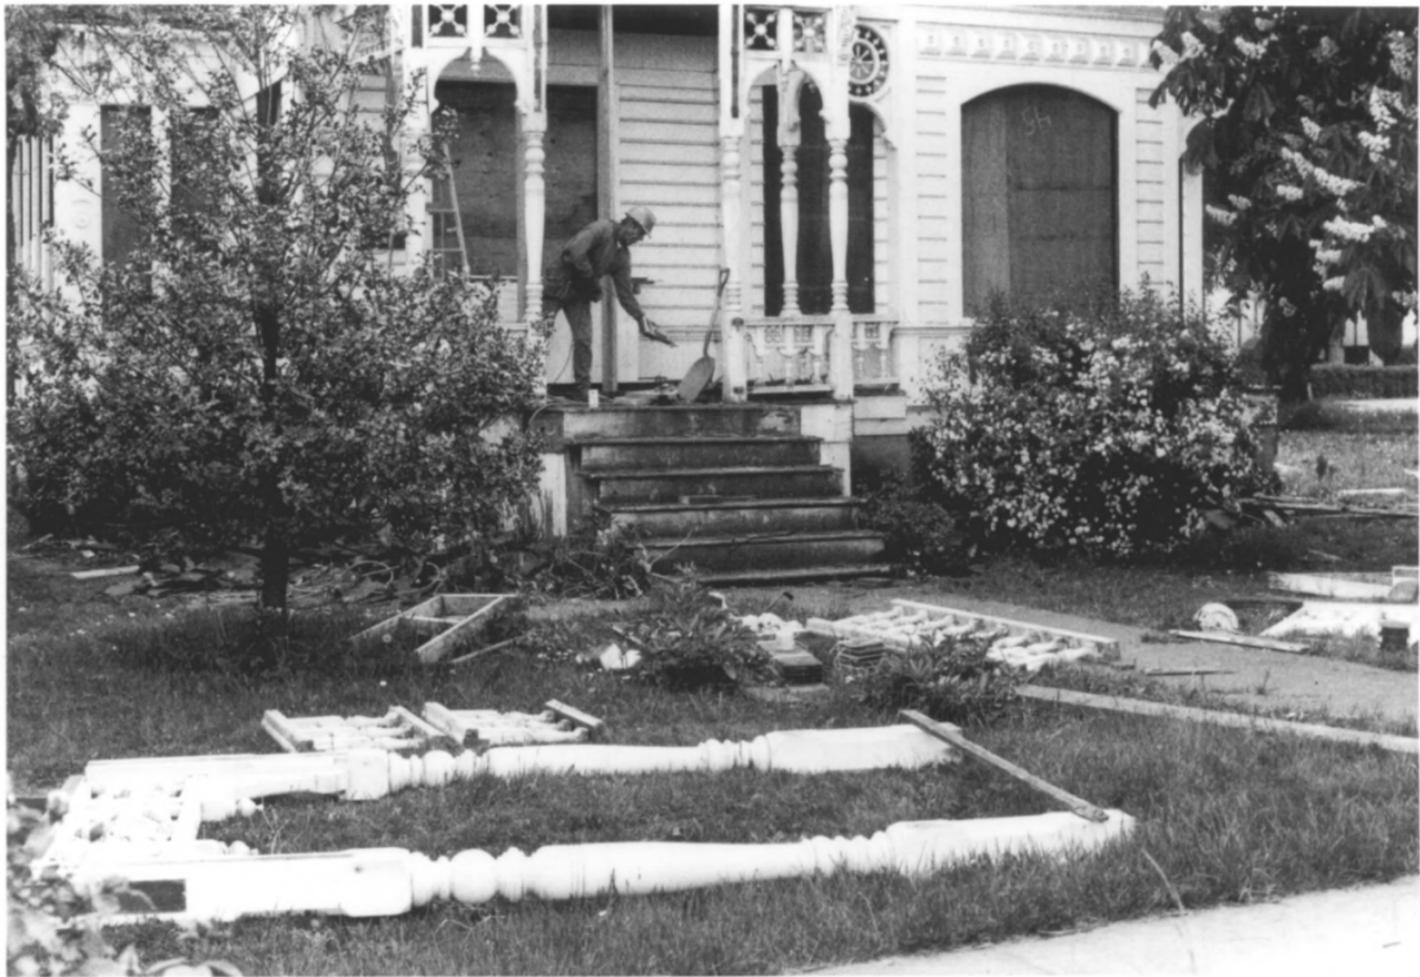
12 of 19  
Removal of front porch

North elevation showing removal  
of front porch. Pieces left in  
contact where possible, chemically  
stipped, neutralized, primed &  
painted before reassembly.

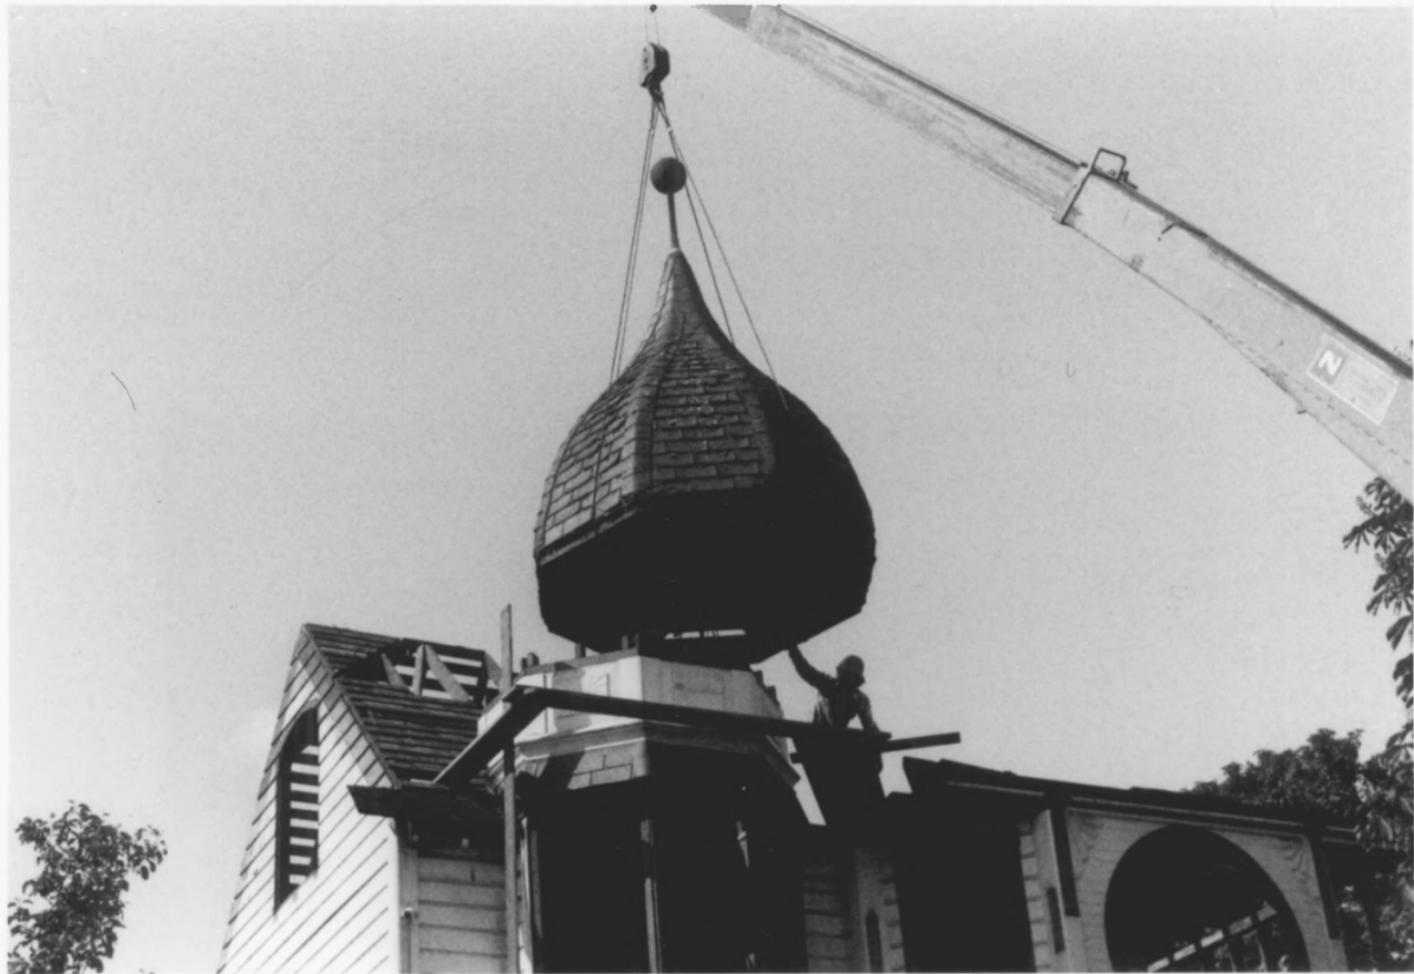
13 of 19  
Removal of turret

North elevation showing removal  
of "onion" turret with crane.  
Crane also facilitated the removal  
of North attic gable wall and  
the West dormer assembly.

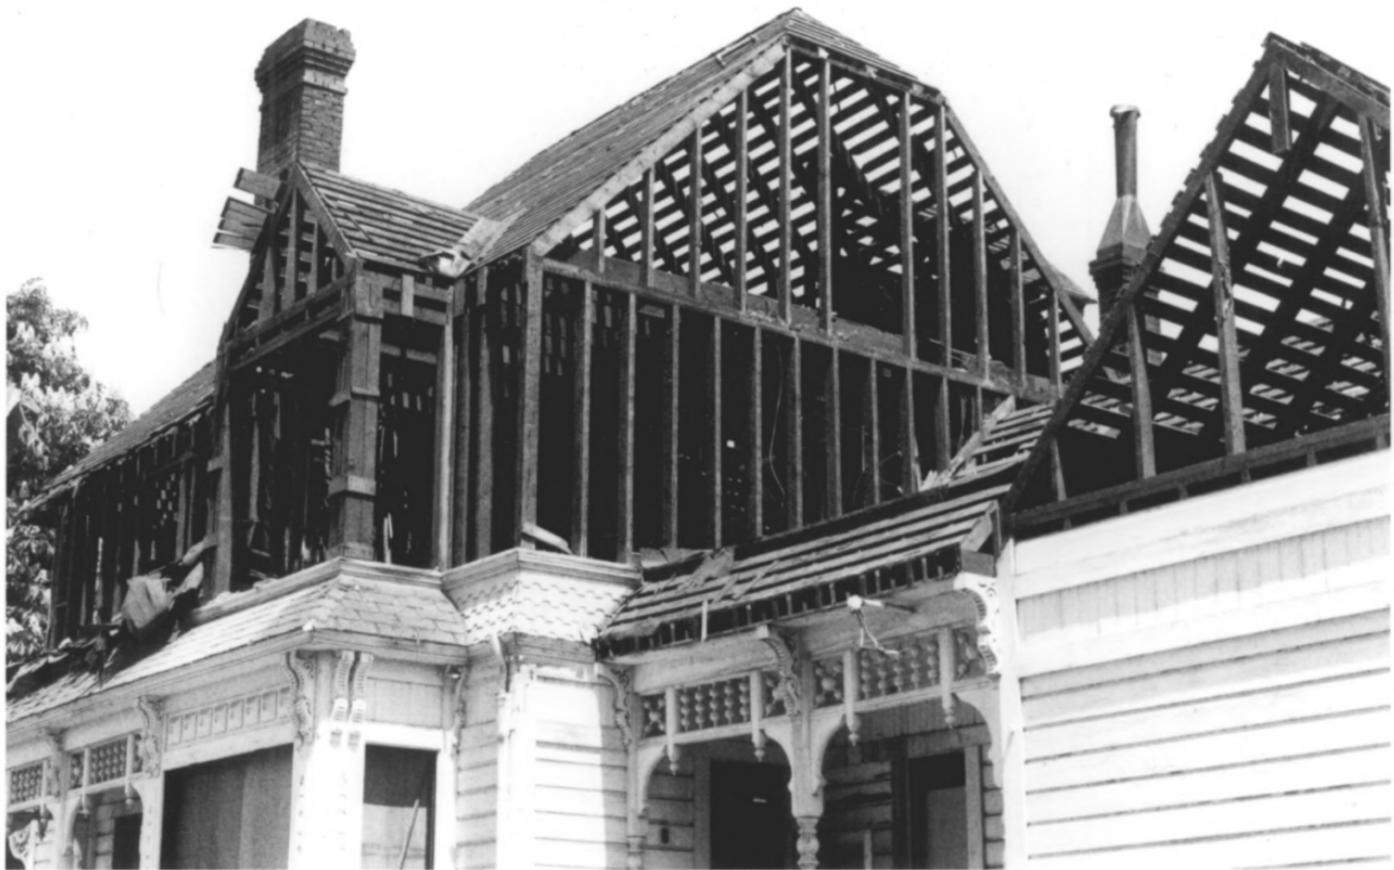
14 of 19  
Upper wall frames

West/South elevation following  
removal & cataloging of siding  
facia's with fake rafter tails  
bargeboards, all 2nd story  
windows & interior trim & roof.

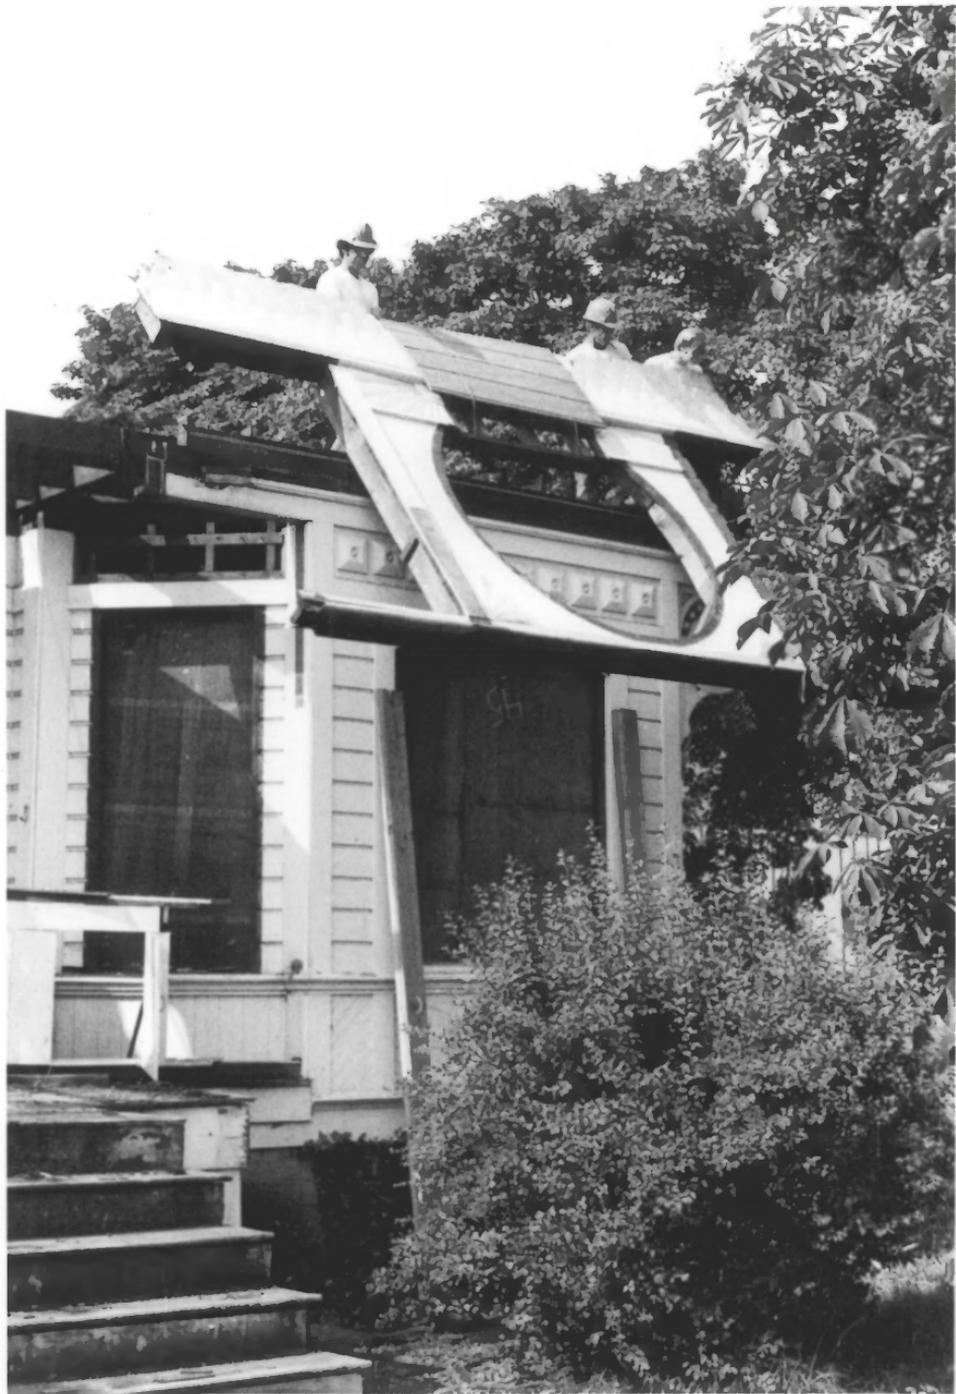
15 of 19  
Dismantling continues

North elevation showing removal of  
2nd story wall. Pieces left intact  
to minimize damage to fragile de-  
tails, & maximize accuracy during  
reassembly.

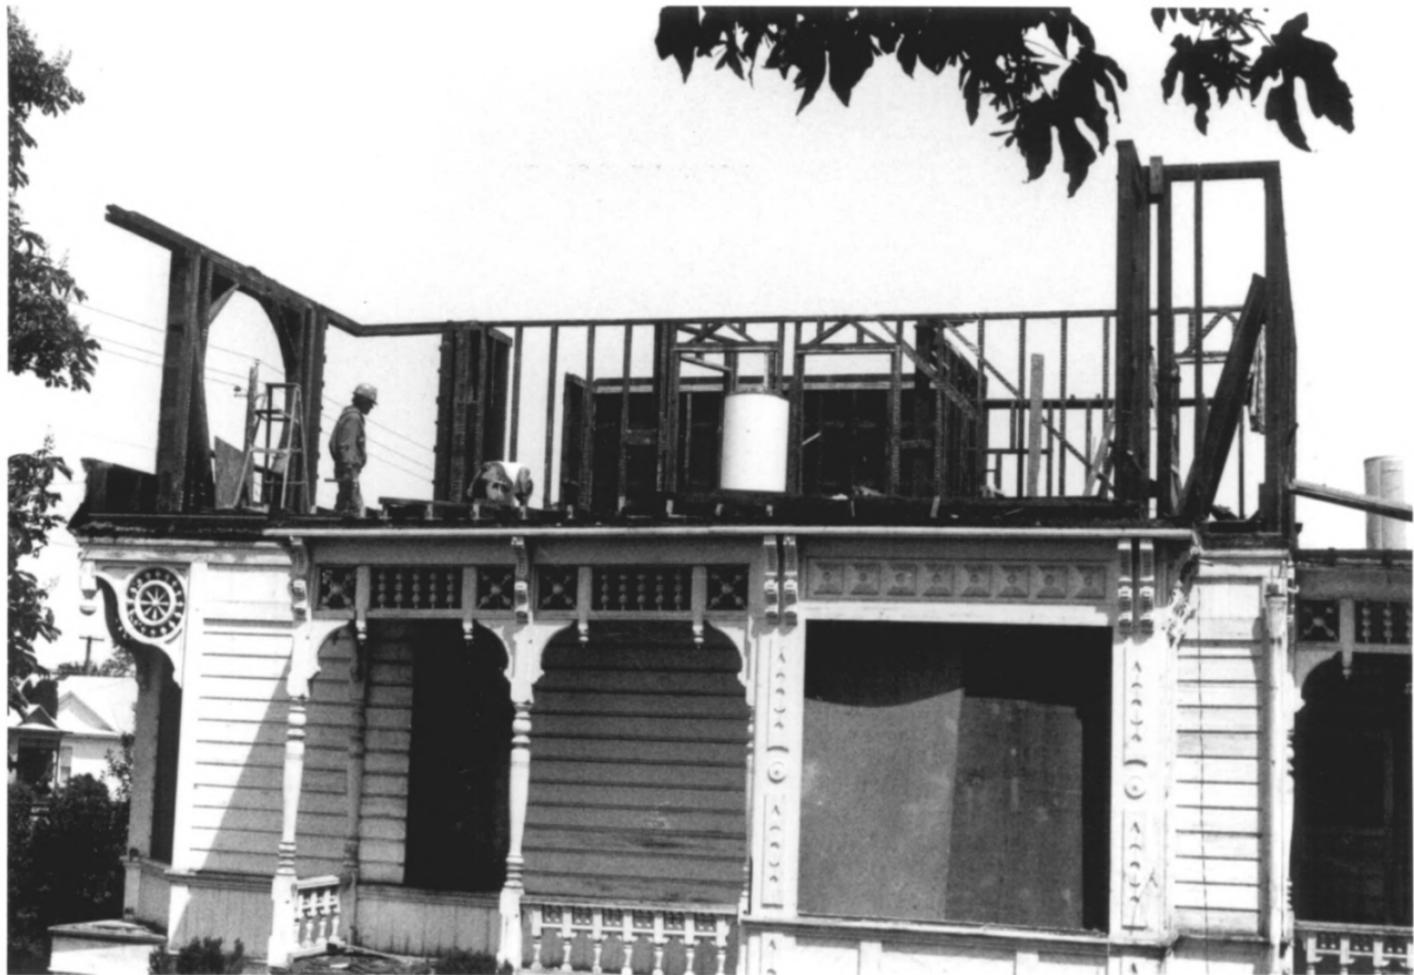
16 of 19  
Dismantling almost complete

West elevation showing removal of second story. Balloon construction was cut off at floor and later reconstructed in the platform style with original 19th century building materials.

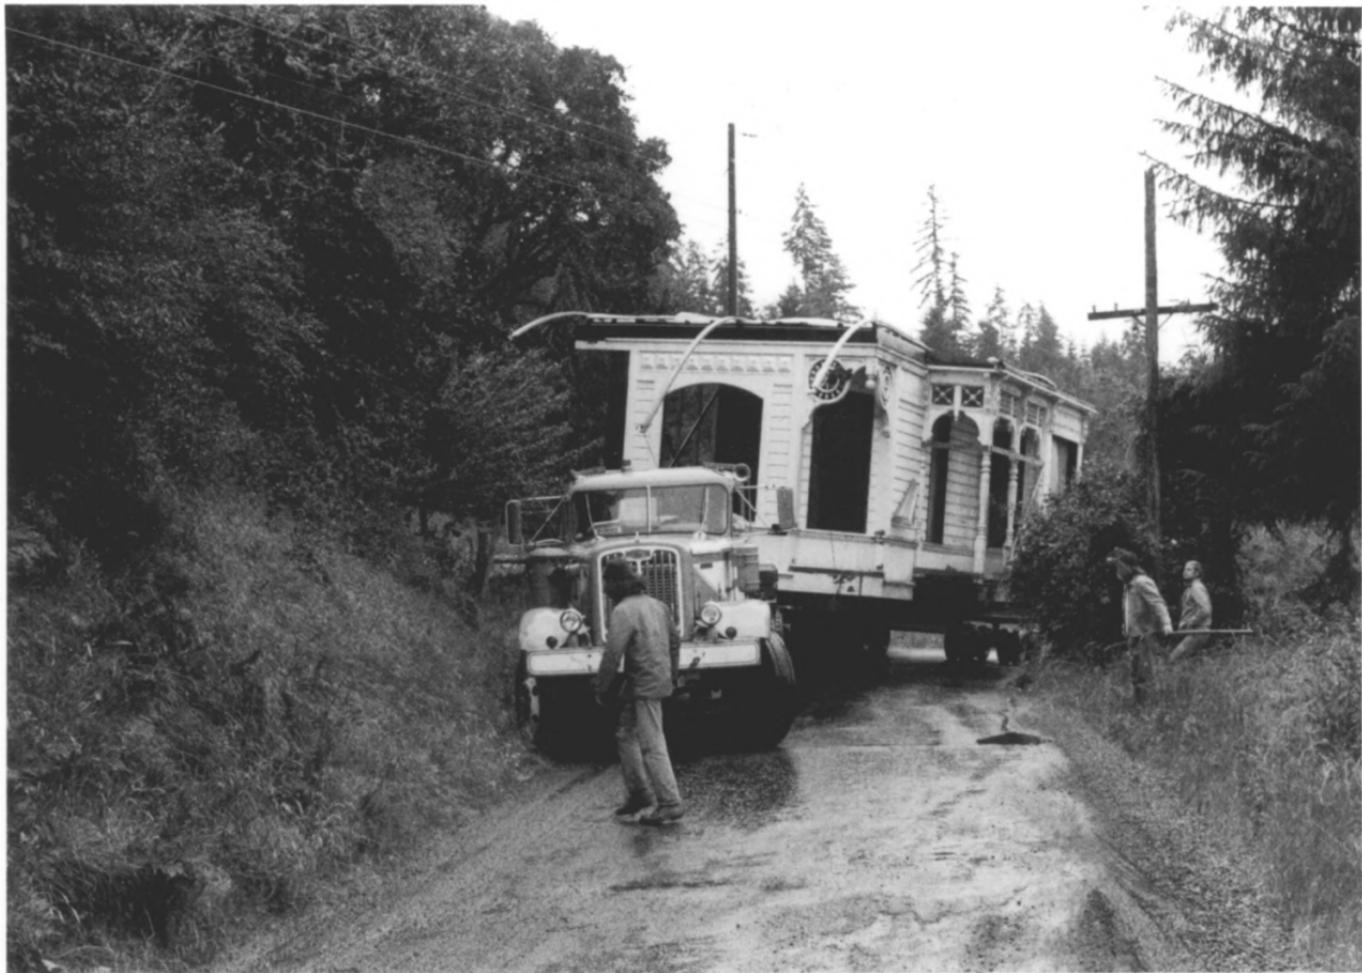
17 of 19  
Relocation of West half of  
lower storey

North elevation, west section of  
main house showing the move on  
July 1st, 1979, along Pedee Cr.  
Road. The East section preceeded  
the West during the move.

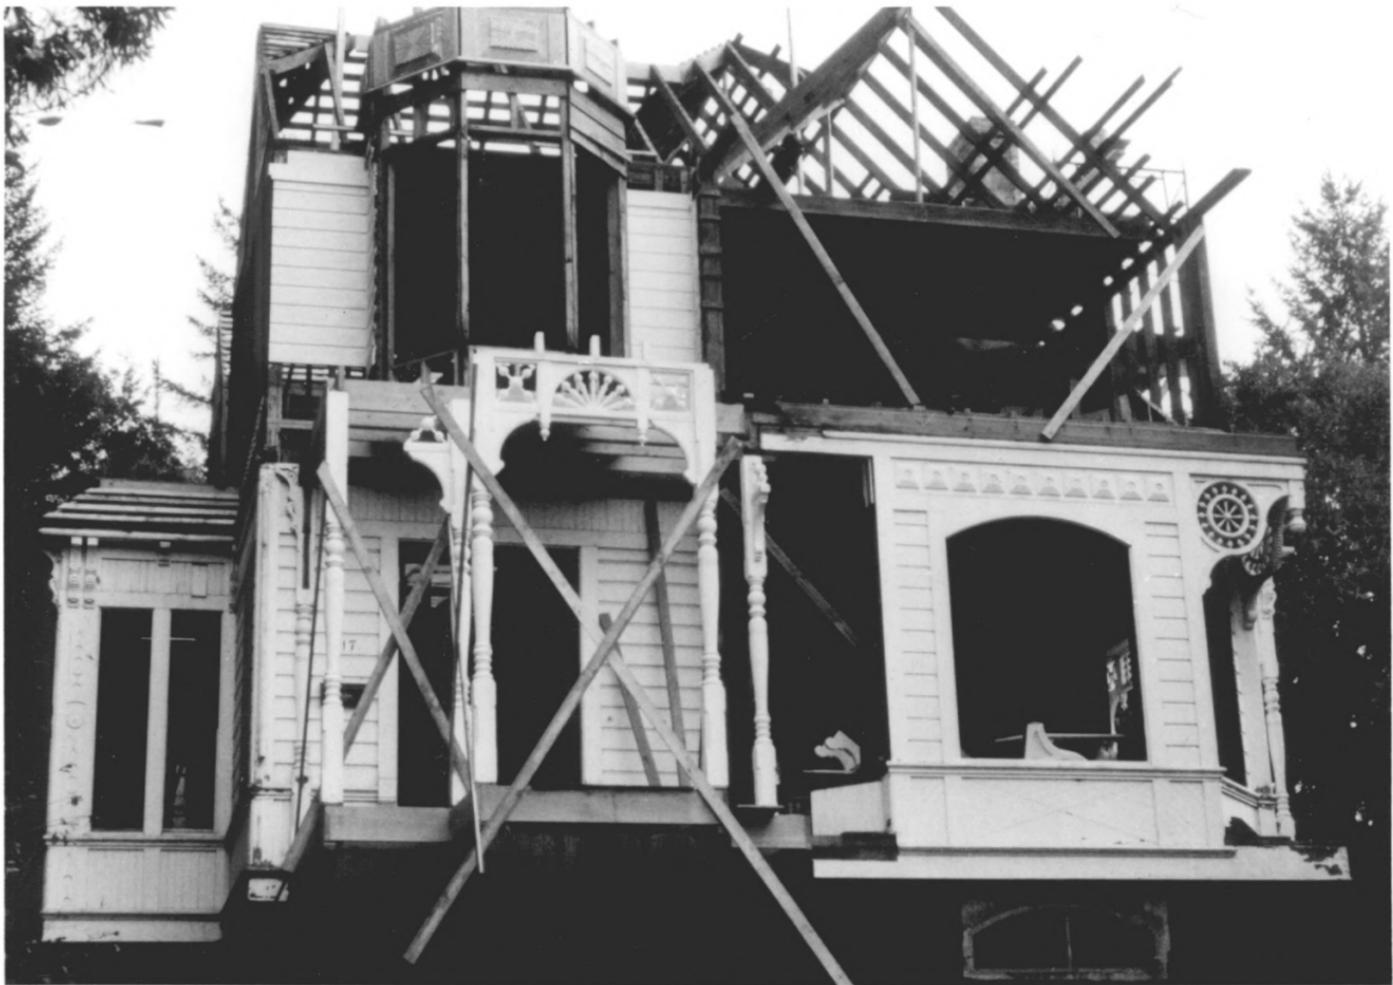
18 of 19  
Reconstruction on new site,  
North elevation

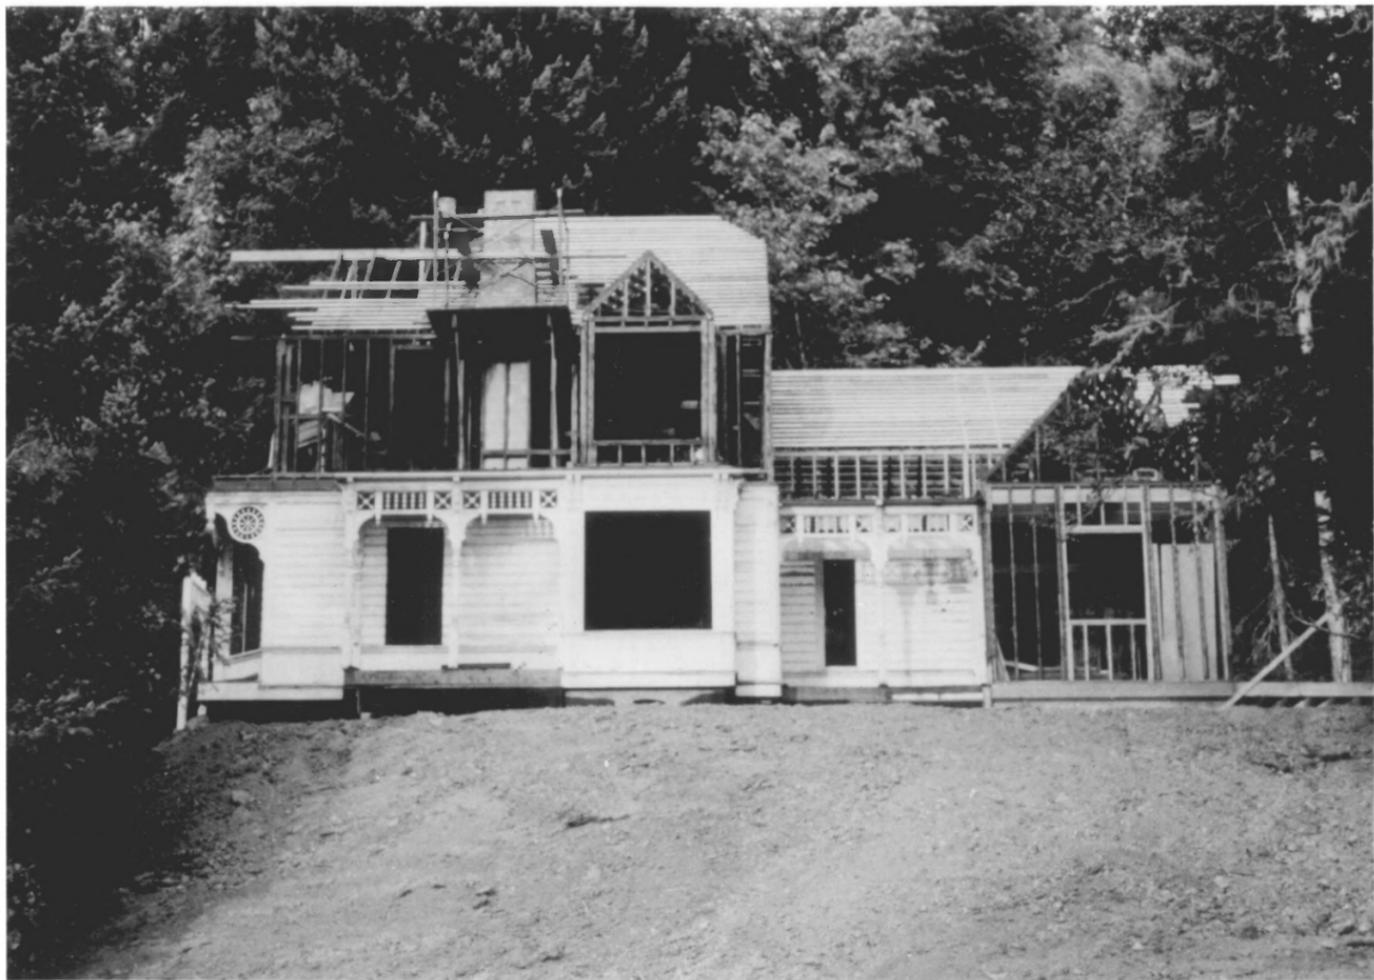
19 of 19

Reconstruction on new site,  
West elevation

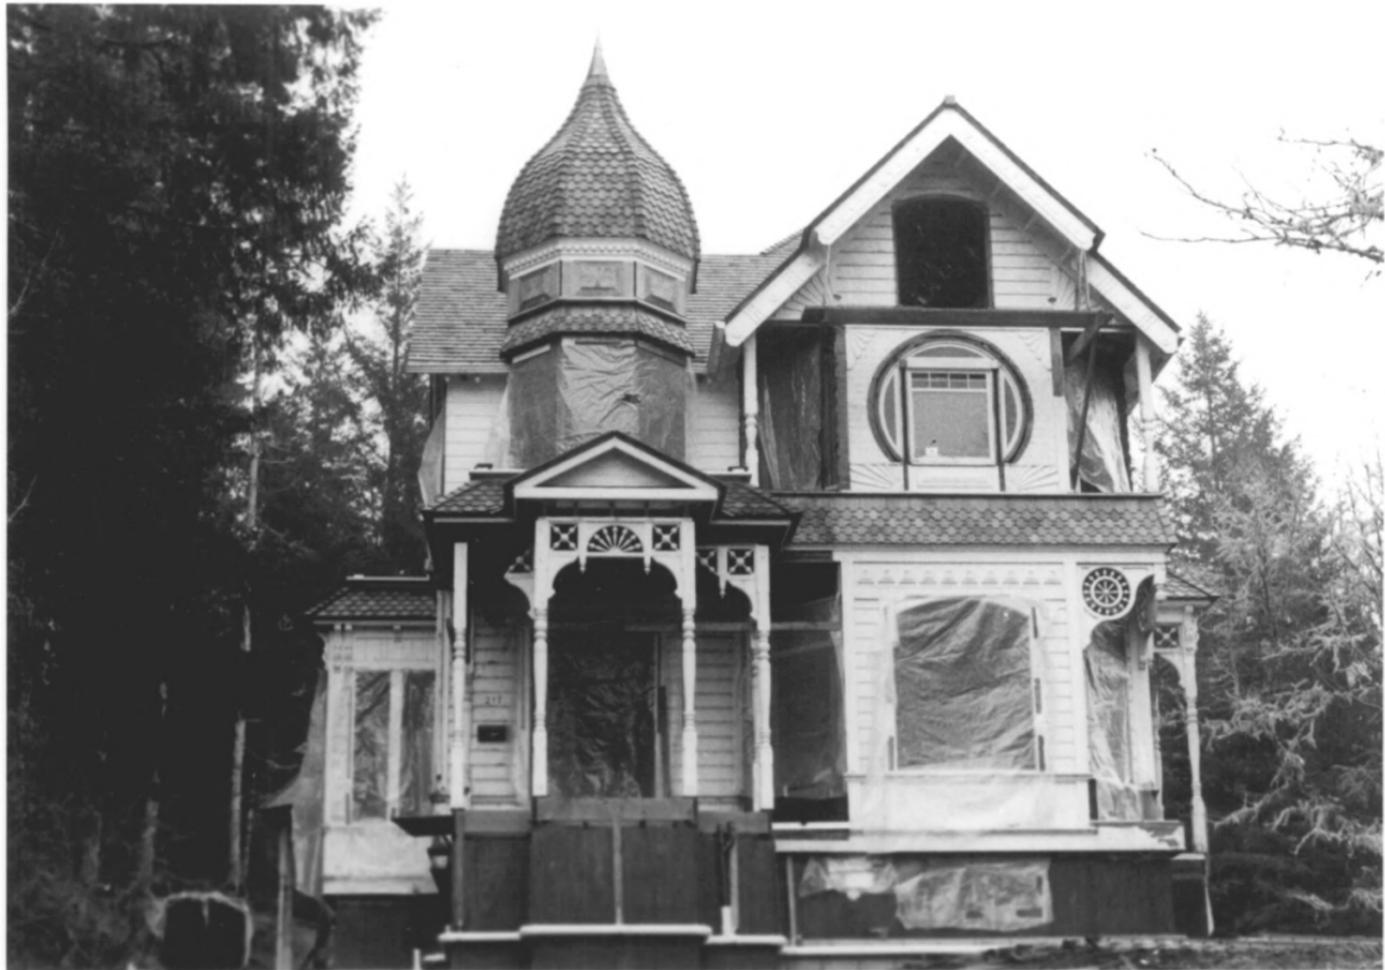
2 of 2nd set of 11 - North  
(front) elevation at present

site, showing accurate restoration in progress.

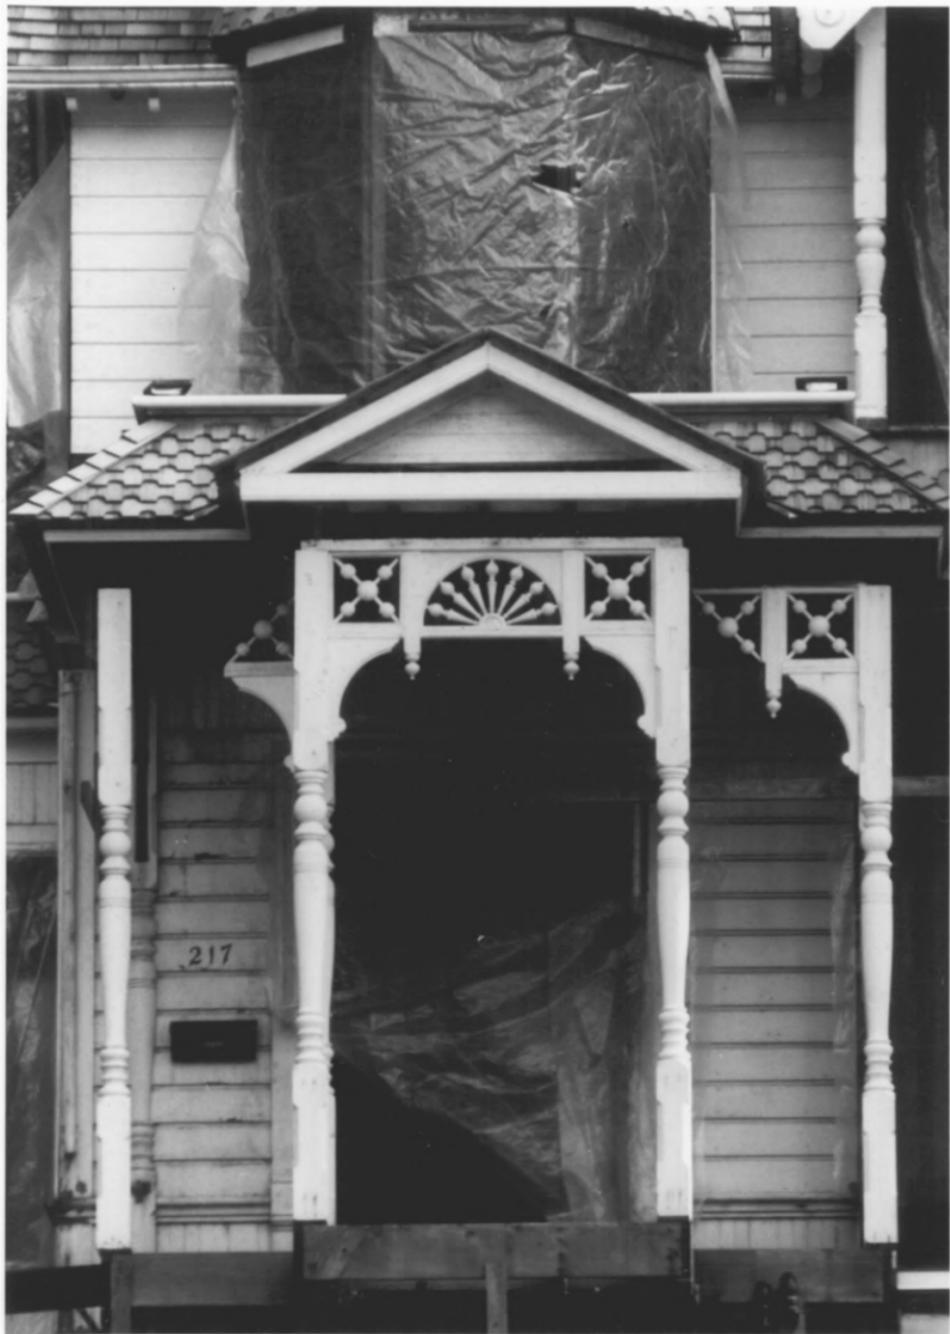
Riley-Cutler House  
11510 Pedee Creek Rd.  
Monmouth vic., Polk Co, Ore.  
3 of 2nd set of 11 - Detail  
of front porch in process of  
re-assembly at present site.

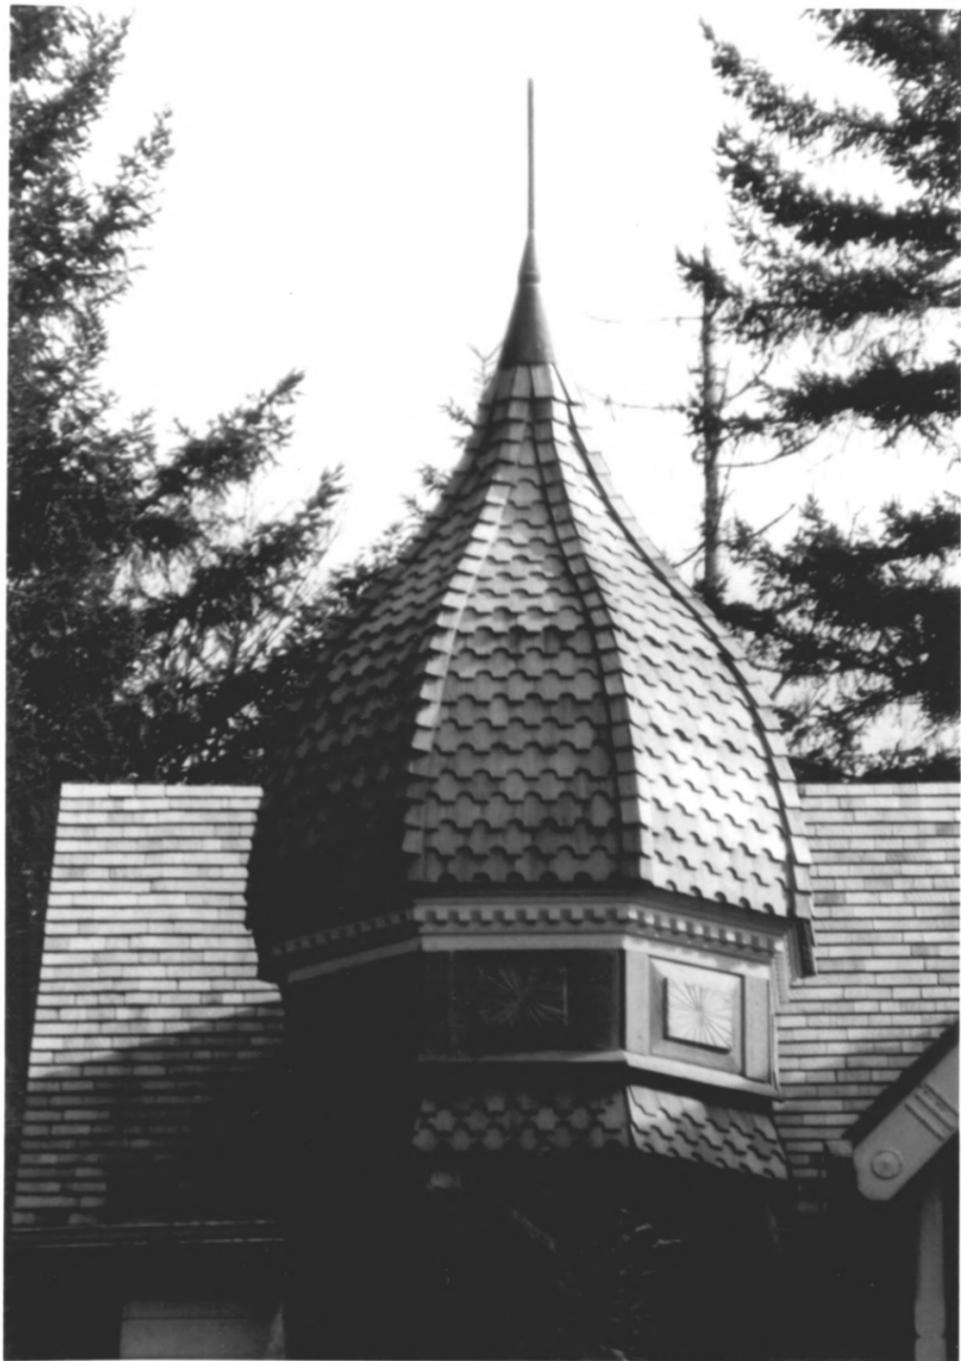
Riley-Cutler House  
11510 Pedee Creek Rd.  
Monmouth vic, Polk Co, Oregon  
4 of 2nd set of 11 - Detail  
of restored turret. Historic  
view of 1941 shows that dome  
shingling had fancy butts,  
whereas roof did not.  
Steve Waller photo, 1980  
11510 Pedee Creek Rd.  
Monmouth, OR 97361

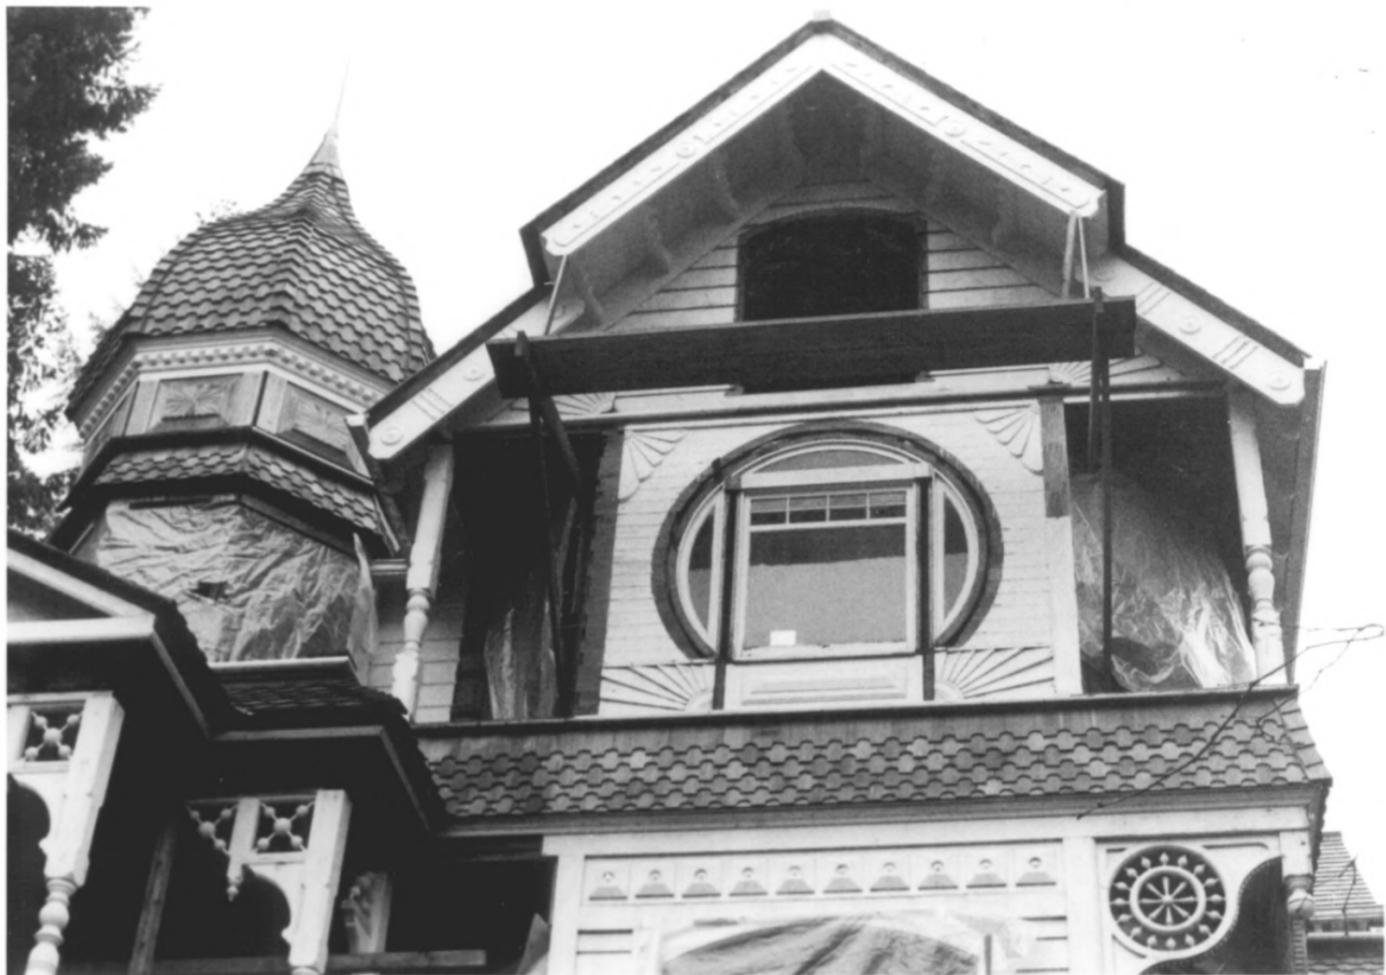
6 of 2nd set of 11 - Detail  
of balconies, north (front)

elevation, in process of re-  
assembly at present site.

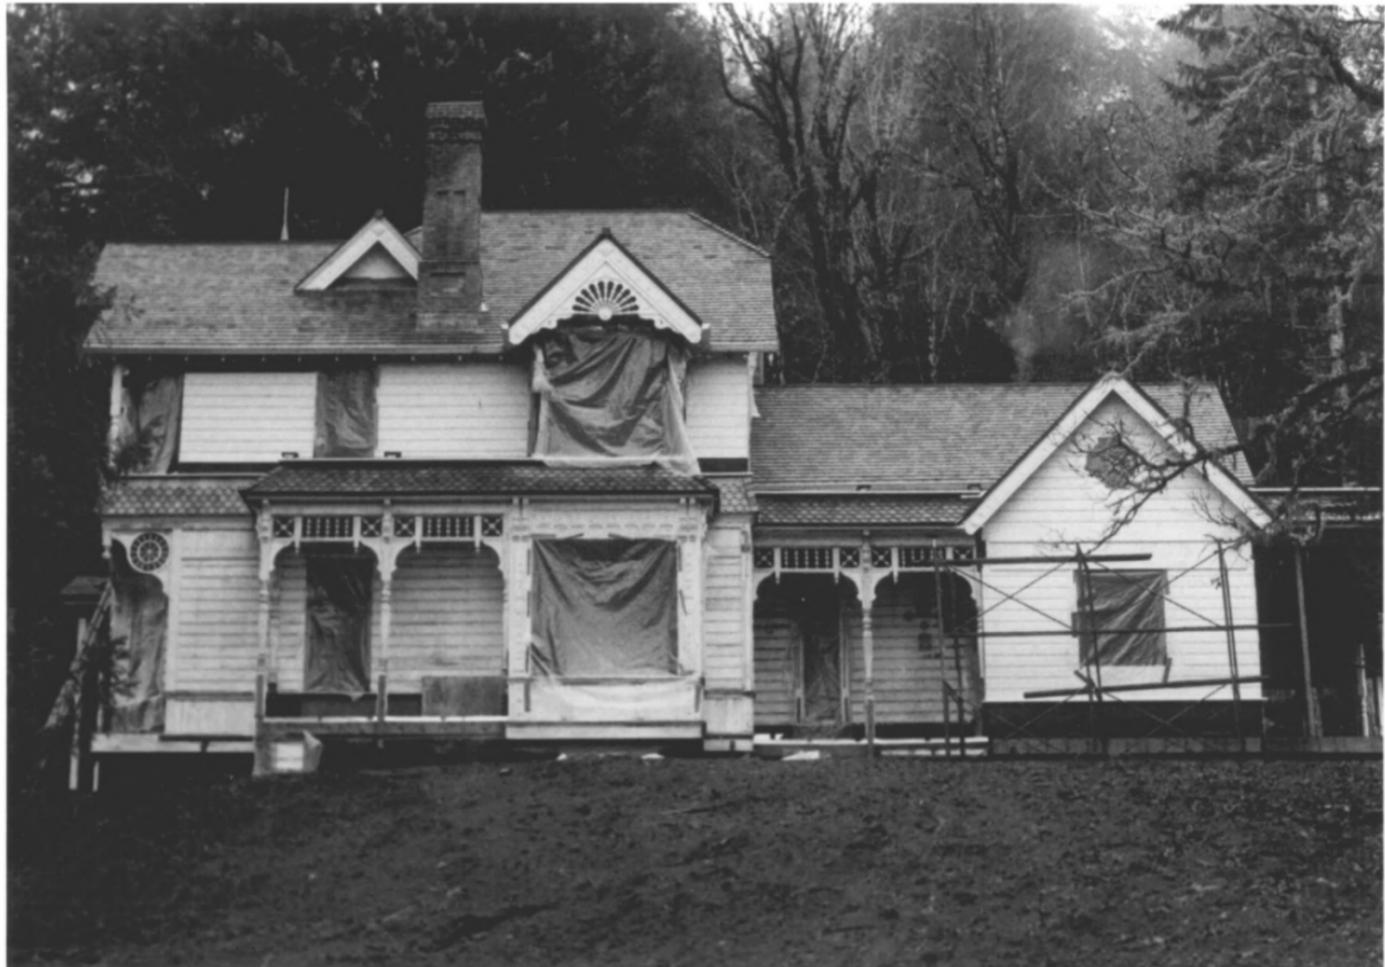
8 of 2nd set of 11 - West  
(side) elevation at present

site, showing accurate restoration in progress.

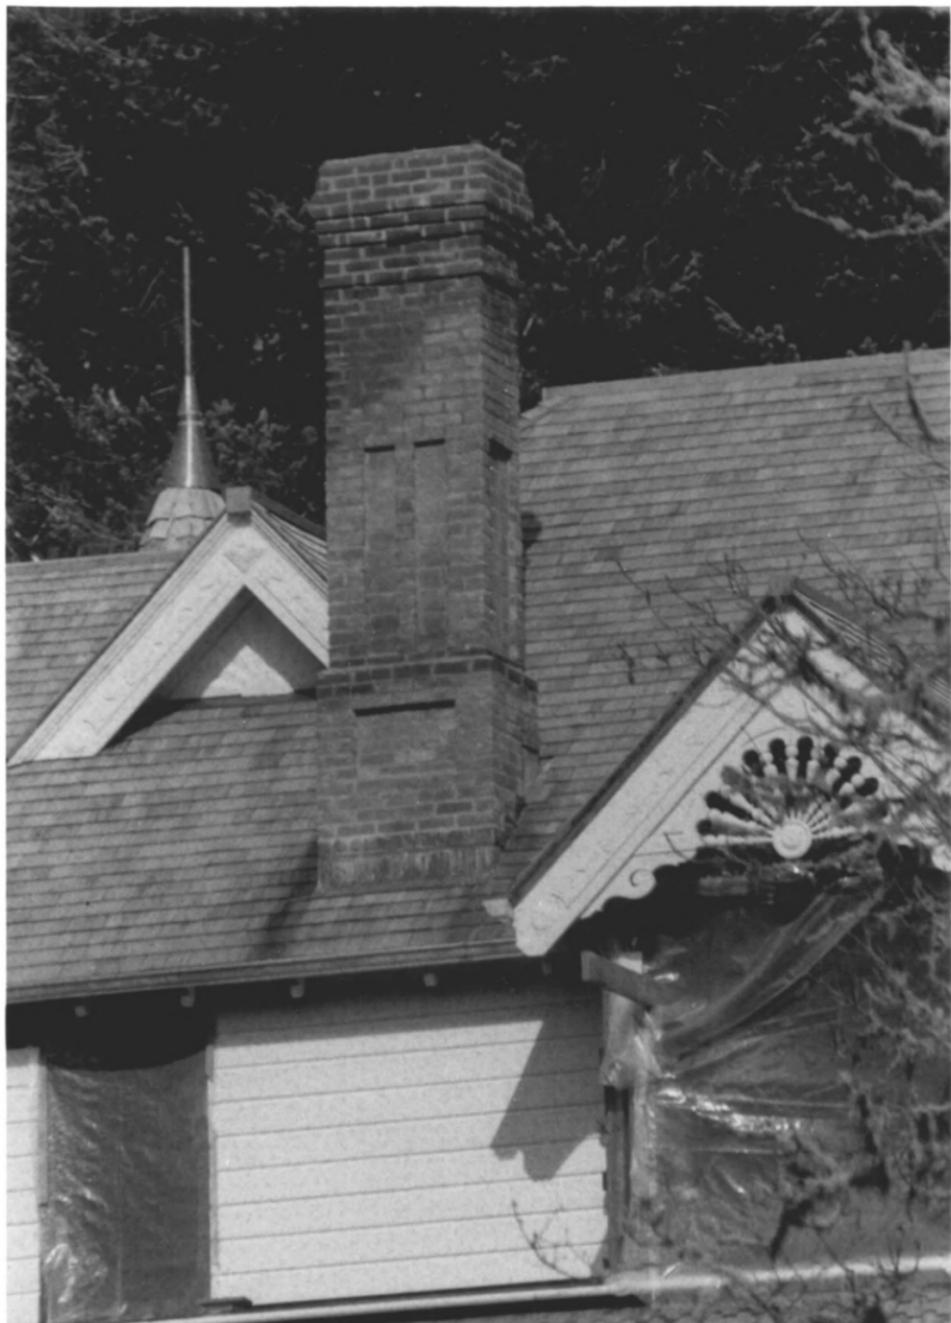
Riley-Cutler House  
11510 Pedee Creek Rd.  
Monmouth vic, Polk Co, Oregon  
9 of 2nd set of 11 - Detail of  
chimney stack as reassembled,  
west elevation, present site.  
Steve Waller photo, 1980  
11510 Pedee Creek Rd.  
Monmouth, OR 97361

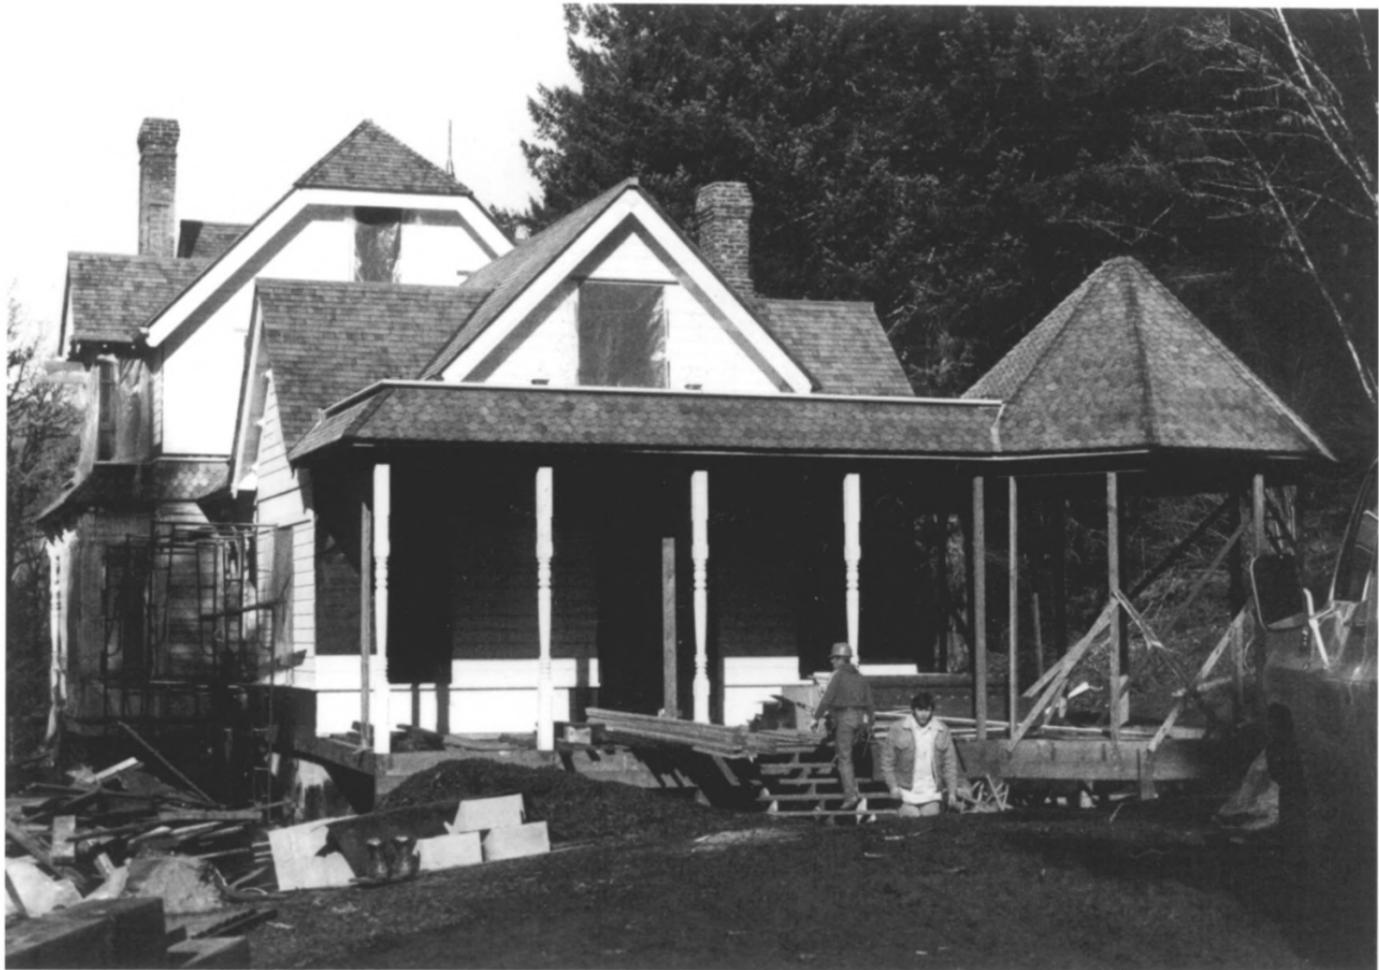
Riley-Cutler House  
11510 Pedee Creek Rd.  
Monmouth vic, Polk Co, Oregon  
10 of 2nd set of 11 - South  
(rear) elevation at present  
site. Rear porch and gazebo  
is sympathetic to house in  
style, but not original.  
Steve Waller photo, 1980  
11510 Pedee Creek Rd.  
Monmouth, OR 97361

This elevation is not  
visible from the public  
right-of-way nor, generally,  
from the private access road.

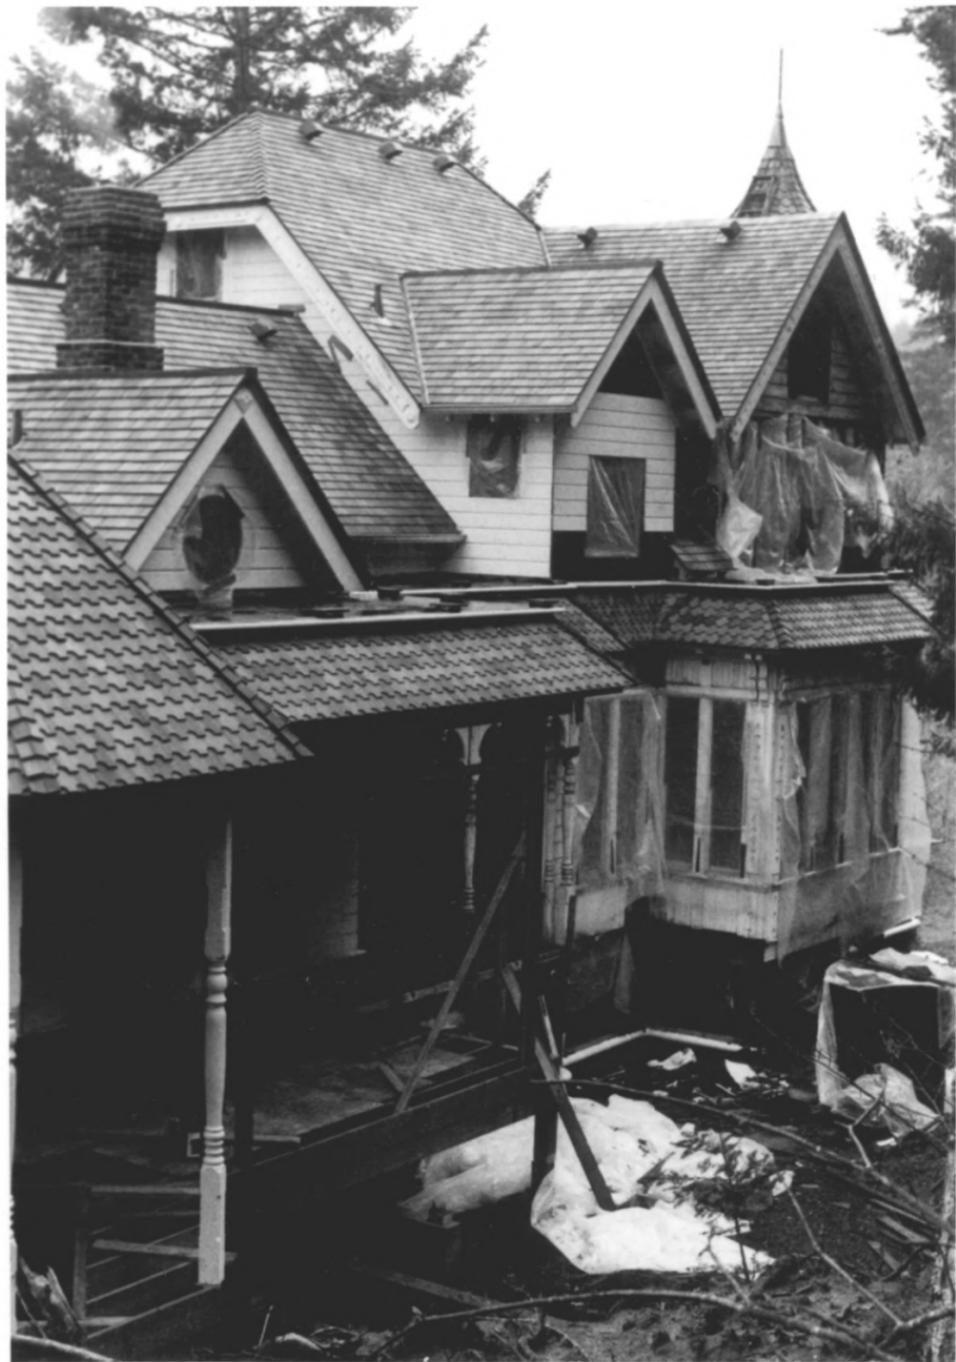
Riley-Cutler House  
11510 Pedee Creek Rd.  
Monmouth vic, Polk Co, Oregon  
11 of 2nd set of 11 - East  
(side) elevation at present  
site, showing accurate restor-  
ation in progress.
