National Register of Historic Places Registration Form

Historic name: Gehring Ranch
Other names/site number: 24LC1846
Name of related multiple property listing: NA
(Enter "N/A" if property is not part of a multiple property listing)

Street & number: 5488 Lincoln Road West
City or town: Helena State: MT County: Lewis and Clark
Not For Publication: Vicinity:

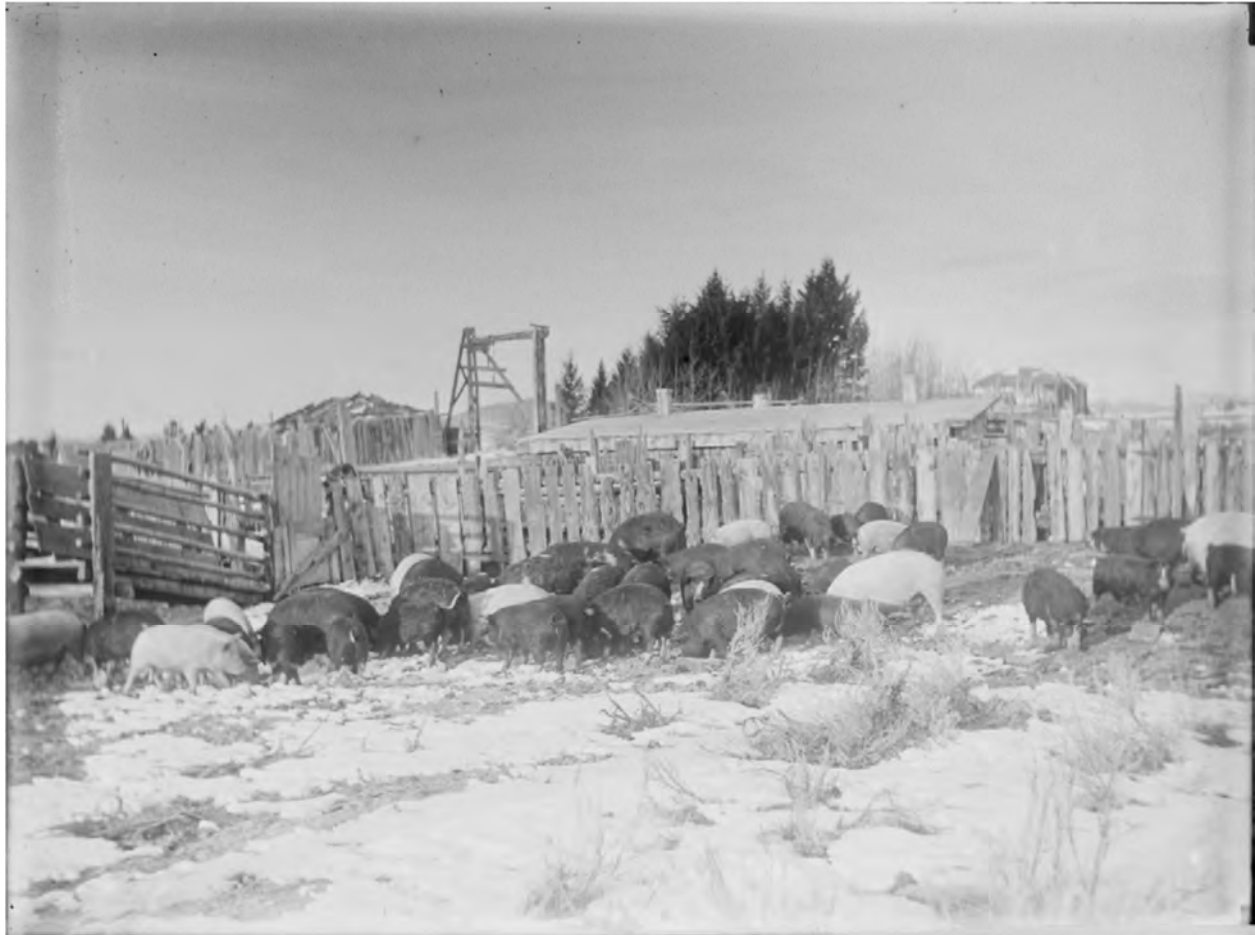
Figure #1 GPC-62 GehringGlassPrint62.tif. Ca. 1914. Hog Shed (Shed #1).

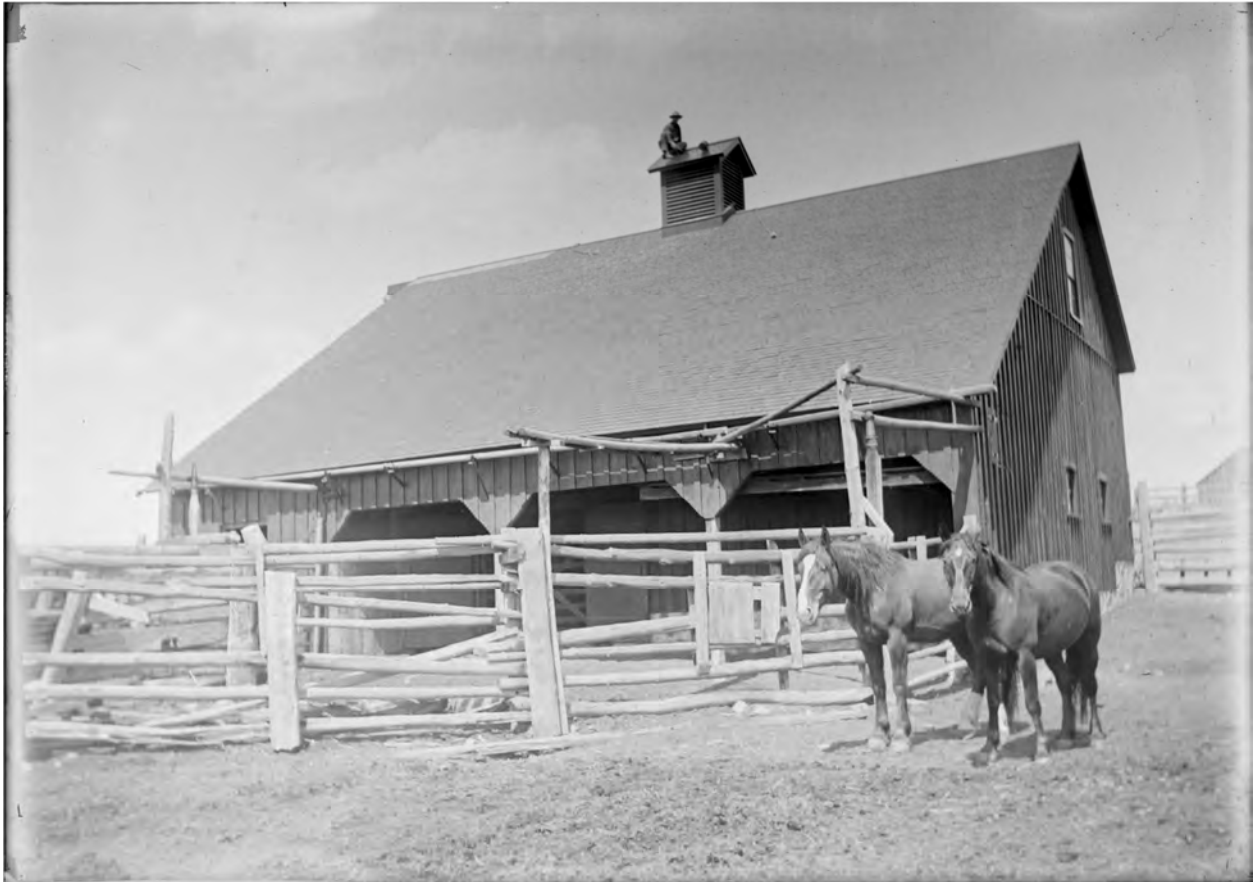
Figure #2 GPC-74 GehringGlassPrint74.tif. Barn on the Gehring Ranch. Burned in 1928 and replaced with Barn #1.

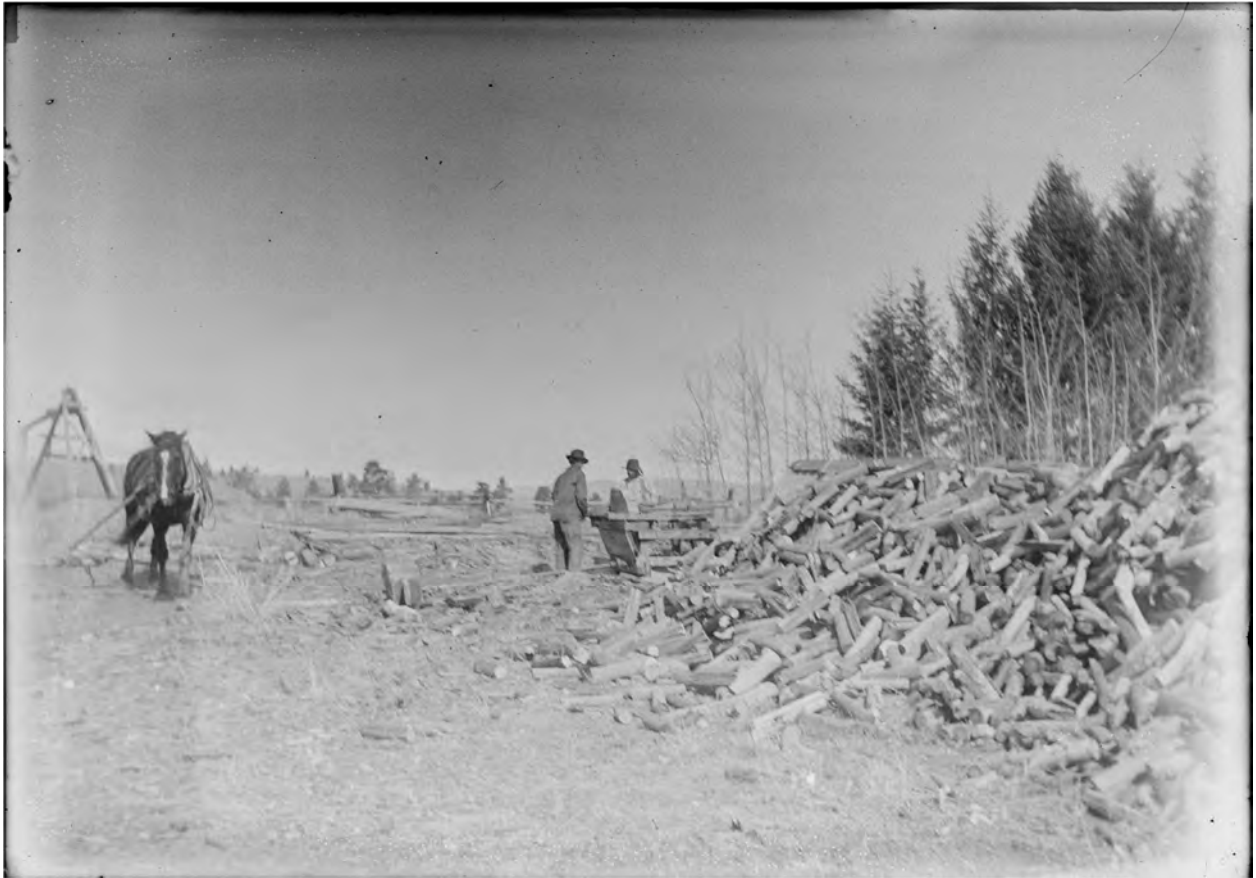
Figure #3 GPC-54 GehringGlassPrint54.tif. The “Horse Power” being used to saw wood.

The mill eliminated the need to grind feed with the Horse Power, the same piece of equipment used to cut wood. David Gehring must have been familiar with its limitations, particularly given the technological advantages of steam and gasoline powered equipment. As much as the family loved and understood horses, their ultimate redundancy was inevitable. The Horse Power was often in use, so much so that its parts required occasional replacement, and its survival on the ranch today remains fortunate as a representative of early agriculture. An illustration of a Carey-Pitts Sweep Horse Power in the Sears Roebuck and Company catalog of 1897 closely resembles this unit.⁶¹

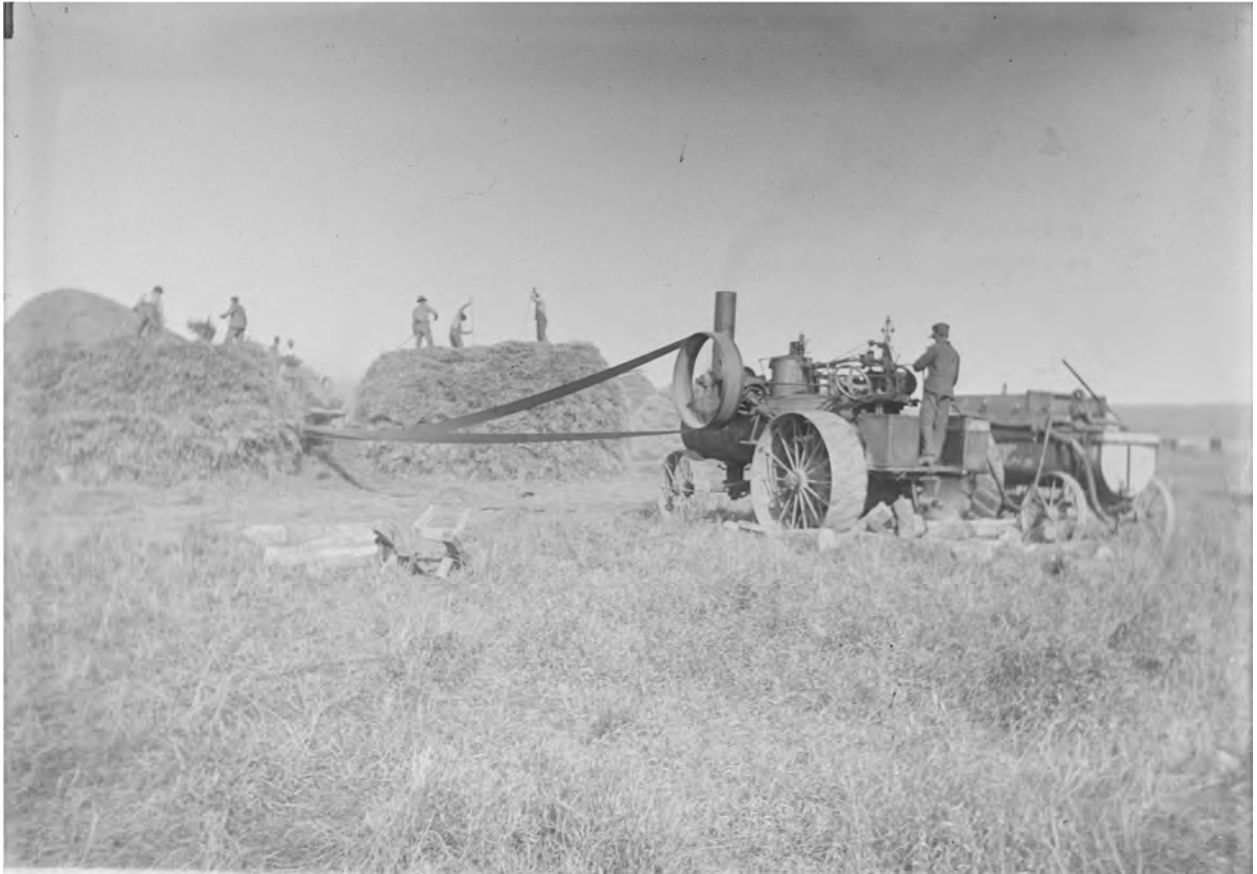
Figure #4 GPC-43 GehringGlassPrint43.tif. Ca. 1910. Steam tractor powering a threshing machine.

Threshing machines were in common use before the turn of the nineteenth century. The early versions were wooden enclosures to which the various gears and pulleys were attached, inside and out. The ruins of three wooden machines are found near the Gehring ranch buildings along with a smaller metal-sided, or "steel", thresher; a later model. The technical term used for such machines was "separator" because they separated grain from chaff and stems. Typical of the sprawling manufacturing scene of the time, grain separators were manufactured by many different companies in savage competition with one another. The Gehring ranch's best surviving model is a large, steel separator built by Advance-Rumely. The constantly evolving Advance-Rumely company built steel separators from 1916 to 1936, when they were absorbed into the more stable Alice-Chalmers Manufacturing Co.⁶⁴ Gehring's machine bears the number 28116 on the panel referencing the machine number (this may also be merely a part number). If this is indeed a serial number, it was built in 1924, early enough to be operated by the Holt tractor then owned by David Gehring.⁶⁵

⁶² See "Additional Documentation—Historic Photographs," Fig. 4.

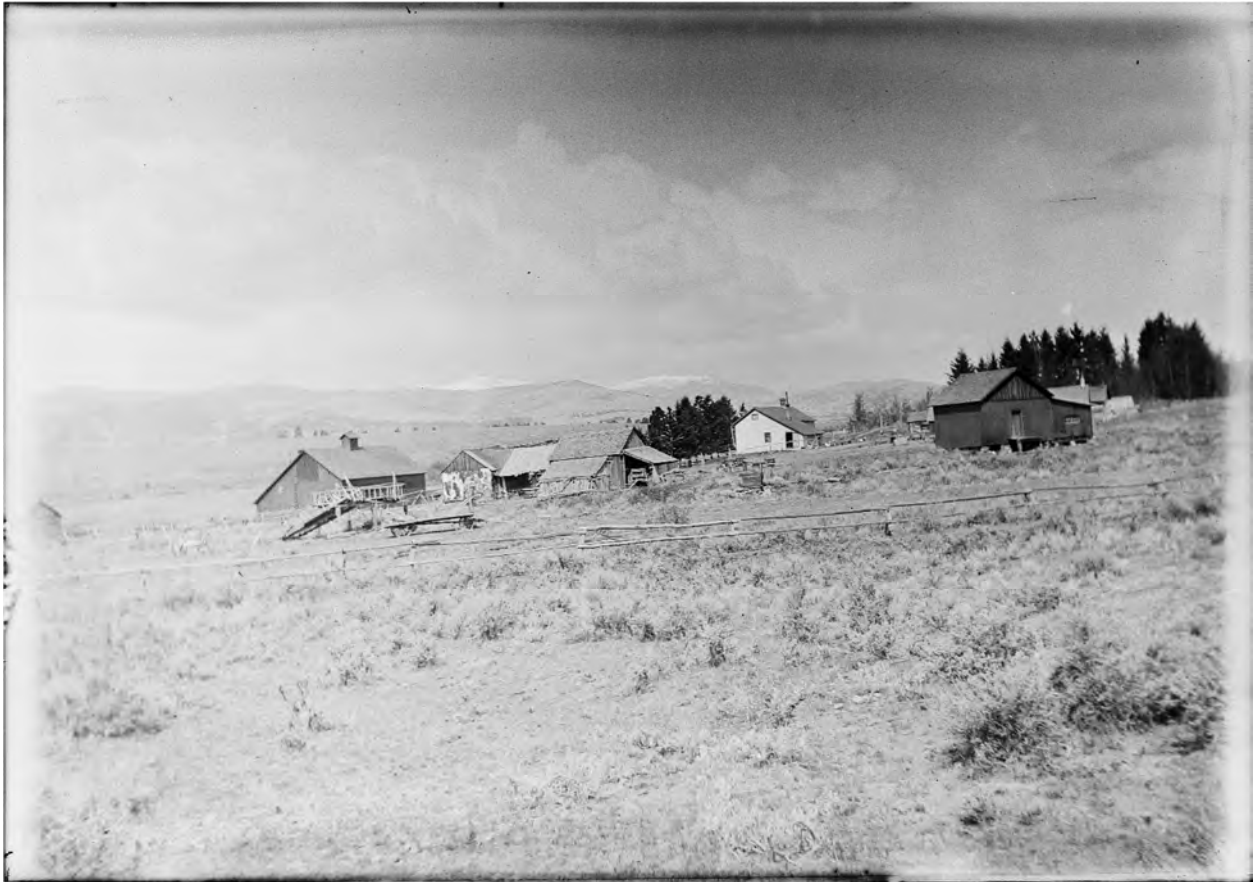
Figure #5 GPC-53 GehringGlassPrint53.tif. Ca. 1914. Ranch Overview. Camera facing northwest.

⁴⁶ See "Additional Documentation—Historic Photographs," Figs 5 and 6.

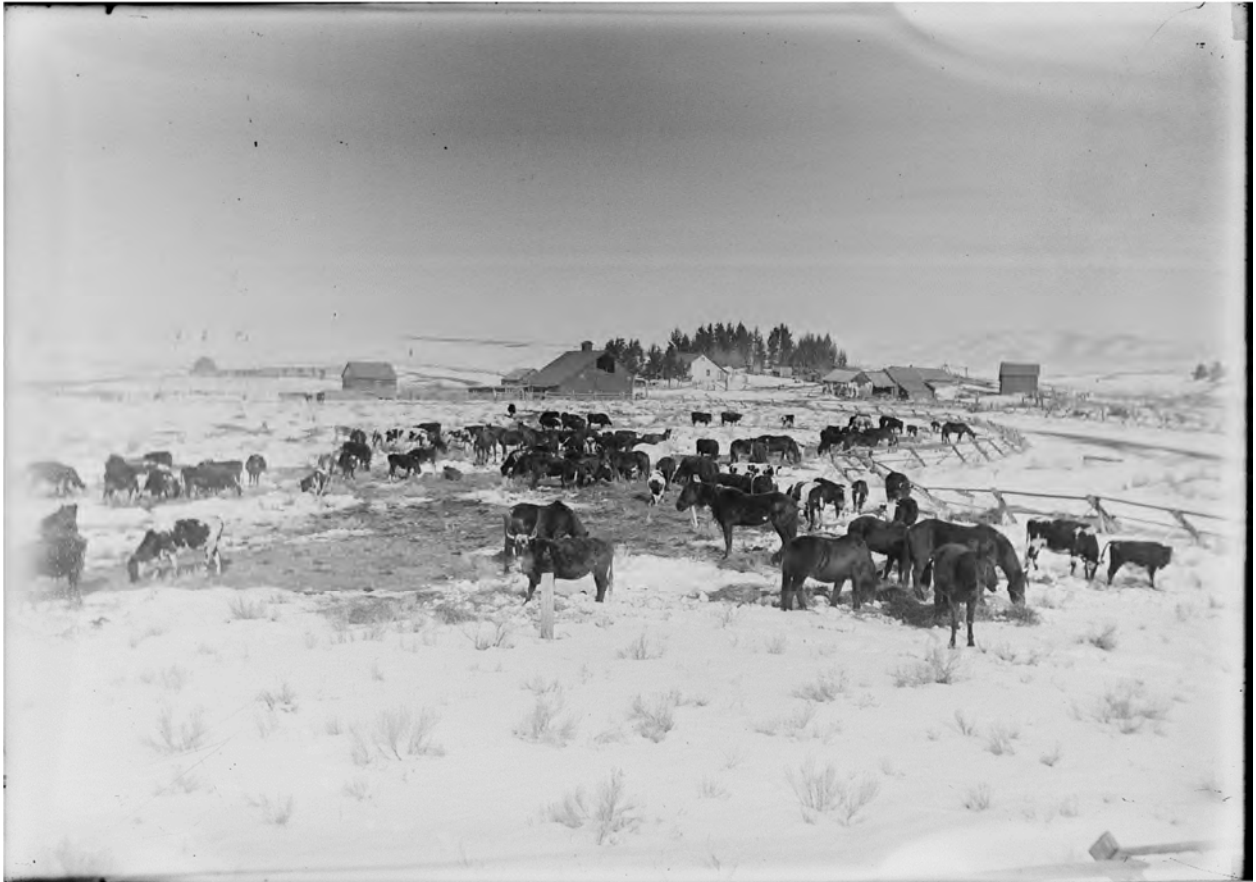
Figure #6 GPC-73 GehringGlassPrint73.tif. Ca. 1914. Camera facing north. Ranch Overview.

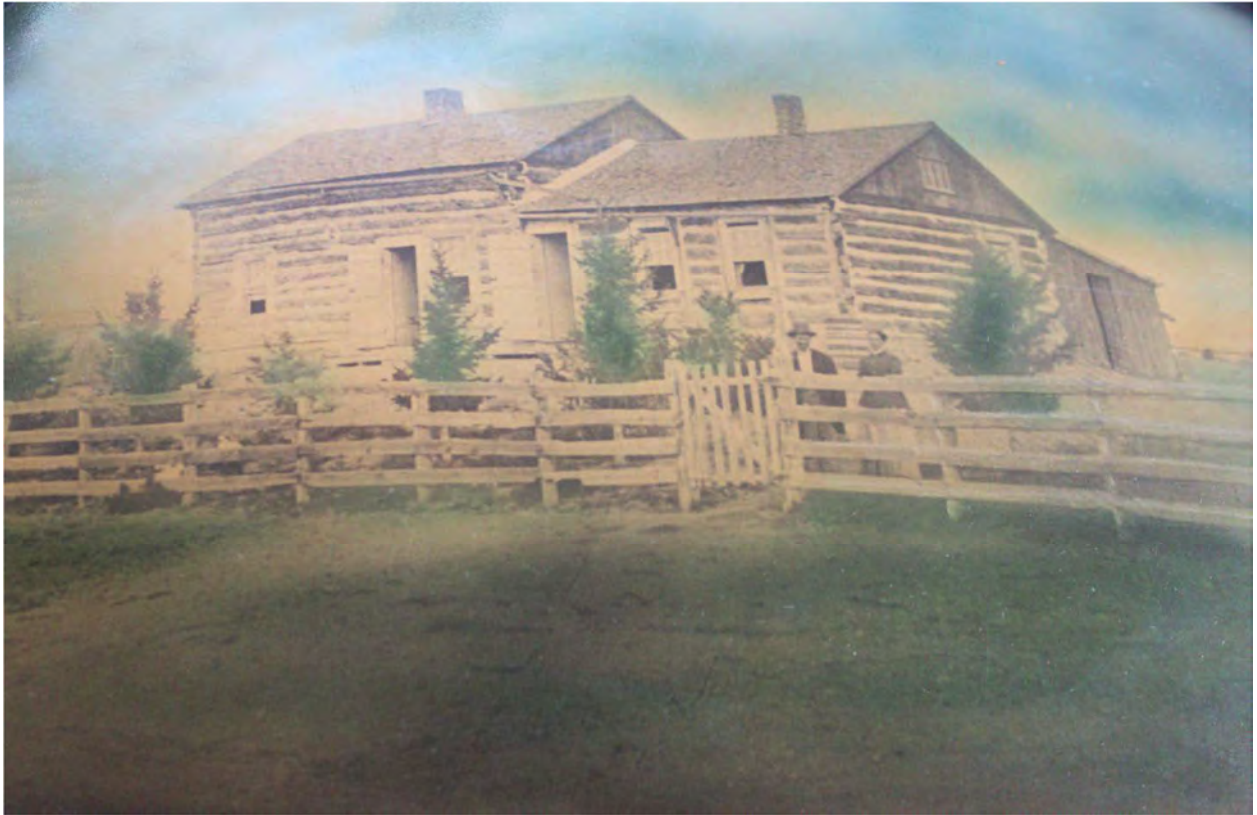
Figure #8 GPC-47 GehringHouse-1870s-2.tif. Ca. 1875-1880. Original log cabins on the Gehring Ranch.

³³ See "Additional Documentation—Historic Photographs," Fig 8.

³⁹ See “Additional Documentation—Historic Photographs,” Fig. 8.

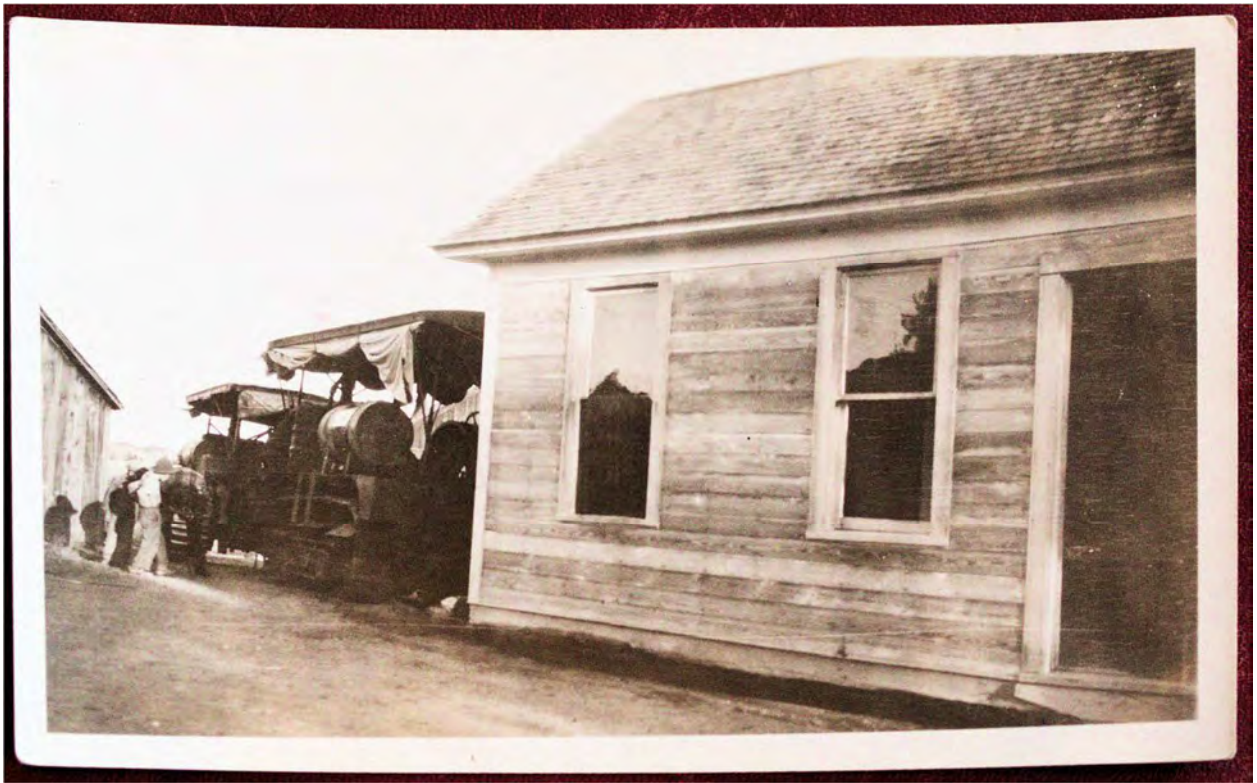
Figure #10 GPC-91 GehringGlassPrint-91.tif. 1929. Moving Bunkhouse #2 from Hardie homestead.

⁶⁹ See "Additional Documentation—Historic Photographs," Fig. 10.

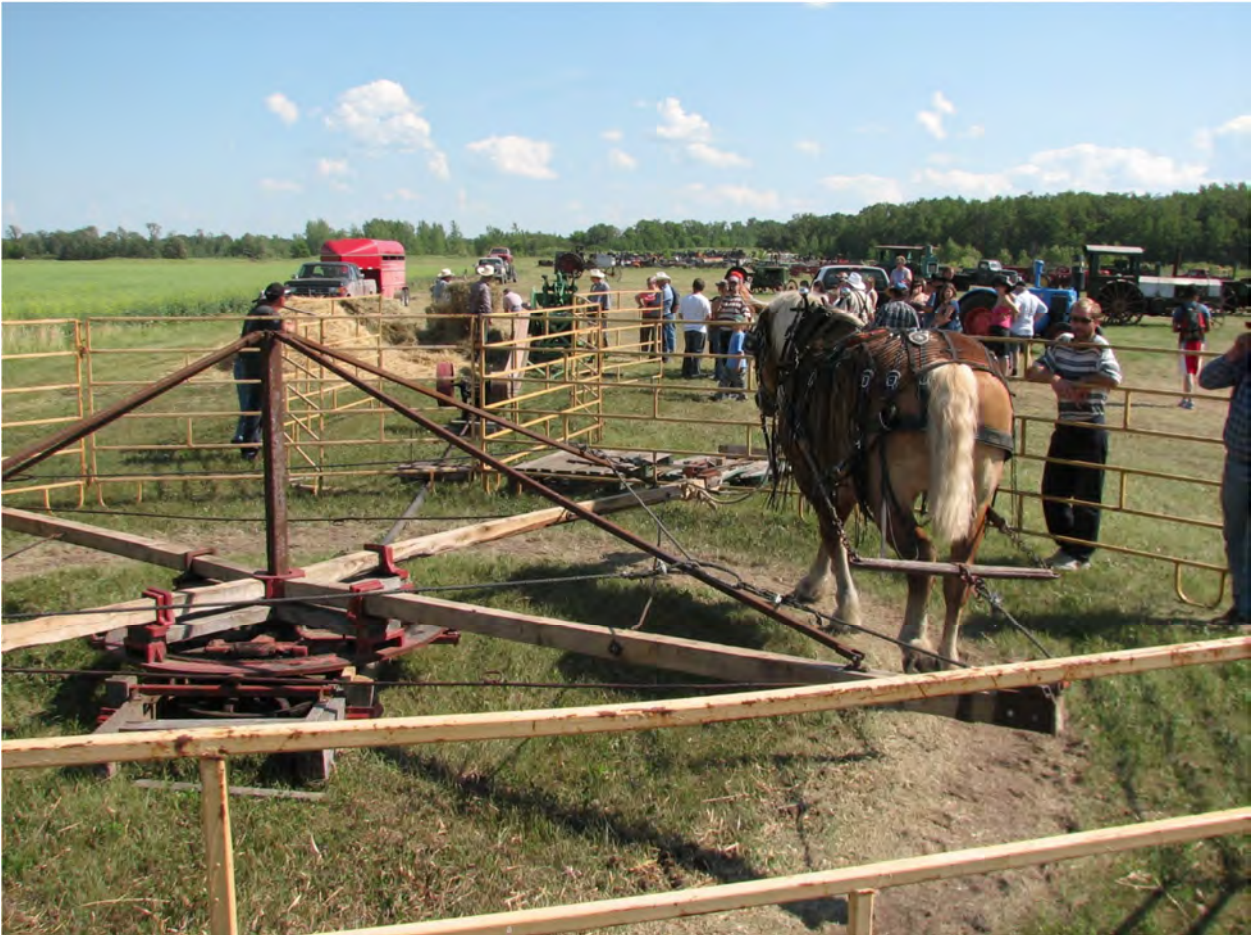
Figure #11 Horse Sweep.jpg. Horse Power machine in operation at the Manitoba Agricultural Museum. No date.

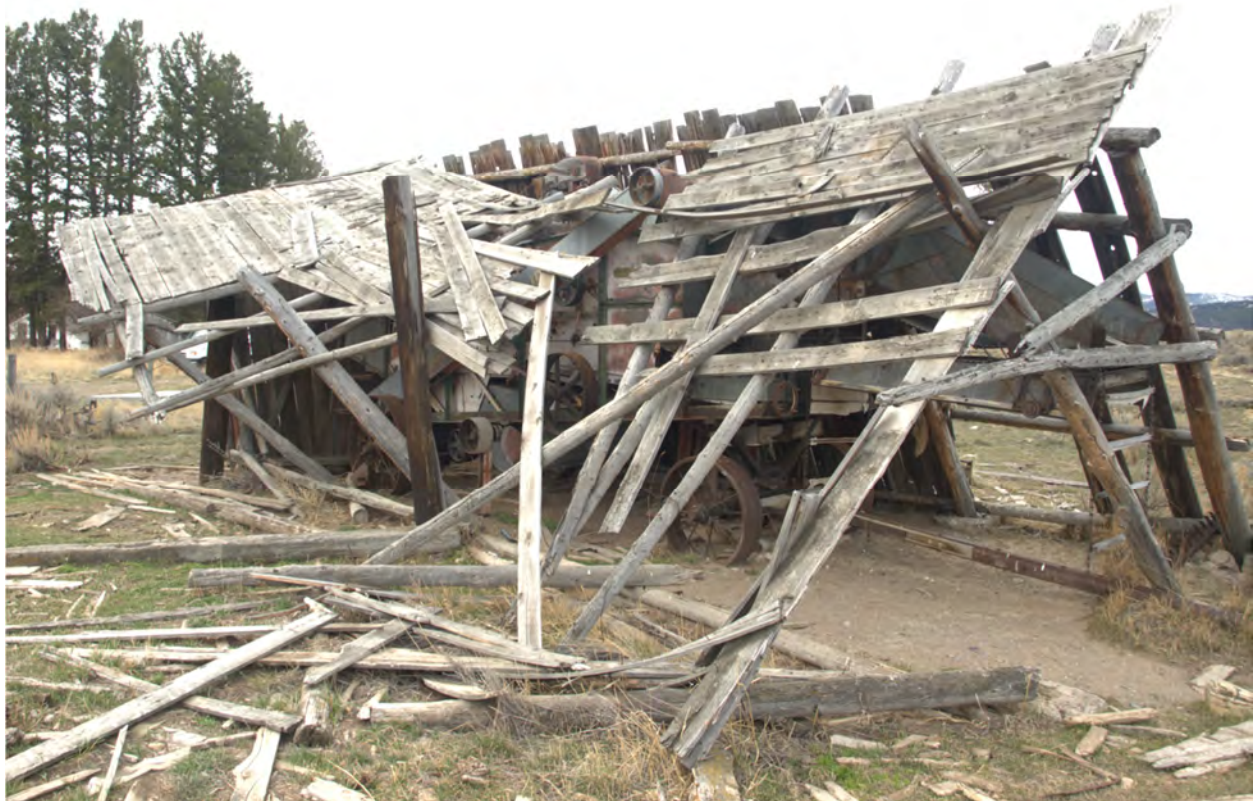
4 of 84

Building #2 Thresher Shed (collapsing on Threshing Machine), Both shed and machine counted as contributing resources) Photo-1

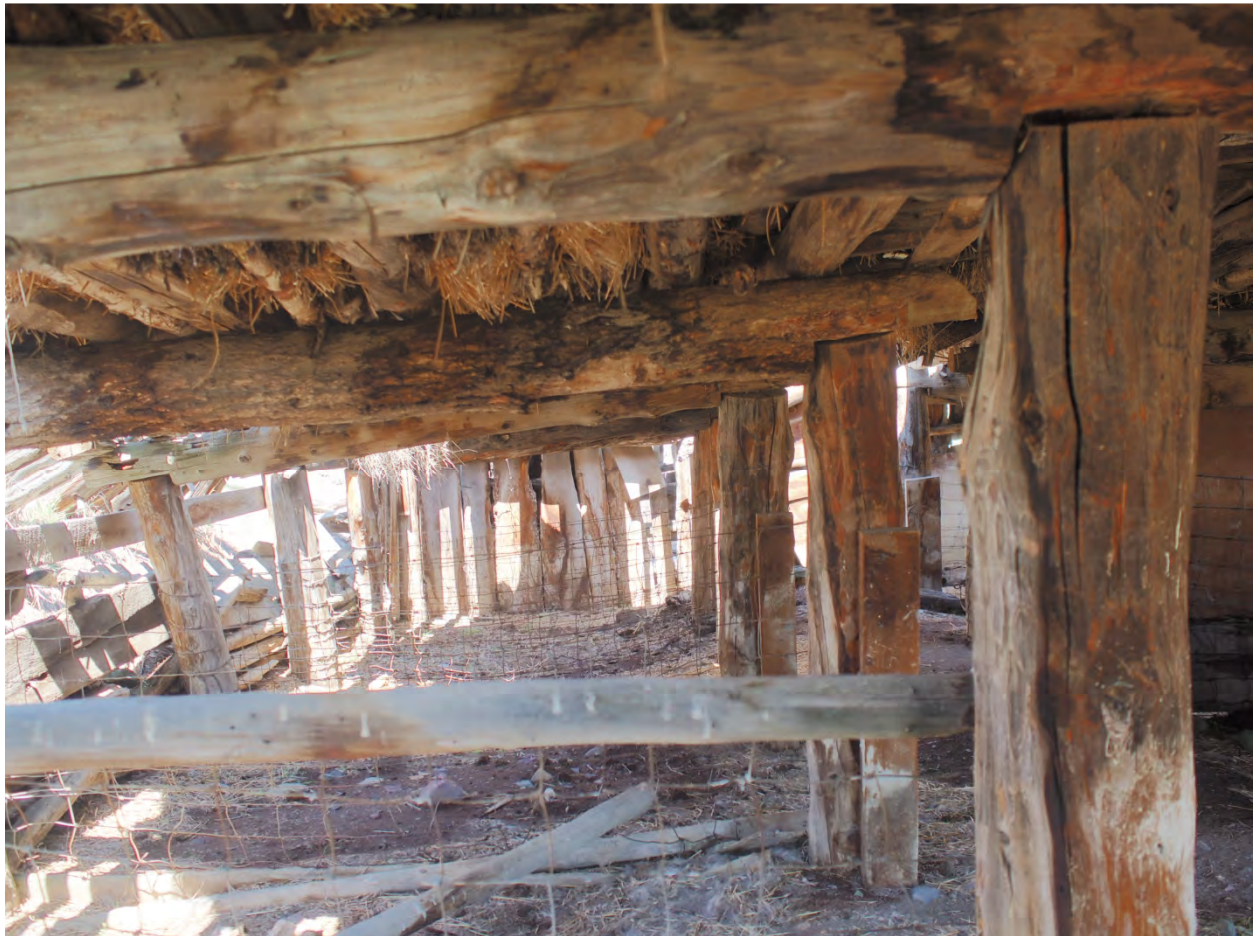
7 of 84

Building #3 Hog Shelter, Contributing, Photo-3
Interior View. Camera Facing North. North wall (right) West wall (left). Upright beams and overhead timbers in middle and foreground.
MT_LewisAndClarkCounty_Gehring Ranch_0007

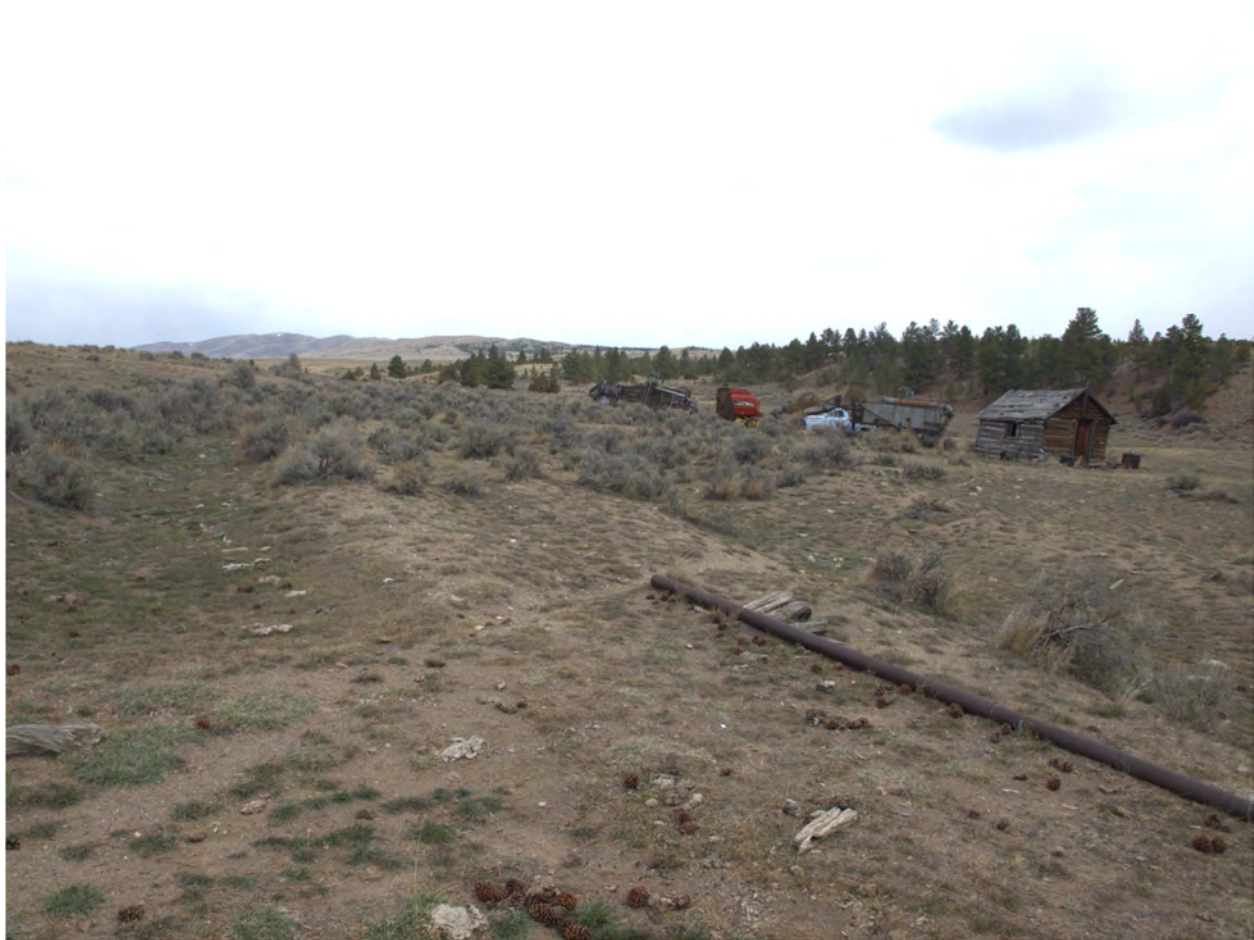
24 of 84

Historic Feature #13 Waterline. Contributing, Photo #1
Camera Facing North. Main Incoming Water Ditch With Pipe (Center)
(Bunkhouse #1 In Background)
MT_LewisAndClarkCounty_GehringRanch_0024

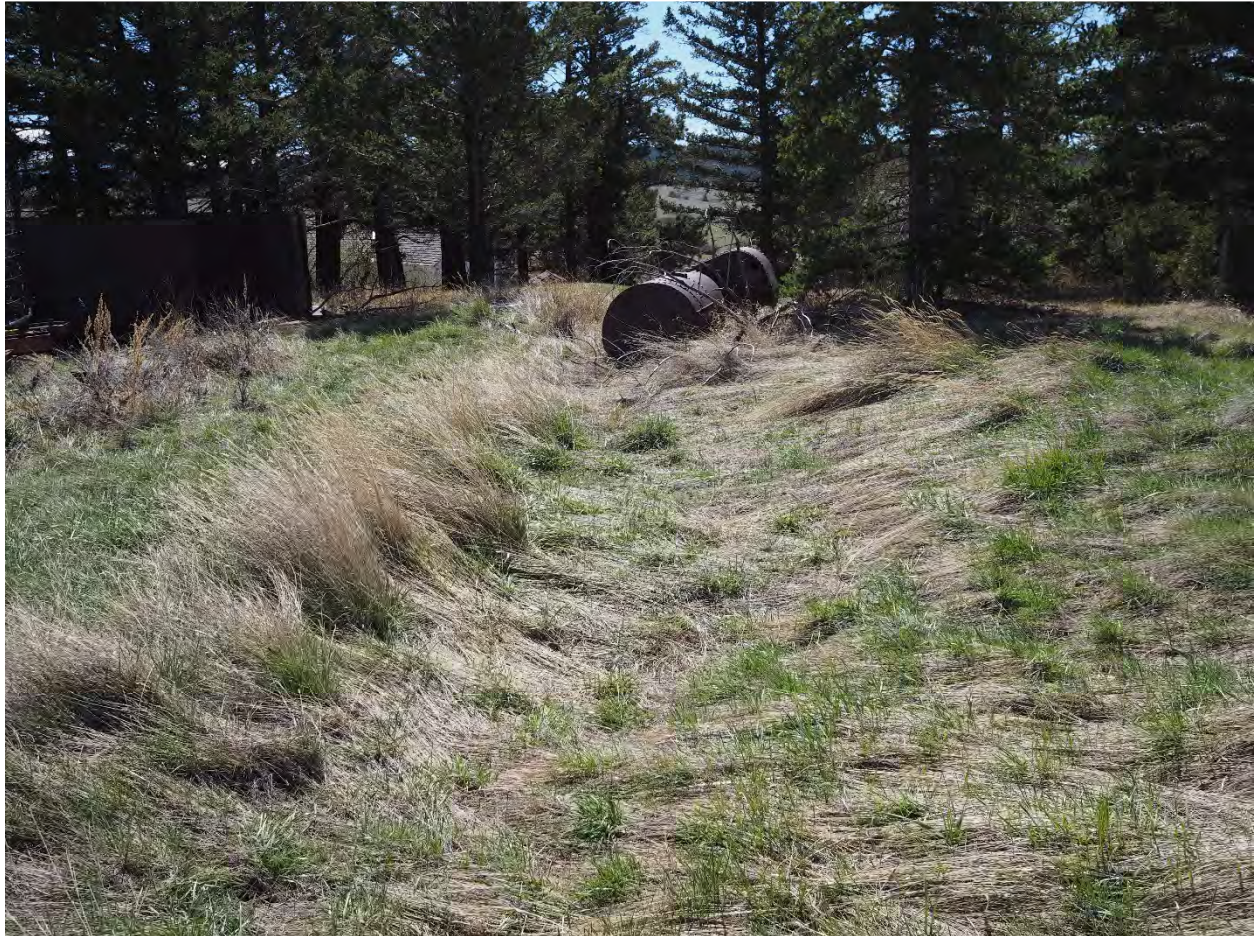
25 of 84

Historic Feature #13 Waterline. Contributing, Photo #2
Camera Facing Southwest. West Branch of Water Ditch (Center)
MT_LewisAndClarkCounty_GehringRanch_0025

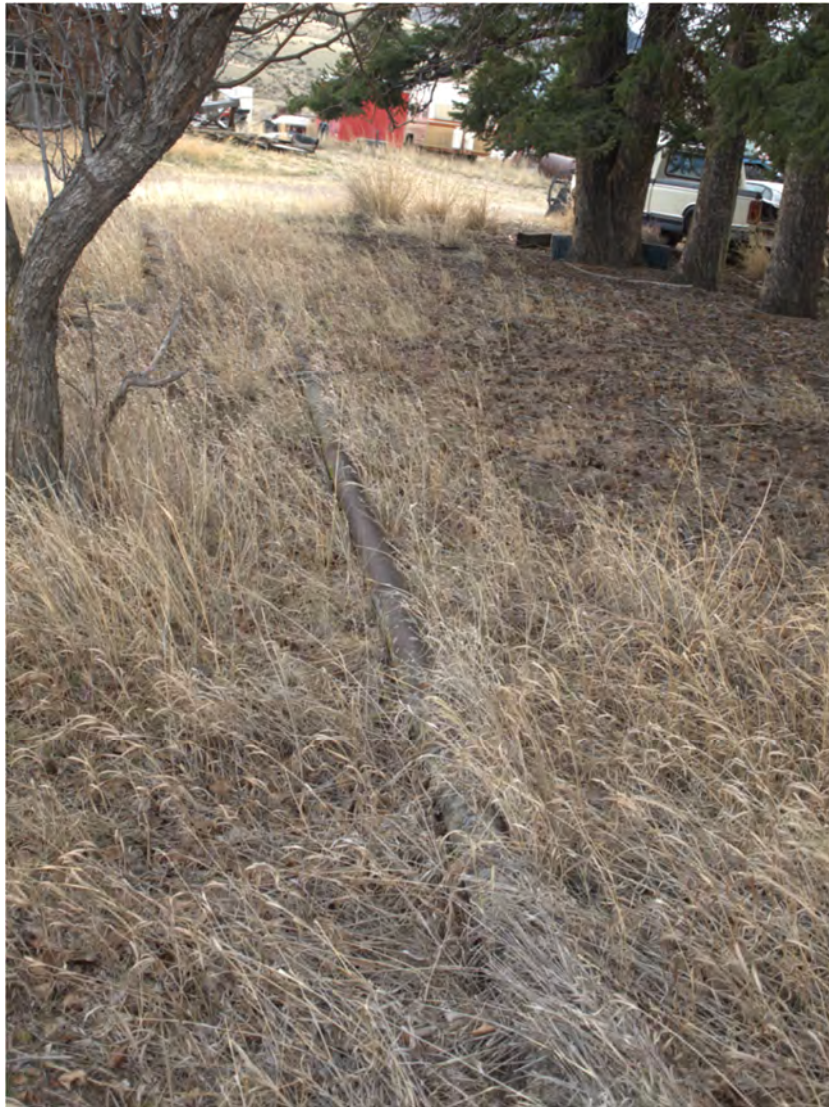
26 of 84

Historic Feature #13 Waterline. Contributing, Photo #3
Camera Facing East. Main Branch of Water Pipe (Center)
MT_LewisAndClarkCounty_GehringRanch_0026

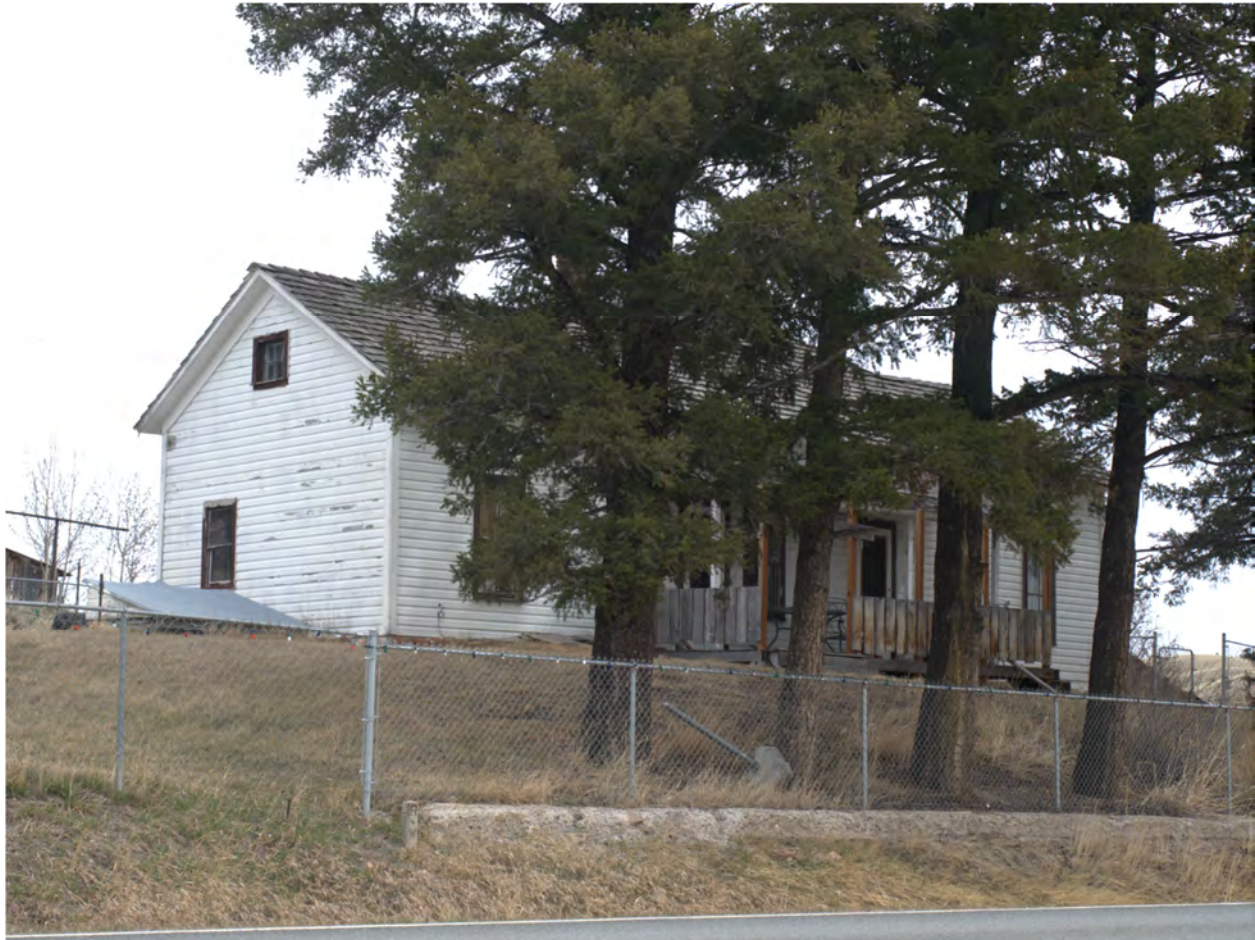
29 of 84

Building #14 House #1, Contributing, Photo-3
Elevation View. Camera Facing East. Northwest and Southwest Elevations.
Well Housing (Far Left) Feature #28, Grove (Foreground)
MT_LewisAndClarkCounty_GehringRanch_0029

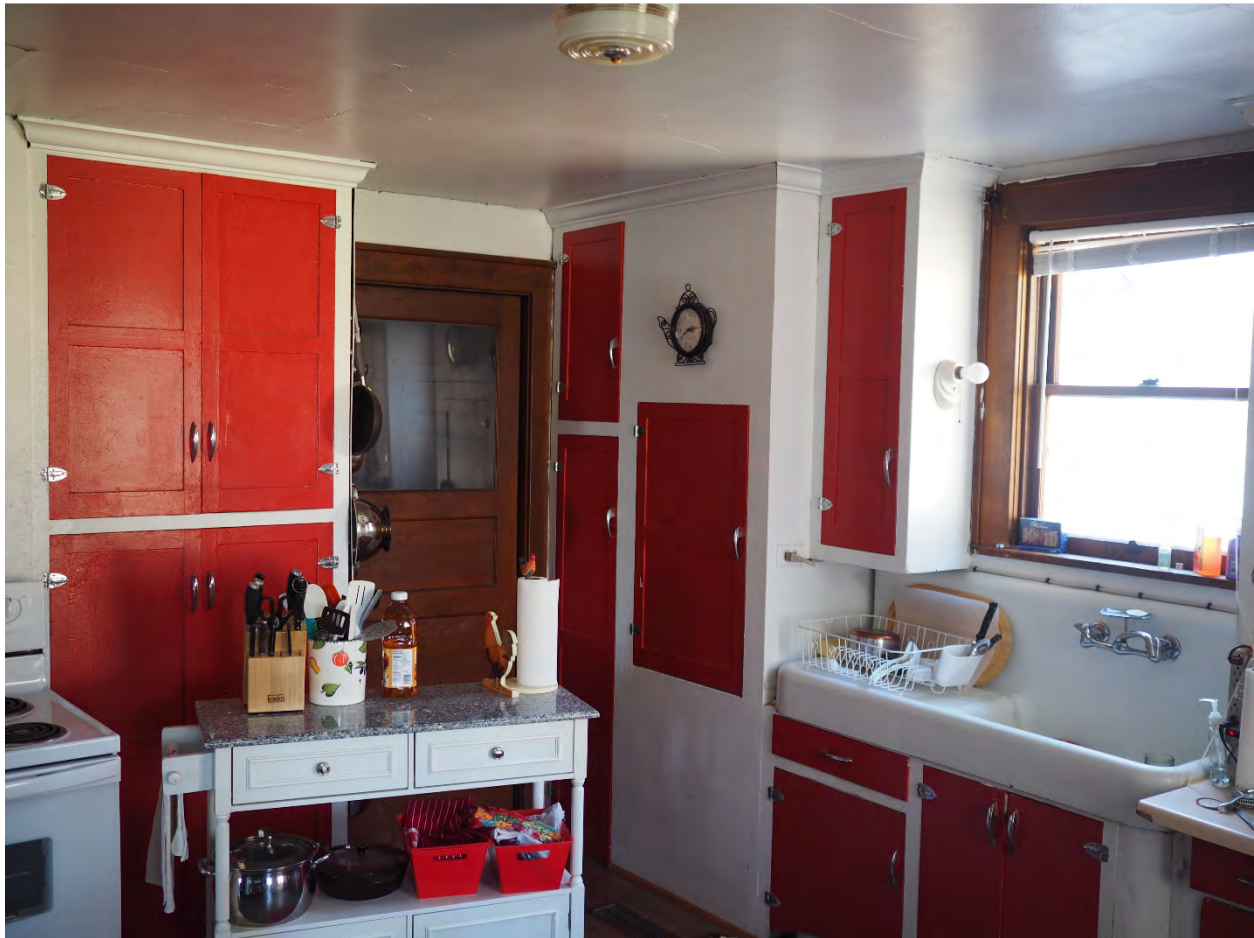
30 of 84

Building #14 House #1, Contributing, Photo-4
Interior View. Kitchen. Camera Facing West. Southwest Interior Wall (Left) Northwest Wall (Right)
(Shows 1920s Cabinetry and Fixtures, Dumbwaiter to Basement (Below Clock Center))
MT_LewisAndClarkCounty_GehringRanch_0030

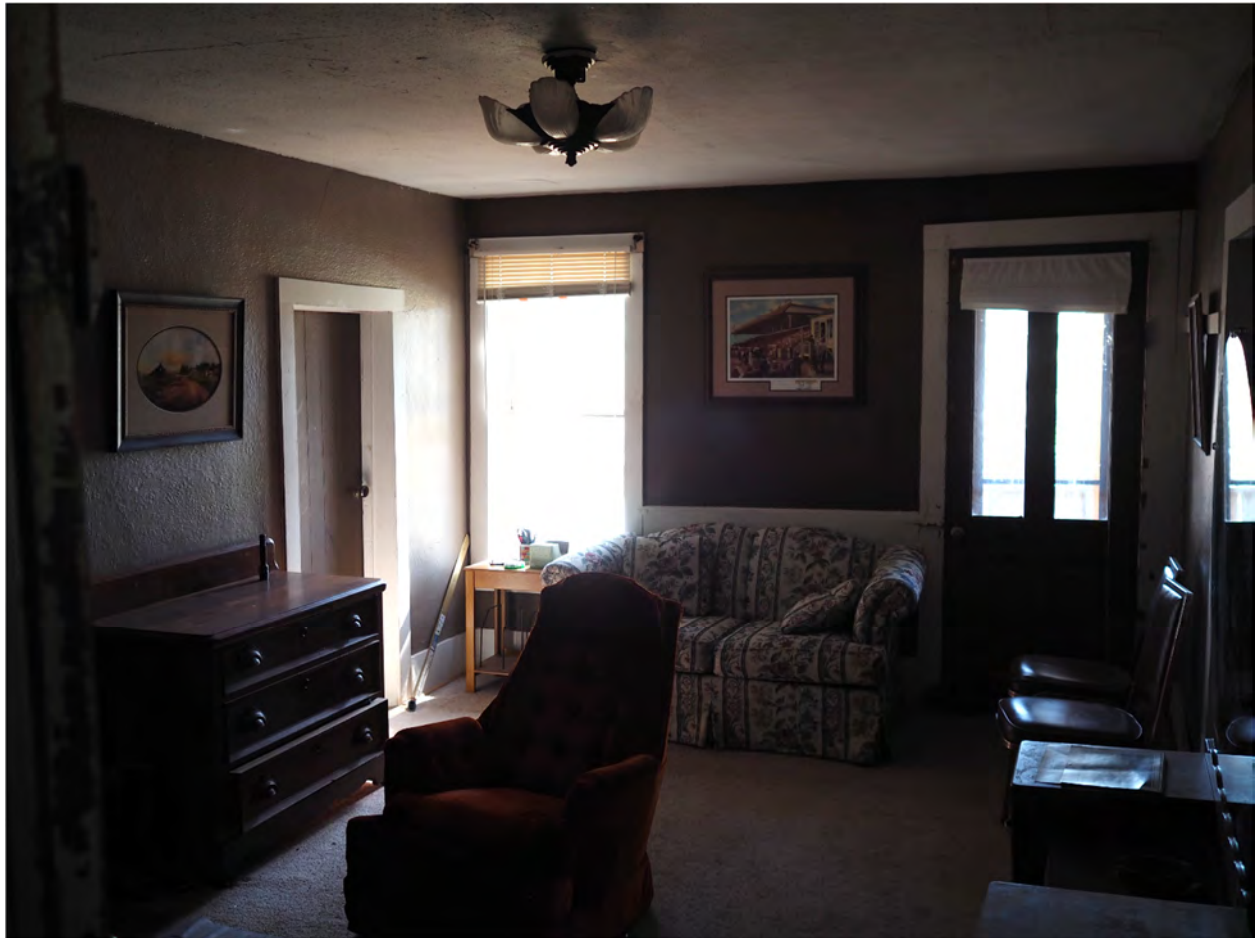
31 of 84

Building #14 House #1, Contributing, Photo-5
Interior View. Parlor. Camera Facing South. Southeast Interior Wall (Left) Southwest Wall (Right)
(Shows Depth of Log Walls, Fenestration, After Pre-1900 Configuration)
MT_LewisAndClarkCounty_GehringRanch_0031

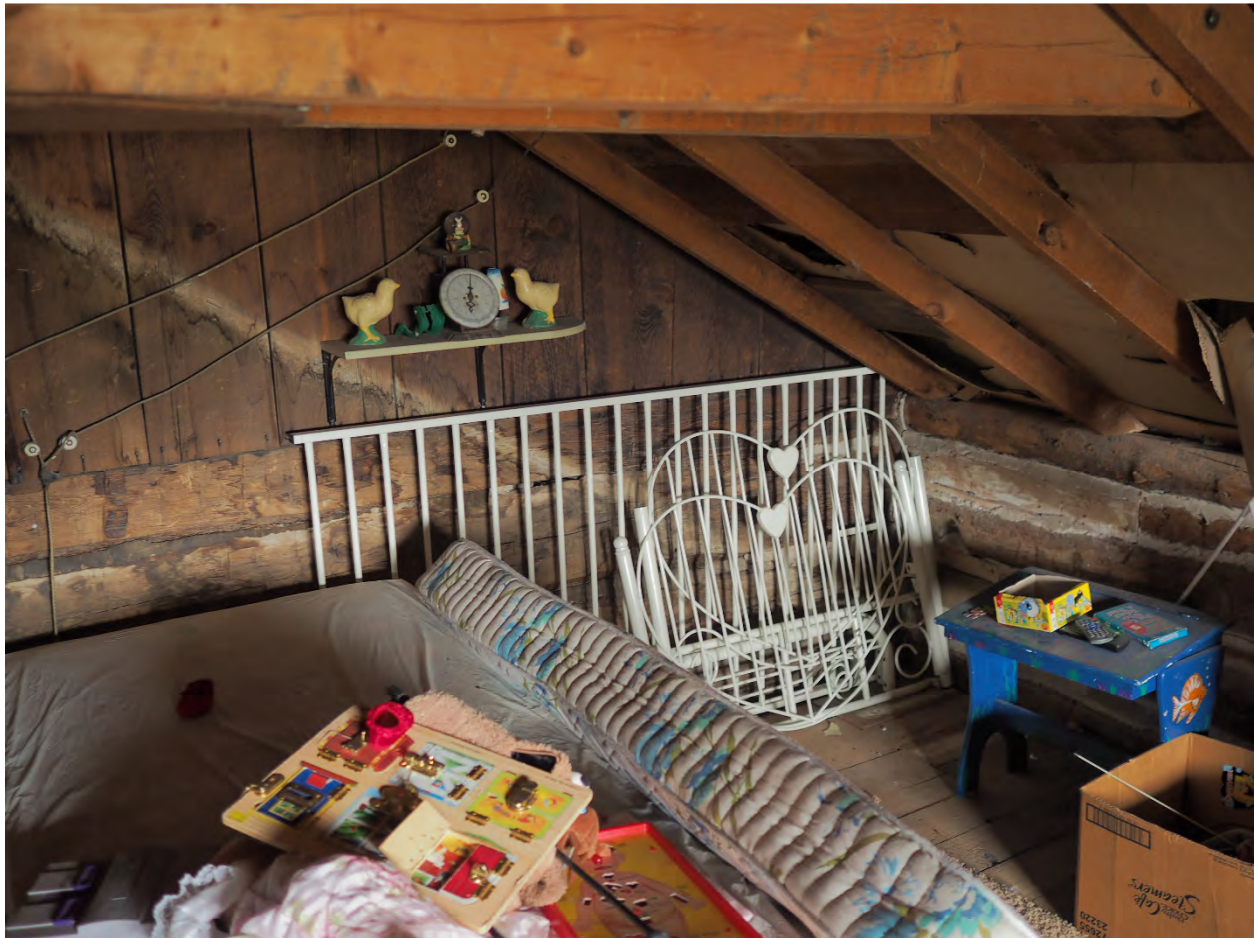
32 of 84

Building #14 House #1, Contributing, Photo-6
Interior View. Southeastern Attic. Camera Facing North-Northwest. Original log cabin's
southeast wall (left) with ghost join of second log cabin. Northeast interior pony wall built up to
bring both roofs to level in pre-1900 configuration (right).
MT_LewisAndClarkCounty_GehringRanch_0032

homestead document is a cellar and this, too, is visible as the high stone foundation under that northwest section.

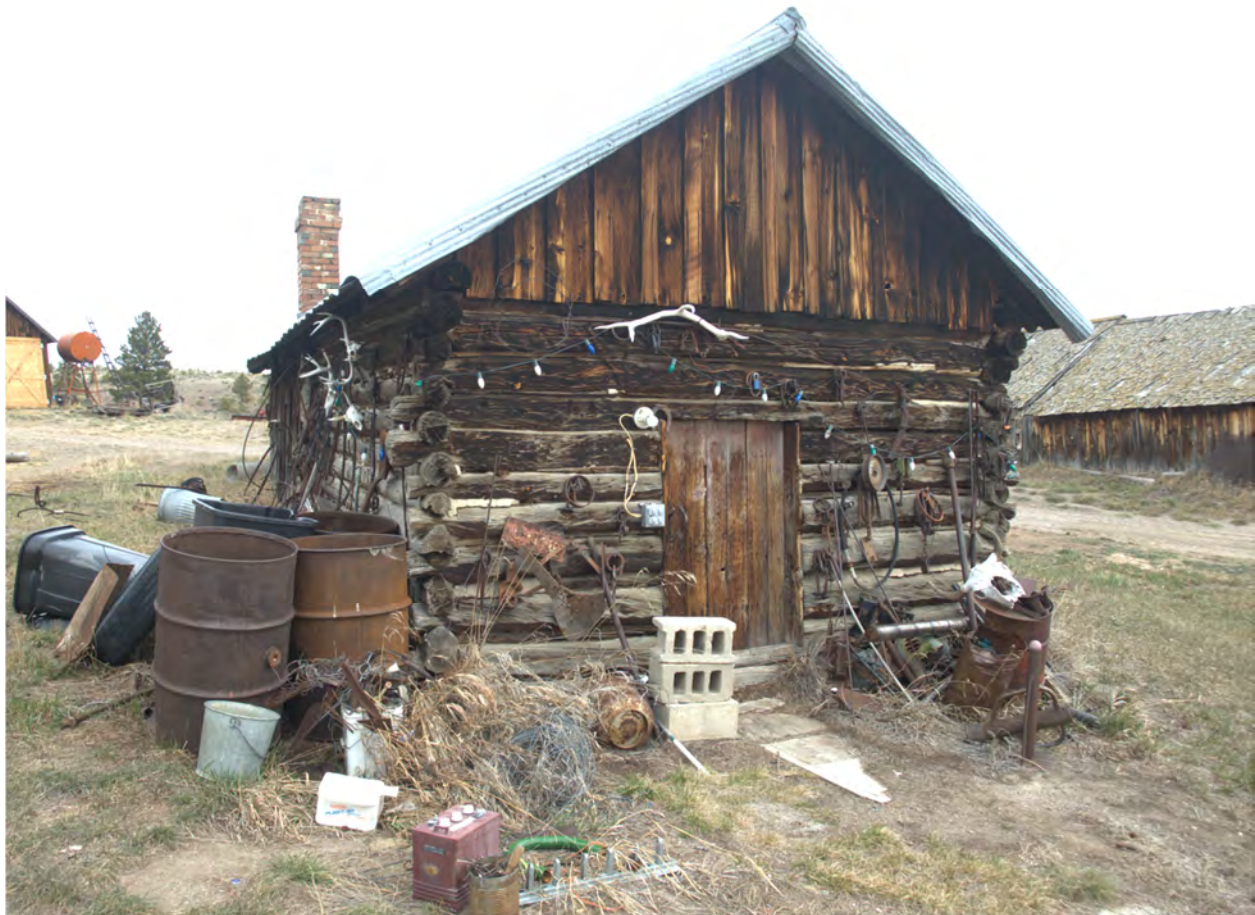
34 Of 84

Building #16 Shop, Contributing, Photo-1
Elevation View. Camera Facing Northeast. Northwest Elevation (Left) Southwest Elevation (Right)
