National Register of Historic Places Registration Form

Historic name: Gehring Ranch
Other names/site number: 24LC1846
Name of related multiple property listing: NA
(Enter "N/A" if property is not part of a multiple property listing)

Street & number: 5488 Lincoln Road West
City or town: Helena State: MT County: Lewis and Clark
Not For Publication: Vicinity:

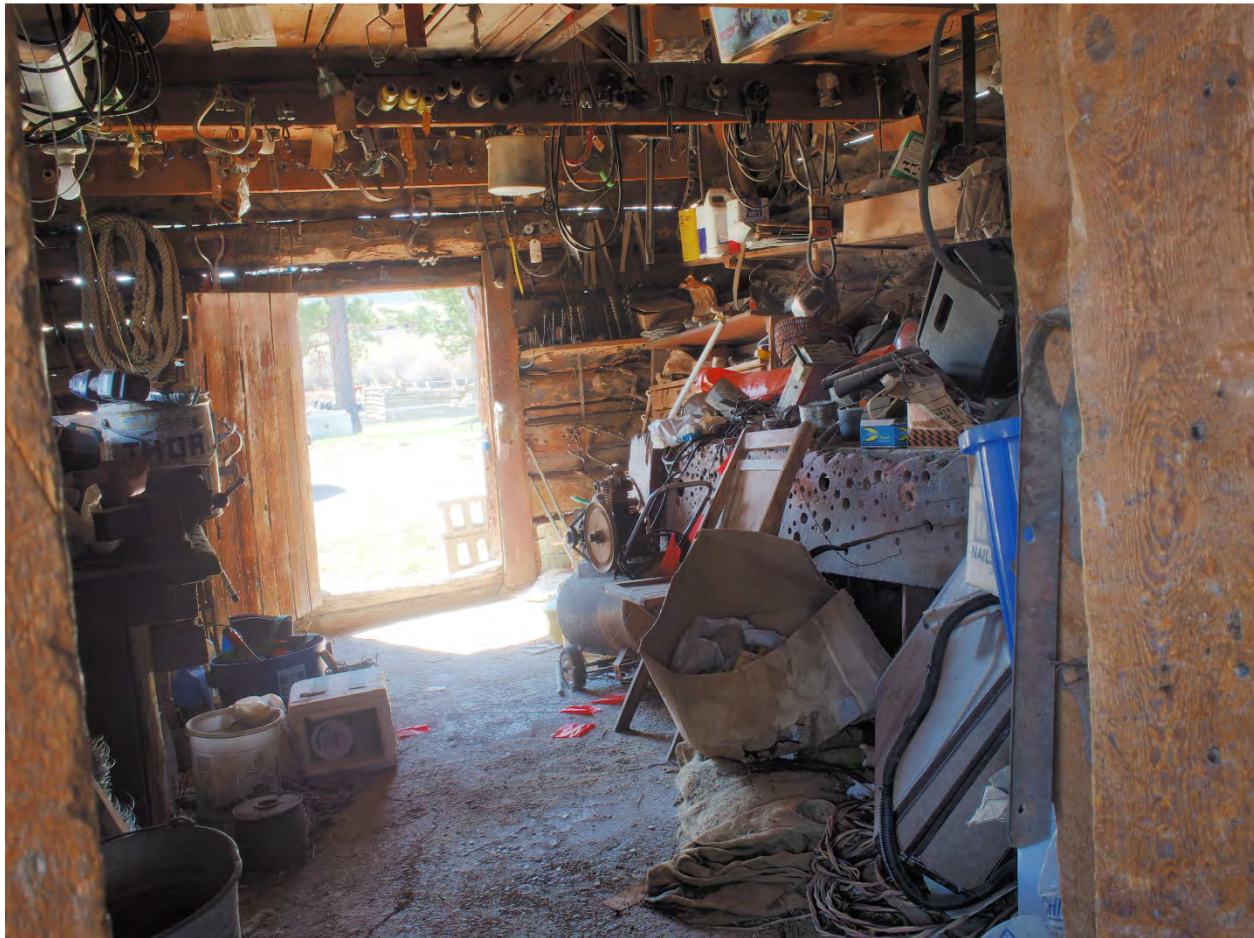
37 Of 84

Building #16 Shop, Contributing, Photo-4
Interior View. Camera Facing Southwest. Carpentry Shop. Southwest Wall (Center) Northwest
Wall (Right)
MT_LewisAndClarkCounty_GehringRanch_0037

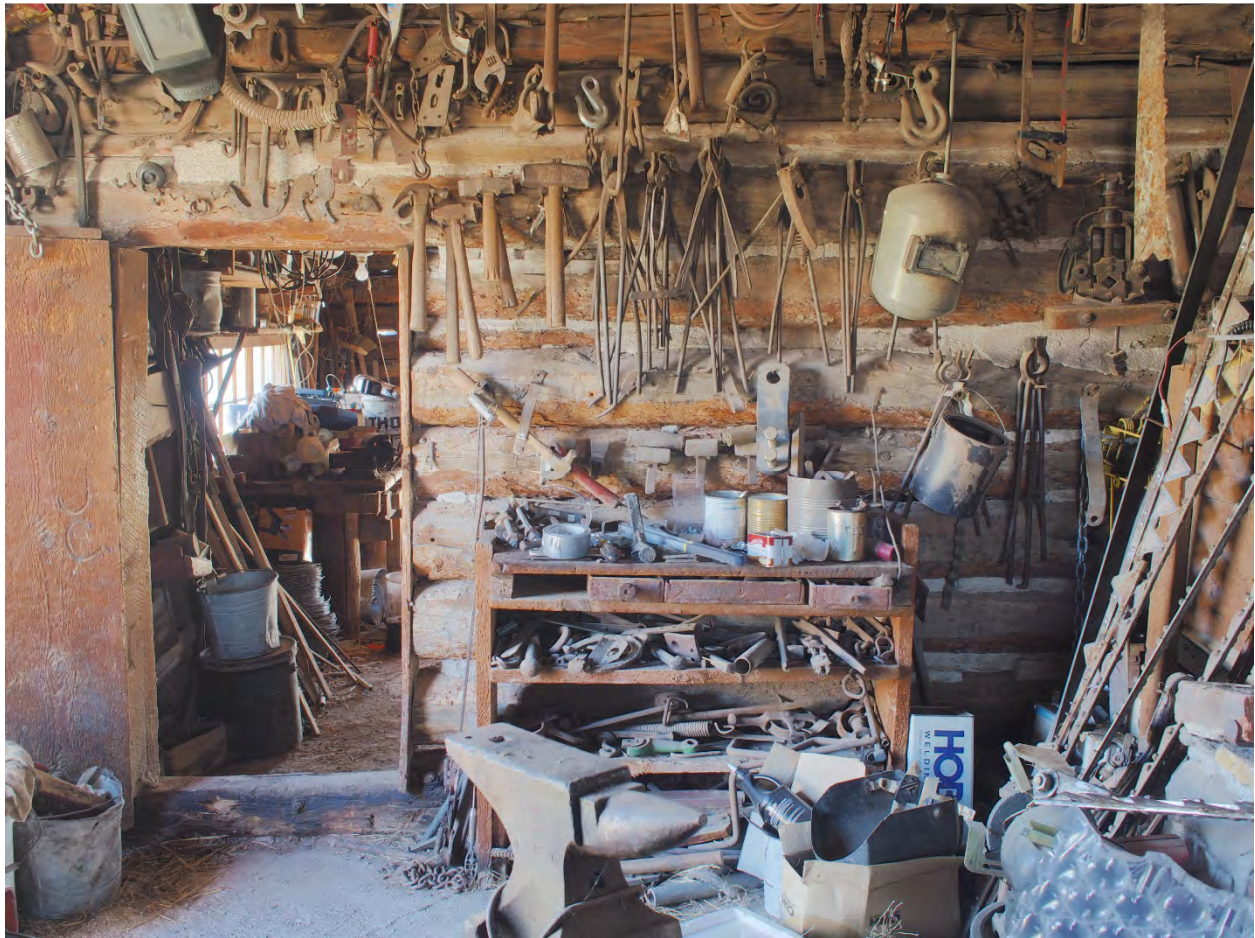
38 Of 84

Building #16 Shop, Contributing, Photo-5
Interior View. Camera Facing Southwest. Blacksmith Shop. Southwest Inner Wall (Rear Of First Log Structure)
MT_LewisAndClarkCounty_GehringRanch_0038

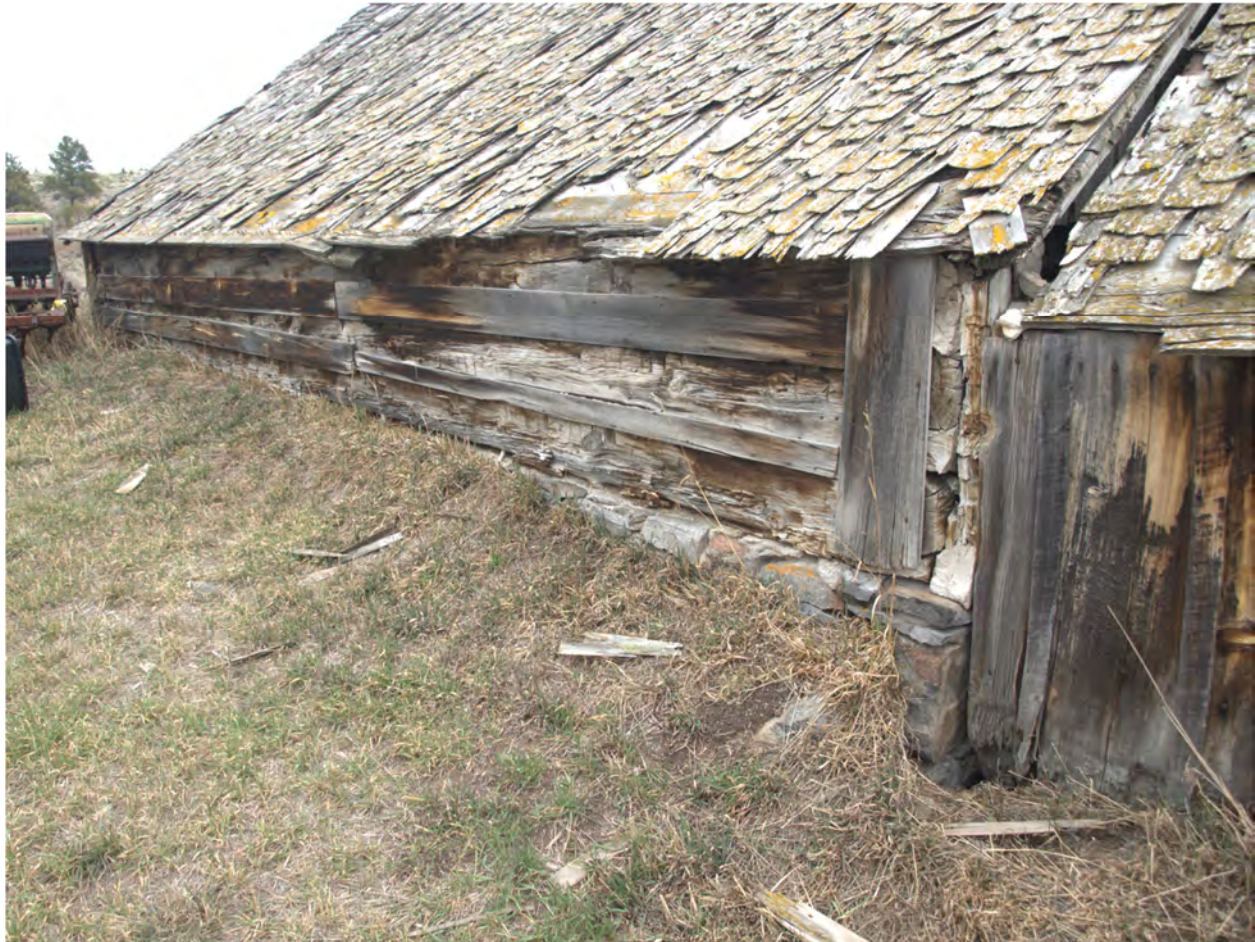
40 Of 84

Building #17 Hen House, Contributing, Photo-2
Elevation View. Camera Facing East. Northwest Elevation. Original Log On Stone Wall (Left)
Board and Batten Addition Wall (Right). Shows shingles prior to re-roofing.
MT_LewisAndClarkCounty_GehringRanch_0040

Later the root house was given an addition. Then or perhaps later it became “the hen house”, identified as such for over a hundred years.³⁴ There are indications that the old root house portion had its roof replaced sometime toward the end of the cut nail era, prior to or soon after 1890. It was double-sheathed, with boards and a liner of heavy paper covering the interior rafters. With the emphasis on insulation, there is a possibility that the original roof was of sod, like the old Auchard cabin. It is the only insulated outbuilding on the ranch.

As for age, this dependency appears to be contemporaneous with the second woodshop addition; the post-1890, mixed cut and wire nail age. It was a hen house at least as early as 1909 when David Gehring recorded in his journal that he “fixed up stove in hen house”. Heat would be needed to support brooder chicks, not hens, who could have survived cold weather in such a bunker. David was referring either to an existing brick chimney or a stove pipe hole in the building. His stove may have caused the fire that deeply charcoaled the inner northwest and consumed a portion of its roof. A photo dated June, 1919 in the Gehring collection shows the easternmost end of the Hen House without its present windows, indicating changes occurred after that date. Whether these were connected with a fire or just improvements remains unknown. A perusal of existing journal entries did not uncover mention of rebuilding this roof or the eastern gable. All of this aside, the conversion of the old root house to a large chickery meant an expansion of the ranch’s emphasis on poultry had taken place. There may have been a commercial outlet for poultry as there was to become for pork, on January 24, 1911, David Gehring recorded that they “*shipped roosters to helena*”.

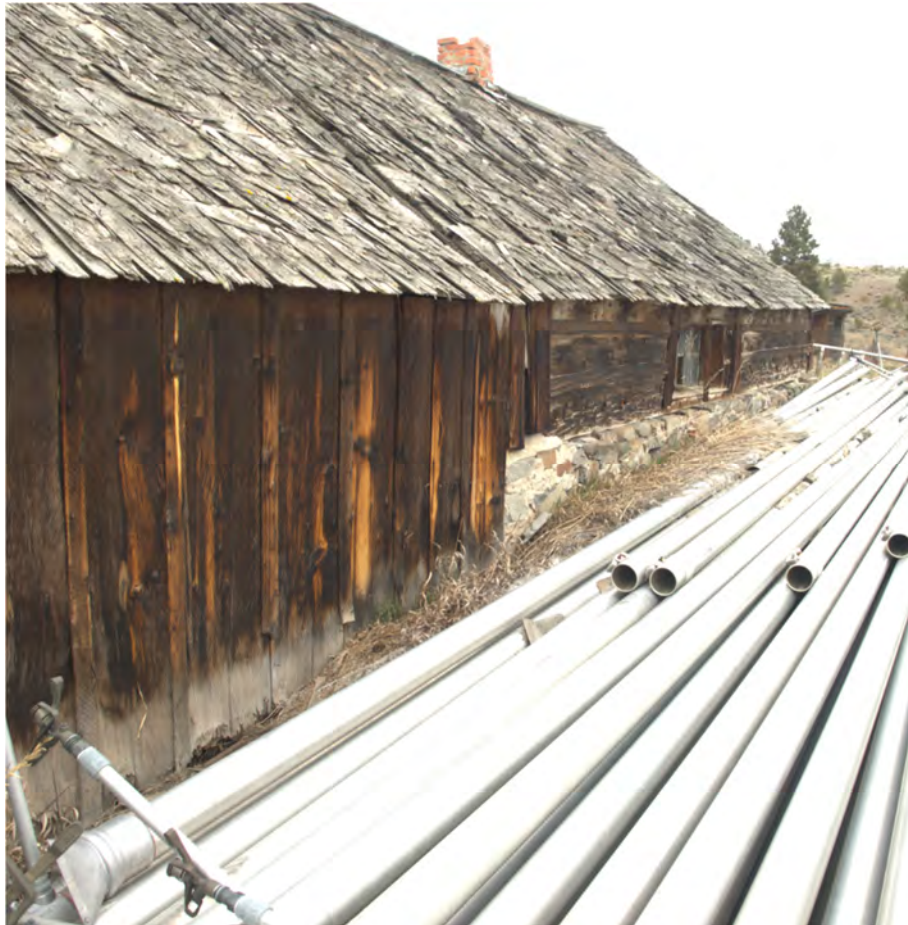
41 Of 84

Building #17 Hen House, Contributing, Photo-3
Elevation View. Camera Facing North. Southeast Elevation. Board and Batten Addition Wall
(Left) Log On Stone Wall (Right). Shows shingles prior to re-roofing.
MT_LewisAndClarkCounty_GehringRanch_0041

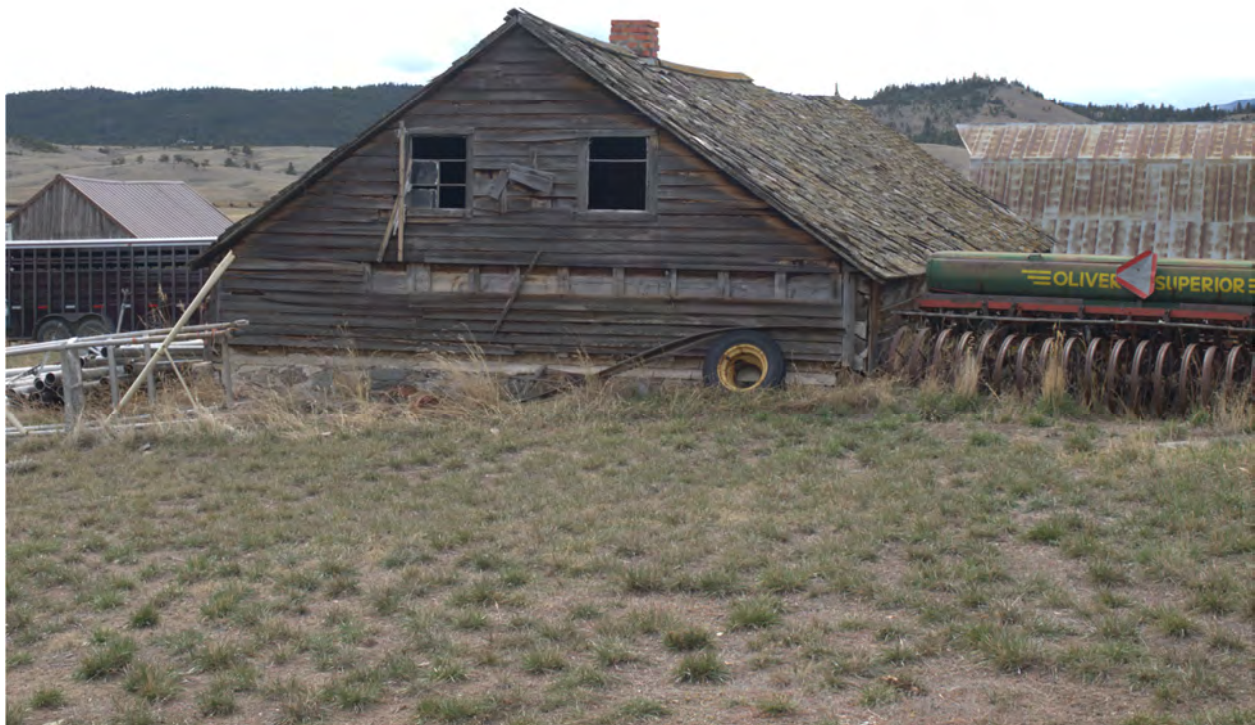
42 Of 84

Building #17 Hen House, Contributing, Photo-4
Elevation View. Camera Facing South. Northeast Elevation. Shows shingles prior to re-roofing.
MT_LewisAndClarkCounty_GehringRanch_0042

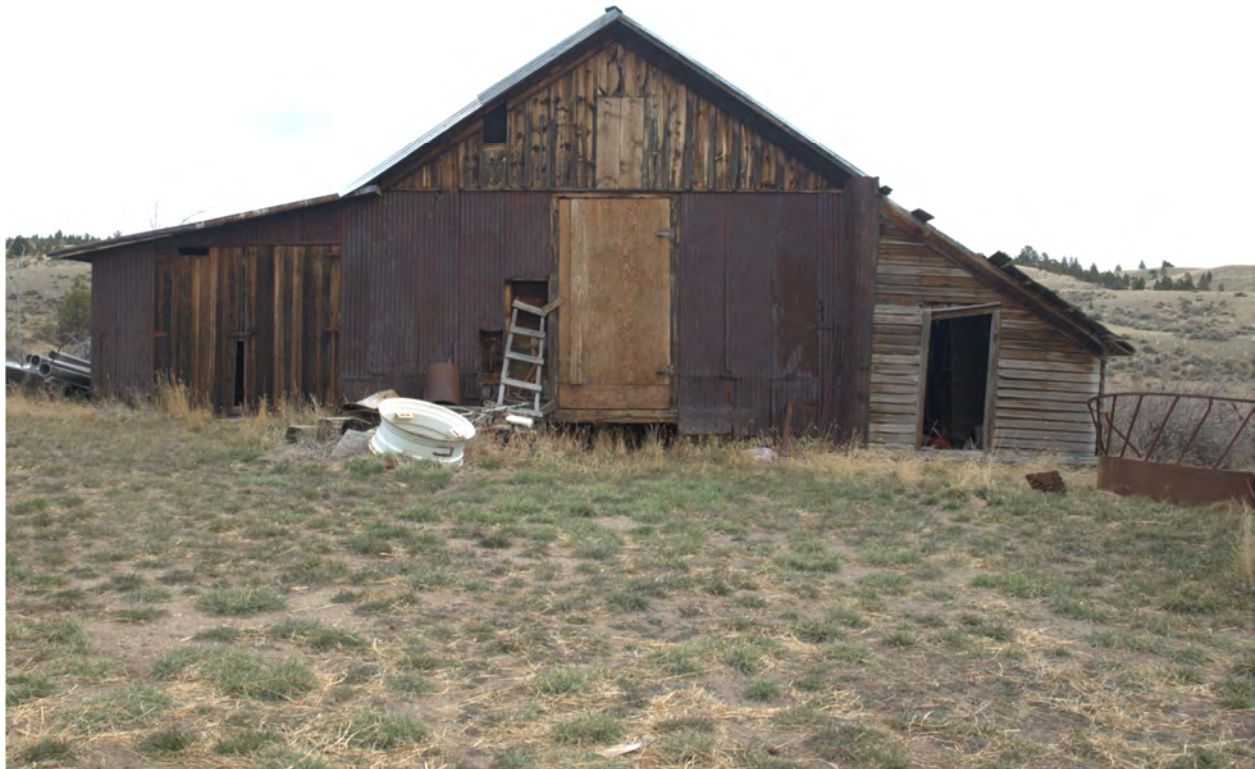
43 Of 84

Building #18 Granary #2, Contributing, Photo-1
Elevation View. Camera Facing East. West Elevation.
MT_LewisAndClarkCounty_GehringRanch_0043

Granary #2 was constructed in three sections, evidence of which is found in the Gehring journals, the panoramic photos of the ranch taken around 1914, and a family snapshot taken in the mid-1920s. The central granary was built first and certainly prior to September, 1913, when David added an automobile shed to one end of what he called the "new granary".⁵⁴ In fact, the central section alone is the granary.

Every element of a classic farm granary is employed here: elevated foundations, tight seams, sturdy studs, partitioned interiors for different grains and specialized access doors - right out of the agricultural publications. The interior of the bin is separated into stalls designed to hold relatively little grain compared to the volumes that would come in later years as farms grew in size and productive capability. Such segmentation also indicates the expectation that different types of grain and different means of processing were to be handled in this building. It is a facility built with flexibility and, by today's standards, modest production in mind.

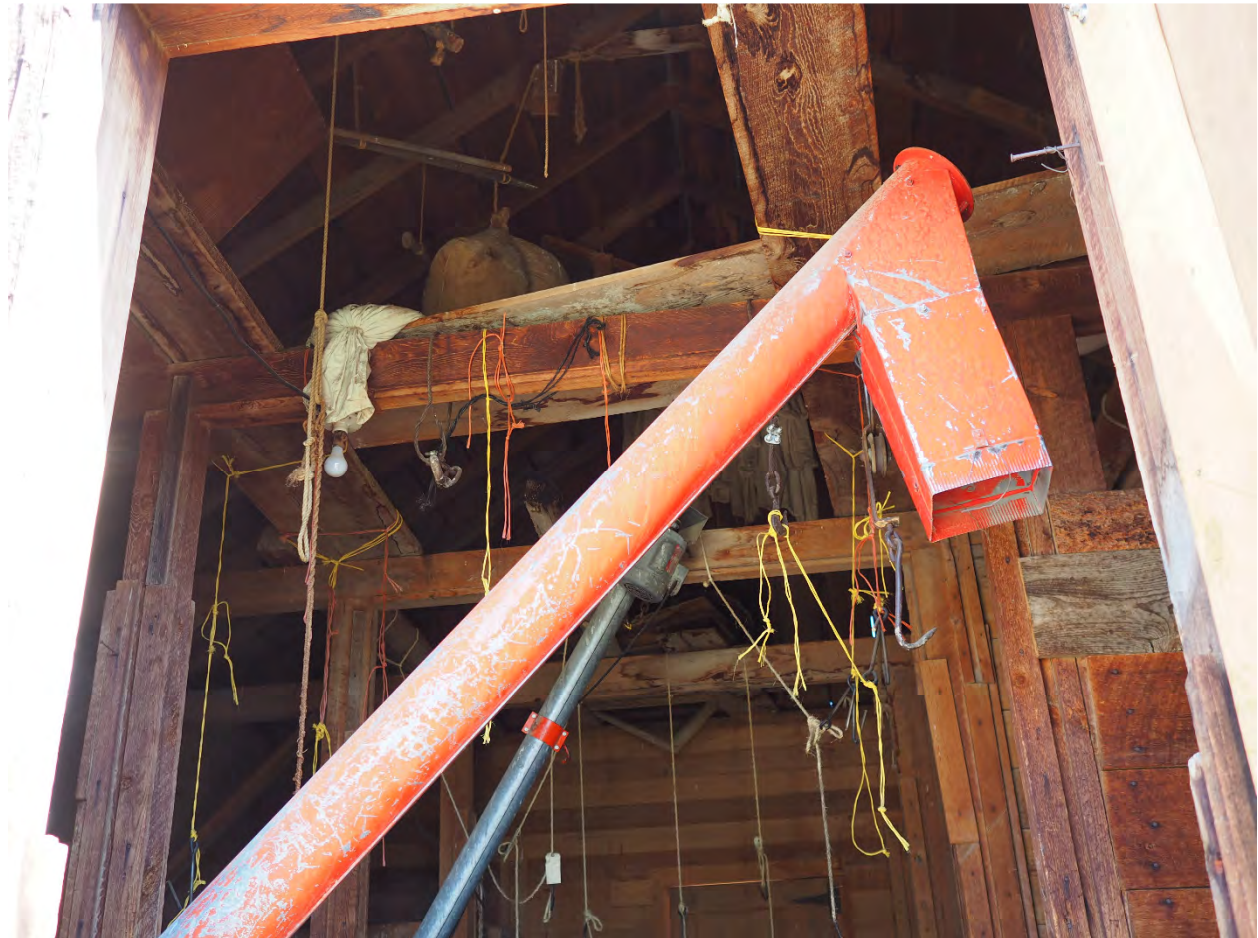
46 Of 84

Building #18 Granary #2, Contributing, Photo-4
Interior View. Camera Facing East. Central Section. East Wall (Background) Grain Bins (Middle
Ground) Feed Grinder Auger (Foreground)
MT_LewisAndClarkCounty_GehringRanch_0046

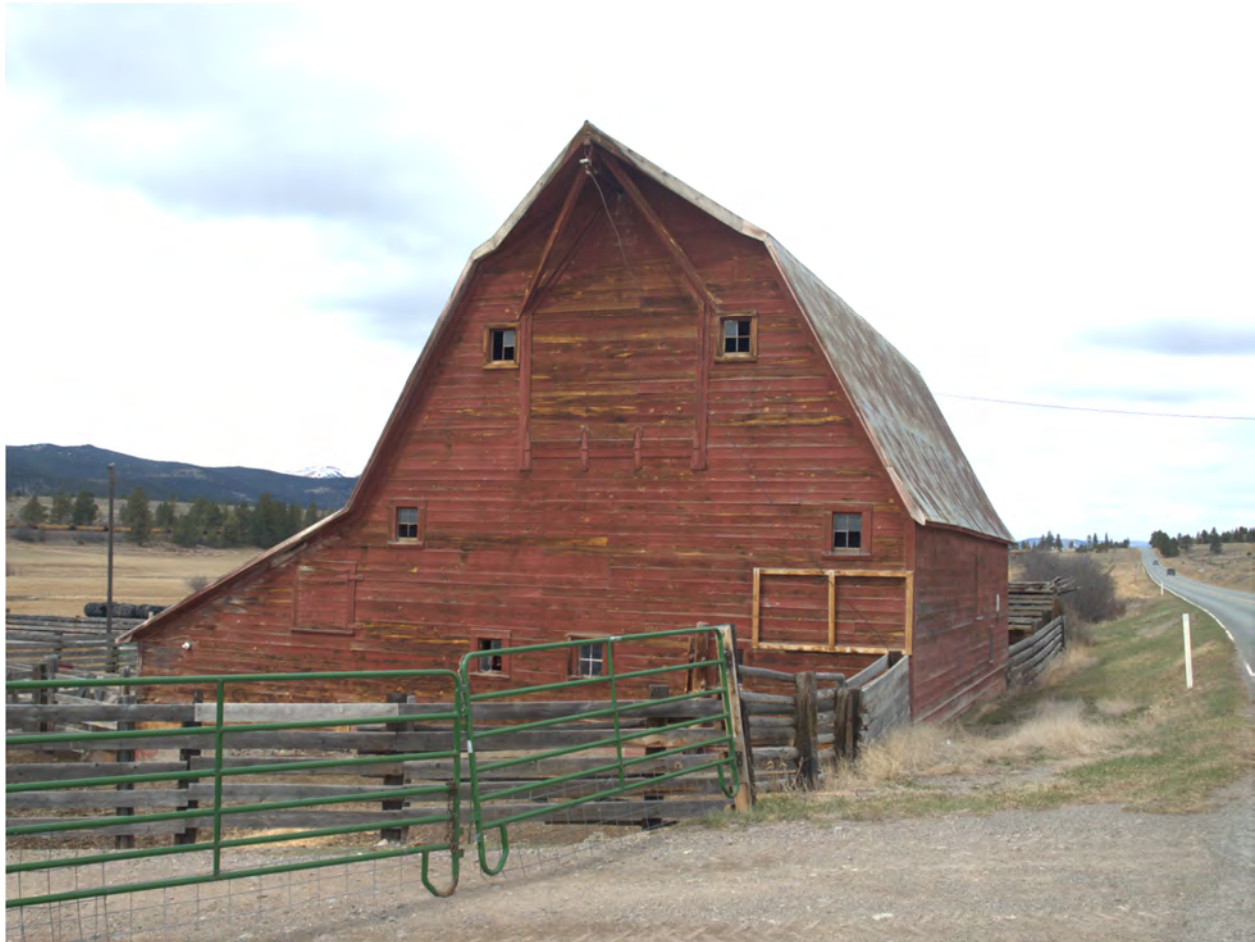
50 Of 84

Building #21 Barn #1, Contributing, Photo-1
Elevation View. Camera Facing West. Southeast Elevation (Left) Northeast Elevation (Right)
MT_LewisAndClarkCounty_GehringRanch_0050

The structure that replaced the burned barn is the present larger, more modern building. Barn #1 is of a standard design probably provided by the contractor, a lumber company or an agricultural publication. It illustrates the configuration necessary to house the many draft horses required in the early days of ranching, despite the quickened-pace of tractors replacing their animal predecessors. With the advent of mechanization, the barn sheltered cows instead of horses.

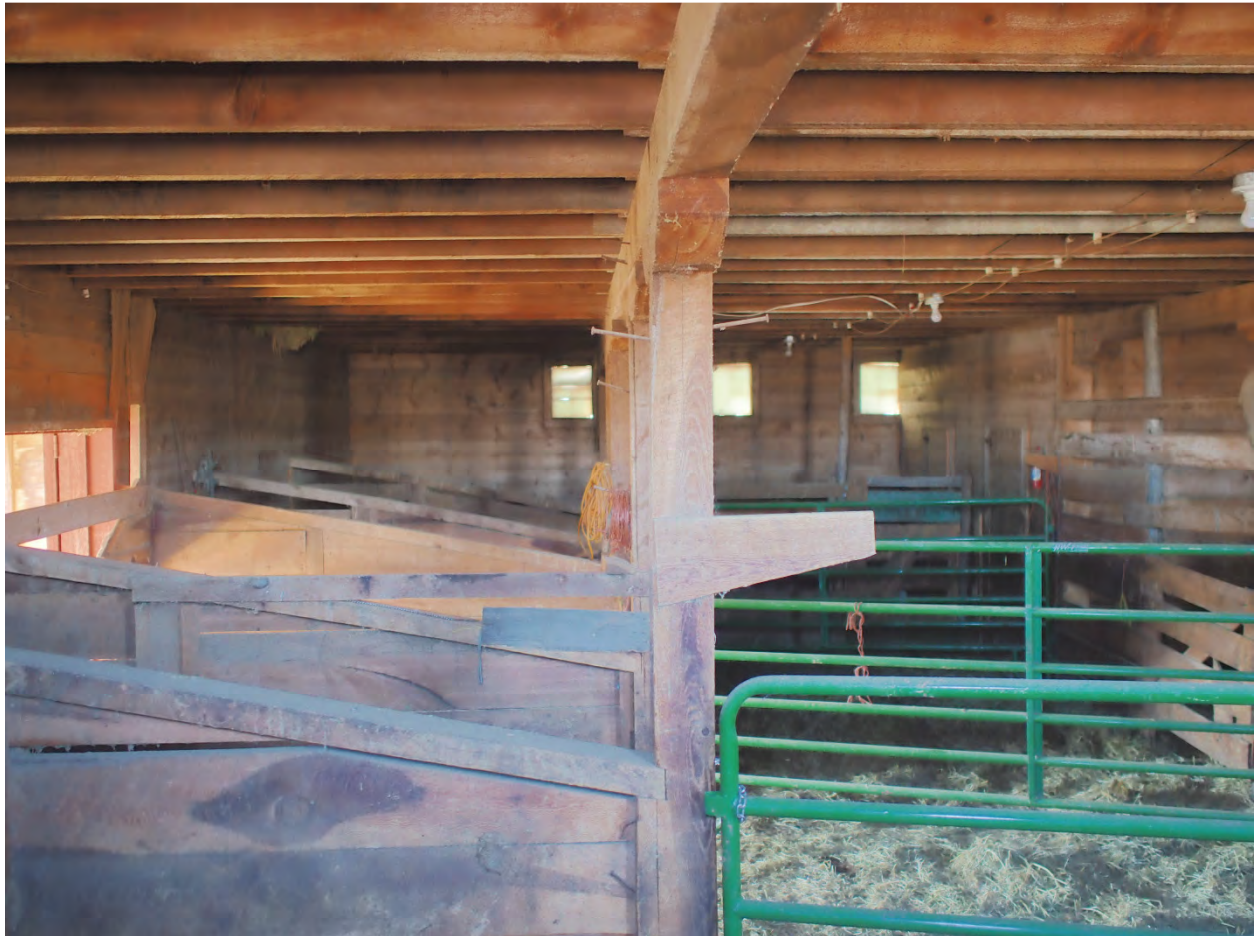
52 of 84

Building #21 Barn #1, Contributing, Photo-3
Interior View. Camera Facing Northwest. Southwest Wall with Stalls (Left) Northwest Wall
(Center) East Wall (Right)
MT_LewisAndClarkCounty_GehringRanch_0052

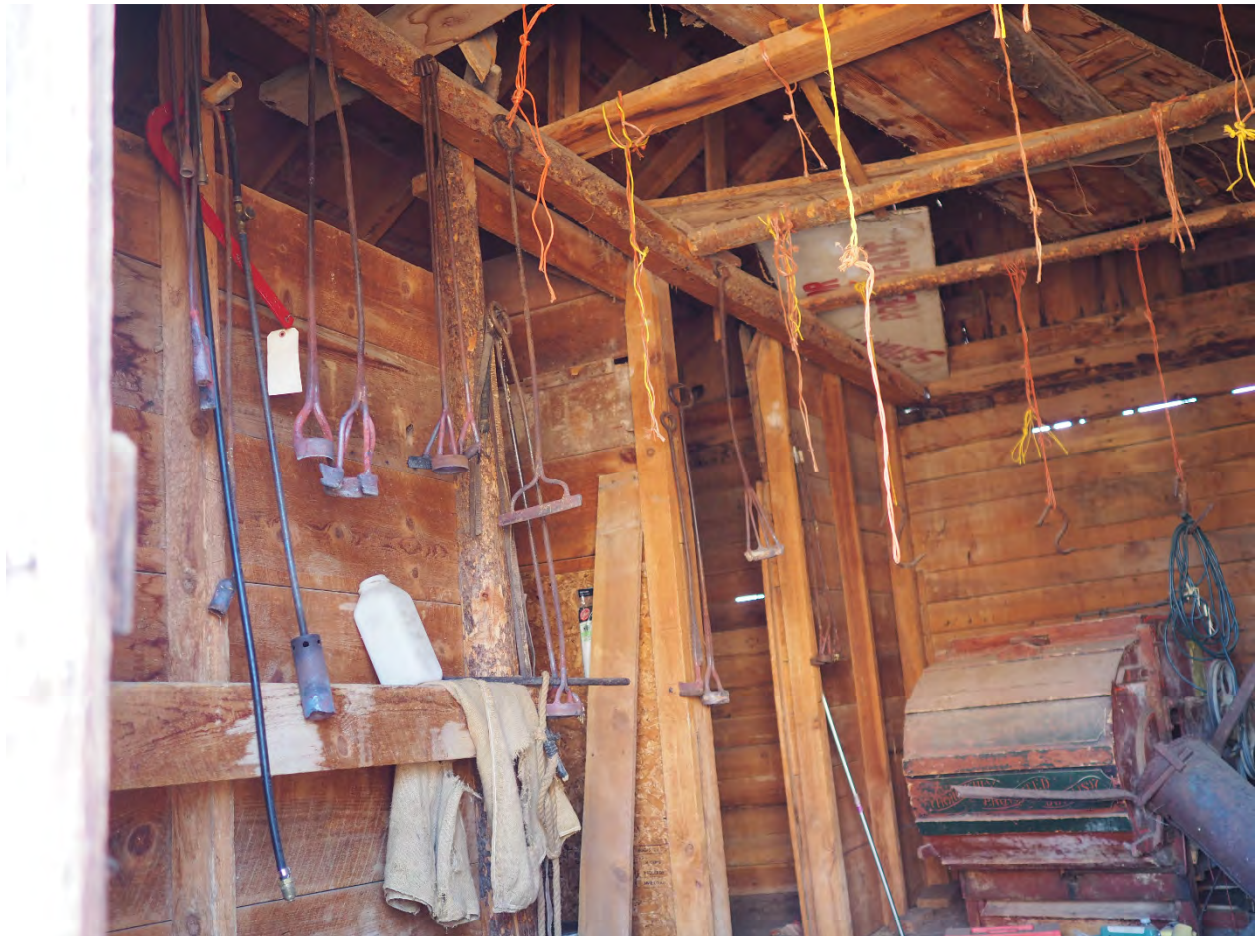
56 of 84

Building #22 Granary #1, Contributing, Photo-3
Interior View. Camera Facing Southwest. Southeast Wall (Left) Southwest Wall (Right) Shows
Fanning Mill (Right)
MT_LewisAndClarkCounty_GehringRanch_0056

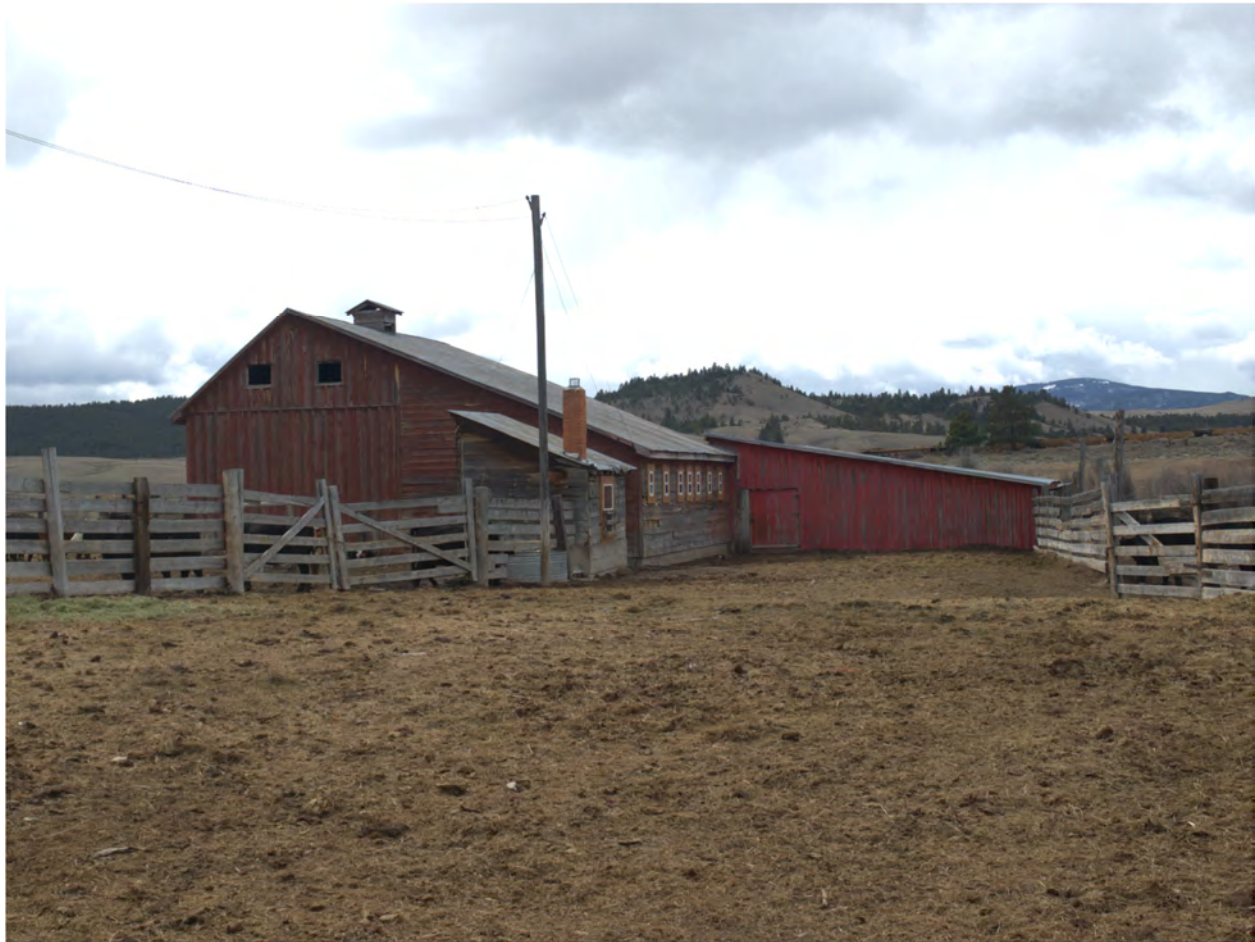
58 of 84

Building #23 Barn #2, Contributing, Photo-2
Elevation View. Camera Facing Southwest. Northeast and Northwest Elevations of Main Barn (Left) with Milk Shed (Left of Center). Cattle Shelter Northeast Elevation (Right of Center) Shows Corrals (Foreground)
MT_LewisAndClarkCounty_GehringRanch_0058

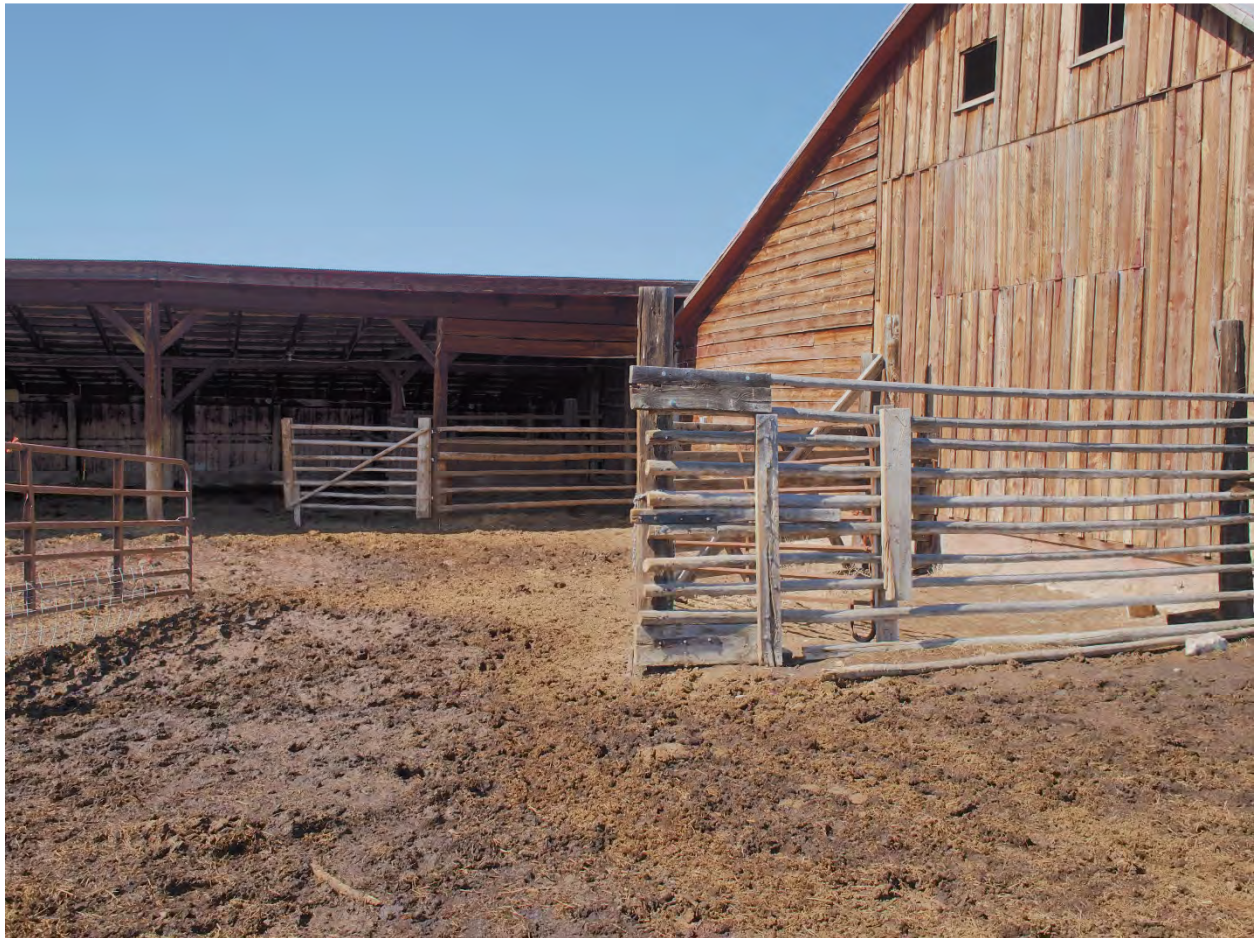
62 of 84

Building #23 Barn #2, Contributing, Photo-6
Elevation and Interior View. Camera Facing Northwest. Cattle Shelter (Left) Southwest
Elevation Milking Section (Right)
MT_LewisAndClarkCounty_GehringRanch_0062

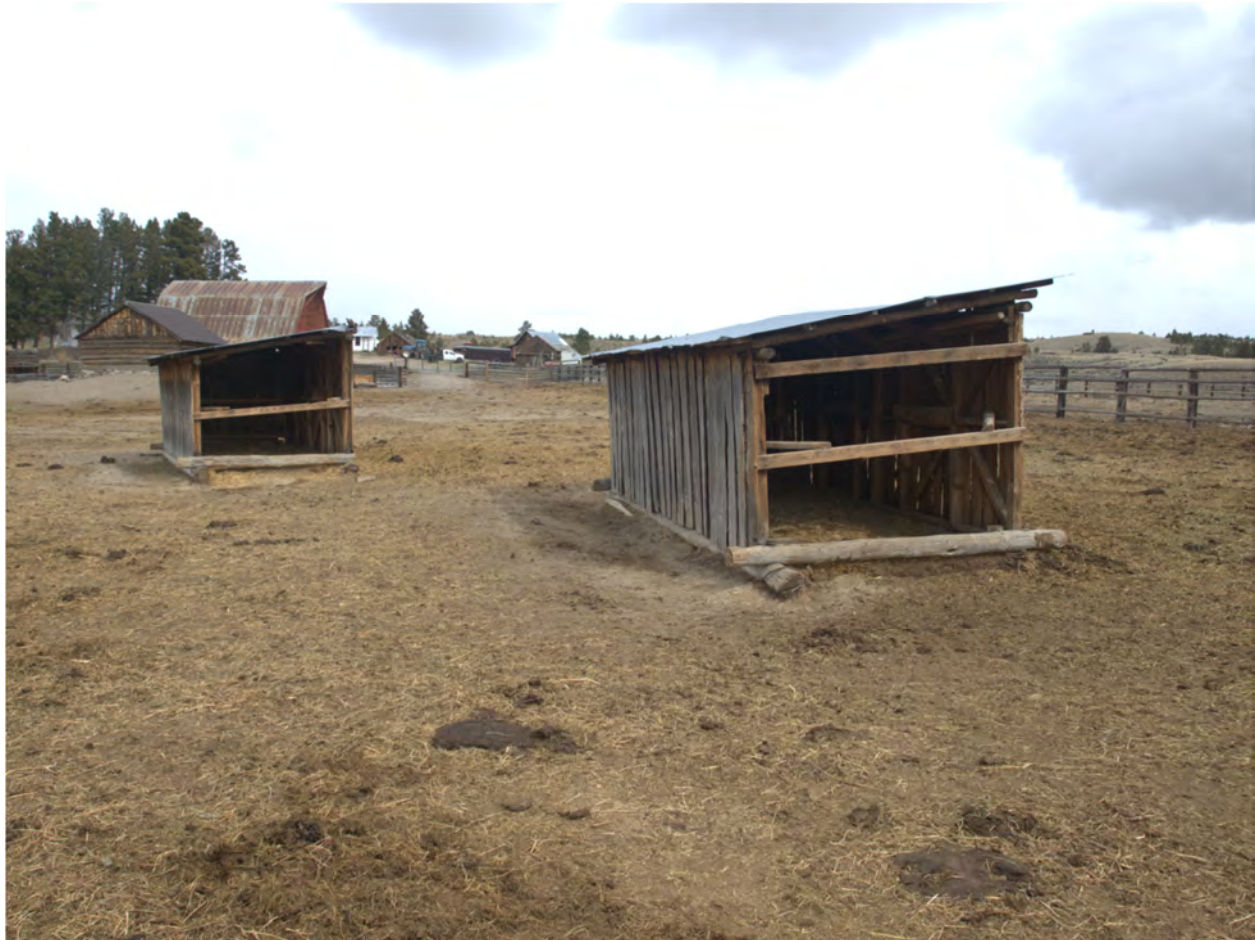
65 of 84

Buildings #25 Calf Sheds, Contributing, Photo-1
Elevation View. Camera Facing North. West Elevation (Left) South Elevation (Right) Barn #1
and Granary #1 (Background)
MT_LewisAndClarkCounty_GehringRanch_0065

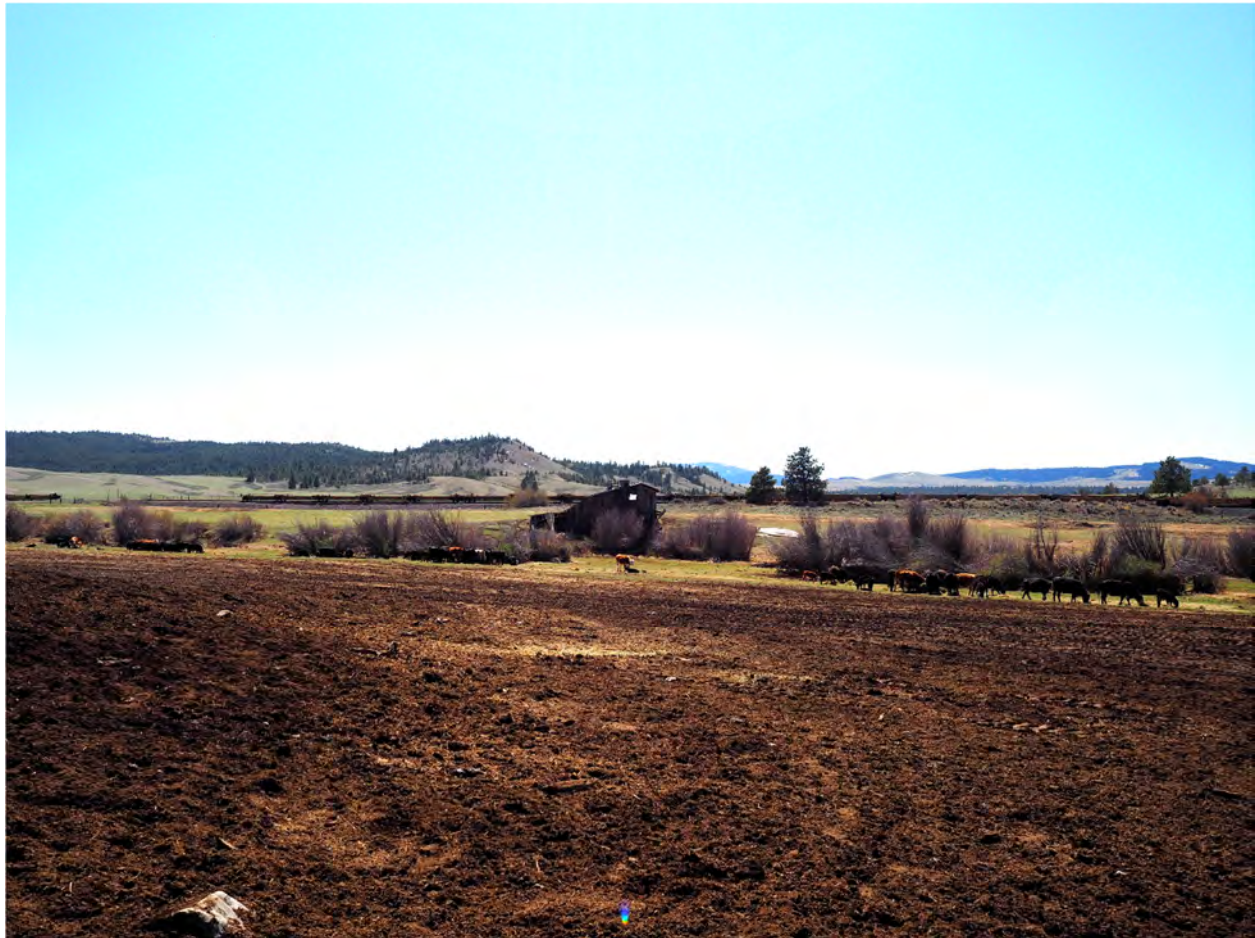
67 of 84

Building #27 Feed Mill, Contributing, Photo-1
Elevation View. Camera Facing Southwest. Northeast Elevation (Center) in Context with
Pasture (Foreground) and Silver Creek.
MT_LewisAndClarkCounty_GehringRanch_0067

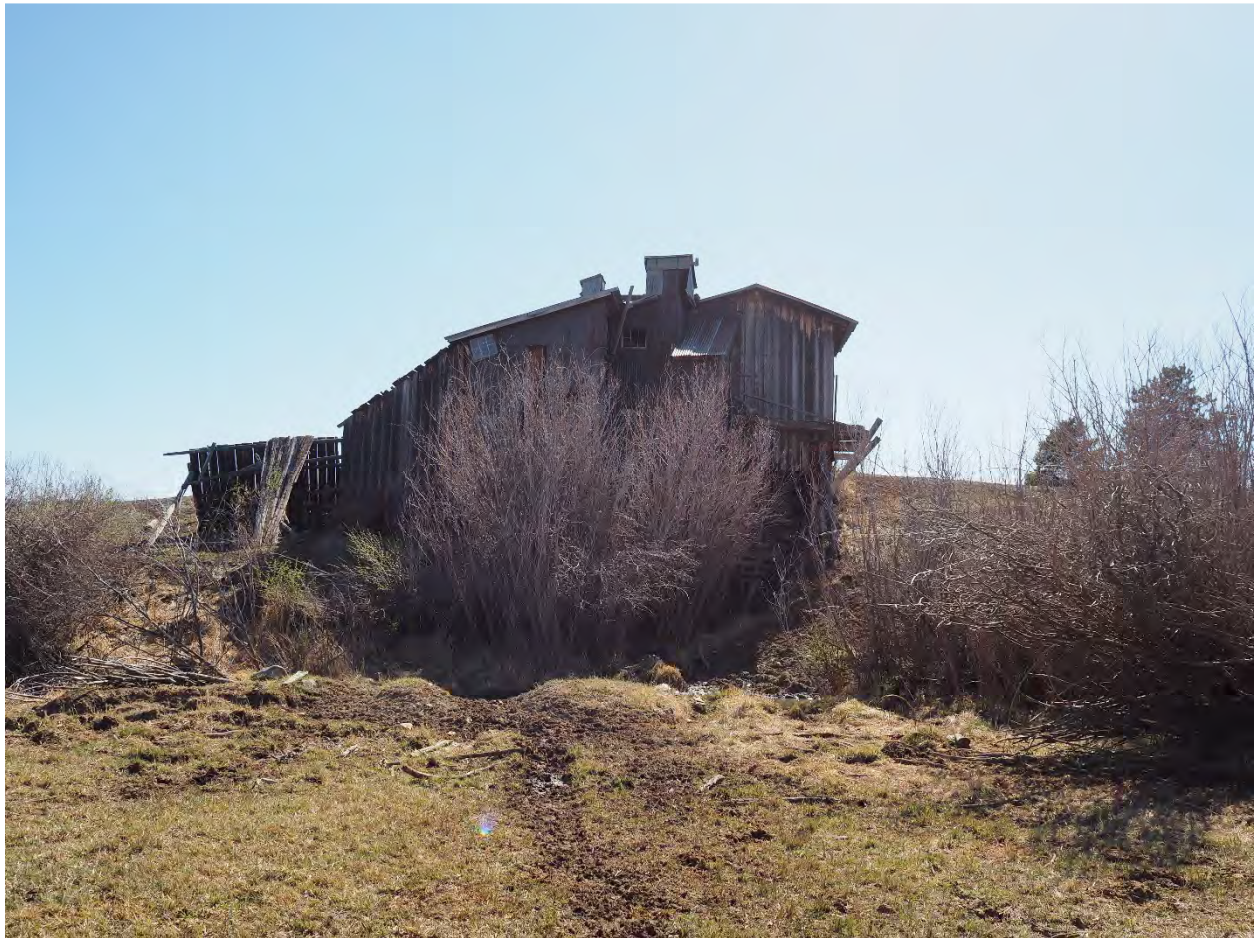
68 of 84

Building #27 Feed Mill, Contributing, Photo-1
Elevation View. Camera Facing Southwest. Northeast Elevation with Silver Creek
(Foreground).
MT_LewisAndClarkCounty_GehringRanch_0068

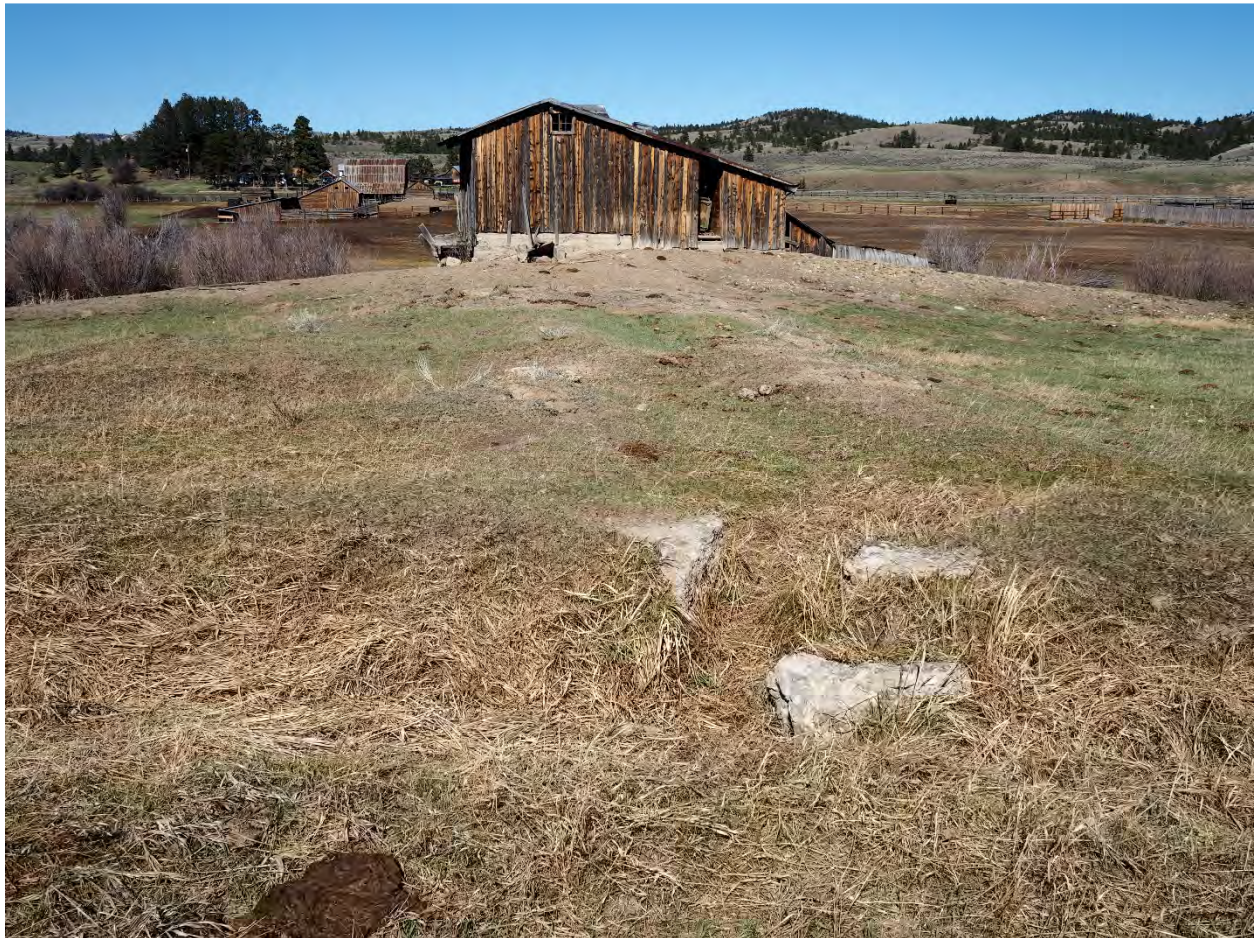
69 of 84

Building #27 Feed Mill, Contributing, Photo-2, also Mill (Irrigation) Ditch (foreground)
Elevation View. Camera Facing Northeast. Southwest Elevation.
MT_LewisAndClarkCounty_GehringRanch_0069

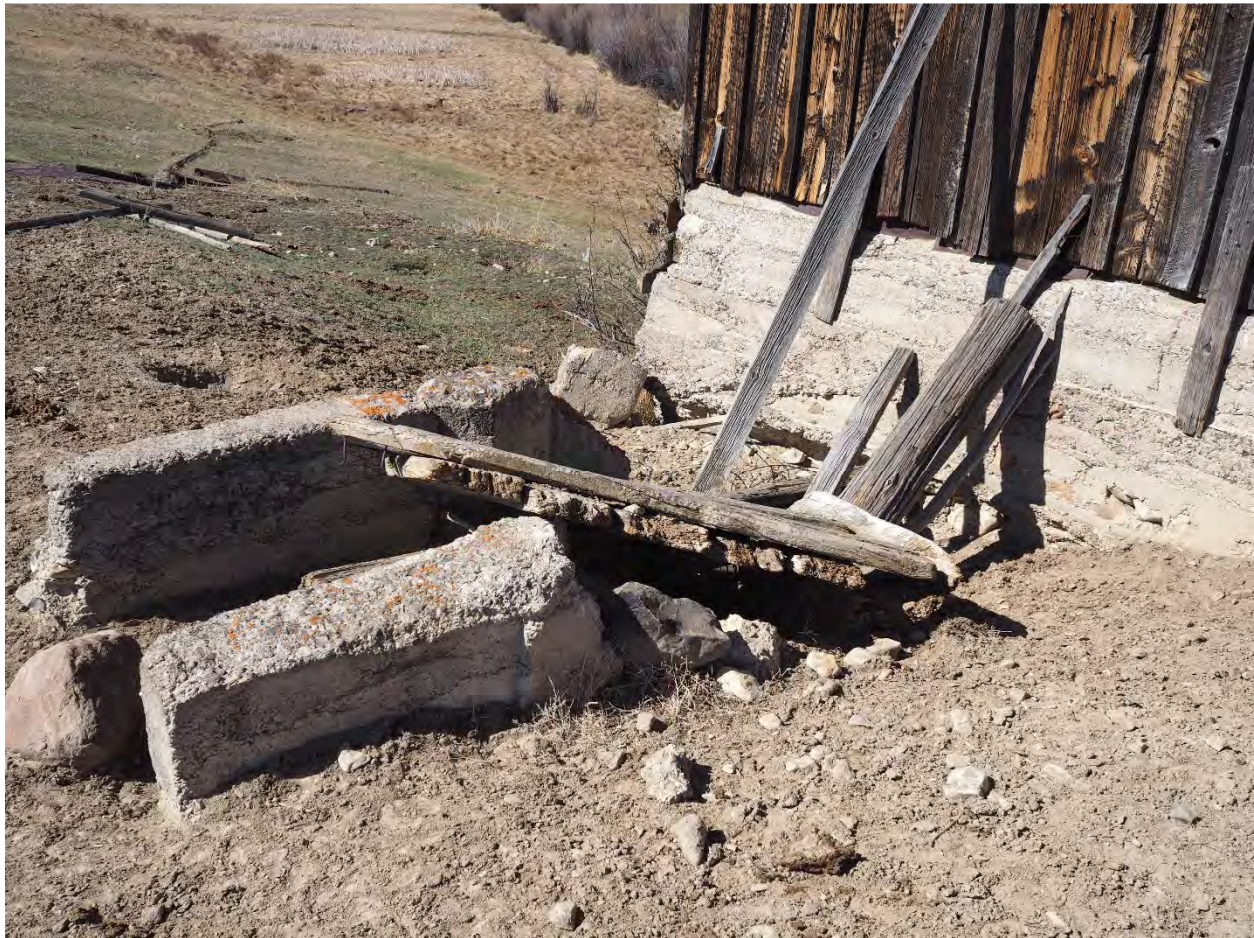
70 of 84

Building #27 Feed Mill, Contributing, Photo-3
Elevation View. Camera Facing North. Concrete Basin (Headgate) to Supply Pipe to
Waterwheel (Foreground). Southwest Elevation of Mill (Right)
MT_LewisAndClarkCounty_GehringRanch_0070

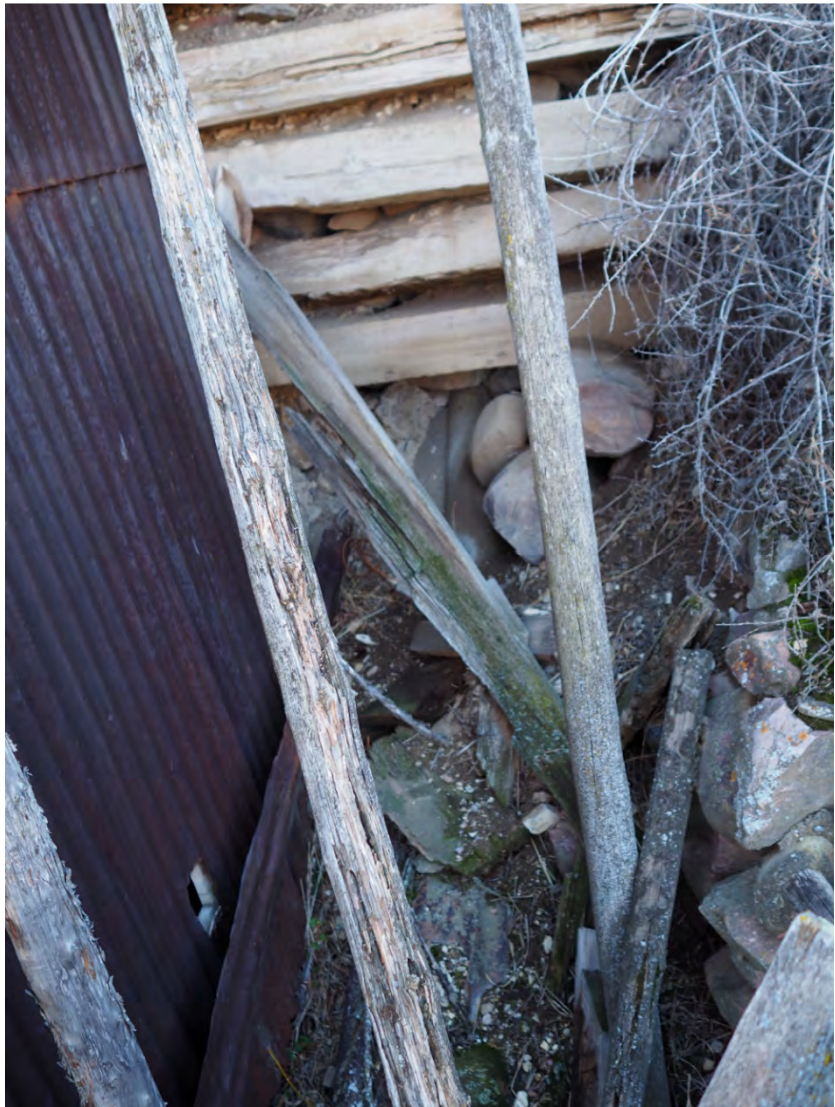
71 of 84

Building #27 Feed Mill, Contributing, Photo-4
Elevation View. Camera Facing Southwest. Pipe (Pen Stock) Outlet to Water Wheel.
MT_LewisAndClarkCounty_GehringRanch_0071
