National Register of Historic Places Registration Form

Historic name: Gehring Ranch
Other names/site number: 24LC1846
Name of related multiple property listing: NA
(Enter "N/A" if property is not part of a multiple property listing)

Street & number: 5488 Lincoln Road West
City or town: Helena State: MT County: Lewis and Clark
Not For Publication: Vicinity:

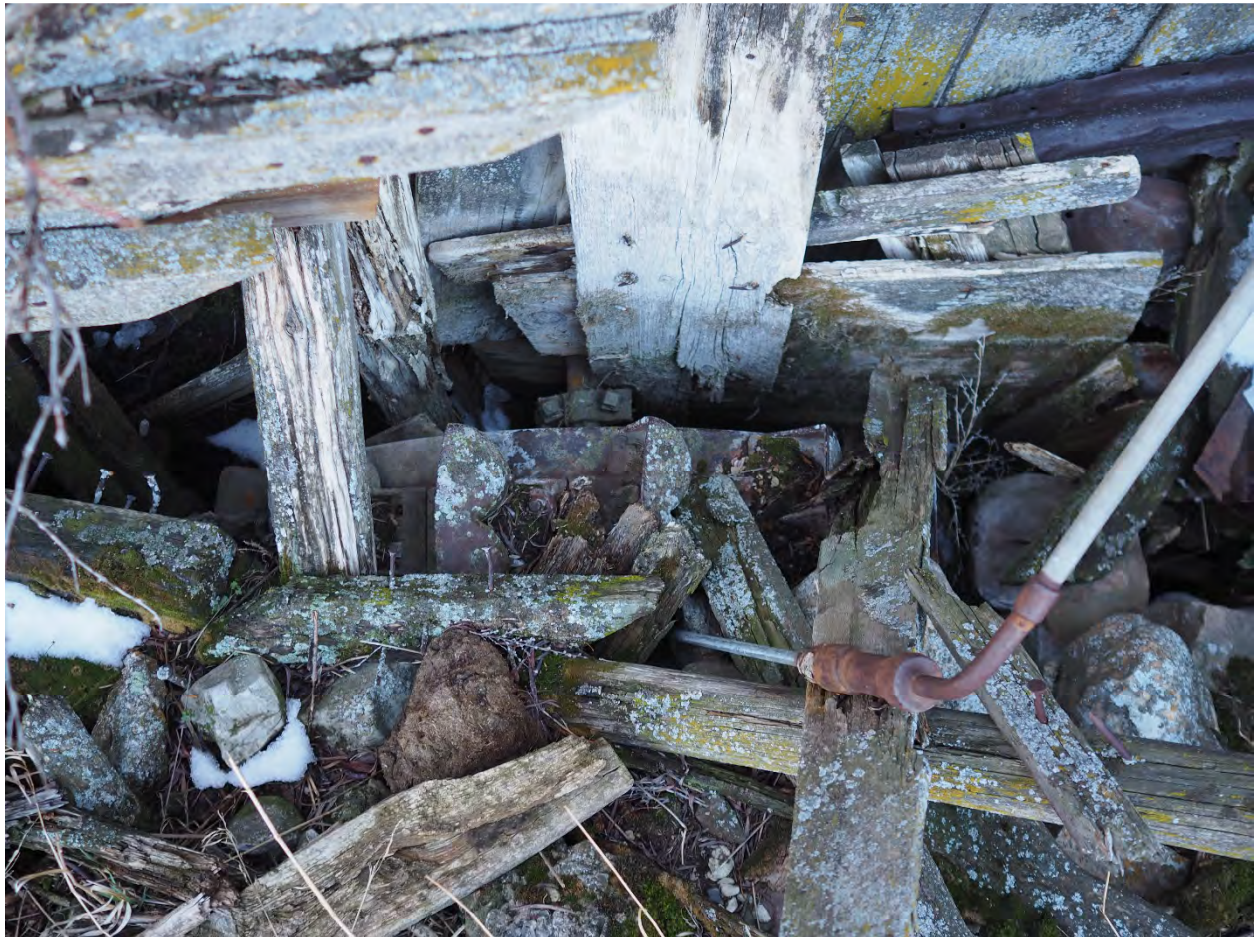
72 of 84

Building #27 Feed Mill, Contributing, Photo-5
Elevation View. Camera Facing Down and Southeast. Northwest Foundation of Machinery
Block. Shows Pelton Type Undershot Waterwheel.
MT_LewisAndClarkCounty_GehringRanch_0072

uprights set on poured concrete piers foundations. Here is found the terminal end of an iron water pipe (pen stock) and the water trough that leads to a partially buried Pelton type water wheel at the base of the machinery block.⁸ When operative, this undershot wheel powered the mill by means of belts running to shafts overhead that lead to the southern part of the machinery block. Above the open space, on the northwest façade of the mill, is a deteriorating catwalk leading to doorways in the machinery block and main section. There is another opening on the southern end of the southwest wall of the main section. Around the corner from here, the southeast wall drops down another floor into a notch where creek bank was excavated away. The notch is walled with timbers extending several feet further out from the main section's south corner. Parallel to this timber wall, 12 feet to the northeast, is the shed dependency. This is open to the south and appears to be the feeding area. It has a high board fence on the west side that was also part of a roofed shelter that is now deteriorated.

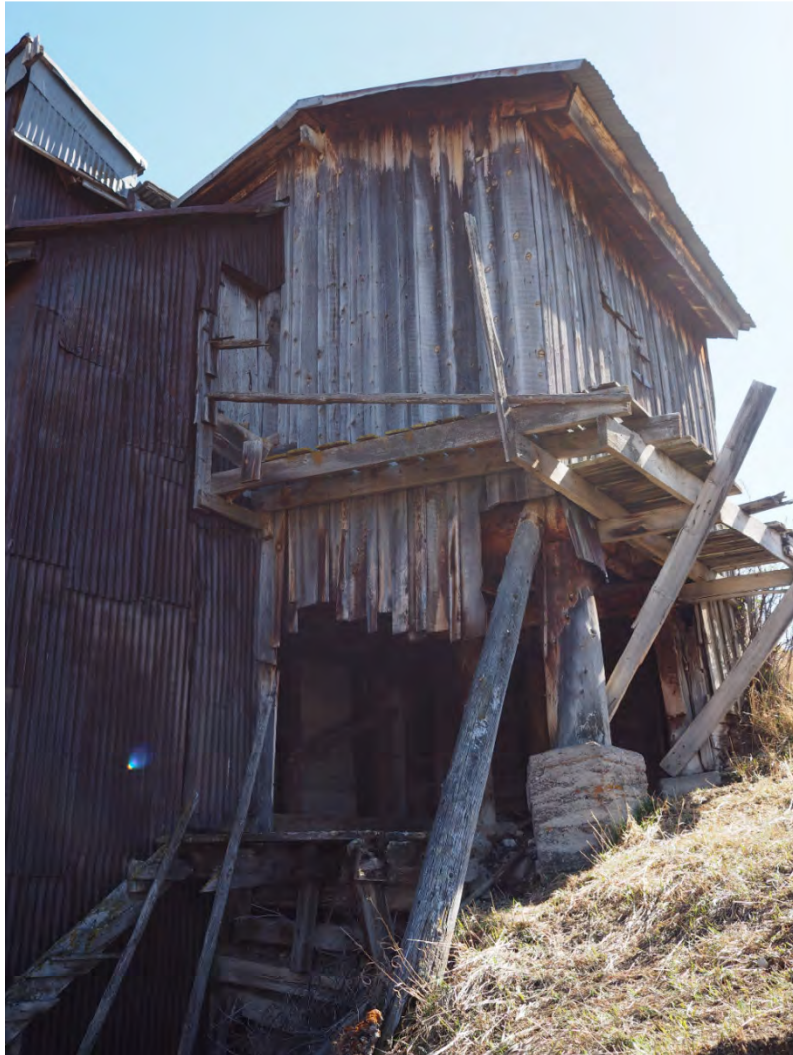
73 of 84

Building #27 Feed Mill, Contributing, Photo-6
Elevation View. Camera Facing South. Northern Corner of Main Block (Center). Shows Open
Lower Level Containing Underground Delivery Pipe (Pen Stock).
MT_LewisAndClarkCounty_GehringRanch_0073

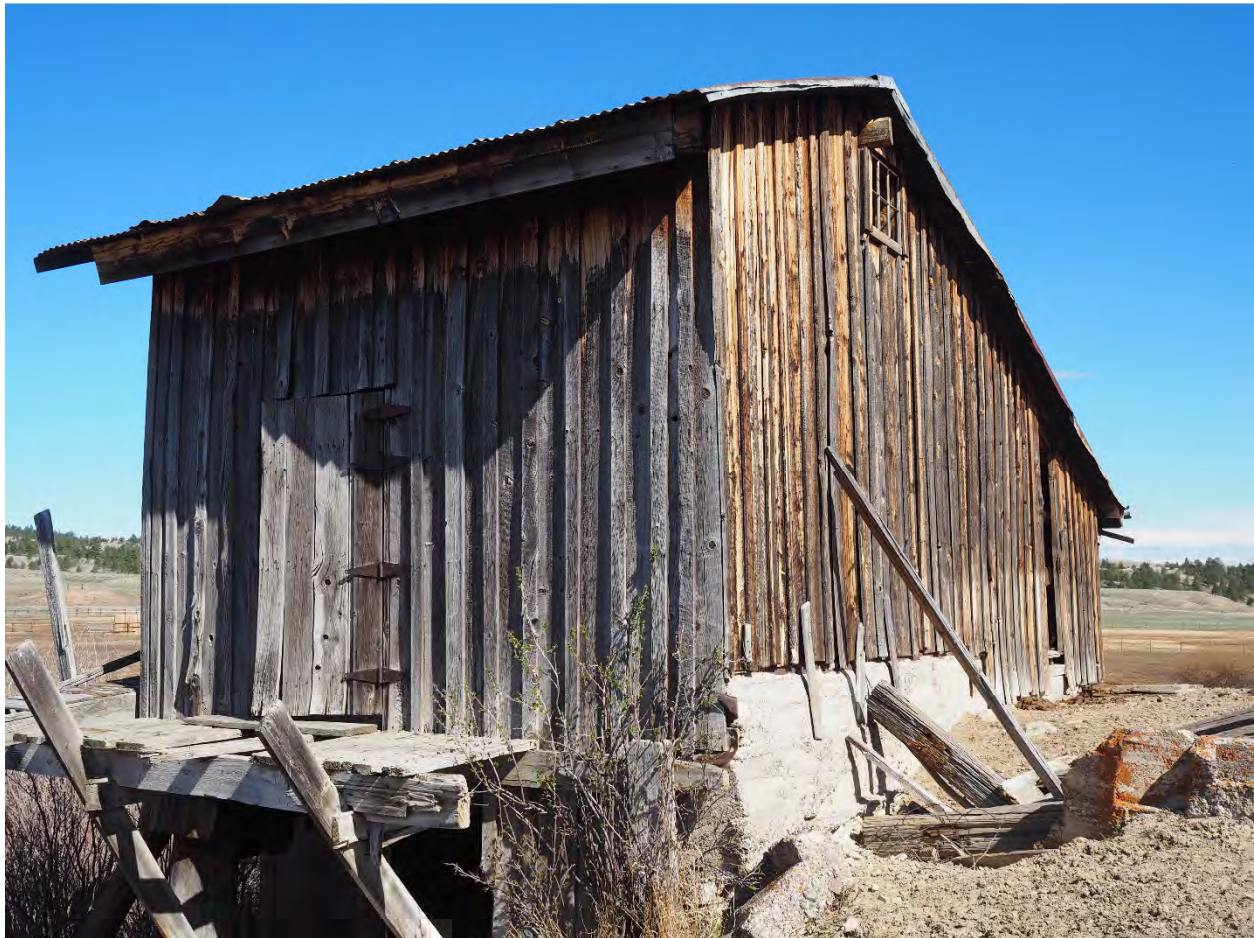
74 of 84

Building #27 Feed Mill, Contributing, Photo-7
Elevation View. Camera Facing East. Northwest Elevation (Left) Southwest Elevation (Right)
MT_LewisAndClarkCounty_GehringRanch_0074

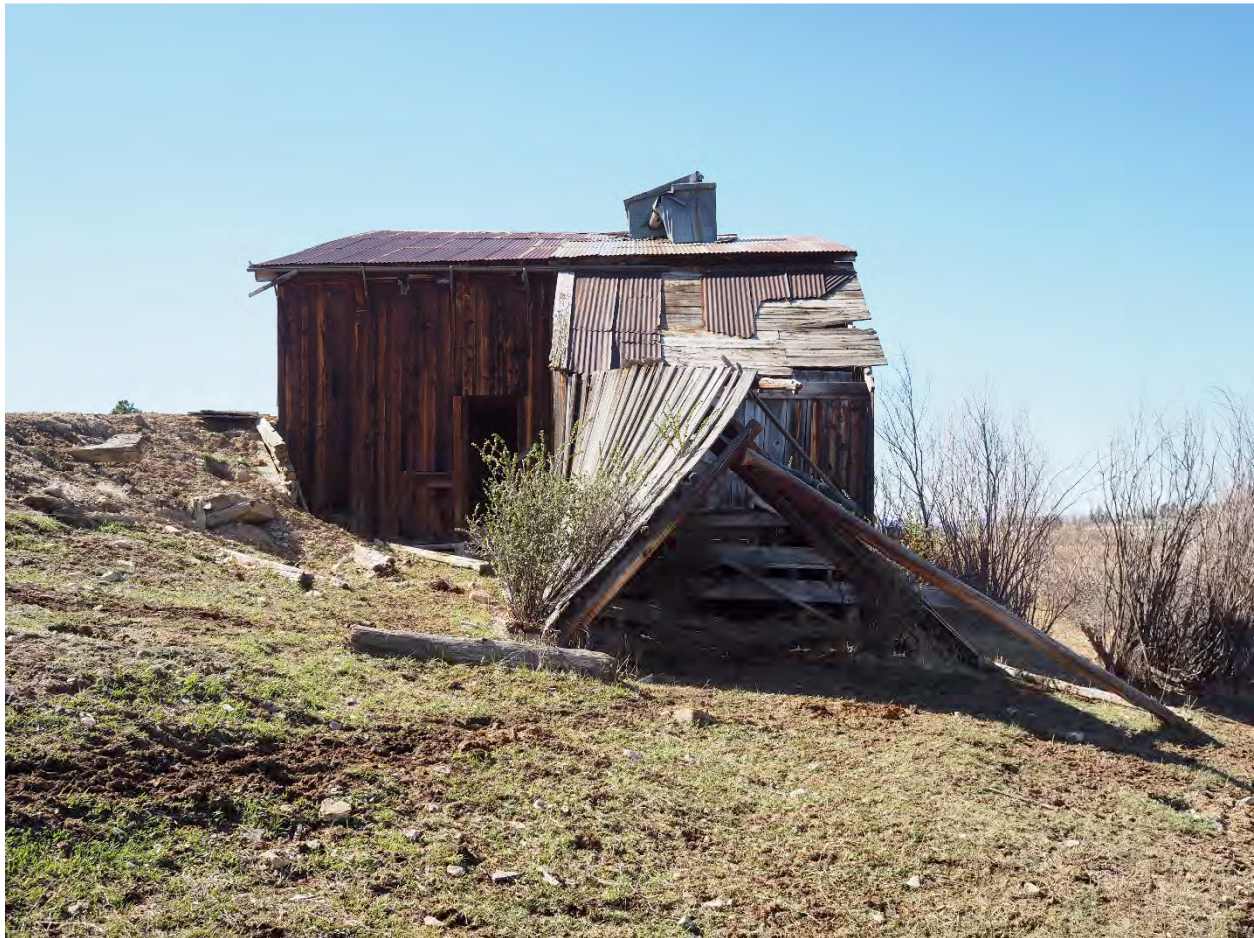
75 of 84

Building #27 Feed Mill, Contributing, Photo-8
Elevation View. Camera Facing Northwest. Southeast Elevation. Shows Hog Feeding Shelter
(Right)
MT_LewisAndClarkCounty_GehringRanch_0075

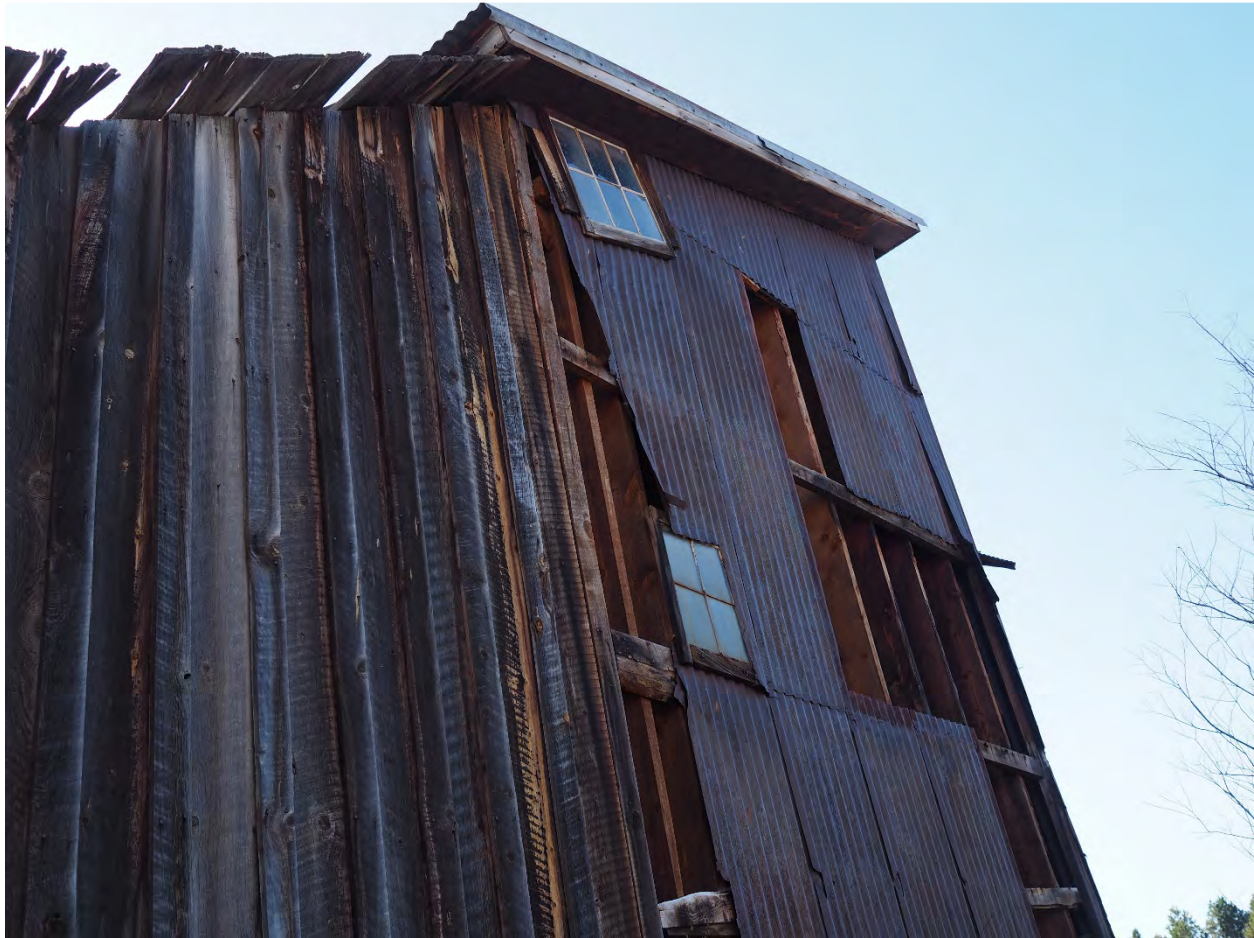
76 of 84

Building #27 Feed Mill, Contributing, Photo-9
Elevation View. Camera Facing West. Northeast Elevation. Feeding Shelter (Left) Eastern Ell
(Right)

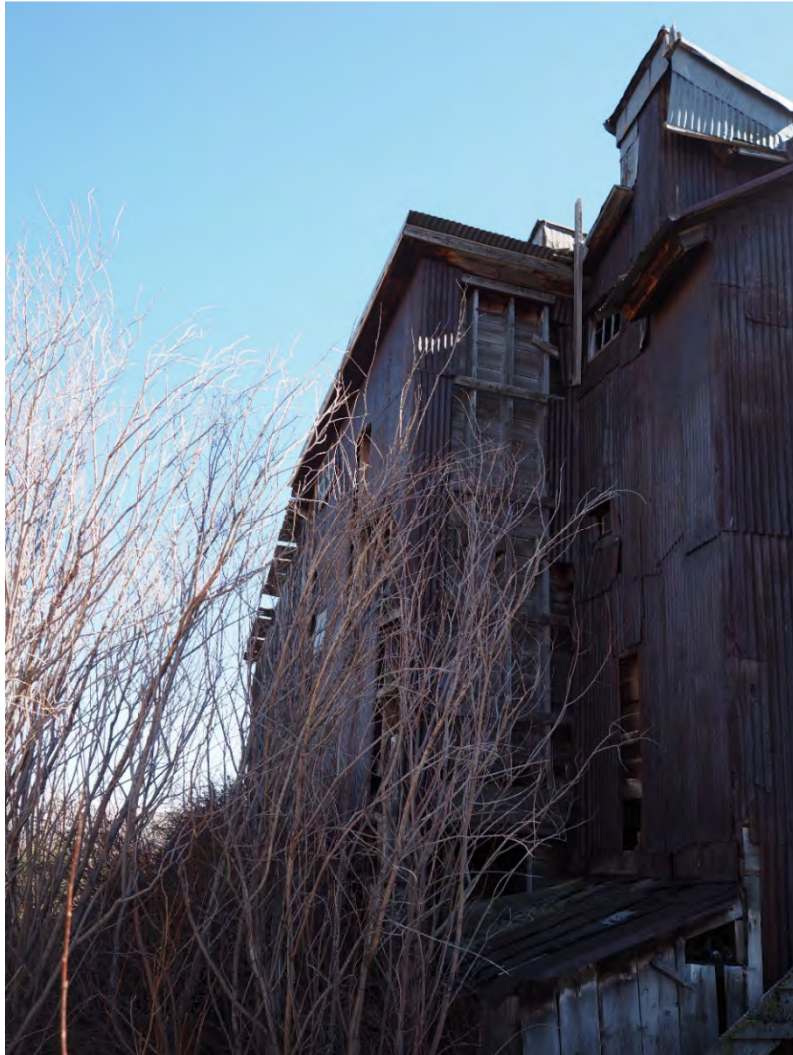
77 of 84

Building #27 Feed Mill, Contributing, Photo-10
Elevation View. Camera Facing South-southeast. Northern Elevation, Eastern Ell (Left)
Machine Block (Right)
MT_LewisAndClarkCounty_GehringRanch_0077

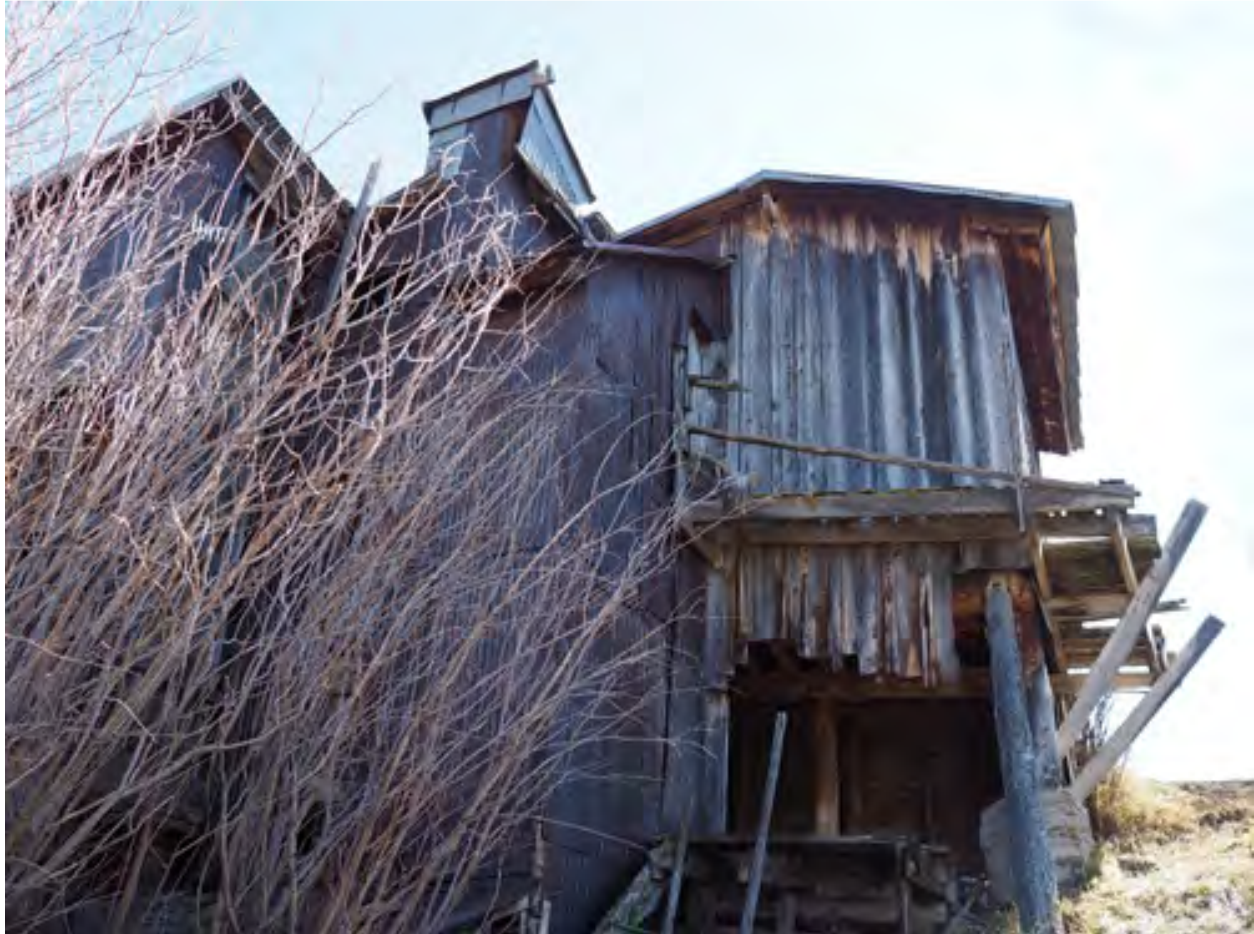
78 of 84

Building #27 Feed Mill, Contributing, Photo-11
Elevation View. Camera Facing Southwest. Northern Elevation Showing Eastern Ell (Left)
Machine Block (Center) Main Block (Right)
MT_LewisAndClarkCounty_GehringRanch_0078

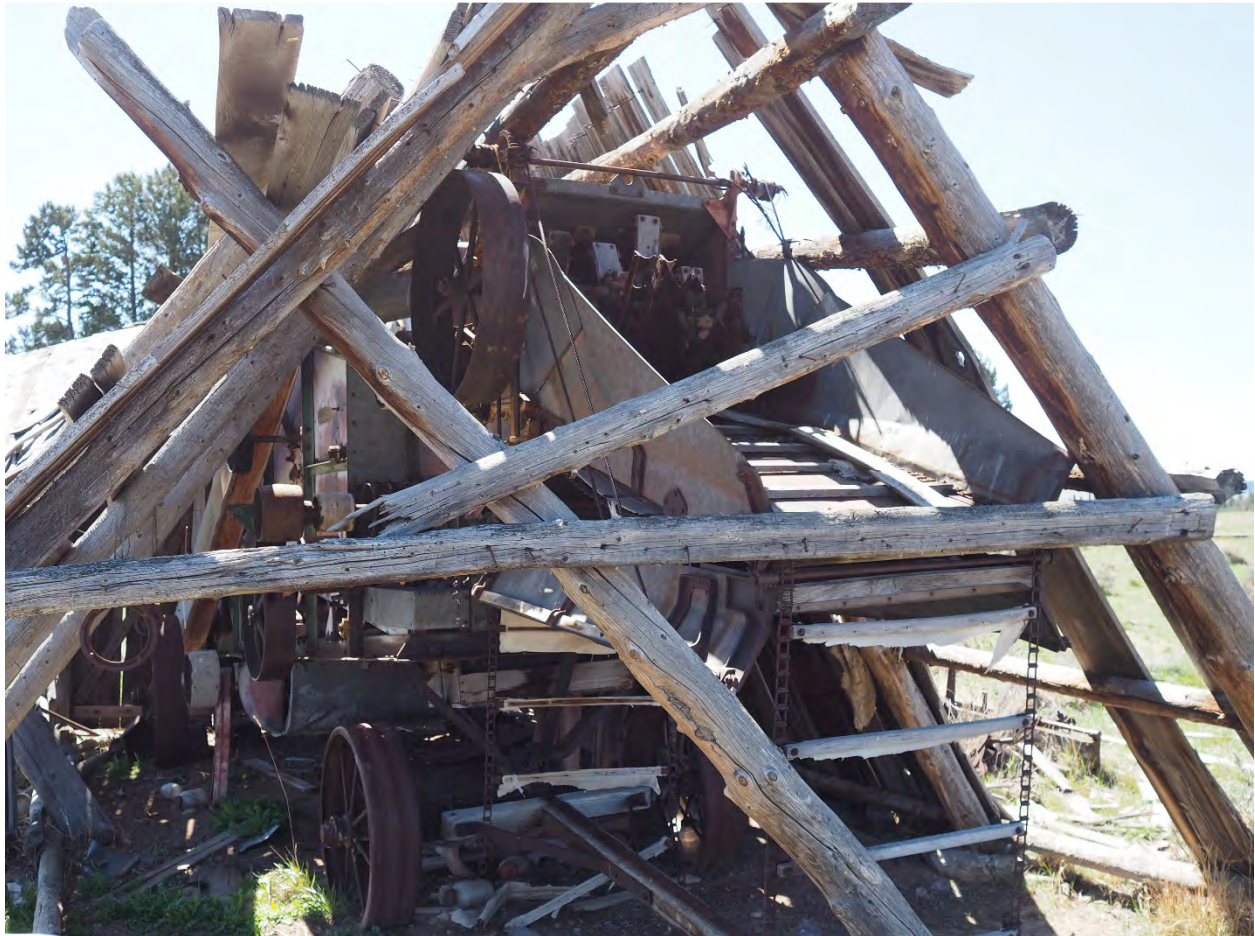
80 of 84

Historic Structure #30 Threshing Machine, Contributing, Photo-1
Elevation View. Camera Facing Southwest.
MT_LewisAndClarkCounty_GehringRanch_0080

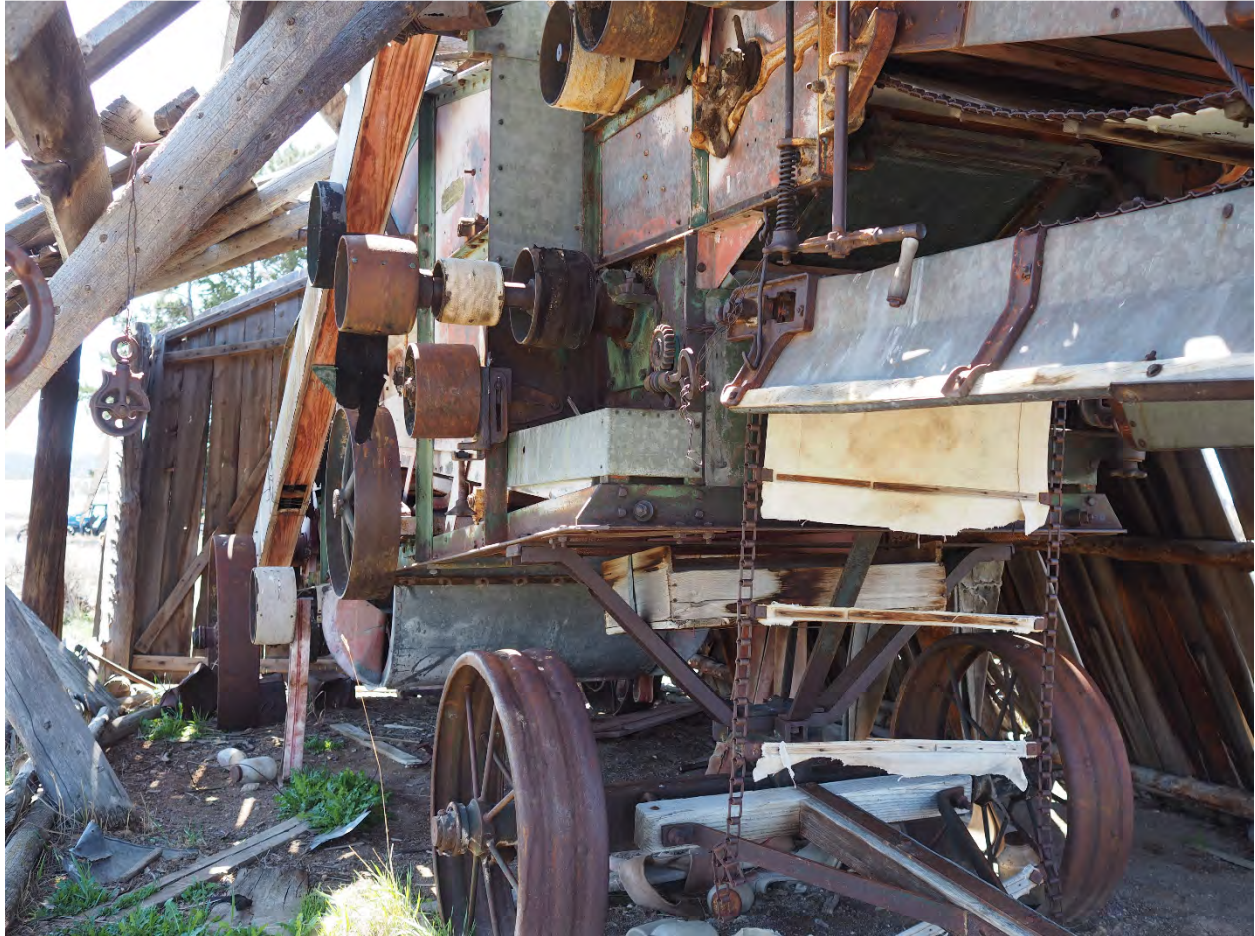
81 of 84

Historic Structure #30 Threshing Machine, Contributing, Photo-2
Elevation View. Camera Facing Southwest.
MT_LewisAndClarkCounty_GehringRanch_0081

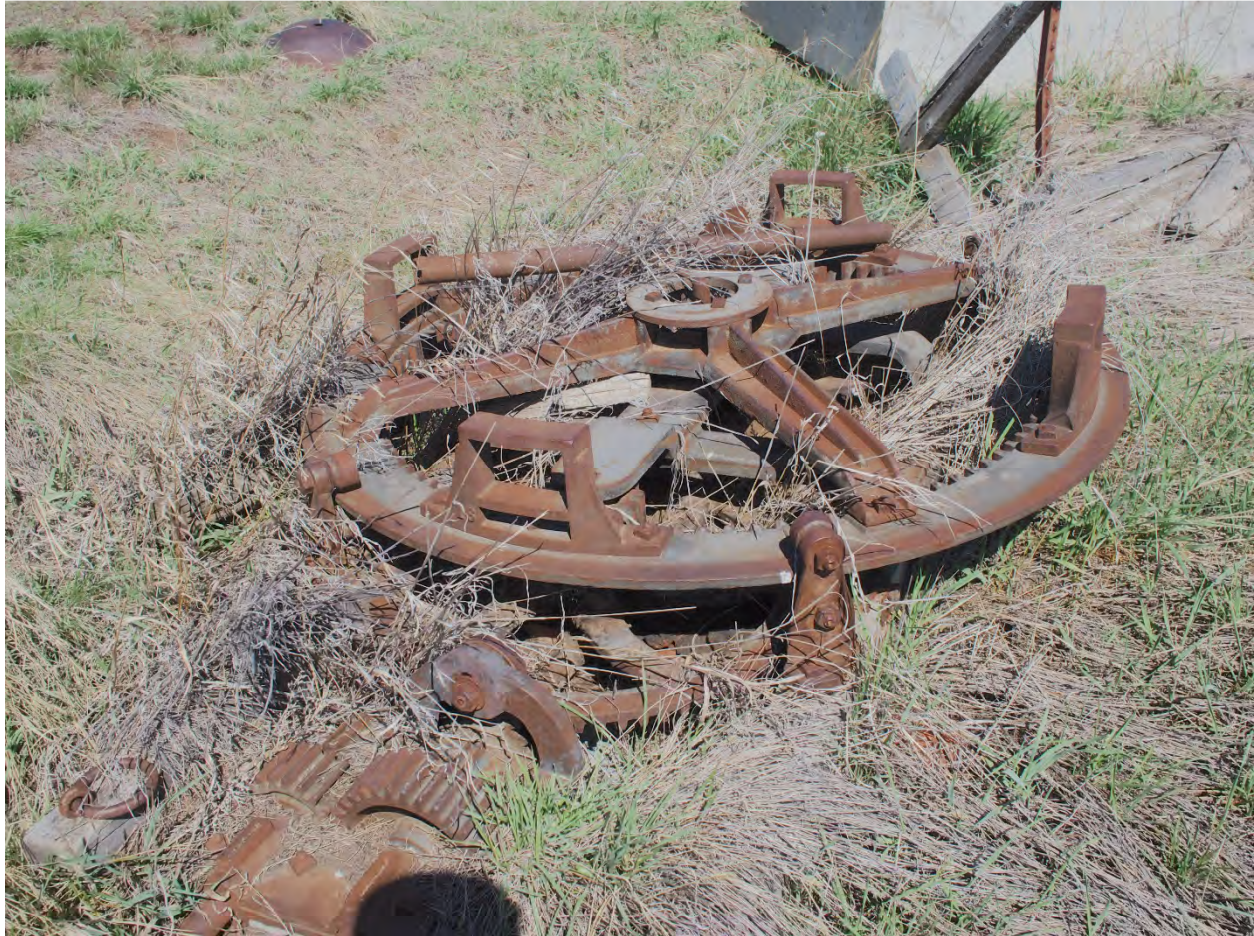
82 of 84

Historic Structure #29 Horse Power, Contributing, Photo-1
Elevation View. Camera Facing Southeast.
MT_LewisAndClarkCounty_GehringRanch_0082
