National Register of Historic Places Registration Form

1. Name of Property		
nistoric name Nachtrieb/Kelly Ranch		
other names/site number Maxwell Ranch/5CF.2876		
2. Location		
street & number 25887 County Road 319		N/A not for publication
city or town Buena Vista		X vicinity
state Colorado code CO county Chaffee	code 015	zip code 81211

Nachtrieb/Kelly Ranch

Chaffee, Colorado

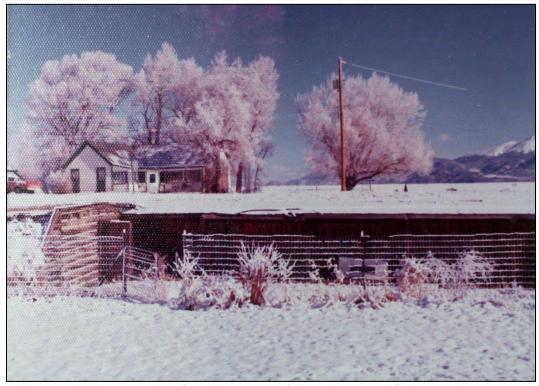
Figure 2. This 1973 view (north-northwest) from the yard of the southern house shows two of the outbuildings (Resources 7 and 8, left and right) built into the slope in the foreground and the homestead house (Resource 2) in the upper left. Courtesy of Bryce and Suzy Kelly, Buena Vista, Colorado.

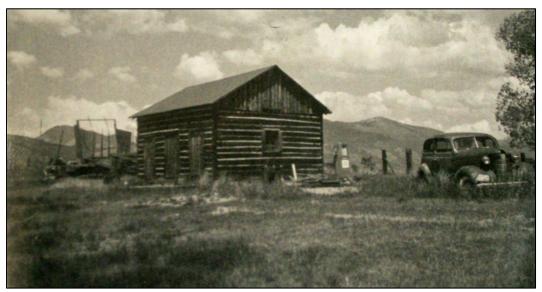
Figure 3. The granary (Resource 6) is shown in this ca. 1970s-80s assessor card photograph (view west-northwest). Courtesy of Chaffee County Assessor, old real property appraisal card, Salida, Colorado.

During the Kelly era the granary was used to store cottonseed meal and cake, molasses, and fertilizer (see Figure 3). The one-and-a-half-story side gabled roof granary (21' x 17') is located southeast of the large utility shed (Resource 14). Partitions divide the interior into three sections. The building faces south, has a concrete-clad stone foundation, and features square hewn log walls with daubing that are joined at the corners with V notches. The front wall contains three vertical board doors with strap hinges facing a raised board deck extending the length of the wall. The west wall has a central square window opening (boarded-up) with a plain wood surround; farm tools are attached to the west wall. The north wall is unfenestrated. The east wall contains a center wood four-light window (boarded-up on the interior) with a plain wood surround. Two metal gasoline signs are displayed on the east wall: Champlin Gasoline and Mobilgas. The gable faces are clad with slab logs and the east gable face contains a slab log hayloft door. The roof is clad with standing-seam metal roofing and has overhanging eaves. *Alterations*: Windows are boarded up and the granary had metal roofing installed in 2000.

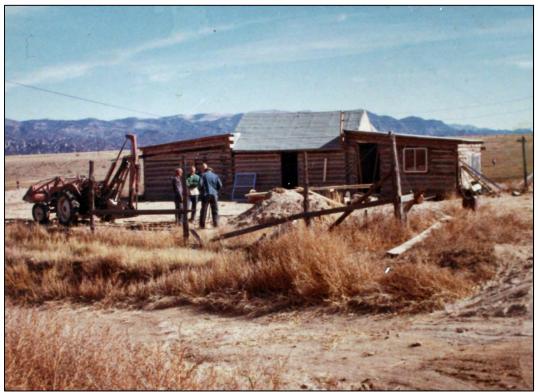
Figure 4. This ca. August 1966 photograph (view southeast) shows the former bunkhouse, used then as a chicken coop, that Bryce and Suzy Kelly remodeled and expanded into their current home (Resource 12; see next figure). Courtesy of Bryce and Suzy Kelly, Buena Vista, Colorado.

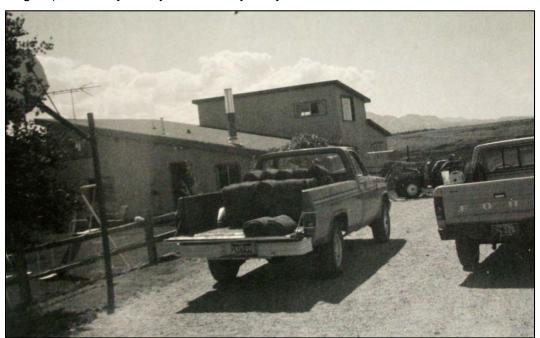
Figure 5. The former bunkhouse took on a new look after Bryce and Suzy Kelly's remodeling and expansion, as shown in this ca. 1970s-80s assessor card photograph (view southeast) (Resource 12). Courtesy of Chaffee County Assessor, old real property appraisal card, Salida, Colorado.

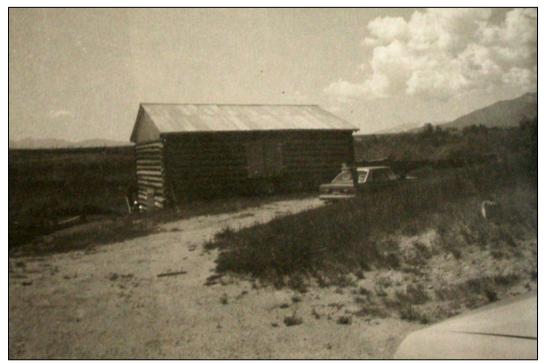
Figure 6. The bank barn (Resource 10) at the south end of the headquarters had a somewhat steeper roofline, as shown in this ca. 1970s-80s assessor card photograph (view south-southwest). After storm damage the roof was rebuilt with its current, shallower slope. Courtesy of Chaffee County Assessor, old real property appraisal card, Salida, Colorado.

Southwest of the new ranch house is this two-story log bank barn (31' x 30') built into the slope of the land to the north (see Figure 6). The foundation is stone. The walls are composed of round logs with daubing and are joined at corners with full dovetail notches; the log ends project slightly at corners. The east wall contains a center double door entrance on the first story; doors are two-part vertical board doors with diagonal bracing (the lower part of the north door is missing). The upper story is blank. The south wall features three small square one- and two-light windows with plain wood surrounds on the first story; the upper story is blank. Extending across the length of the south wall is a one-story open shed roof addition (date unknown) with log supports and ribbed metal panel roofing. The west wall is blank. The north wall contains center double plywood doors with a timber sill on the second story; the bottoms of the doors are about 4' above ground level. A portion of the first story is visible at the east end and is composed of roughly coursed stone. The barn roof is clad with corrugated metal roofing and has overhanging eaves and exposed rafter tails. *Alterations*: The full-width shed roof section on the south was added after 1963. The roof collapsed due to snow in 1973 and was replaced with a shallower pitch roof. The roof and gable faces were clad with standing seam metal panels in 2013. The double doors on the north wall are replacements made of plywood.

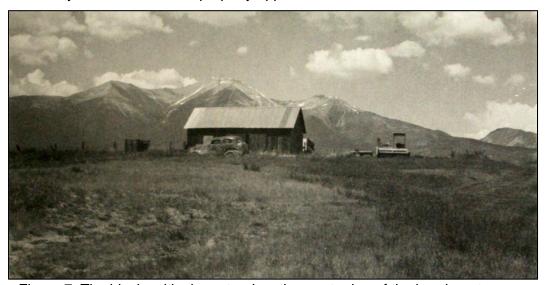
Figure 7. The blacksmith shop stood on the west edge of the headquarters until it was blown down by strong winds ca. 1996. Its concrete foundation remains. It is shown in this ca. 1970s-80s assessor card photograph (view west). Courtesy of Chaffee County Assessor, old real property appraisal card, Salida, Colorado.

The headquarters originally held a blacksmith shop (see Figure 7) until ca. 1996, when it was blown down by wind. The ruins of its concrete foundation (36' x 18') lie on the west edge of the headquarters about 142'

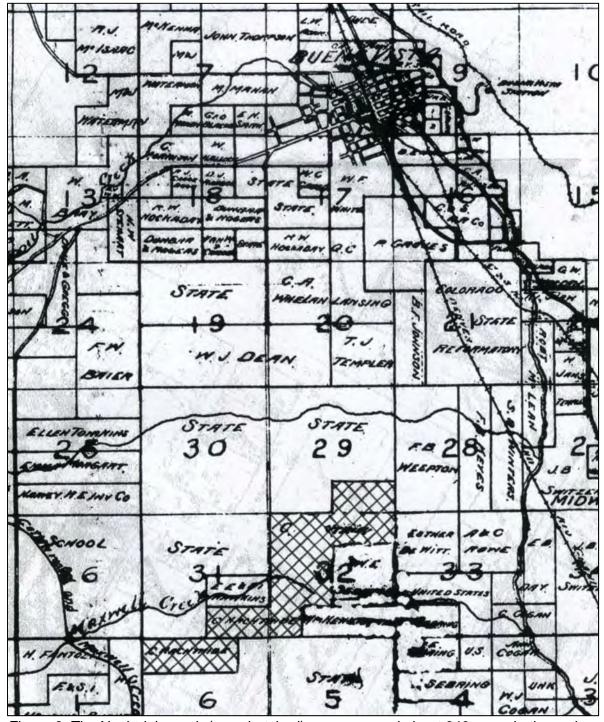
Figure 8. The Nachtrieb ranch (crosshatched) encompassed about 640 acres in the early 1900s. The original 160 acres obtained by a cash entry patent in 1876 is at the northeast corner. The Nachtriebs also acquired long-term leases on the state land abutting the ranch. Buena Vista is in the upper right of the map. Courtesy of Shaputis, *Where the Bodies Are in Central Chaffee County*, Some Land Owners and Old Roads in Northern Chaffee County, ca. 1900-10, map.
