National Register of Historic Places Registration Form

Historic name: S. Zollinger Company Building

Street & number: 101 South Wayne Street

City or town: Piqua State: Ohio County: Miami

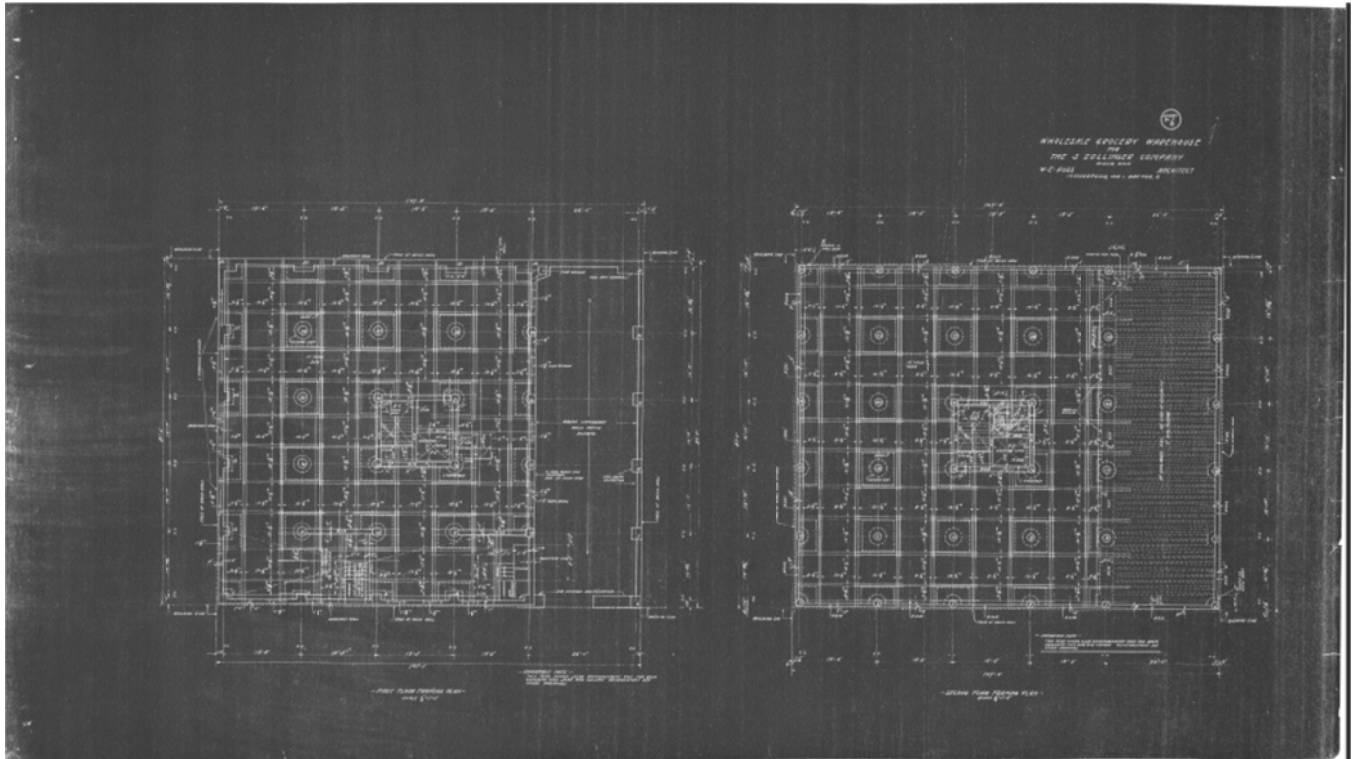
Figure 7: Reflected ceiling plans showing structural layout of the Zollinger Building prepared by William Earl Russ, Architect, in 1914.

Construction drawings of the Zollinger Building (**Figures 3-7**), a description of the building published in the *Piqua Daily Leader Dispatch* on February 3, 1915, upon its opening, and a 1947 photograph (**Figure 8**) of the building provide evidence of its exterior appearance and layout of spaces. Construction drawings depict a three story, rectangular building with brick walls 107 feet by 87 feet in dimension with a flat roof and a partial basement of concrete construction. The four faces of the building vary in their treatment, ranging from the most ornate main Wayne Street

The arrangement of elements along the exterior walls, from the vents along the foundation to the setting of doors and windows, suggests the organization and uses of the interior spaces of the Zollinger Building. The building is openly planned around a central circulation core with a staircase, an elevator that provides access to all the floors, and a spiral ramped steel chute boxed in a corner to move goods between floors. A grid comprised of six mushroom columns in each direction provides structural support to the building. A row of columns in each direction is engaged with the exterior walls, while the remaining twenty four columns are free-standing or engaged with the central core. With the exception of the south bay looking at Wayne Street and associated with the large doorway, each bay is a square 19 feet 3 inches in dimension. The south bay is 26 feet 11 inches wide with the distance between columns remaining 19 feet 3 inches in the transverse direction. The open plan with largely unrestricted spaces at all floor levels, as well as the dimension and configuration of the structural grid lend their support to the functions of the warehouse. Indeed, that much of the building's arrangement and character relates to utility becomes clear in the layout of its spaces (**Figures 3-7**).

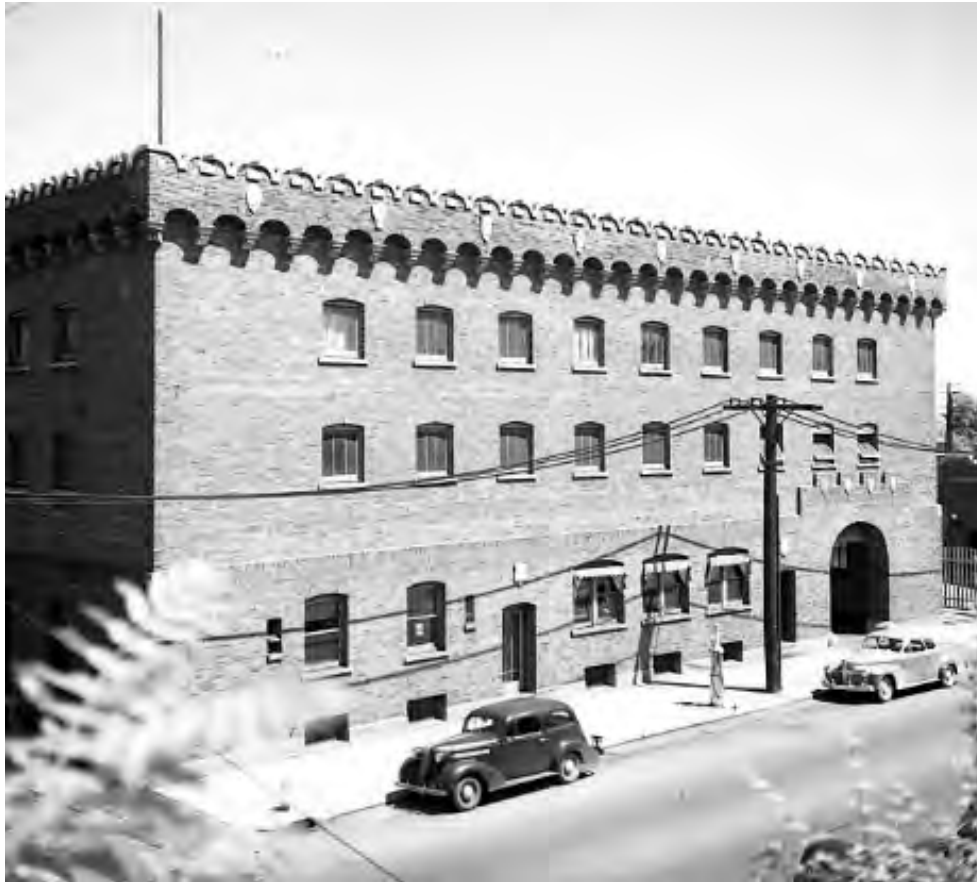
Figure 8: Photograph of the S. Zollinger Company Building looking southeast, 101 South Wayne Street, Piqua, ca. 1945 (Piqua Chamber of Commerce File, Piqua Public Library).

The main façade comprises a first floor that is separated from the upper floors by a brick coping (**Figures 6 and 8; Photograph 5**). A large, elliptical arched, wooden, multi-paneled sliding doorway topped with a brick arch is set in the south bay of this façade (**Photograph 6**). Construction drawings show that cast iron lamps were to be installed on either side of the gateway; however, the lamps were never installed, as confirmed by the historic photograph (**Figure 8**) of the building and its contemporary appearance. The coping above the first floor level over the gateway is expressed as battlements, within which are set terra cotta cartouches with the S. Zollinger Company initials engraved on them. A raised concrete foundation with rectangular vents shows the location of the part basement that extends to the fourth bay from the north, allowing for ground level entry for vehicles to the building from the large gate in the fifth bay.

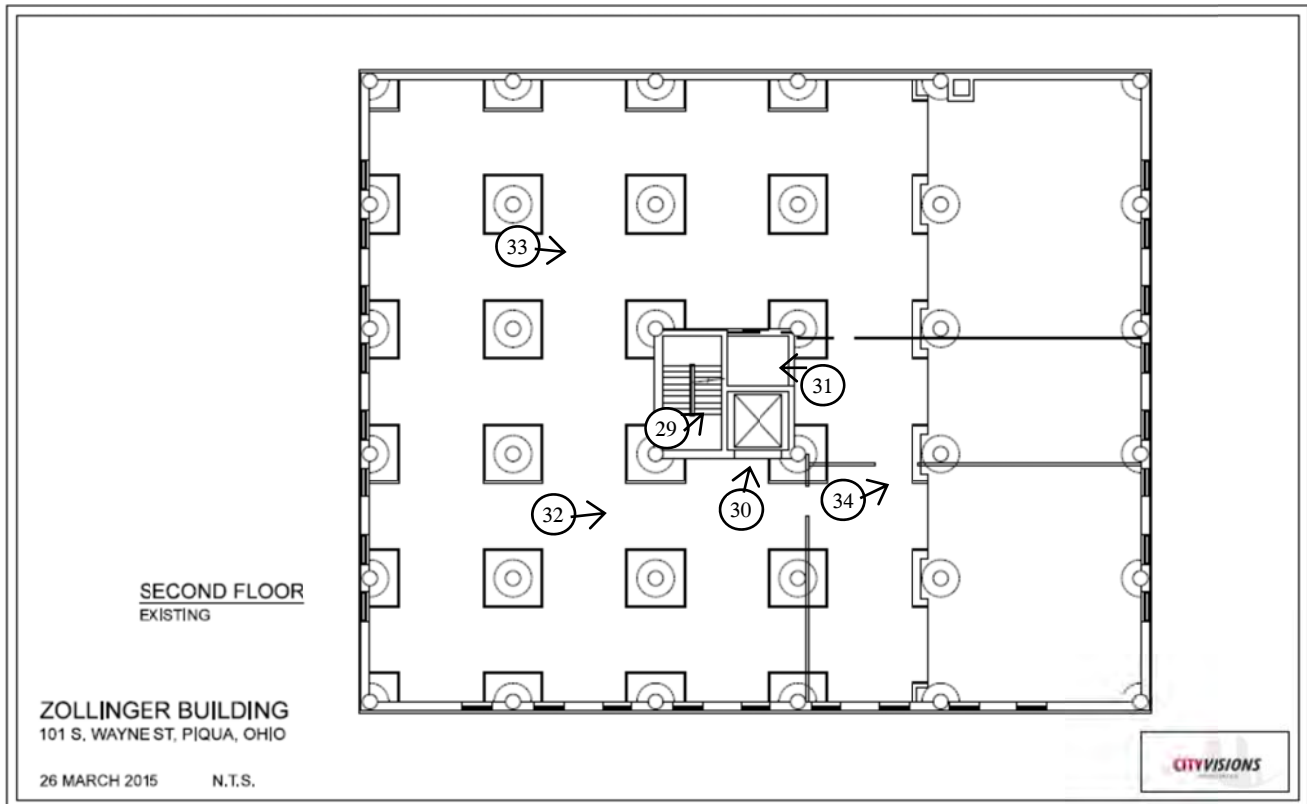
Figure 11: Existing Second Floor Plan, Zollinger Building showing locations of photographs 29-34 (City Visions, Inc.)

With the exception of the newer partitions at the second floor level, the second and third floors appear largely unaltered (**Photograph 34; Figure 11**). At the third floor level, portions of the plaster that cover the clay tiles attached to the ceiling of the southern-most bay have peeled off, revealing the tiles behind (**Photograph 37; Figure 12**). The configuration of the central circulation core is intact. While the original elevator gates at the different floor levels remain intact, the elevator car has since been removed. The downspout pipe in the staircase landing has deteriorated and leaks when there is precipitation. The chute is intact in appearance; however, it is covered with rust due to lack of use and maintenance, and its usefulness could not be ascertained (**Photographs 28, 29, and 31**). The terrace is also in a good condition, with newer

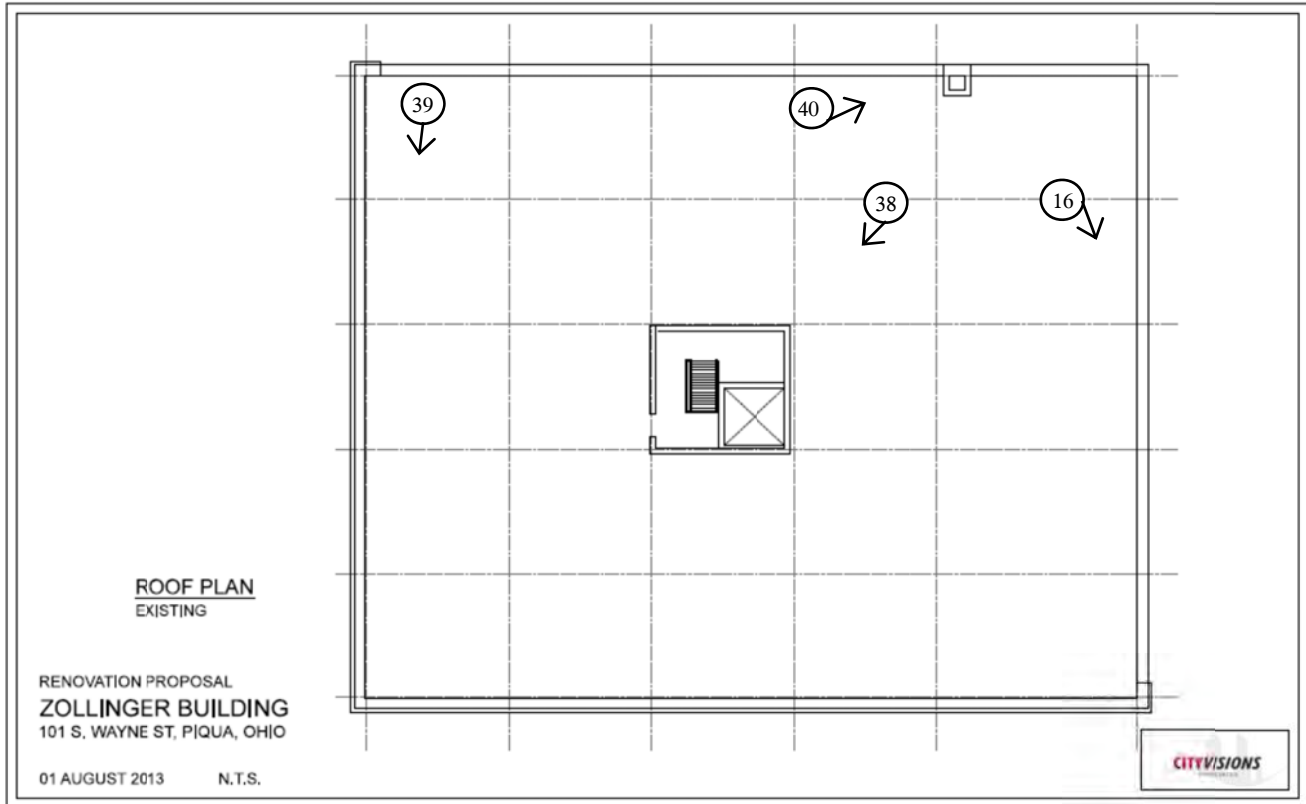
Figure 13: Existing Terrace Floor Plan, Zollinger Building showing location of photographs 16 and 38-40 (City Visions, Inc.)

asphalt covering the surface while some of the vitrified tiles used as coping are missing **(Photographs 16 and 40; Figure 13)**. As mentioned above, three small rooms, likely for storage, have been partitioned off with wood-frame walls in the otherwise unaltered basement **(Photographs 41; Figure 9)**.
