KENTUCKY HISTORIC RESOURCES
Individual Inventory Form

Resource # 175
Madison County

1. Name of Resource: Kirksville Christian Church

KENTUCKY HISTORIC RESOURCE INVENTORY SUPPLEMENT
BOUNDARY AND LOCATION INFORMATION

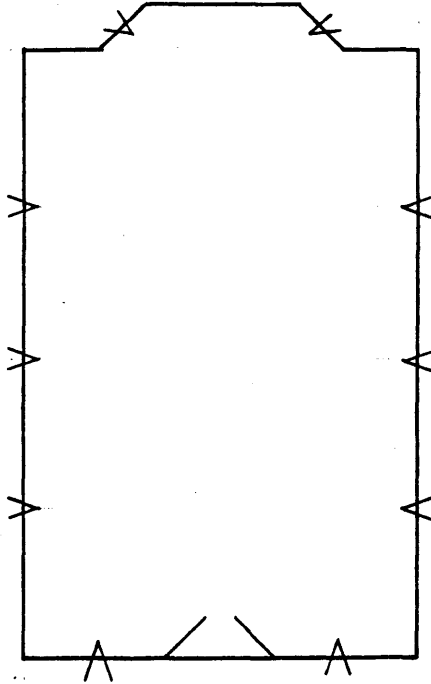
The Kirksville Christian Church is a one story rectangular frame sanctuary building with the entrance on the gable end. The front or east facade is three bay with a central doorway. The paired doors form a lancet shape. The windows to either side of the door are lancet shape with a half lancet lunette in the apex of the gable. The south and north facades are three bays formed by windows similar to those on the front. The foundation is brick. A bay window projects from the rear or west facade of the building. The roof is gable shaped with overhanging eaves upheld by wooden brackets.

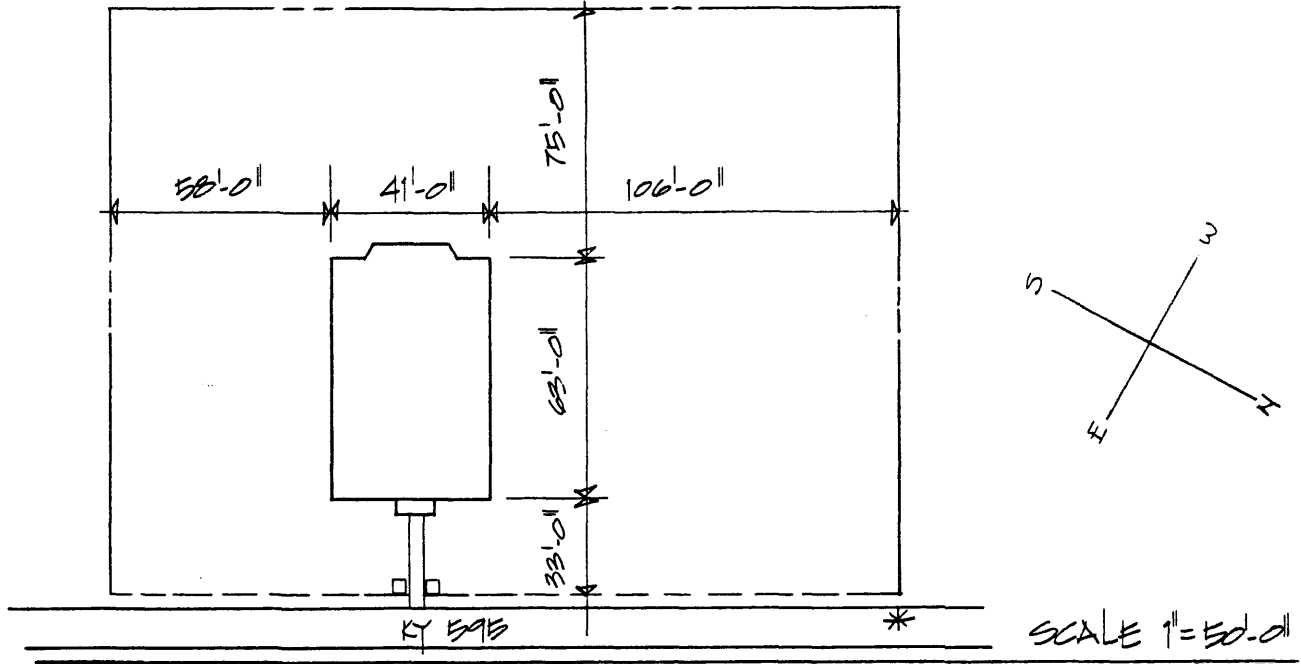
Sketch of Site Plan (Showing outbuildings, structures, landscape features and the site boundary as described above.)

From a point in the west right of way of KY 595, then south 205 feet to a point; then west 171 feet to a point; then north 205 feet to a point; then east 171 feet to the point of beginning. The point of beginning is 106 feet north and 33 feet east of the northeast corner of the church.

The boundary was chosen to preserve the church's setback from, the road (KY 595) and to provide a minimal setting for the building.
