NATIONAL REGISTER OF HISTORIC PLACES
REGISTRATION FORM

historic name Van der Veer - Harris House
other names/site number Van Derveer House

name/title Ann M Keen, Architectural Historian
organization Farewell Mills Gatsch Architects, LLC date February 2007
street & number 200 Forrestal Road telephone 609/452-1777
city or town Princeton state NJ zip code 08540

**Van der Veer – Harris House
Somerset County, New Jersey
Description**

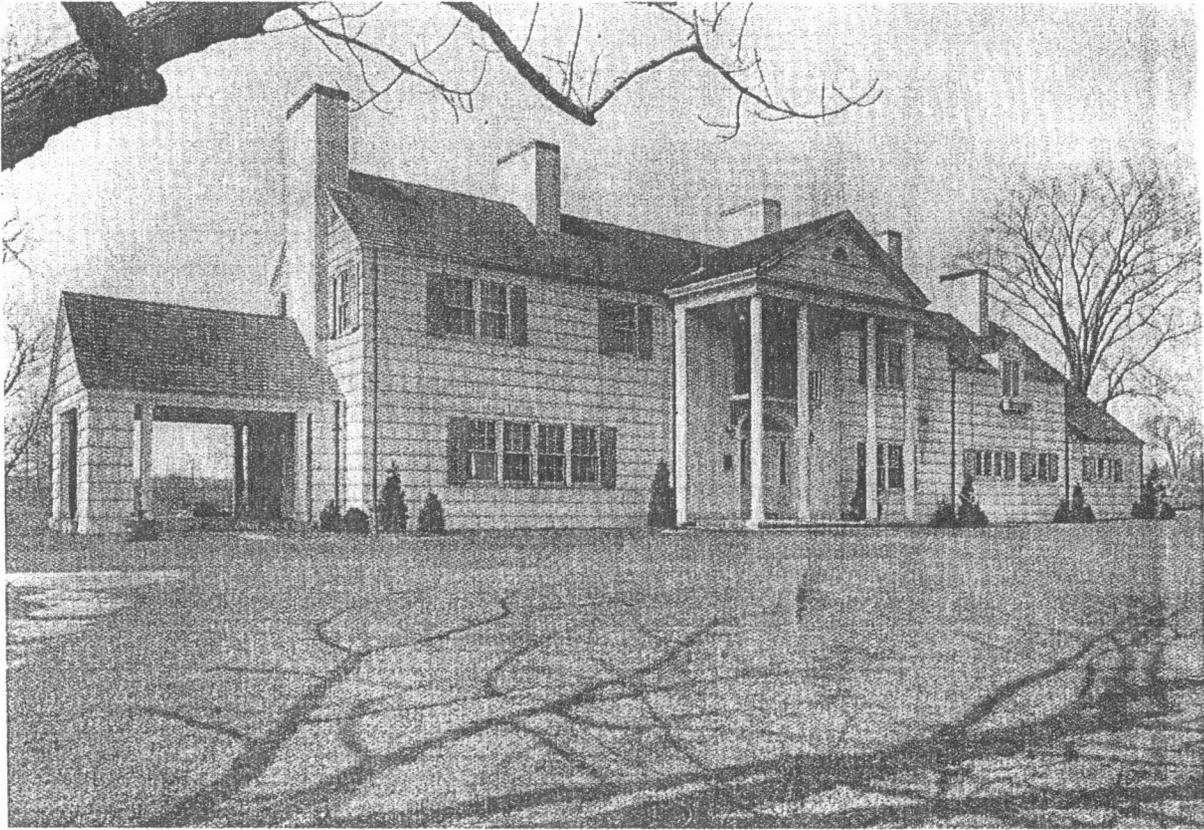
Murry Lee House, Rye, New York, by Patterson and Willcox, Architects. Printed in *The Architect*, vol. 6, June 1926, Plate LXX.

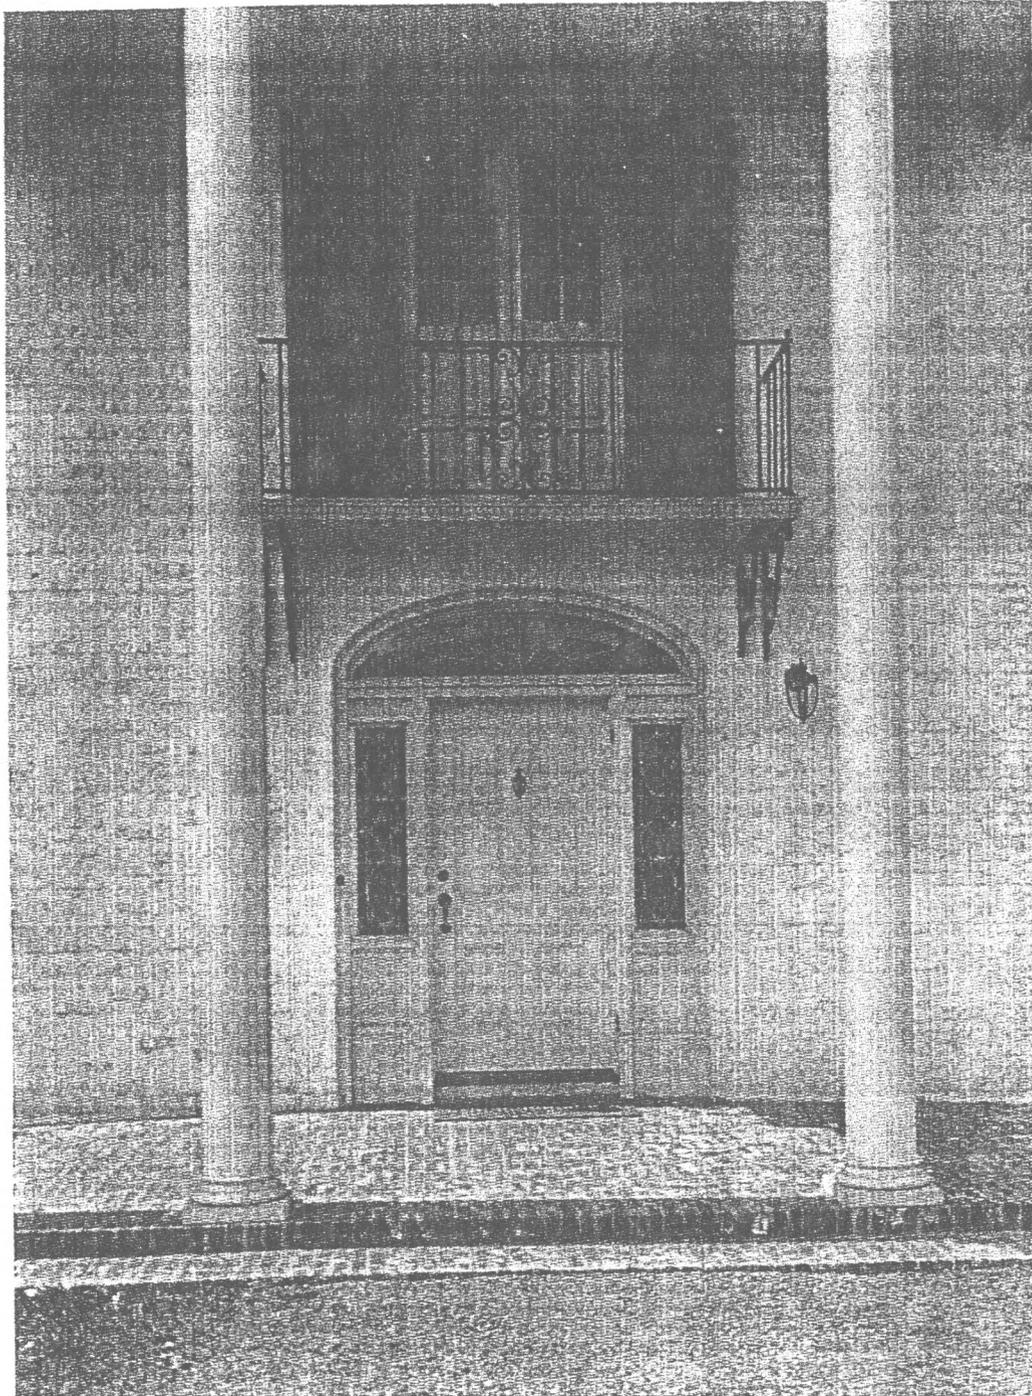
Murry Lee House, Rye, New York, by Patterson and Willcox, Architects. Printed in *The Architect*, June 1926, Plate LXXI.

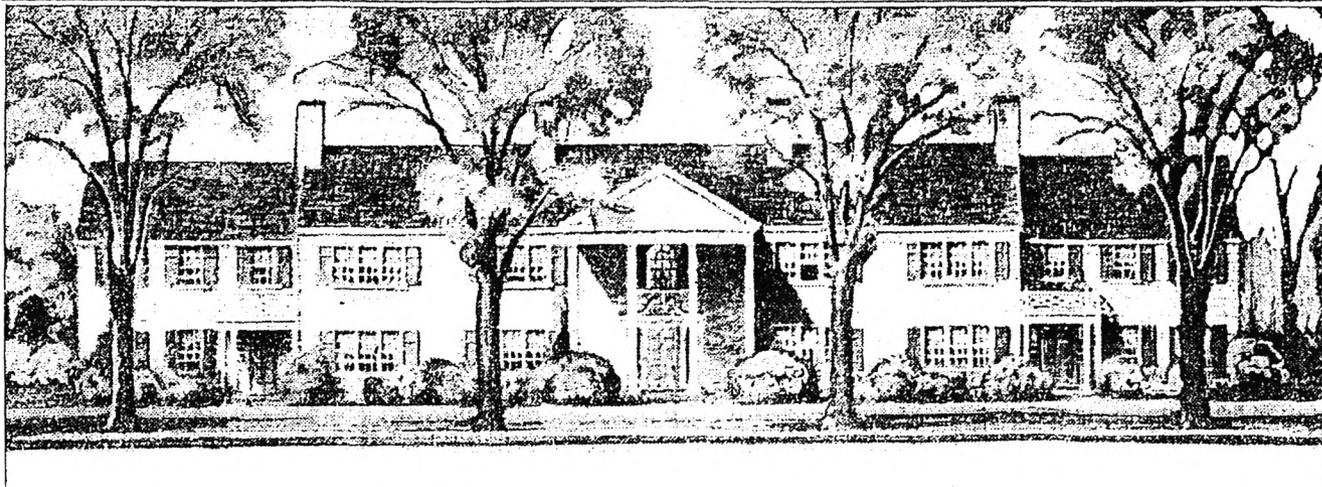
Apartment Building for Everett T. Young, Peekskill, New York, by Chester A. Patterson, Architect.
New York Times, 17 March, 1929, p. RE2.

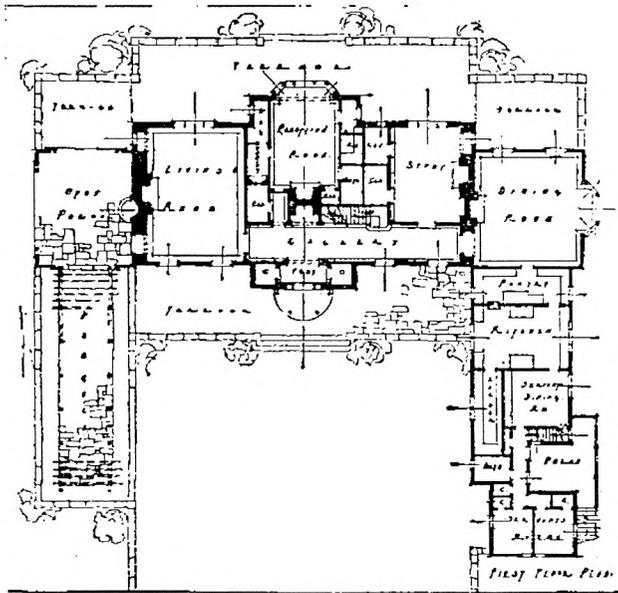
Large Living Room and Gallery Are Features of First Floor Layout.

AN INTERESTING example of Long Island Colonial design in a modern country house is found in the residence being erected at Mill Neck, L. I., for Mrs. Prescott Slade. Construction has been started by the O'Sullivan Harney Company, and completion is scheduled for next June. The cost will be about \$150,000. Chester A. Patterson is the architect.

On the second floor is a commodious owner's suite of chamber, dressing room and bath, with fireplace and built-in dressing table; four double bedrooms, each with bath, and a servants' wing of six maids' rooms

and two baths. In exterior design the house is of pleasing low lines, proportioned to nestle into its hill-top setting, a harmonious feature of this rolling section of the Long Island north shore.

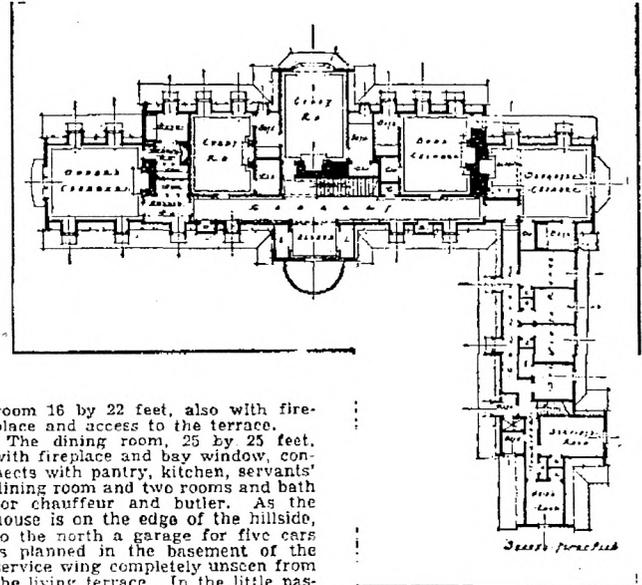
The Owner's Suite and All Chambers Have Individual Baths.

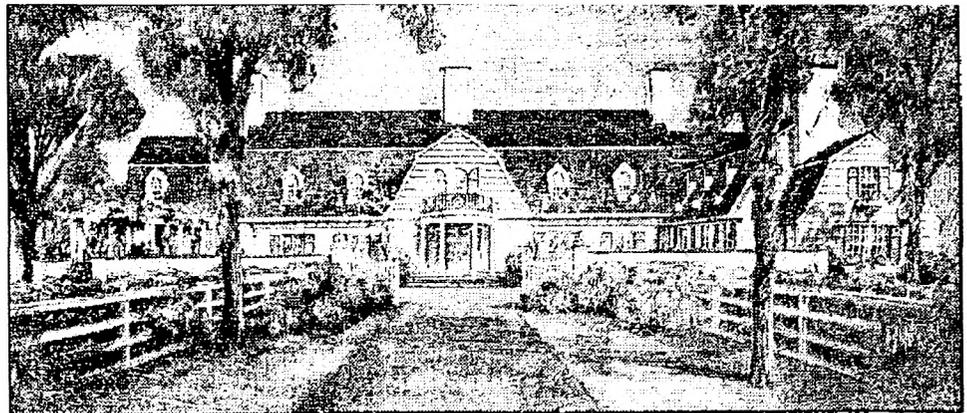
Country House of Mrs. Prescott Slade, Being Erected at Mill Neck, L. I. Chester A. Patterson, Architect.
