NEW JERSEY OFFICE OF CULTURAL AND ENVIRONMENTAL SERVICES
HISTORIC PRESERVATION SECTION
INDIVIDUAL STRUCTURE SURVEY FORM

HISTORIC NAME: Glanville Blacksmith Shop
LOCATION: 47 Bank Street

COMMON NAME: Wells Rug Service
BLOCK/LOT B283/L 11 & 12

MUNICIPALITY: Morristown
USGS QUAD: Morristown
OWNER/ADDRESS: Wells Holding Co., Inc.
130 Pollard Rd., Mountain Lakes, NJ 07046

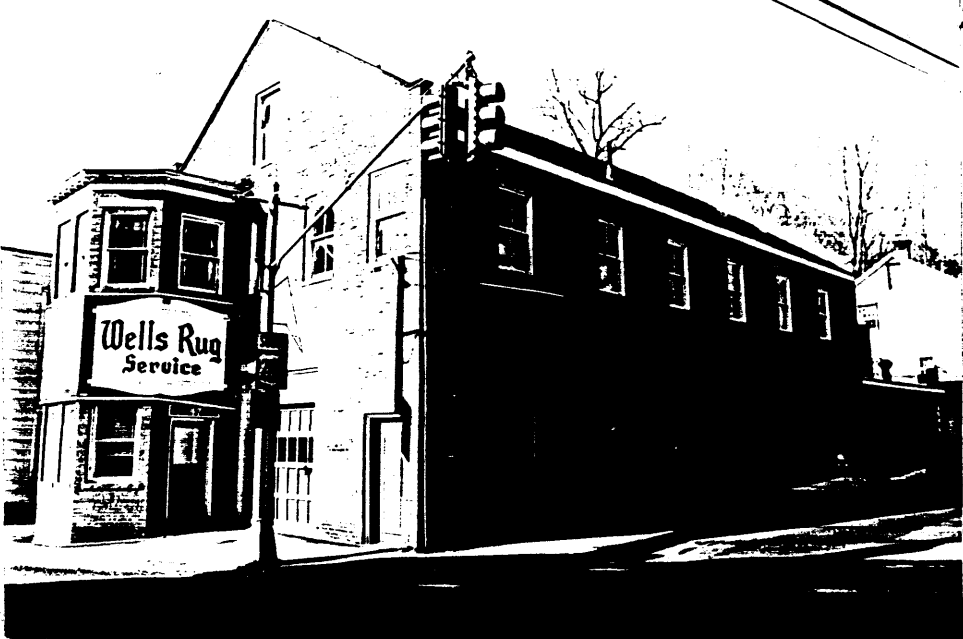
PHOTO Negative File No.

- eared and corbelled gable end parapets; flush eaves on both sides with wooden fascia board
- semi-octagonal, 2 story front bay has a wooden, modillioned and denticulated cornice, 1/1 sash windows with stone lintels and sills, and an entry with modern glass and panel door.
- wide main entry, occupying the two middle bays, is fitted with a modern overhead garage door; above it the original opening is framed in and spanned with a steel I-beam.
- secondary entry in north end bay has a stone sill, molded surround and a modern panel door
- a painted sign, now badly faded, on the north wall advertised, "Glanville & Gaston" and a carpentry furniture repair business.

COMMENTS: Both structures are in need of some maintenance and repairs. *"horse shoeing" in a new brick building on the corner site. On June 16, 1905 the newspaper commended Henry W. Armstrong's new livery stable on Bank Street, evidently the frame structure at #45. Sometime between 1916 and 1919 Armstrong moved several doors down the street and opened a combination livery and garage. Glanville apparently took over the frame building, but by 1923 his blacksmithy had ceased operation.
