KENTUCKY HISTORIC RESOURCES  
Individual Inventory Form

Resource # Be-10  
Boone County

1. Name of Resource:  
Flick house

5. Location:  
6282 Burlington Pike  
Bellevue, KY 41005

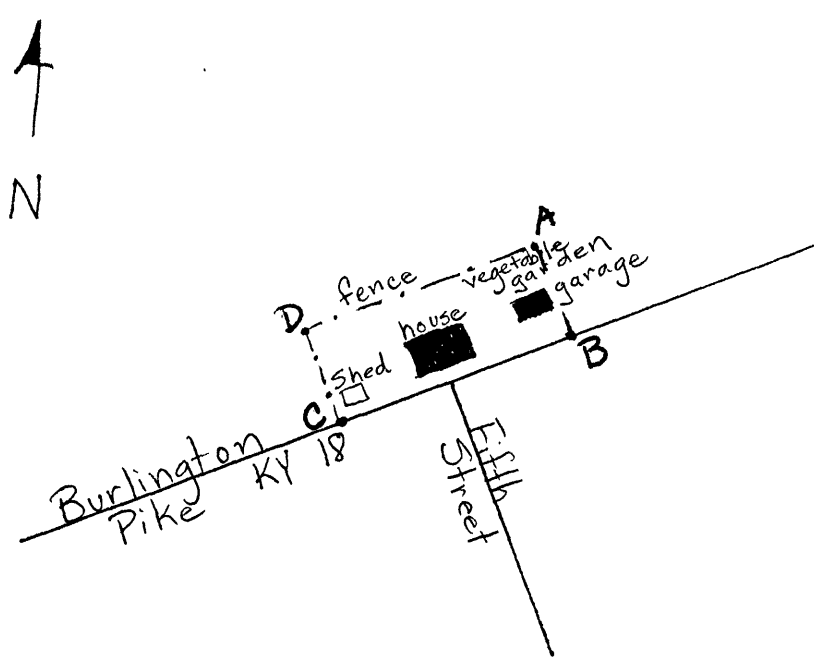
44. Site Plan (and boundary description and justification for N.R. sites):

Beginning at a point (C) on the north side of Burlington Pike (Ky 18) and 100' southwest of Fifth Street, proceed northwest 200' (D). Then proceed northeast 250' (A), turning southeast for 200' to the north side of Burlington Pike (B). Then proceed southwest along Burlington Pike 250' to the point of origin. The boundary includes the house, outbuildings, and contiguous field and garden. The much larger tract behind the house and historically associated with it has lost integrity and is now used as a gravel pit.

Contributing: 2 buildings, 1 structure  
 Noncontributing: 1 building

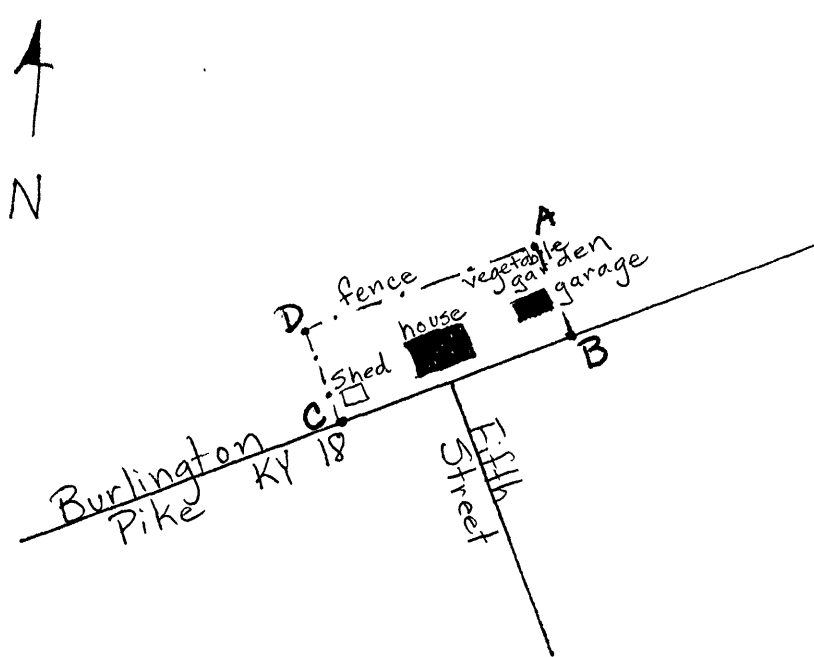
44. Site Plan (and boundary description and justification for N.R. sites):

Beginning at a point (C) on the north side of Burlington Pike (Ky 18) and 100' southwest of Fifth Street, proceed northwest 200' (D). Then proceed northeast 250' (A), turning southeast for 200' to the north side of Burlington Pike (B). Then proceed southwest along Burlington Pike 250' to the point of origin. The boundary includes the house, outbuildings, and contiguous field and garden. The much larger tract behind the house and historically associated with it has lost integrity and is now used as a gravel pit.

Contributing: 2 buildings, 1 structure  
 Noncontributing: 1 building
