National Register of Historic Places Registration Form

Historic name: Reformed Church of Melrose

Street & number: 746 Elton Avenue

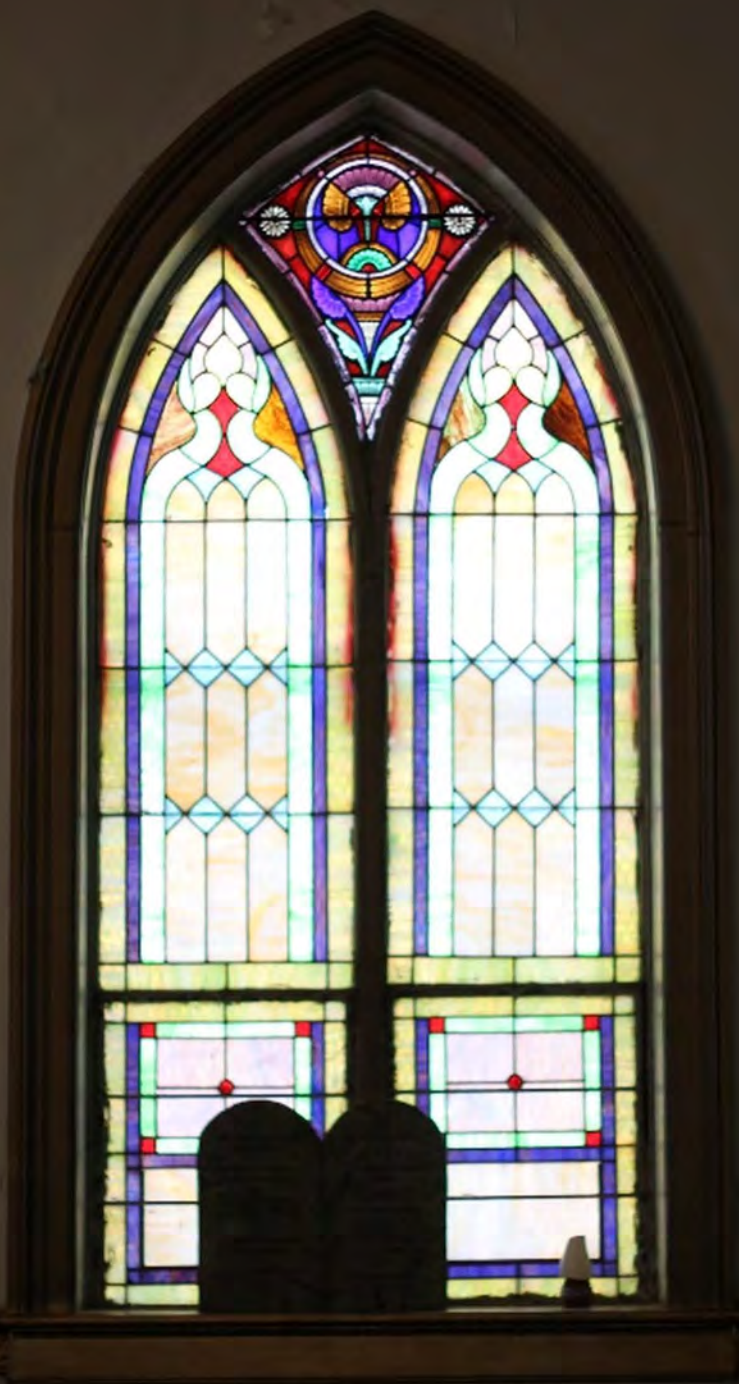
Looking down the primary access stairs from the main sanctuary space. Note how the stairs cover the stained glass windows. These windows can be seen from the outside at the first floor of the primary façade. (April 28, 2016).

The building's primary entrance is located at the west façade behind a metal roll-up door. Behind the roll-up door, wood non-historic double doors provide access to a small, carpeted lobby. To the north and south, wide, L-shaped stairs lead up to the main floor. The stairs are likely additions, as they cover up the original stained glass windows at the ground floor of the façade (Figure 8).
