Address 76 Treaty Elm Lane

Historic Name Hapgood House

INVENTORY FORM CONTINUATION SHEET

National Register of Historic Places  
Continuation Sheet

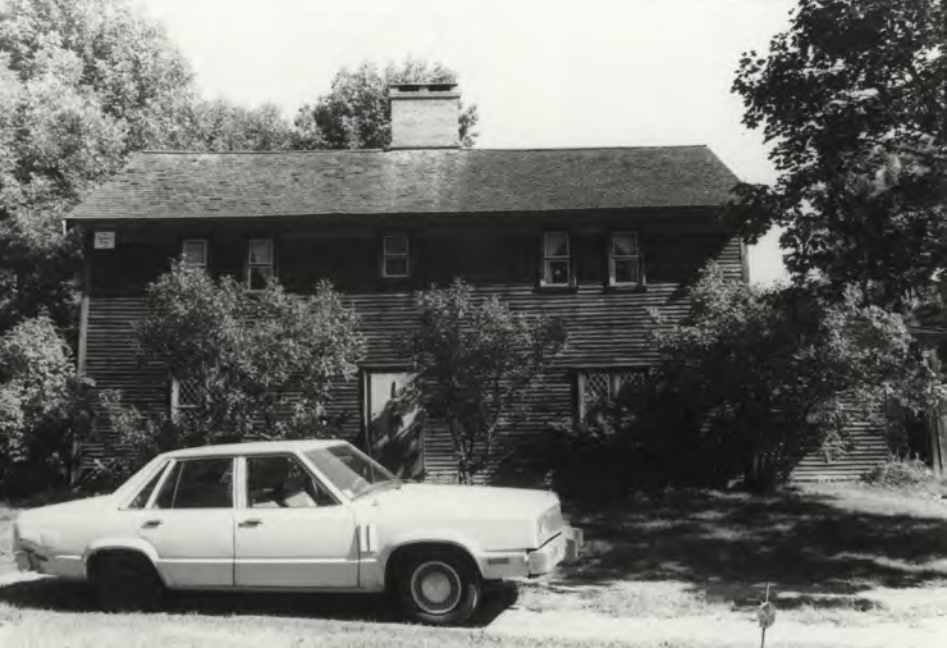
- 7:8 exterior  
7:9 exterior  
7:10 first floor, left-hand room  
fireplace  
7:11 first floor, left-hand room  
summer and joists  
7:13 first floor, stair hall  
7:14 2nd floor, stair hall

The Hapgood House is a 2 1/2 story clapboarded central chimney structure five bays wide with an added lean-to and a small one story ell projecting from the right gable end. The roof deeply overhangs the front facade. The first floor windows have been 'restored' to paired casements by the present owner.

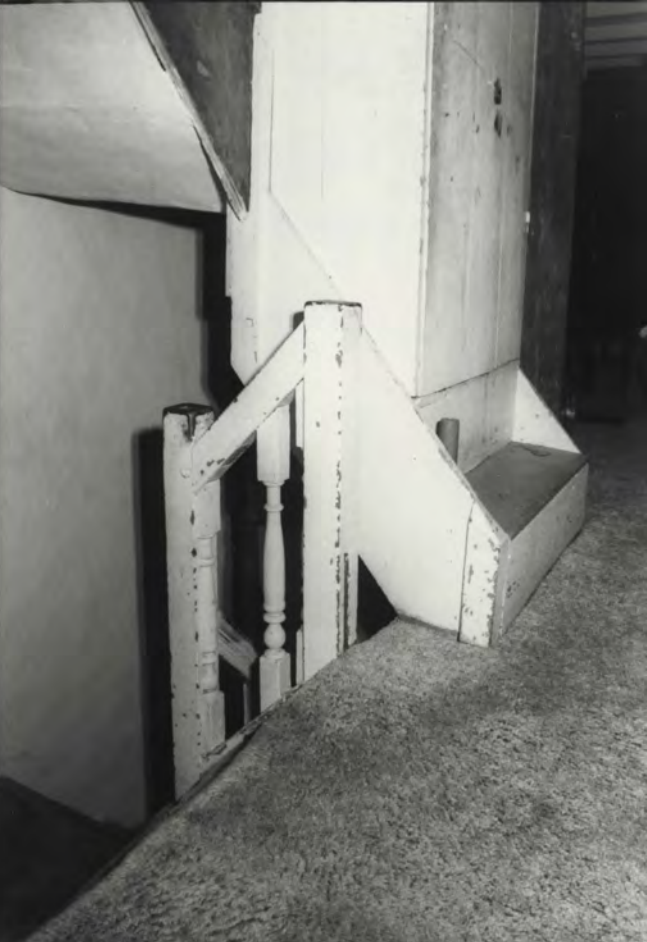
7:14

The lobby retains its original two-landing stairway. The original balustrade has a handrail molded on the outside only, and turned balusters with 1/2 balusters at the top and bottom of each section of the balustrade. The square newels have holes in their tops. The second floor shows evidence that the balustrade originally continued up to the attic (it is now enclosed in vertical sheathing). The top newel post has a mortise hole in the top, and there is a cut off newel at the bottom of the attic stairs. At the point where the balustrade would have joined the wall on the side of the attic stairs, there is a mortise hole filled with a cut off tenon.

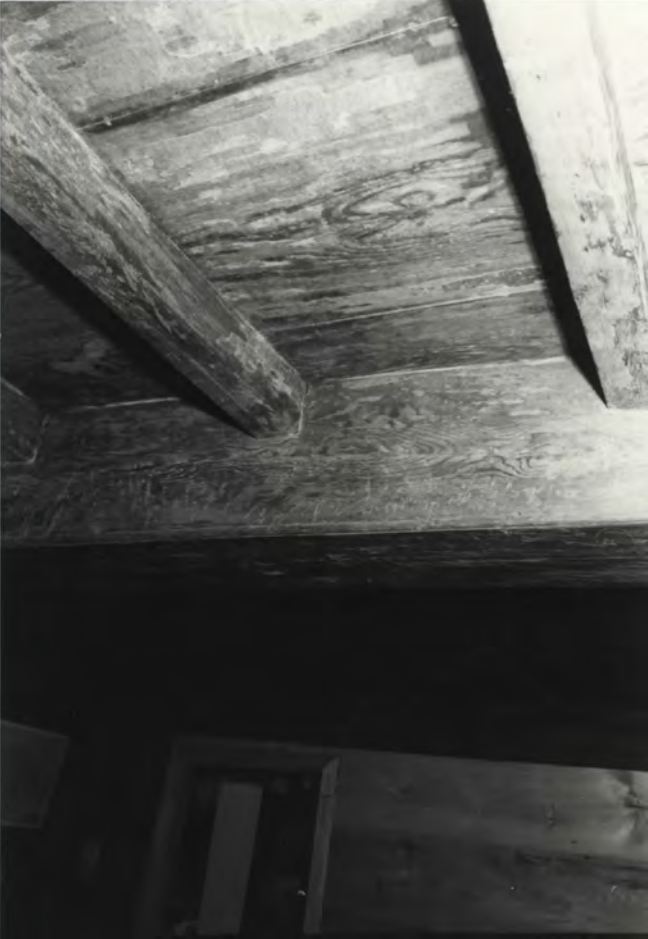
7:11

The house exhibits good transitional features, with beaded beams on the first floor, and unusual longitudinal summer beams on the second floor combined with a common rafter roof. The first floor left room has exposed longitudinal summer beam, front, rear, and chimney girts with late First Period quirk beading. The exposed joists are 22" apart on center. The original fireplace, exposed by the present owner, measures 89" x 57" and has a wide smoke panel in the rear wall and the remains of a beehive oven in the left side, which would have originally projected out of the rear wall of the house. The right first floor room has exposed quirk-beaded longitudinal summer beam and chimney girt. The exposed joists are 22" apart and have slightly planed edges, resulting in a very narrow flat chamfer decoration.
