### National Register of Historic Places Registration Form

Historic name U.S. Inspection Station—Beebe Plain, Vermont

*U.S. Inspection Station—Beebe Plain  
Orleans County, Vermont*

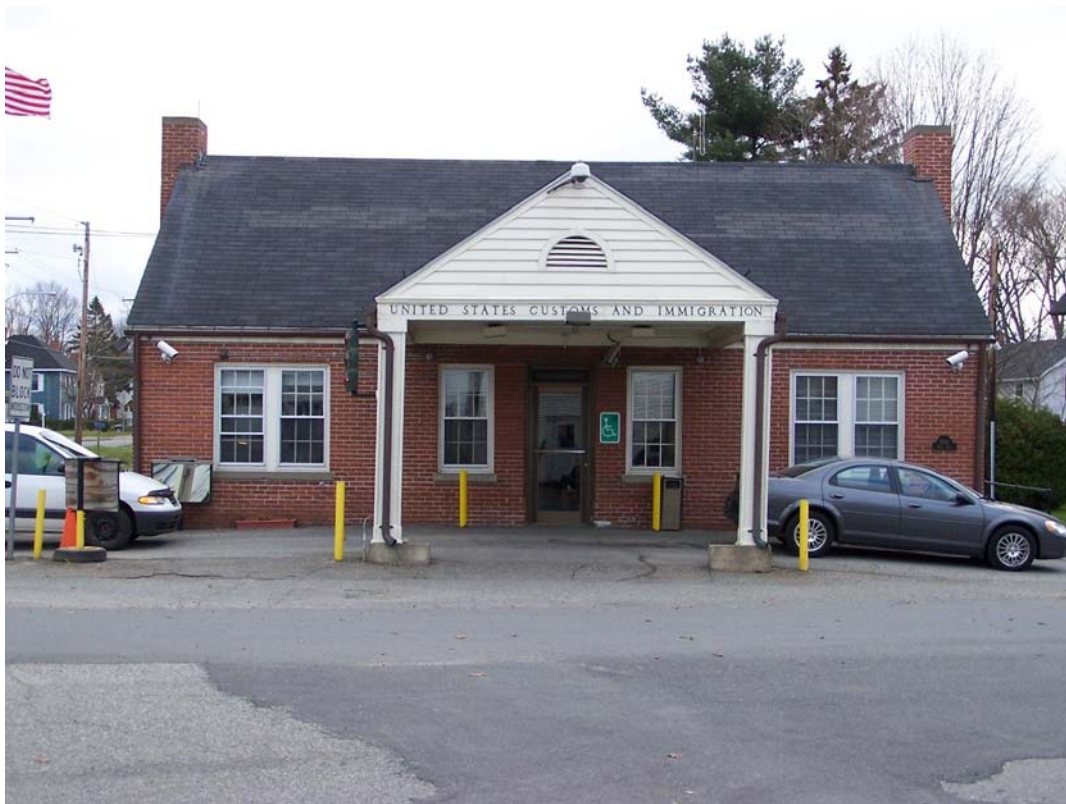
*Photo number:* VT\_OrleansCounty\_BeebePlainBorderStation1.tiff

*Description of view:* front elevation, view: east

The Beebe Plain Inspection Station possesses a variety of Colonial Revival design features. The complex 3-bay front elevation is highly symmetrical, and features a centered front entrance. The centrally located entrance bay consists of an aluminum frame single leaf storefront door that is a later, c.1960s era alteration. This door frame is of a similar stained aluminum and features a single transom window. This door is flanked closely on either side by 6/6 wood frame double hung sash windows inset into the wall with molded wood picture framing and underscored by exposed concrete sills. Each outer bay of the front elevation features a pairing of 6/6 woodframe windows with the same design treatment as the windows, except one continuous sill underscores each pair. A bronze aluminum rain gutter with floral patterned bronze bracketing is present at either end of the front elevation.

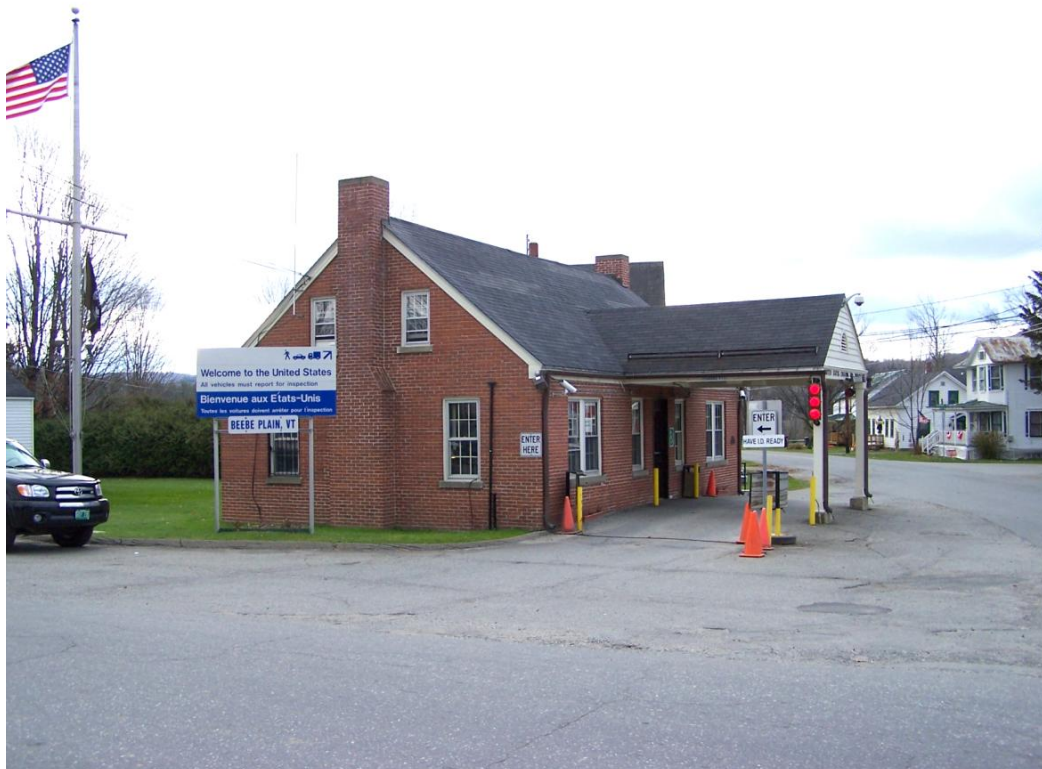
*Photo number:* VT\_OrleansCounty\_BeebePlainBorderStation2.tiff

*Description of view:* north (side) and front elevation, view: southwest

Windows that are 6/6 double hung sash and similar in scale and design features to those at the front elevation are symmetrically placed at the first level of each side elevation. The building features running course brick outside end chimneys at either side, and the southern of these is *faux*. The upper level of each side elevation features smaller scale 6/6 windows, identically treated as the others, placed adjacent to each side of the chimney. A plain fascia is present at each gable. The highly symmetrical rear elevation of the Beebe Plain Inspection Station is 4 bays wide with a 3-bay

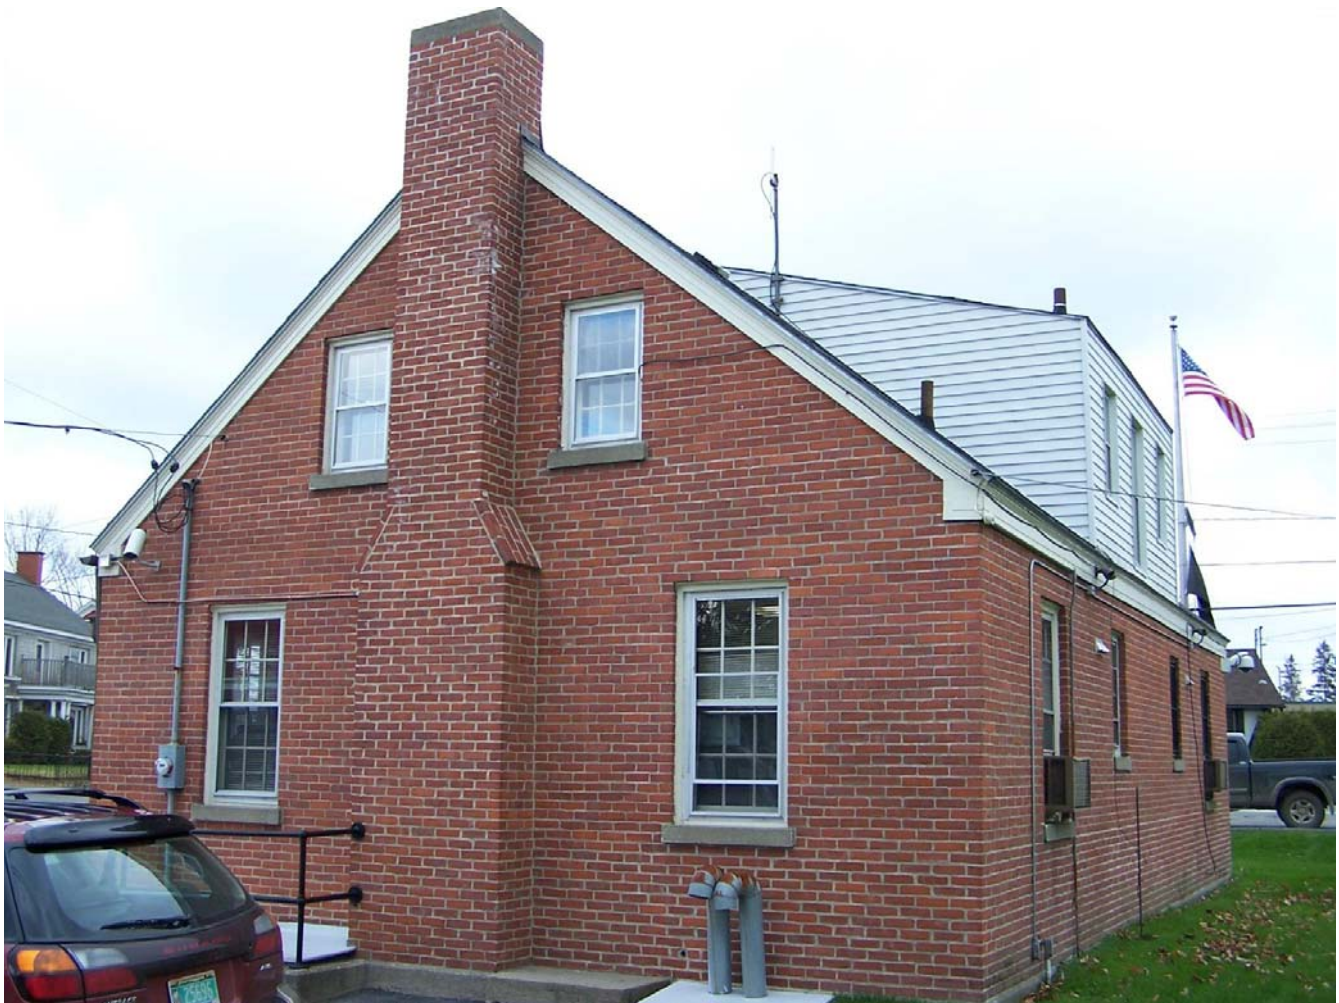
*Photo number:* VT\_OrleansCounty\_BeebePlainBorderStation3.tiff

*Description of view:* south (side) and east (rear) elevation, view: north

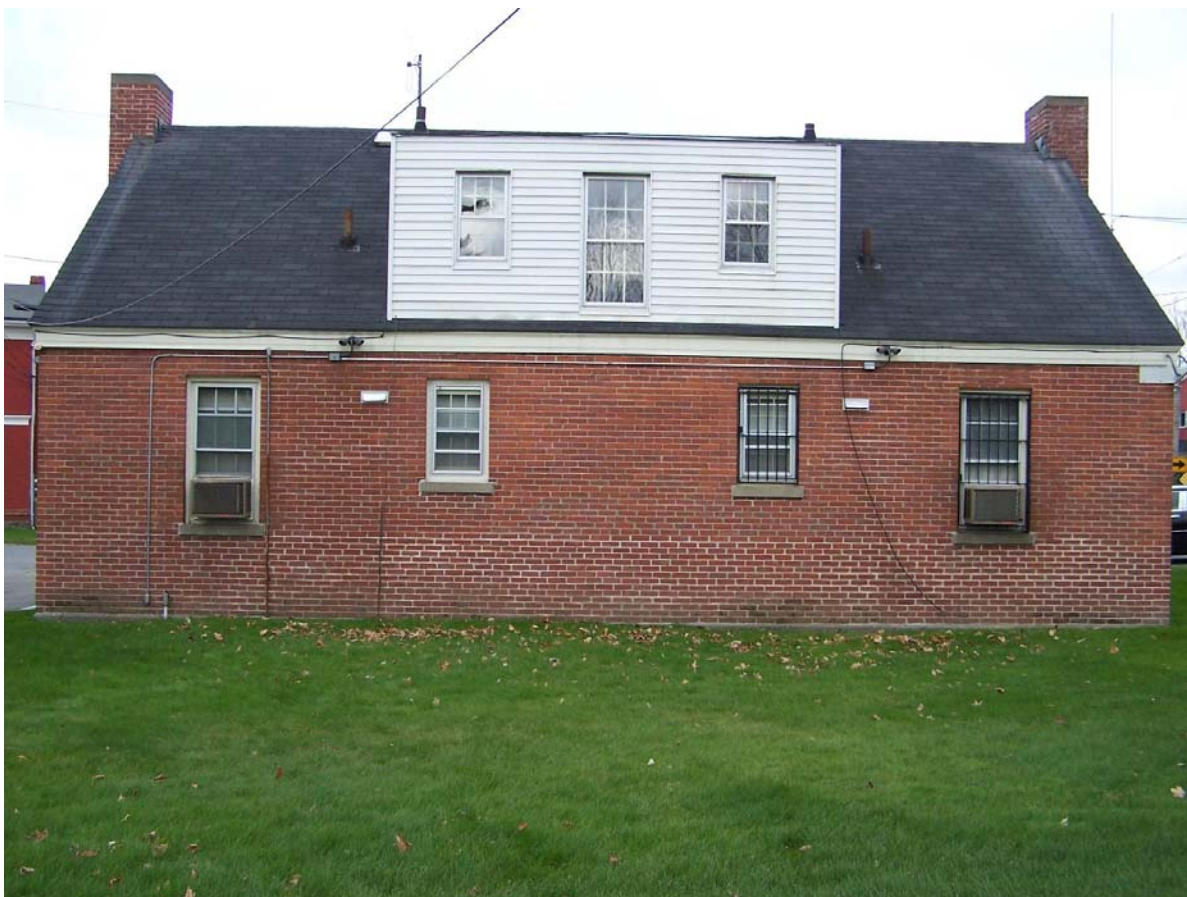
*Photo number:* VT\_OrleansCounty\_BeebePlainBorderStation4.tiff

*Description of view:* rear elevation, view: west

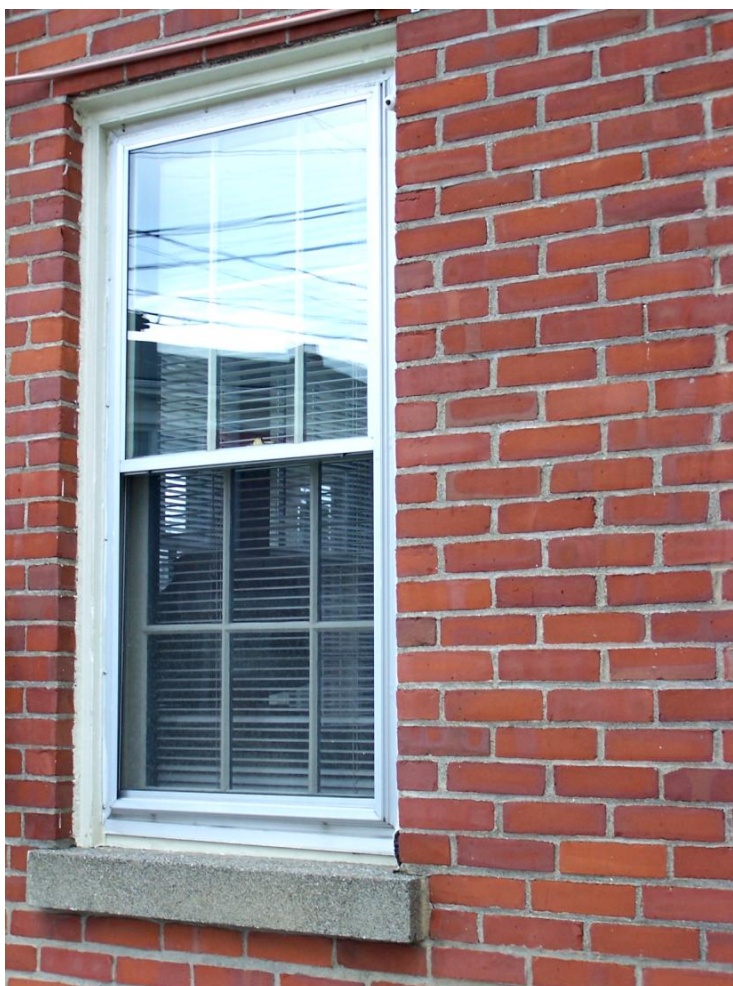
*Photo number:* VT\_OrleansCounty\_BeebePlainBorderStation5.tiff

*Description of view:* standard window, view: northwest

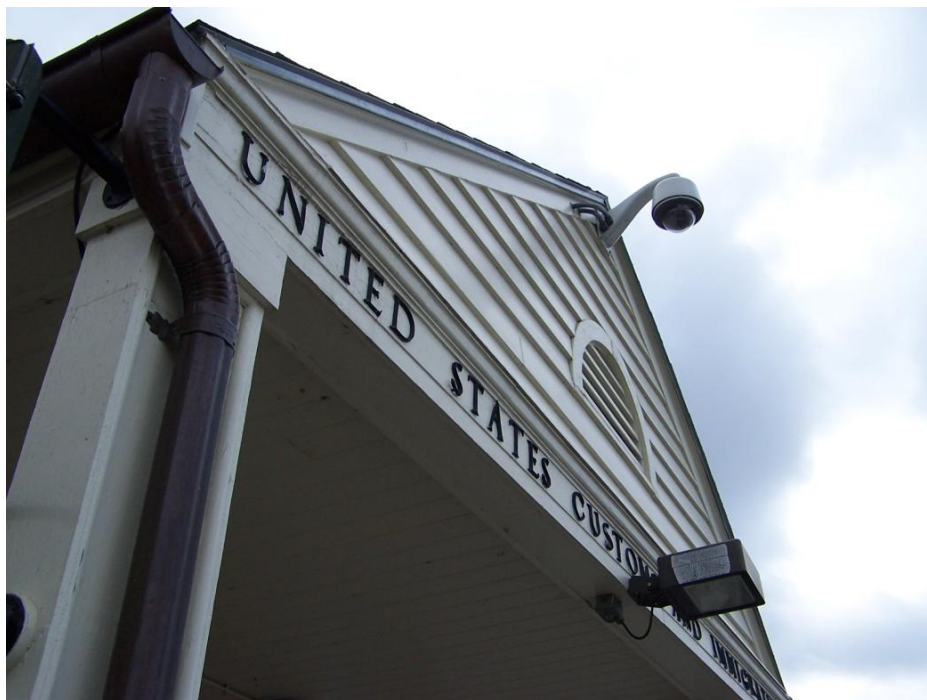
*Photo number:* VT\_OrleansCounty\_BeebePlainBorderStation6.tiff

*Description of view:* porte-cochere gable, view: southeast

The front gable of the porte-cochere is clad in wood clapboard, and centered within it is a lunette shaped vent. Both the gable and the vent are trimmed in wood. At the bottom portion of the gable is metal, Roman style, serif lettering spelling out "UNITED STATES CUSTOMS AND IMMIGRATION." Steel columns clad in paneled wood rectangular columns support the porte-cochere. Bronze rain gutters similarly detailed to those previously mentioned are placed upon each column. A mowed grass yard is present behind both the Inspection Station and the garage. A mast style metal flagpole with a balloon finial is located near the northwest corner of the property.

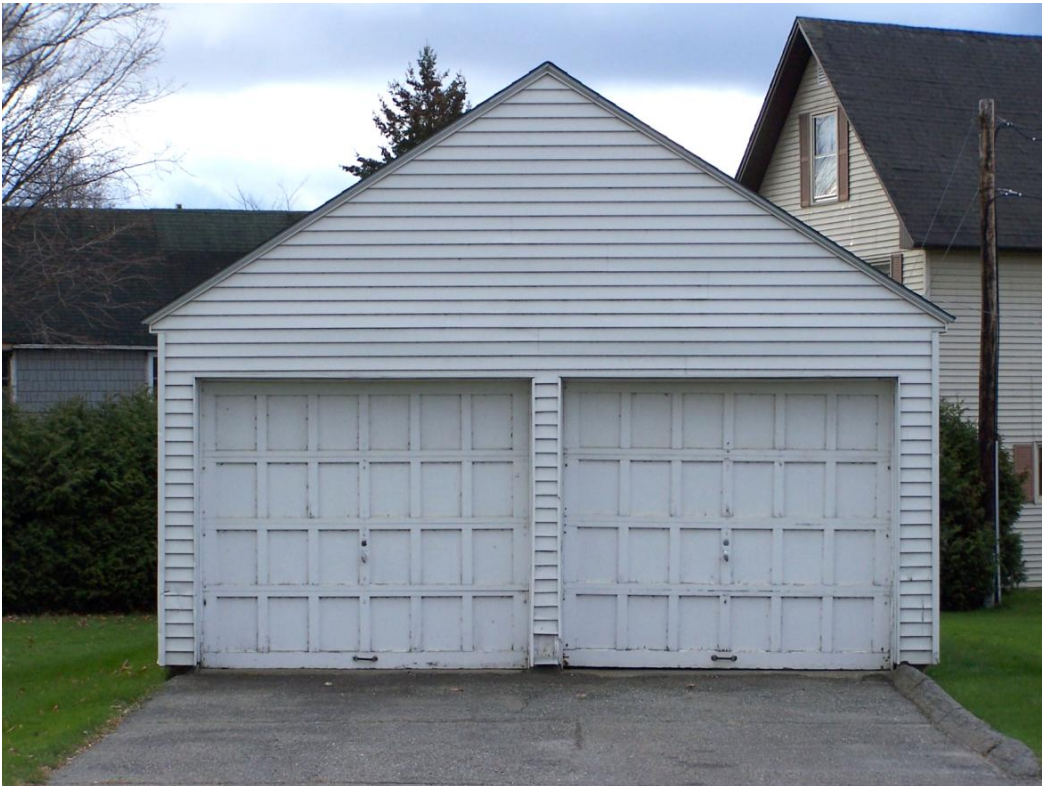
*Photo number:* VT\_OrleansCounty\_BeebePlainBorderStation7.tiff

*Description of view:* garage front elevation, view: south

A detached 2-bay automobile garage is located east of (behind) the inspection station building. The garage is clad in wood clapboard terminated with cornerboards. The roof of the garage is front gabled and is clad in asphalt shingle and is underscored with a fascia board at each side. The garage bay doors are multi-paneled wood. A 6/6 wood frame double hung window with wood trim is present in middle of each side elevation, and in the rear elevation.

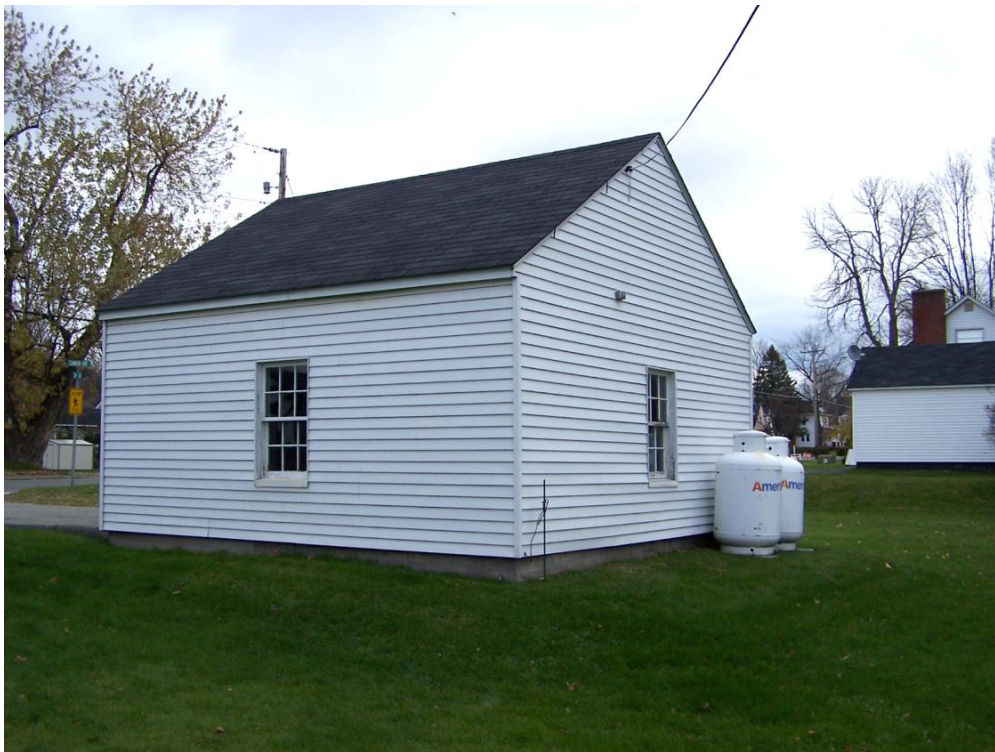
*Photo number:* VT\_OrleansCounty\_BeebePlainBorderStation8.tiff

*Description of view:* garage west (side) and rear elevation, view: northeast

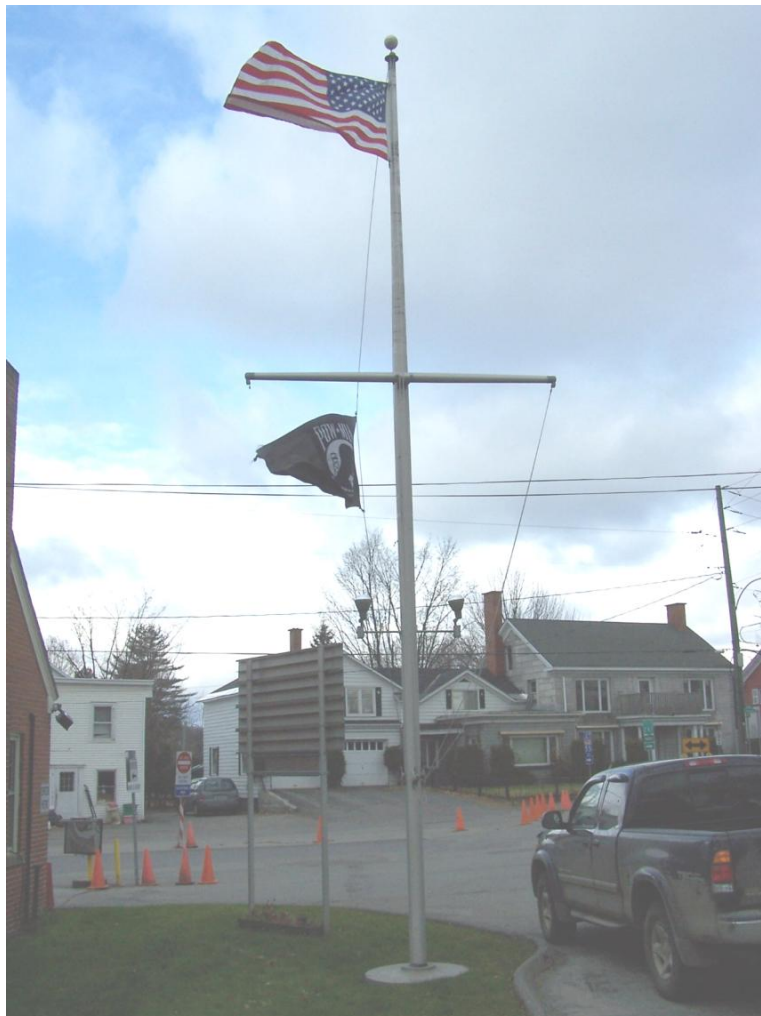
*Photo number:* VT\_OrleansCounty\_BeebePlainBorderStation9.tiff

*Description of view:* flagpole, view: west/northwest

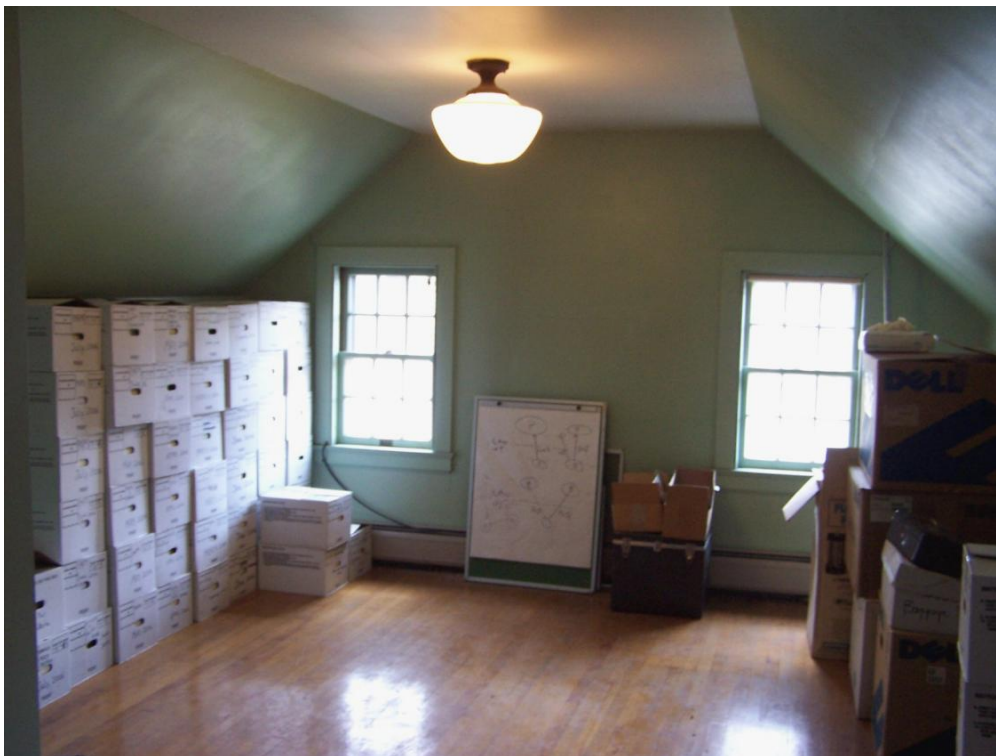
*Photo number:* VT\_OrleansCounty\_BeebePlainBorderStation10.tiff

*Description of view:* general purpose room, second floor, view: south/southeast

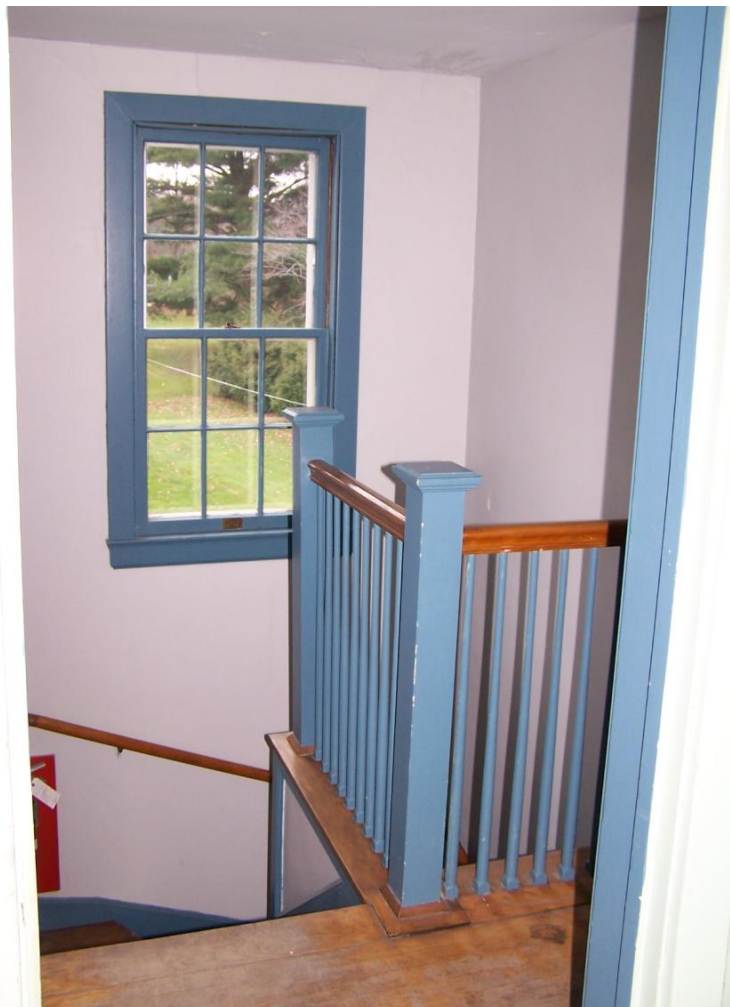
*Photo number:* VT\_OrleansCounty\_BeebePlainBorderStation11.tiff

*Description of view:* stairwell, view: east

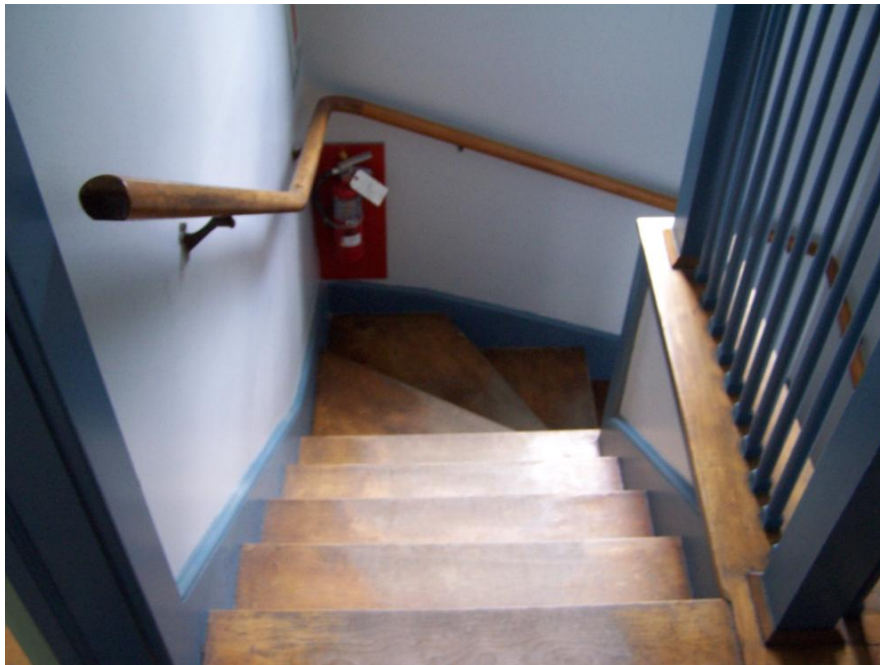
*Photo number:* VT\_OrleansCounty\_BeebePlainBorderStation12.tiff

*Description of view:* stairwell view: east

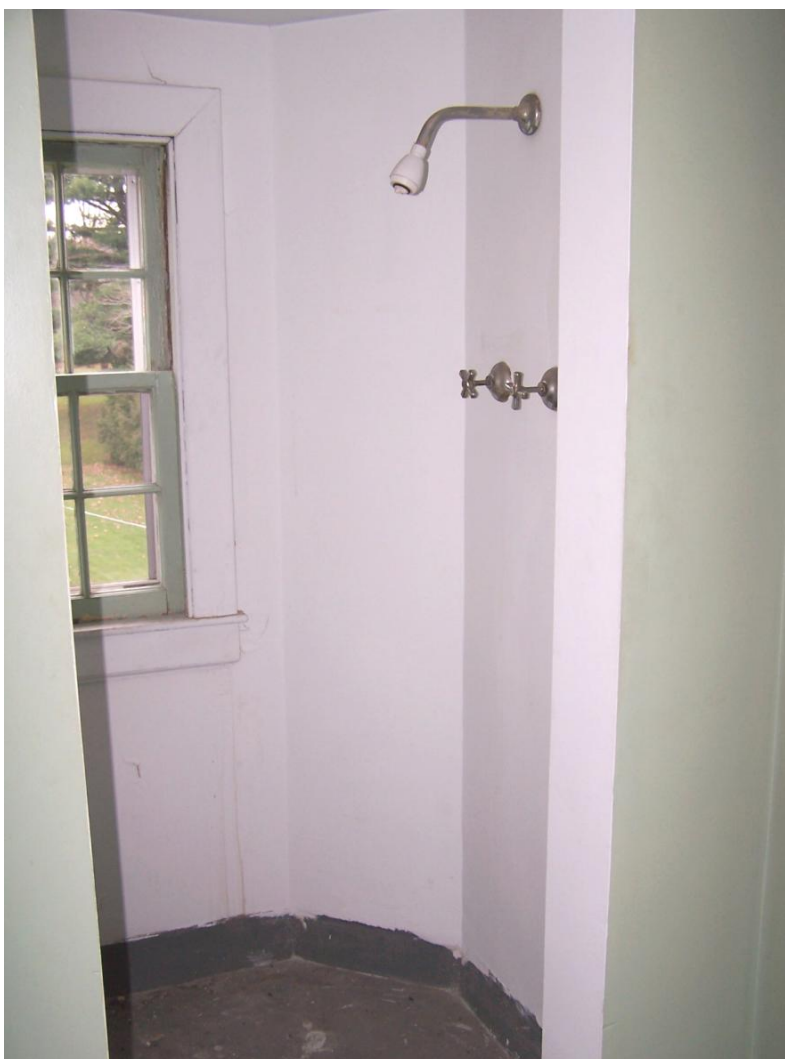
*Photo number:* VT\_OrleansCounty\_BeebePlainBorderStation13.tiff

*Description of view:* shower, second floor, view: east/southeast

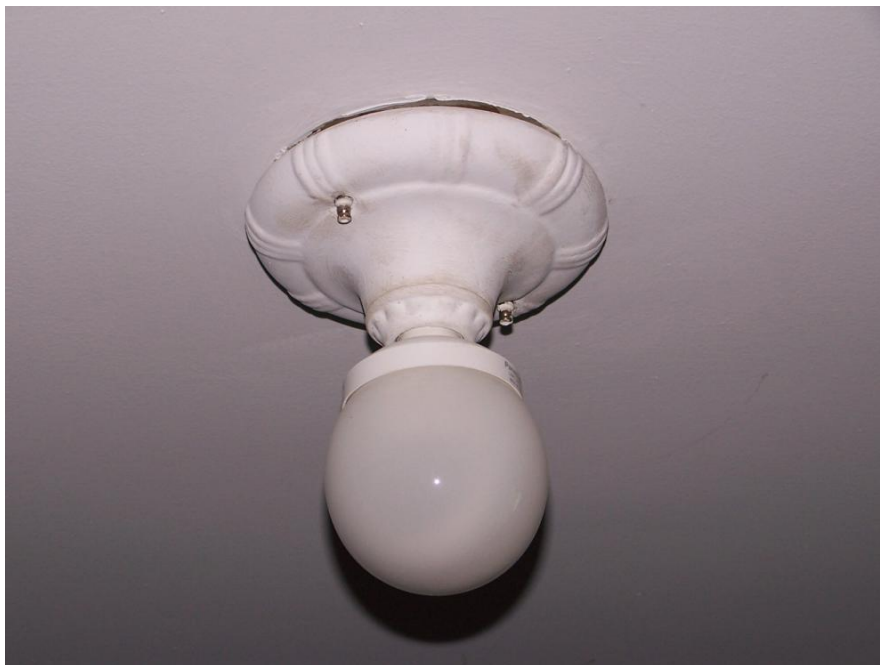
*Photo number:* VT\_OrleansCounty\_BeebePlainBorderStation14.tiff

*Description of view:* original light fixture, second floor, view: south

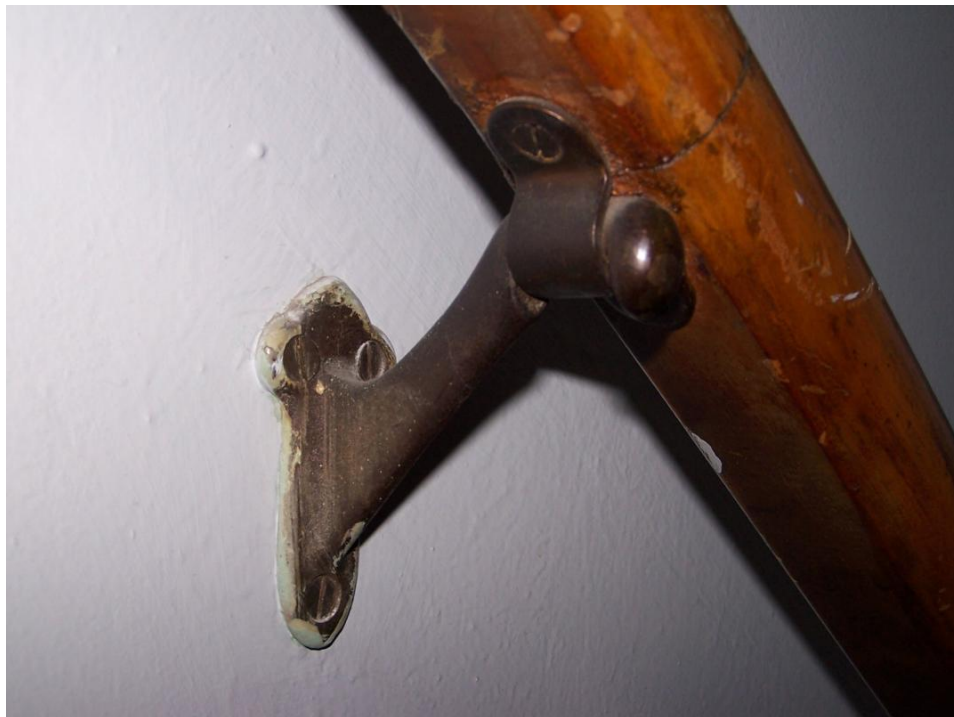
*Photo number:* VT\_OrleansCounty\_ BeebePlainBorderStation15.tiff

*Description of view:* rail bracket, stairwell, view: northwest

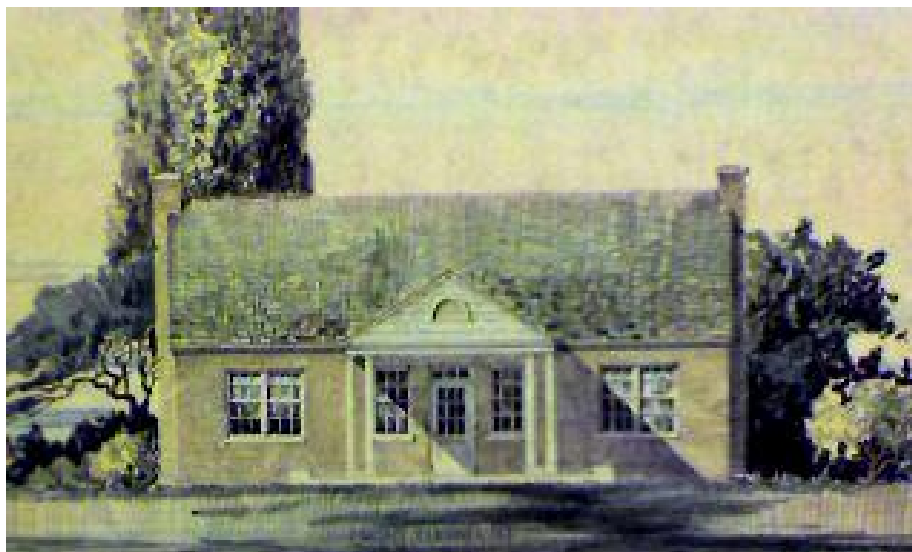
*Date: 1936*

*Description of view: front elevation*

The renderings for the U.S. Inspection Stations are found at the National Archives and Records Administration (NARA). The U.S. Inspection Station--Beebe Plain shares an identical set of plans with the Sasabe, Arizona U.S. Inspection Station. Compared to many other Inspection Stations from the Public Works Administration (PWA) era, the details on the Beebe Plain building are relatively sparse, and of inexpensive materials. According to the General Services Administration, this may have been because these designs were completed in the midst of the Great Depression.<sup>4</sup> The U.S. Inspection Station--Beebe Plain continues to possess many features originally depicted in the front elevation rendering. Aside from the replacement of the entry door and its transom, the U.S. Inspection Station--Beebe Plain as extant looks remarkably similar to its original rendering.<sup>5</sup>
