**National Register of Historic Places
Registration Form**

historic name D. S. Chamberlain Building

other names/site number L. W. Taylor Motor Company and Payne Motor Company Building

street & number 1312 Locust Street [N/A] not for publication

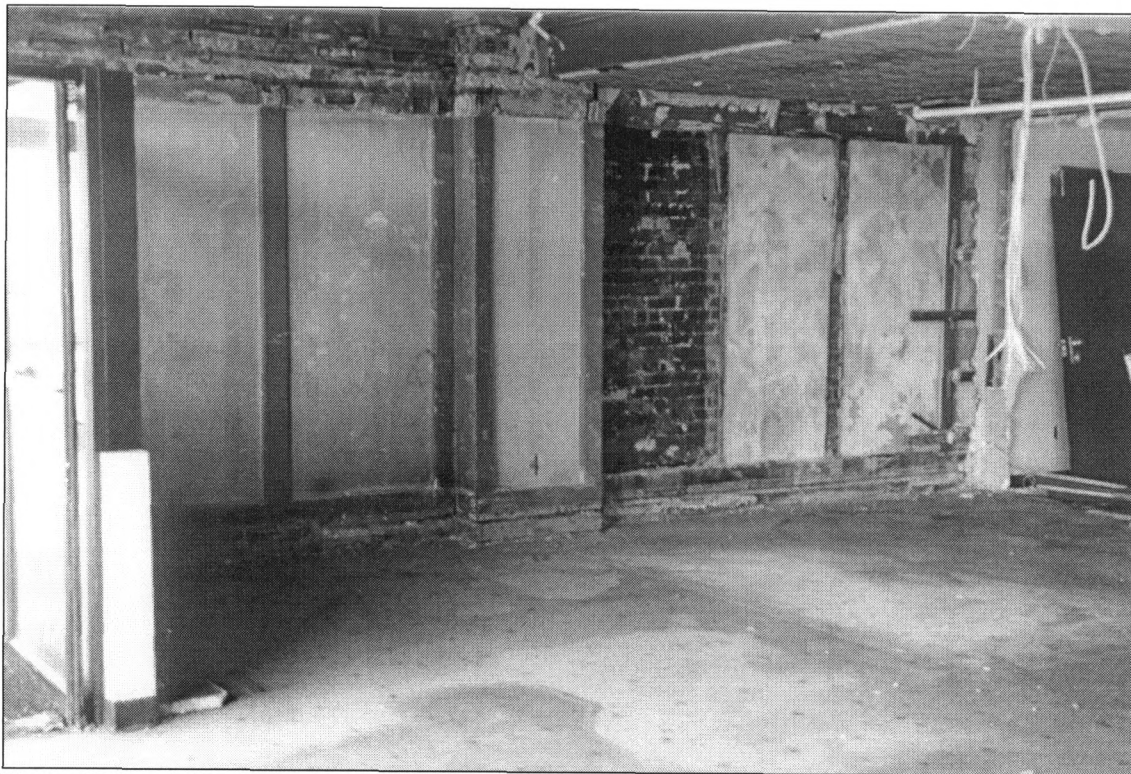
Figure 6: Surviving framed plaster wall panels, east sidewall, surviving tile floor, view southeast
(Photo by J. Jacobsen, August 2006)

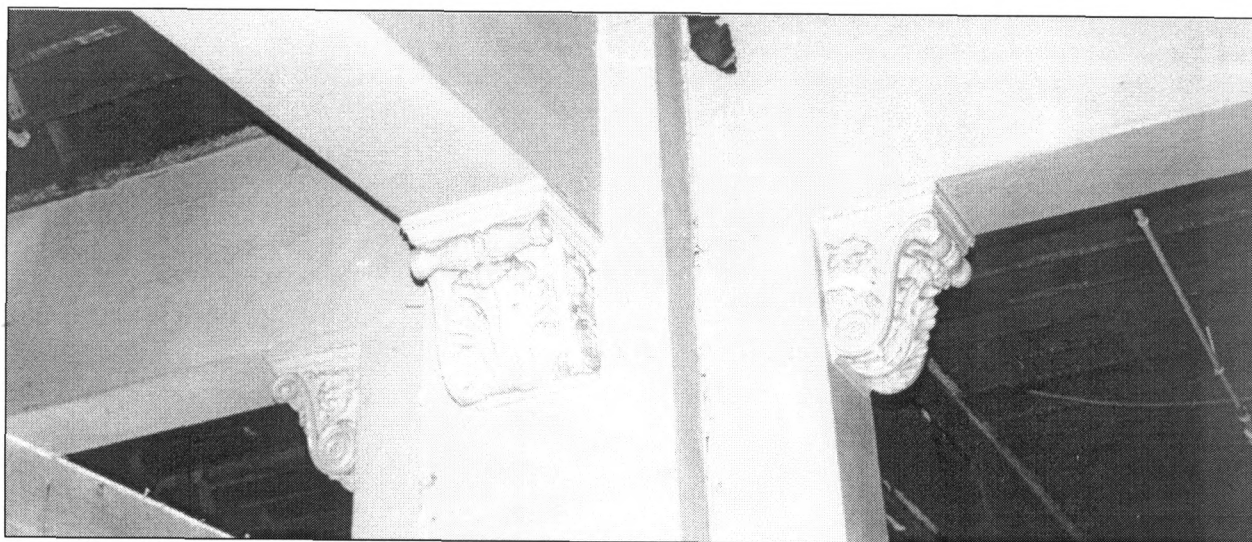
Figure 7: Decorative brackets at showroom juncture of former partition, view southwest
(Photo by J. Jacobsen, August 2006)

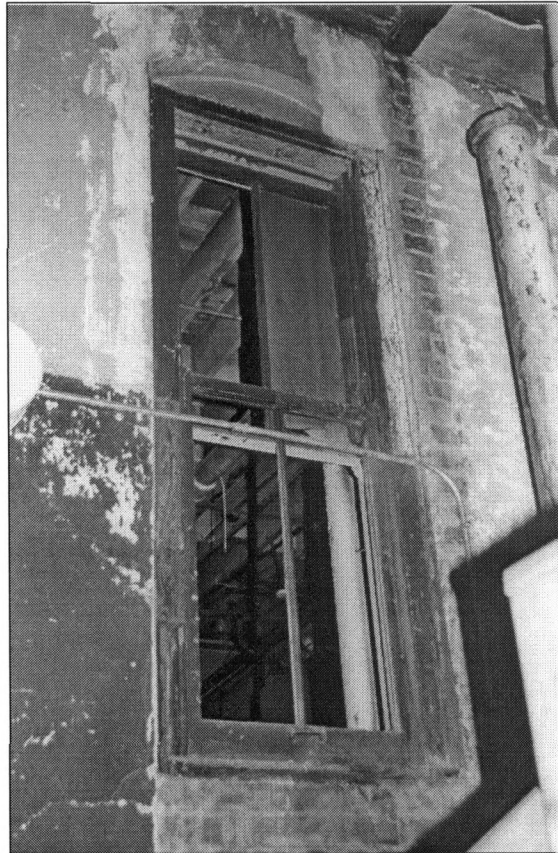
Figure 8: Surviving elongated 2/2 window on former or original rear wall, view northeast
(Photo by J. Jacobsen, August 2006)

3) featured narrow elongated windows (one of which survives, Figure 8), evidence of a design aesthetic that transcended simple façade ornamentation.

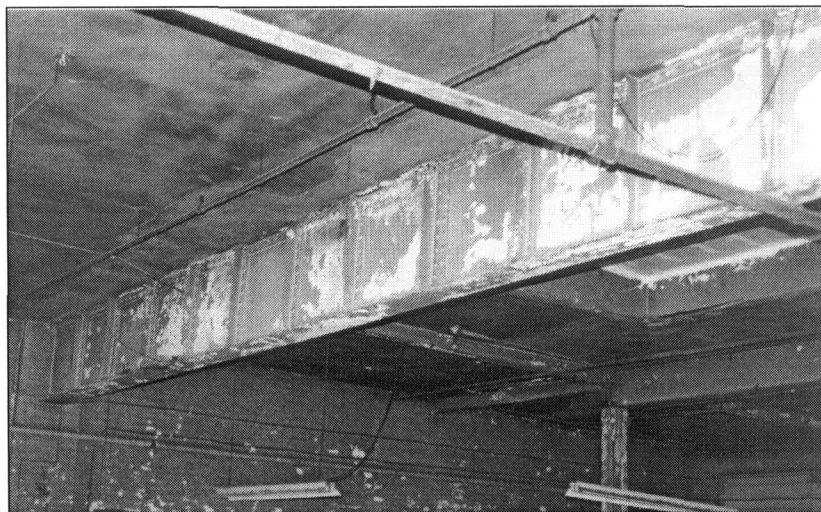
Figure 9: Structural truss above showroom area on second floor, view southeast
(Photo by J. Jacobsen, August 2006)
