Thomas Prince house, Portland, Oregon Mulinom And County Photographer unknown, date unknown Negative held by Oregon Historical Society #orhi 59078

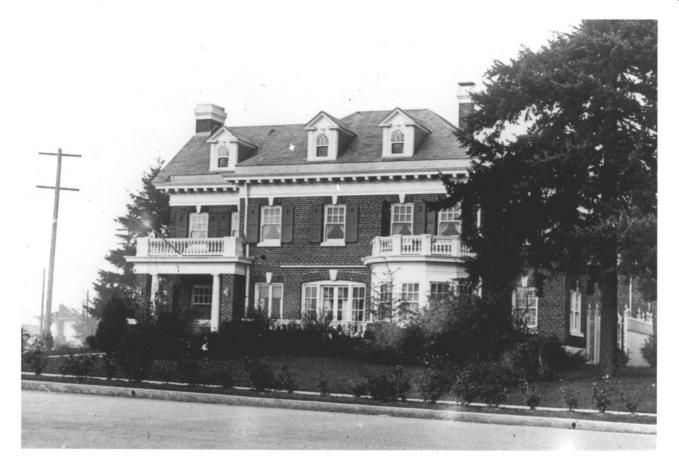
Photo #1 0F22

Historic view of main (south) elevation, looking north, showing slate roof; pedimented roof dormers; typical window type; balconies with balustrades; central element with french doors; polygonal bay window.

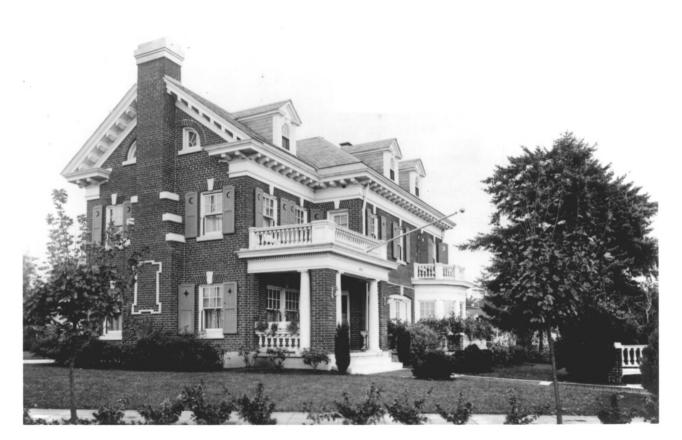
Photo #2 0F 22

Historic oblique view of main (south) elevation and side (west) elevation, looking northeast, showing the end wall chimney; portico over entrance; slate roof details; entrance walk and carriage waiting bench location.

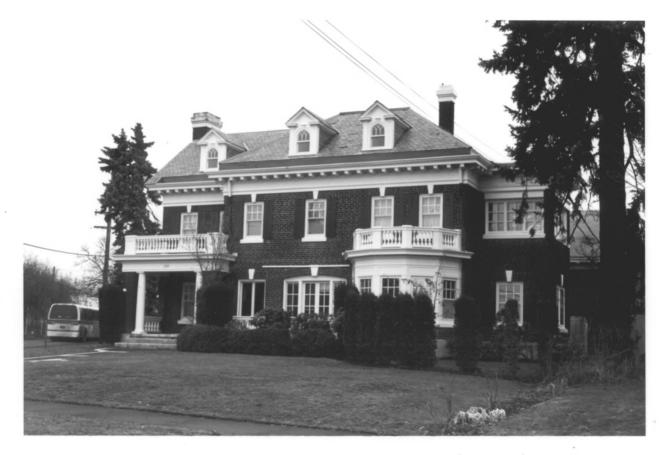
Photo #3 OF 22

View of the main (south) elevation, looking north, showing the east wing; hipped roof central element; slate roof.

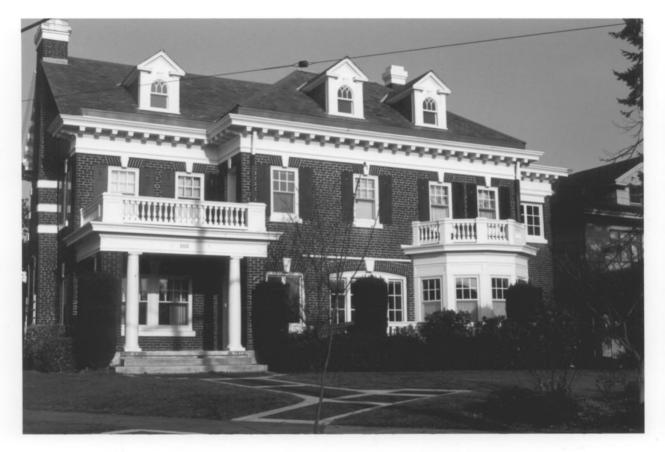
Photo #4 OF 22

View of the main (south) elevation, looking northeast, showing the west wing with entrance portico; balcony with painted wood balustrade and wide rail; original brick walkway from 29th Avenue to entrance porch.

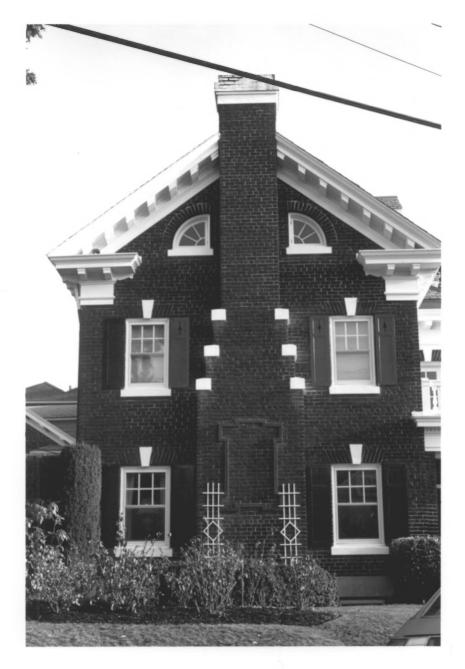
Photo #5 OF 22

View of the side (west) elevation, looking east, showing the dominant form of the end wall chimney; primary window type; quarter round fan lights; fascia return; decorative dentils.

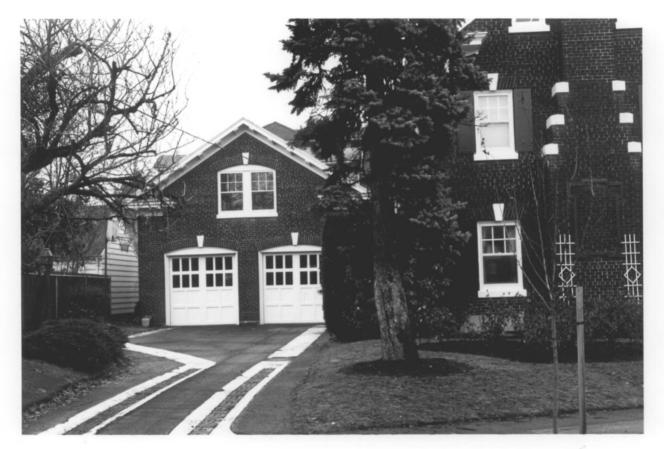
Photo #6 0F 22

View of the main (west) elevation of the carriage house, looking east, showing primary window type and vehicle entry doors in relieving arched openings; fascia return; original brick drive way.

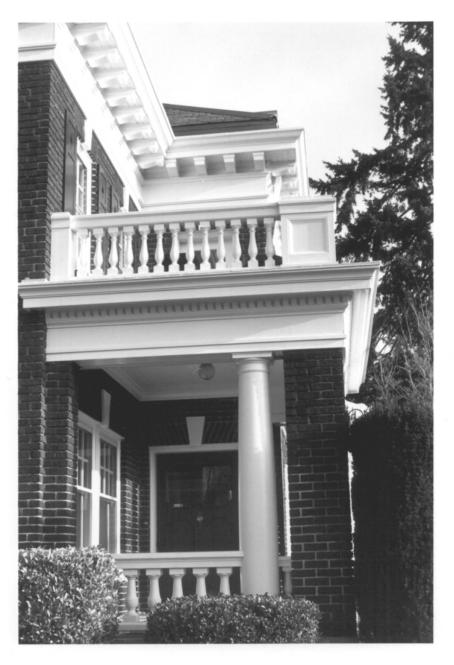
Photo #7 or 22

Exterior detail view of entrance portico with balcony, looking east, showing wood column of Doric order; wood balustrade and wide painted wood rail; flat arch opening over accentuated entrance door.

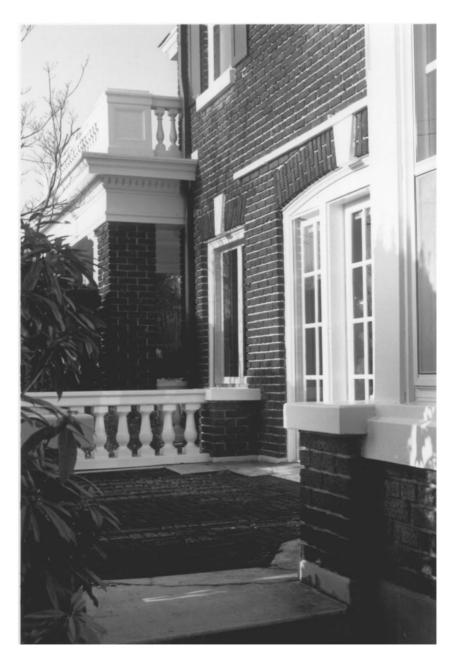
Photo #8 0F 22

Exterior detail view of the central ground level porch, looking west. View shows the french doors and side windows giving access to the porch from the sun room; original brick porch floor in basket weave pattern; wood balustrade with wide rail.

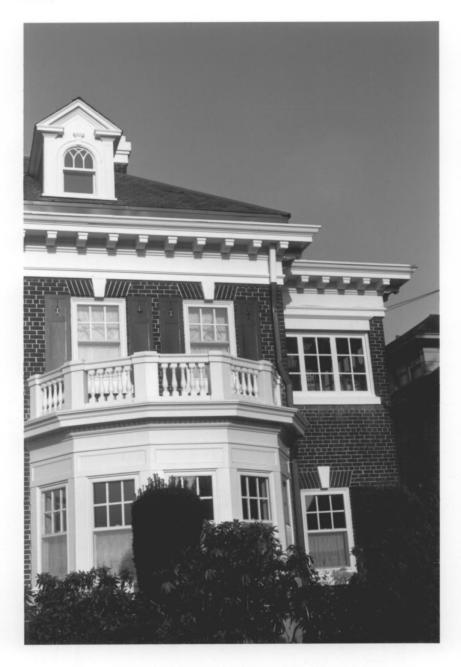
Photo #9 0 2 2 2

Exterior detail view of the polygonal bay window with balcony, and east wing, looking north, showing the pedimented roof dormers; dentils; flat arch with pronounced keystones over primary window type; casement windows in sleeping porch.

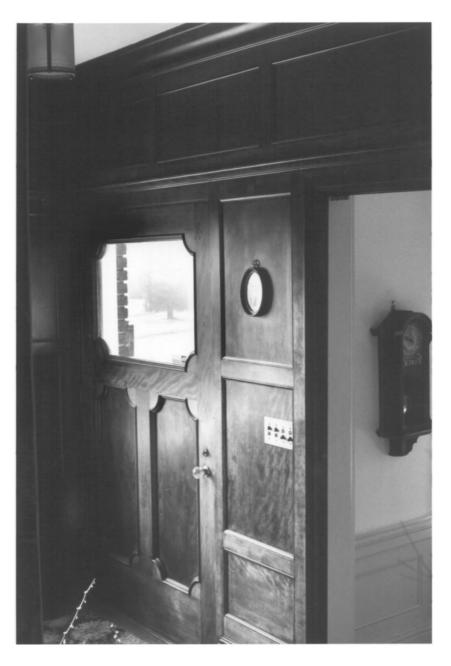
Photo #10 DF 22

Interior view from the entry hall of the entrance door, looking west, showing white birch paneling, the door, panel cove at the ceiling; painted wood wainscot in the living room.

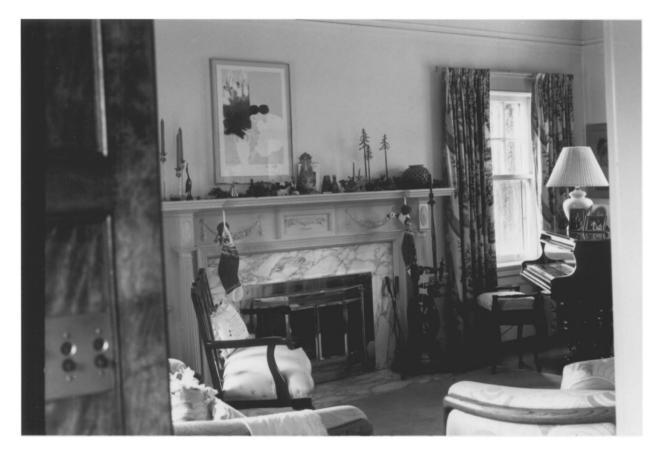
Photo #11 or 22

Interior view, from the entry hall, of the living room, looking northwest, showing the original fireplace, with marble face and hearth; painted wood fireplace decoration

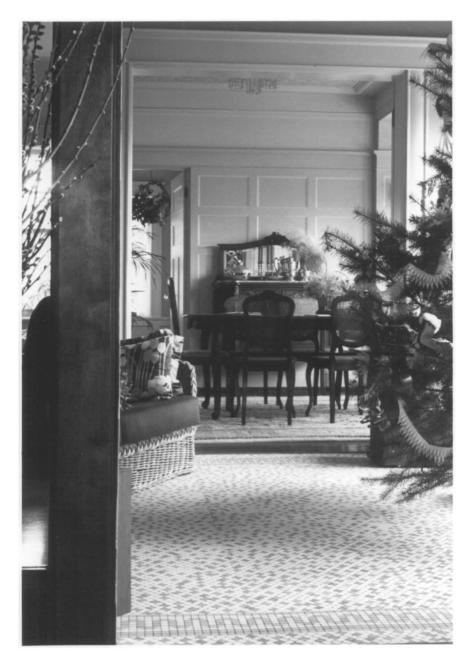
Photo #12 or 22

Interior view, from the entry hall, of the sun room and dining room beyond, looking east, showing tile flooring in sun room; 3/4 painted wood panel wall in dining room.

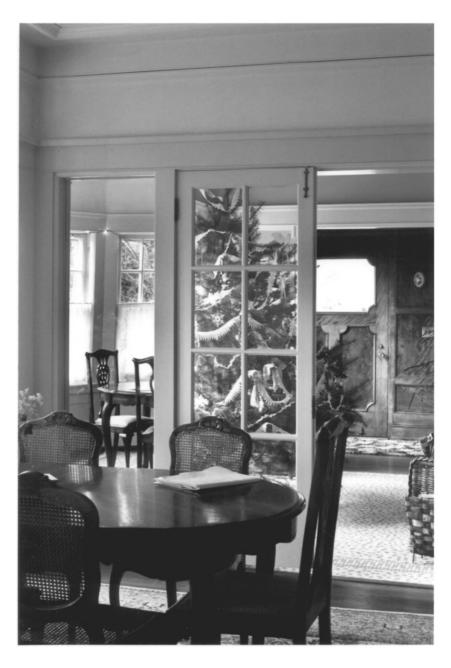
Photo #13 0F 72

Interior view, from the dining room, of the sun room and entry hall, looking west, showing the french doors between dining and sun room; mirrored side panel alongside french door; sun room tile floor; entry hall paneling and white birch entrance door.

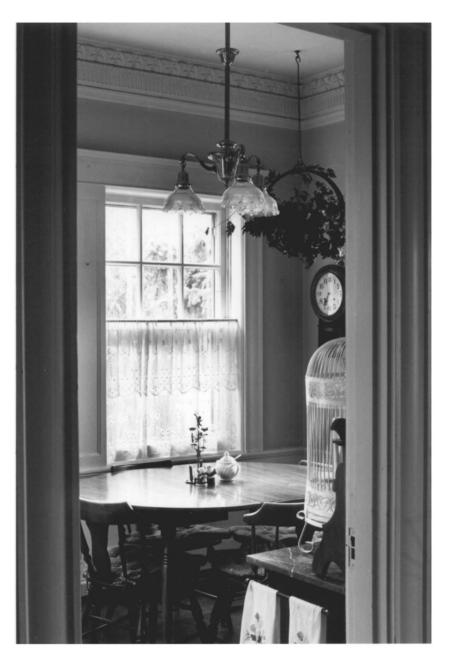
Photo #14 0F 62

Interior view from the butler's pantry, of the breakfast room, looking southeast, showing the primary window type; decorative wall plaster work at the ceiling with acanthus leaves, bead and reel detailing.

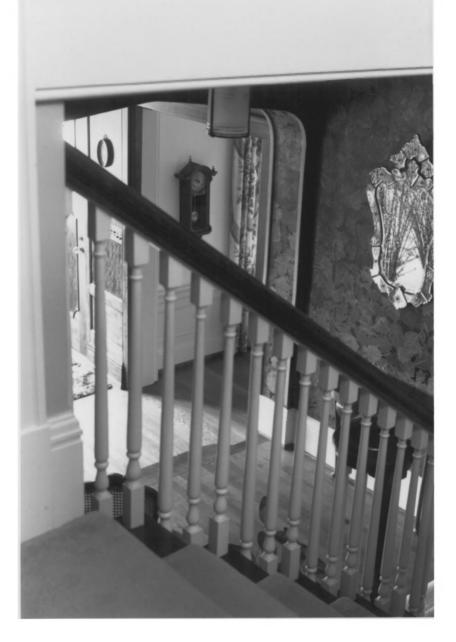
Photo #15 0 12 2

Interior view, from the main stair, looking south west, showing the entry hall paneling and painted wood panel wainscot in the living room.

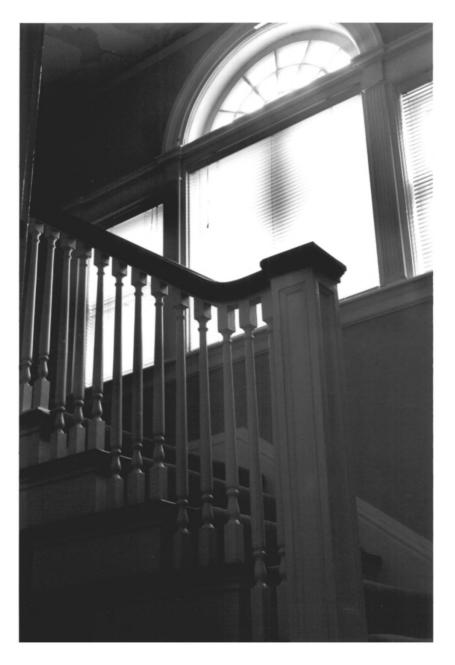
Photo #16 0F22

Interior view from the main stair landing, looking north west, showing the central fan light window; primary window type side windows; window and stair wood trim.

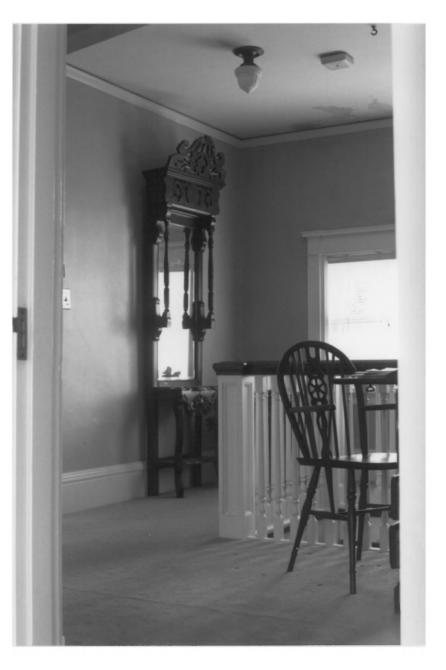
Photo #17 0F 22

Interior view, from the second floor hall, looking north west, showing the second floor entry; window, stair and wall trim of painted wood.

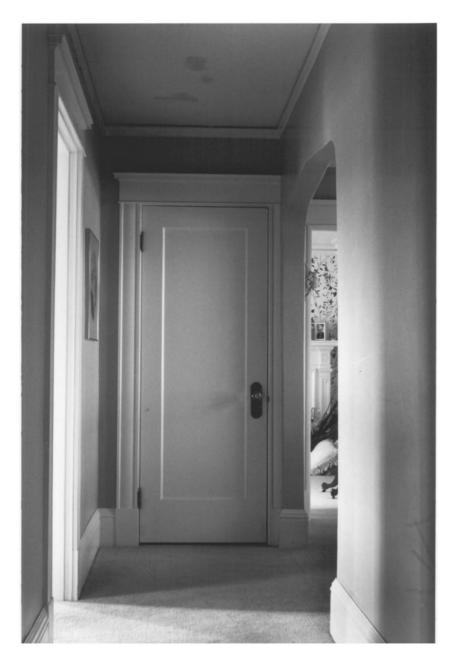
Photo #18 or 22

Interior view, from the second floor hall, looking west, showing a typical interior door; convex milled wood trim; door hardware; arched second floor entry.

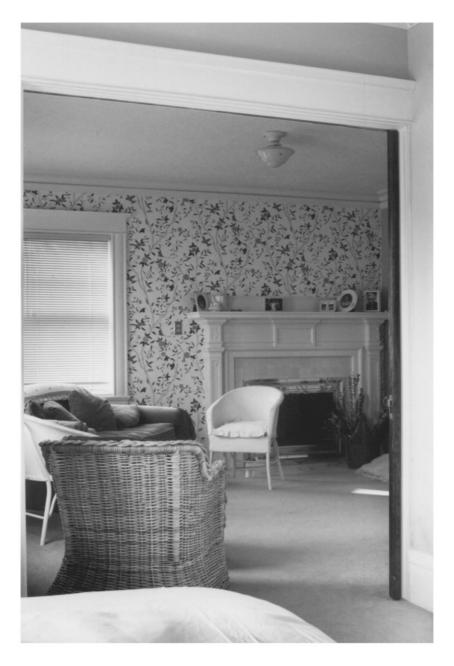
Photo #19 OF 22

Interior view, from the master bedroom, looking west, showing second floor fireplace with decorative wood trim; wall and window trim.

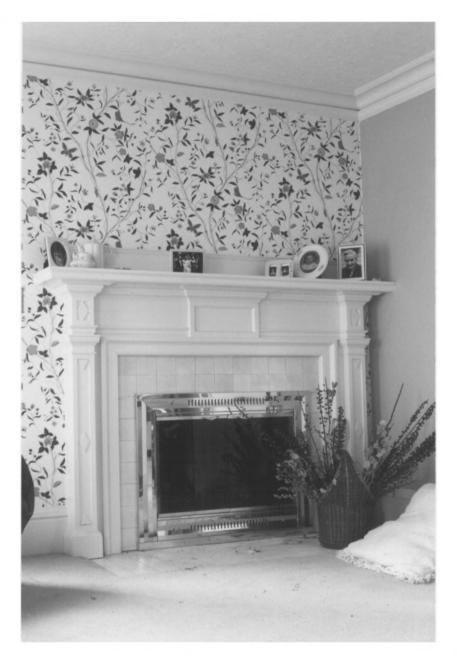
Photo #20 0x 22

Interior view, from the master bedroom, looking west, showing details of the master bedroom fireplace with tile facing and hearth; painted wood trim.

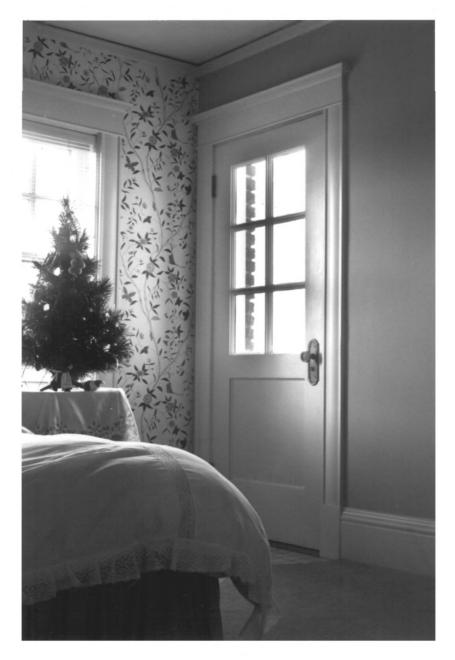
Photo #21 0F 22

Interior view, from the master bedroom, looking south west, showing the glazed and panel door giving access to the second floor balcony over the entrance portico; door window and wall trim detailing.

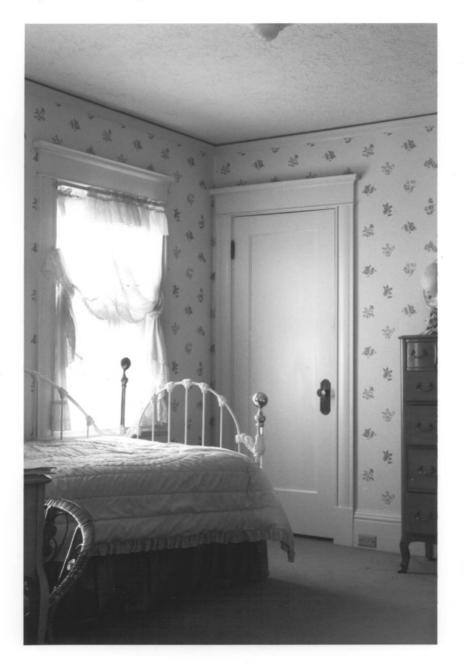
Photo #22 0 € 22

Interior view, from the second bedroom, looking southwest showing the typical window and door detail in bedrooms.
