# NEW JERSEY TRANSIT RAILROAD STATION SURVEY

- ✓ A. Name: Common Ampere Station Historic Line: Hoboken Division, Montclair Branch (DL&W)
- ✓ B. Address or location: E of Ampere Plaza at Whitney Place East Orange, NJ County: Essex Municipality: City of East Orange Block & lot:
- C. Owner's name: NJ Transit Address: Newark, NJ
- D. Location of legal description: Office of the County Clerk, Essex Co. C. H. Newark, NJ
- E. Representation in existing surveys: (give number, category, etc., as appropriate)

FACILITY NAME: Ampere

# SUMMARY

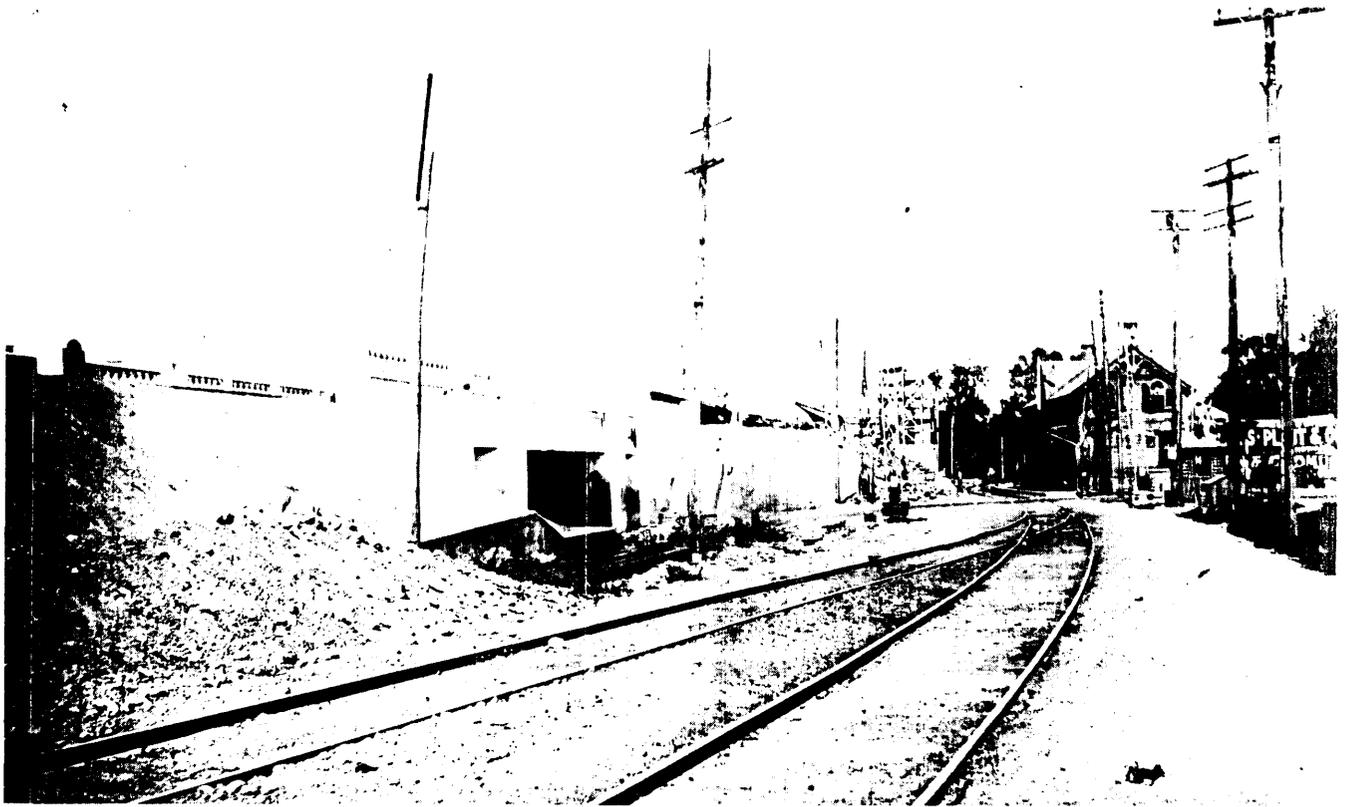
74 4-3 Bloomfield Railroad Station (Taber, 20th, p. 74)

The old Bloomfield station with its single track is to the right, and the elevated new station is nearing completion in September 1911.

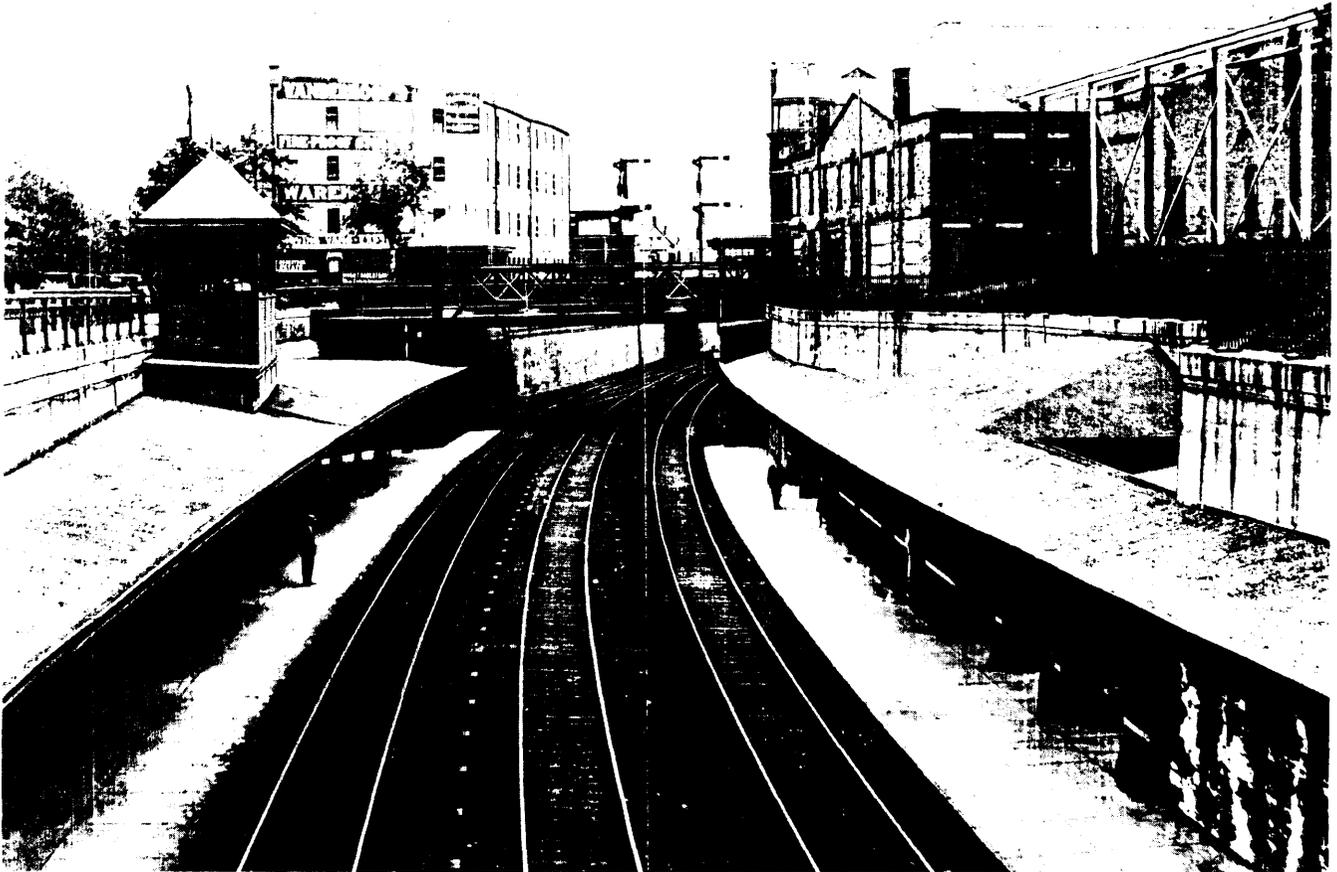
70 4-1 Ampere Railroad Station (Taber, 20th, p. 70)

At Roseville Avenue in Newark, the tracks are 22 feet below ground. This view looks east. This station and cut were completed in December 1905. The Montclair Branch can be seen swinging off to the left. The Roseville Avenue tower is partially obscured behind the road bridge at the left.

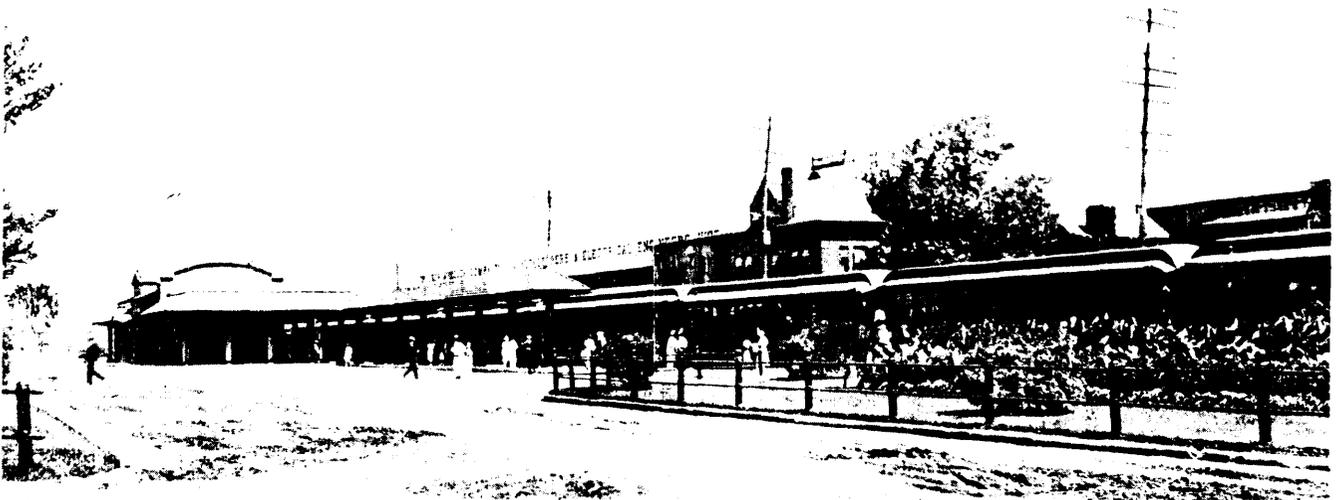
First stop on the Montclair Branch is Ampere in East Orange, so named for the Crocker Wheeler Company, manufacturers of electrical motors whose plant is across the tracks from the station. After Roseville Avenue was completed in 1905, a new Ampere station was built in 1907-08. Because of lack of cooperation from the East Orange borough government, the tracks were not changed and grade crossings remained at each end of the new station. Plans were completed in 1910 to double track the final 1.5 miles from Bloomfield to Montclair and eliminate all grade crossings on the 2.5 miles of the branch lying in Bloomfield, Glen Ridge, and Montclair. A new Montclair terminal would be constructed with the idea of future electrification of the line.

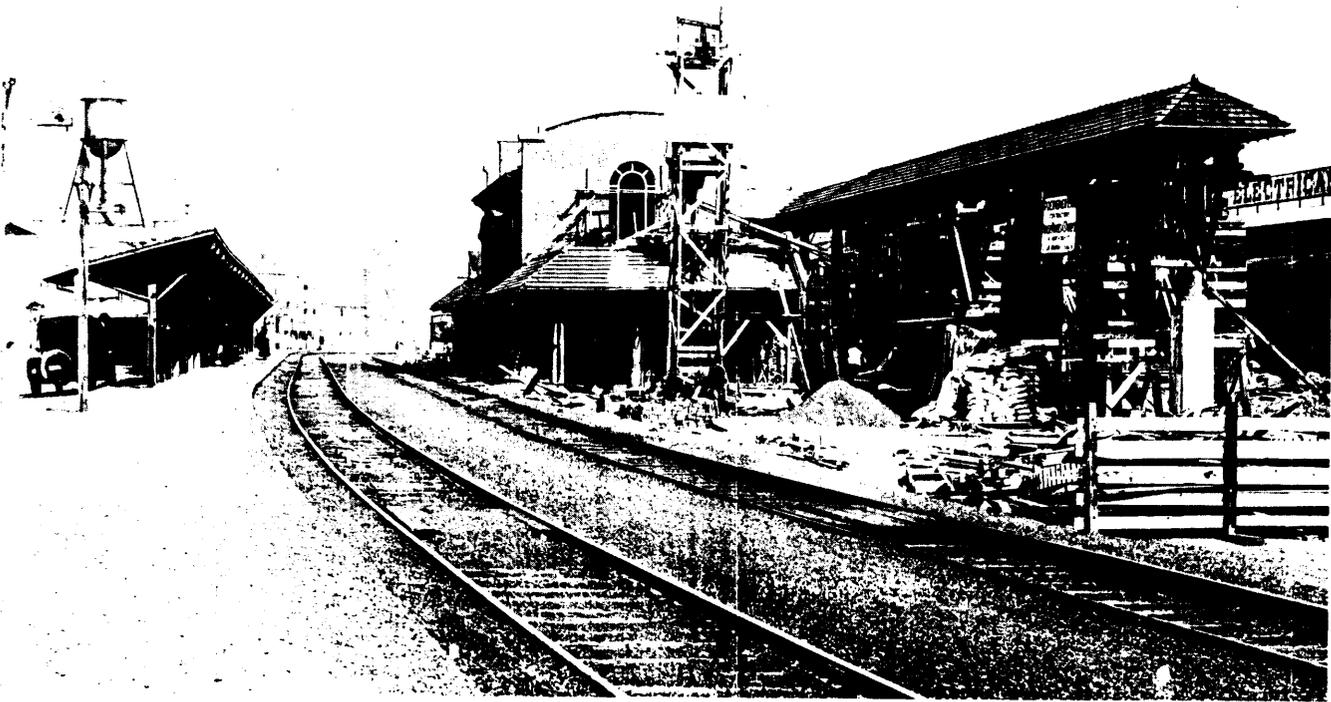
## 4-1 Ampere Railroad Station (Taber, 20th, p. 71)

In 1921 the City of East Orange was forced by the courts to give approval and financial support to the Lackawanna's plans. At Ampere the two grade crossings would be eliminated by raising the tracks and lowering the streets. A temporary track was built to the west of the station, and a second floor was placed on the building. Three quarters of a mile of track was raised. This picture was taken in October 1921 with the second floor completed and the canopies being raised.

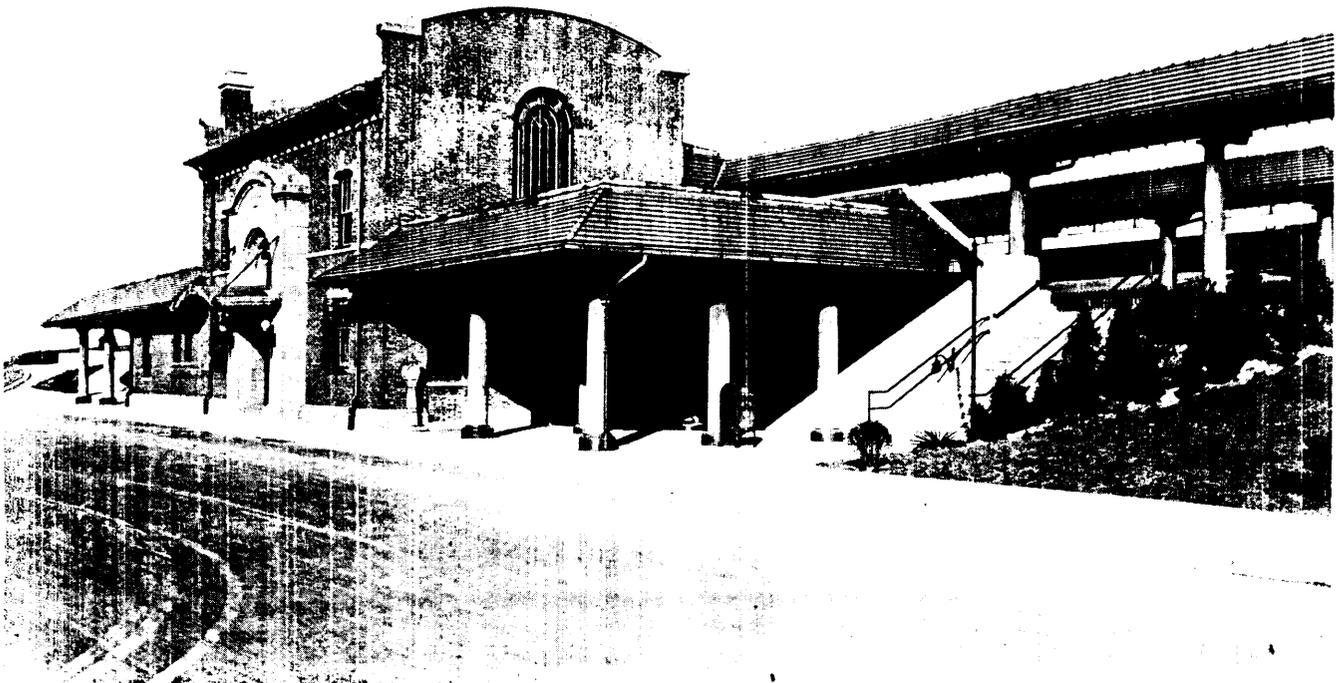
The newly completed Ampere station with the tracks raised about twelve feet.

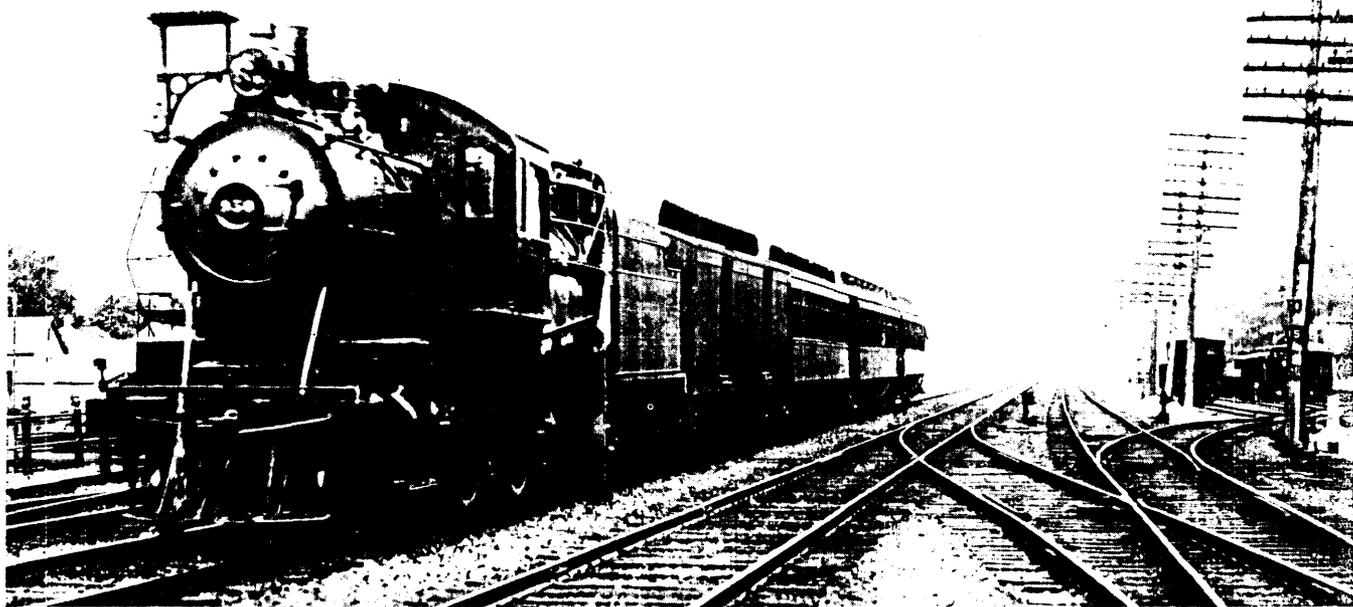
Engine No. 950 drifts into Dover with a four car local. Most photos showing Lackawanna engines taken prior to 1935 can be dated within three years because the railroad was continually changing something on the engines. The headlight at the top of the smoke box indicates that this picture was taken about 1910.
