NEW JERSEY TRANSIT RAILROAD STATION SURVEY

- ✓ A. Name: Common White House ^{Station} Historic Line: Raritan Valley (Jersey Central)
 - B. Address or location:
 - ✓ Main Street
 - ✓ White House, ^{Station} _{NJ}
 - ✓ County: Hunterdon
 - Municipality: Readington Township
 - Block & lot:
 - C. Owner's name: NJ Transit
Address: Newark, NJ
 - D. Location of legal description: Recorder of Deeds, Hunterdon County
Courthouse, Flemington, N.J. 08822
 - E. Representation in existing surveys: (give number, category, etc.,
Y-1 (see Bibliography), pp. 48-49 as appropriate)
- HABS _____ HAER _____ ELRR Improvement _____ NY&LB Improvement _____
- Plainfield Corridor _____ NR(name, if HD) _____
- NJSR (name, if HD) _____
- NJHSI (#) _____
- Northeast Corridor _____
- Local _____ (date _____)
- Modernization Study: site plan X floor plan X aerial photo _____
- other views No photos of NR quality? No

FACILITY NAME: White House

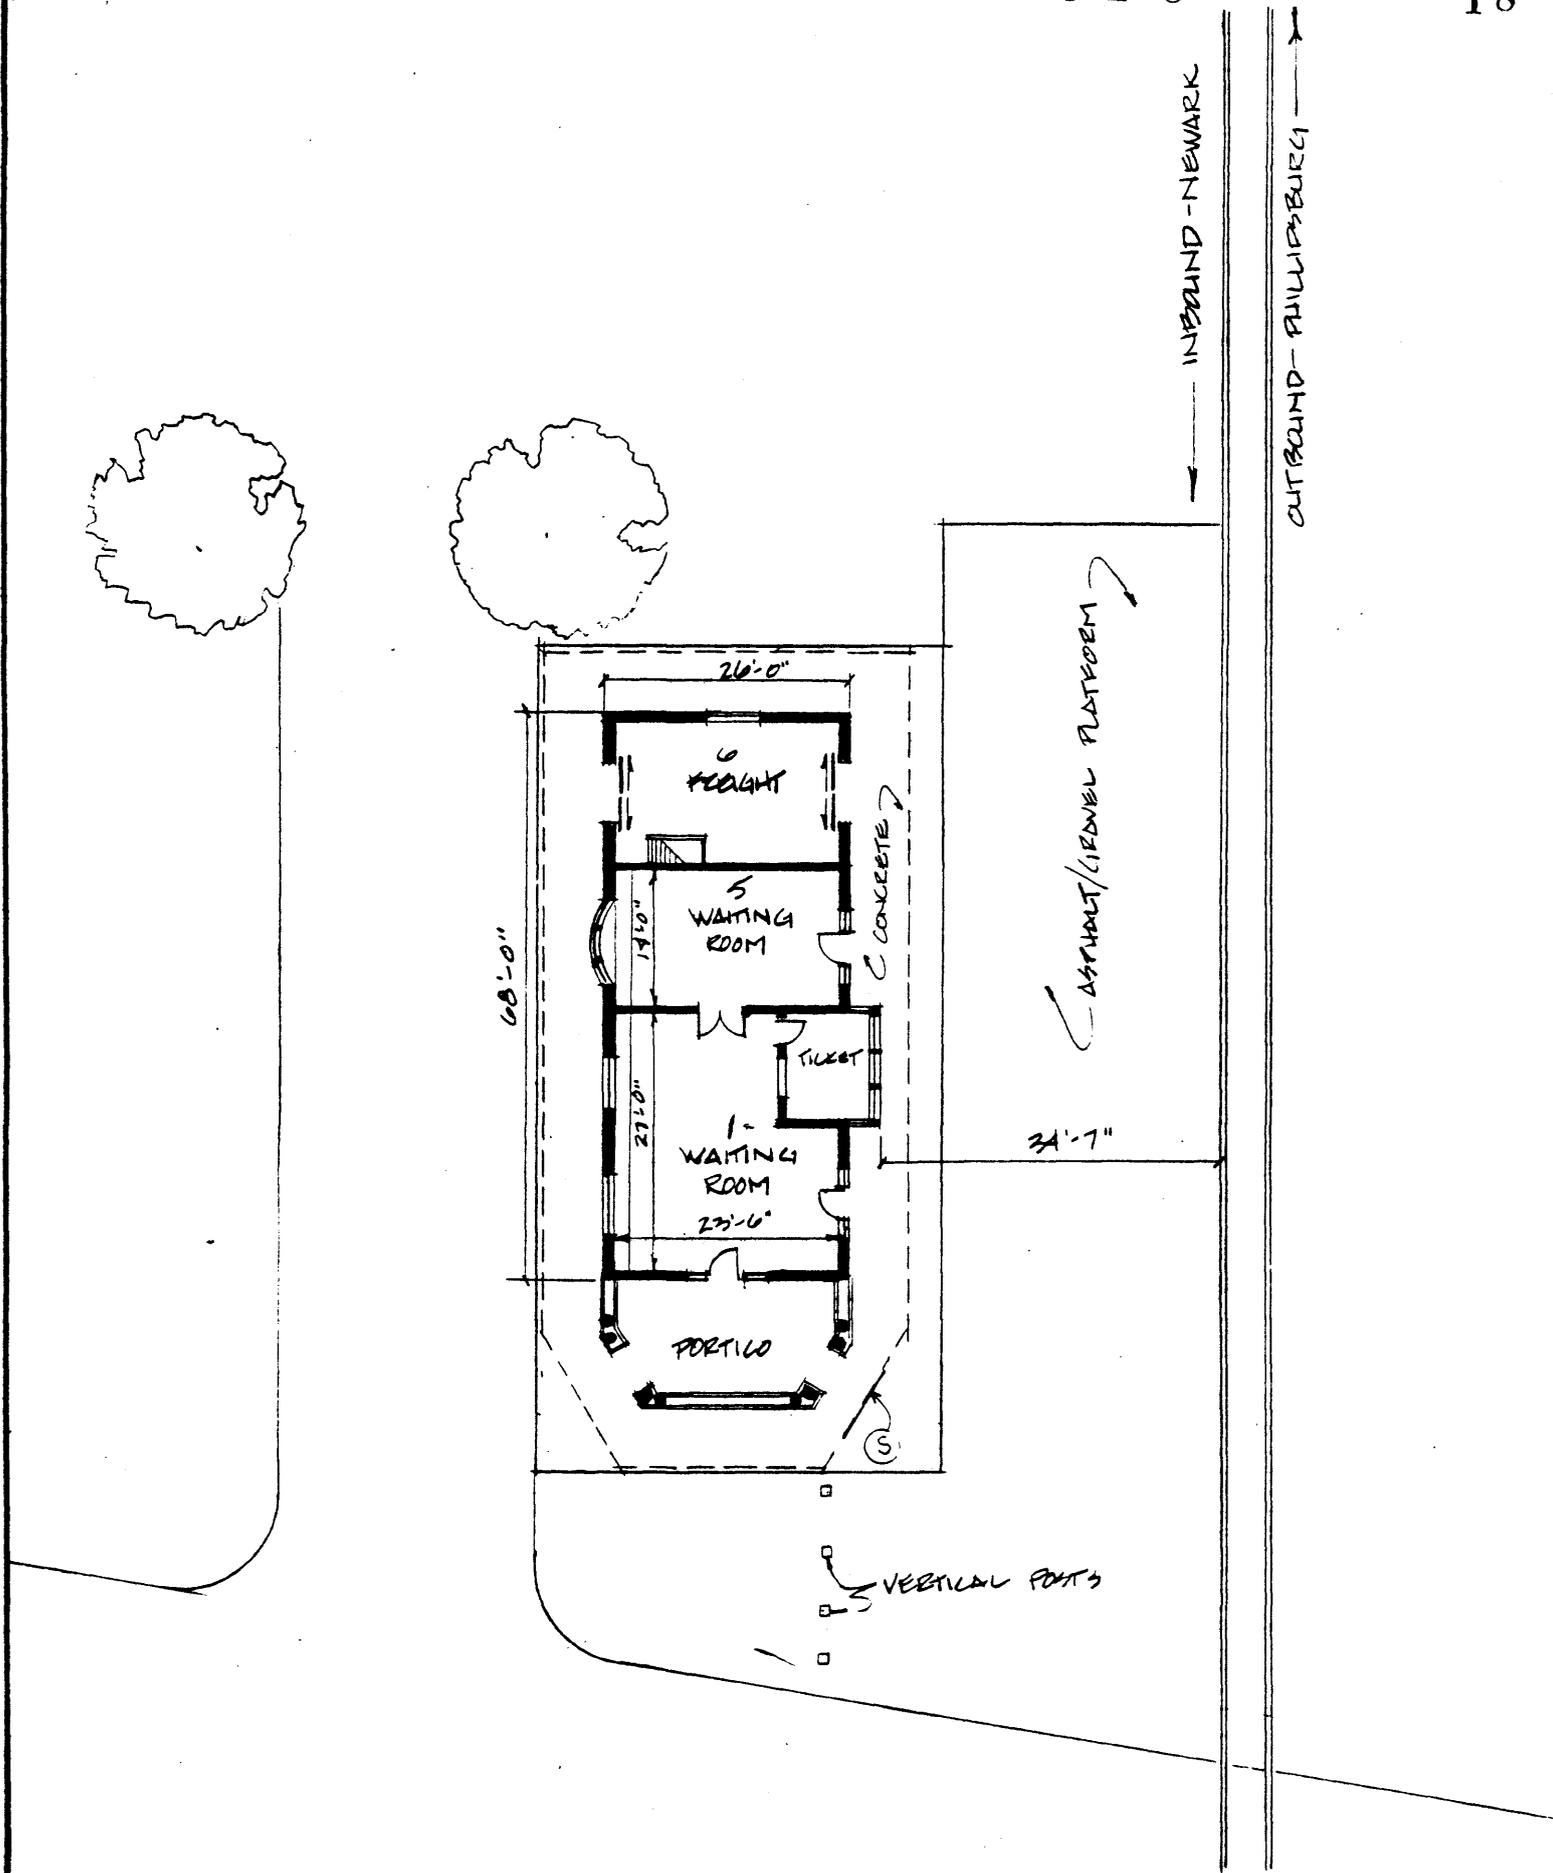
The station, a one-story stone building in the Richardsonian Romanesque style, is located in downtown White House Station, south of (and parallel to) the tracks. There is no canopy except for the building's eaves, and there is a concrete platform. The 35' (±) from the station to the tracks is mostly gravel, indicating that one or two tracks have been removed.

Some parking is provided southwest of the station (1), and on the street immediately south.

There is a gravel area, 122' x 24' (approx.) between the station and the tracks.
