NATIONAL REGISTER OF HISTORIC PLACES
CONTINUATION SHEET

Frog Creek Cabin
Property Name

historic name Frog Creek Cabin
other names/site number Frog Creek Egg-collecting Station, Lake Eleanor Egg-Collecting Station
Yosemite National Park Building No.MA2300

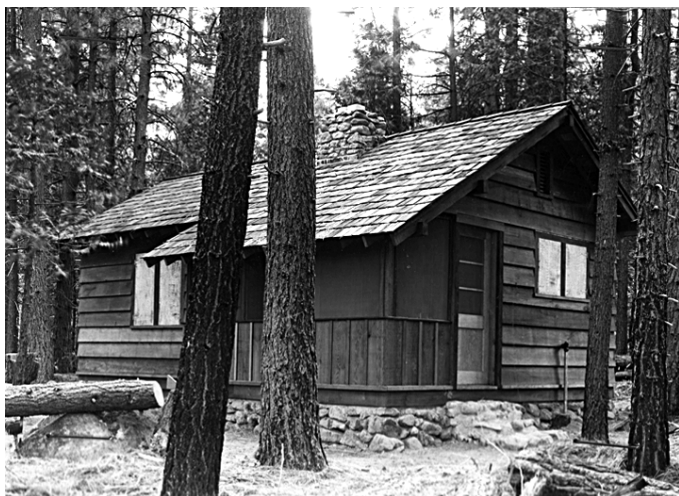
Historic Photo 1

Frog Creek Cabin shortly after construction. This photo is the same image seen on the Oct.1936 Monthly Report. Photographer: unknown. Date Photographed: October, 1936.

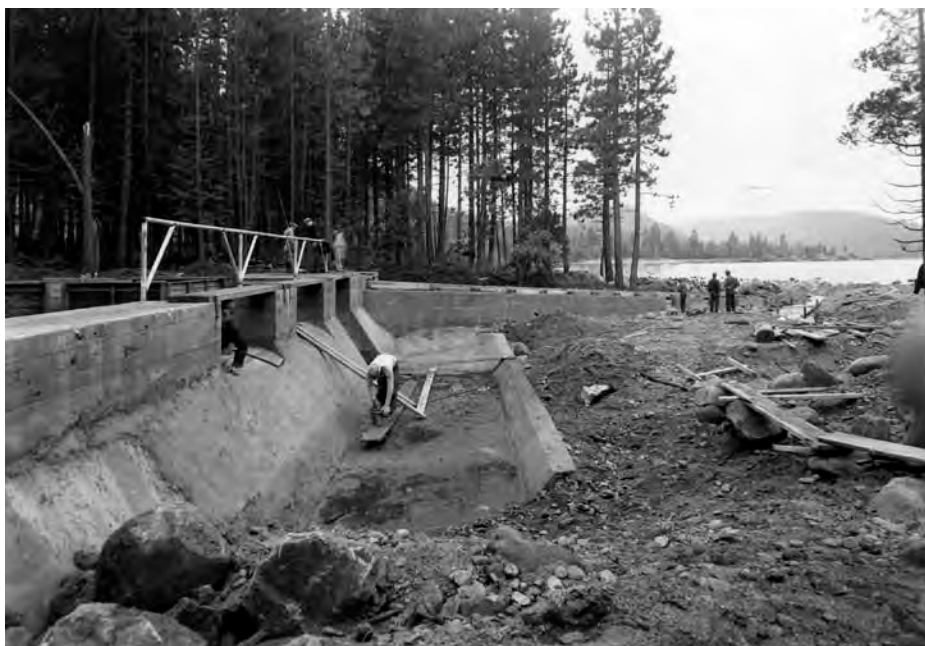
Historic Photo 2

Construction photograph of egg-collecting station in the south fork of Frog Creek, facing southwest.

The Frog Creek egg-collecting station was built in 1934 for purposes of supplying the Happy Isles Fish Hatchery in Yosemite Valley. Like the Frog Creek Cabin, building specifications were provided by the National Park Service Regional Branch of Plans and Designs. The station facilitated a self-sustaining rainbow trout propagation program in Yosemite National Park and was the only egg-collecting station to be erected within its boundaries. The original egg-collecting station consisted of a fish ladder, wooden fish traps, and a concrete spillway. *(A detailed description of the egg-collection station as-built is provided in Section 8.)* The facility spanned across two channels that make up Frog Creek, approximately 250 feet.

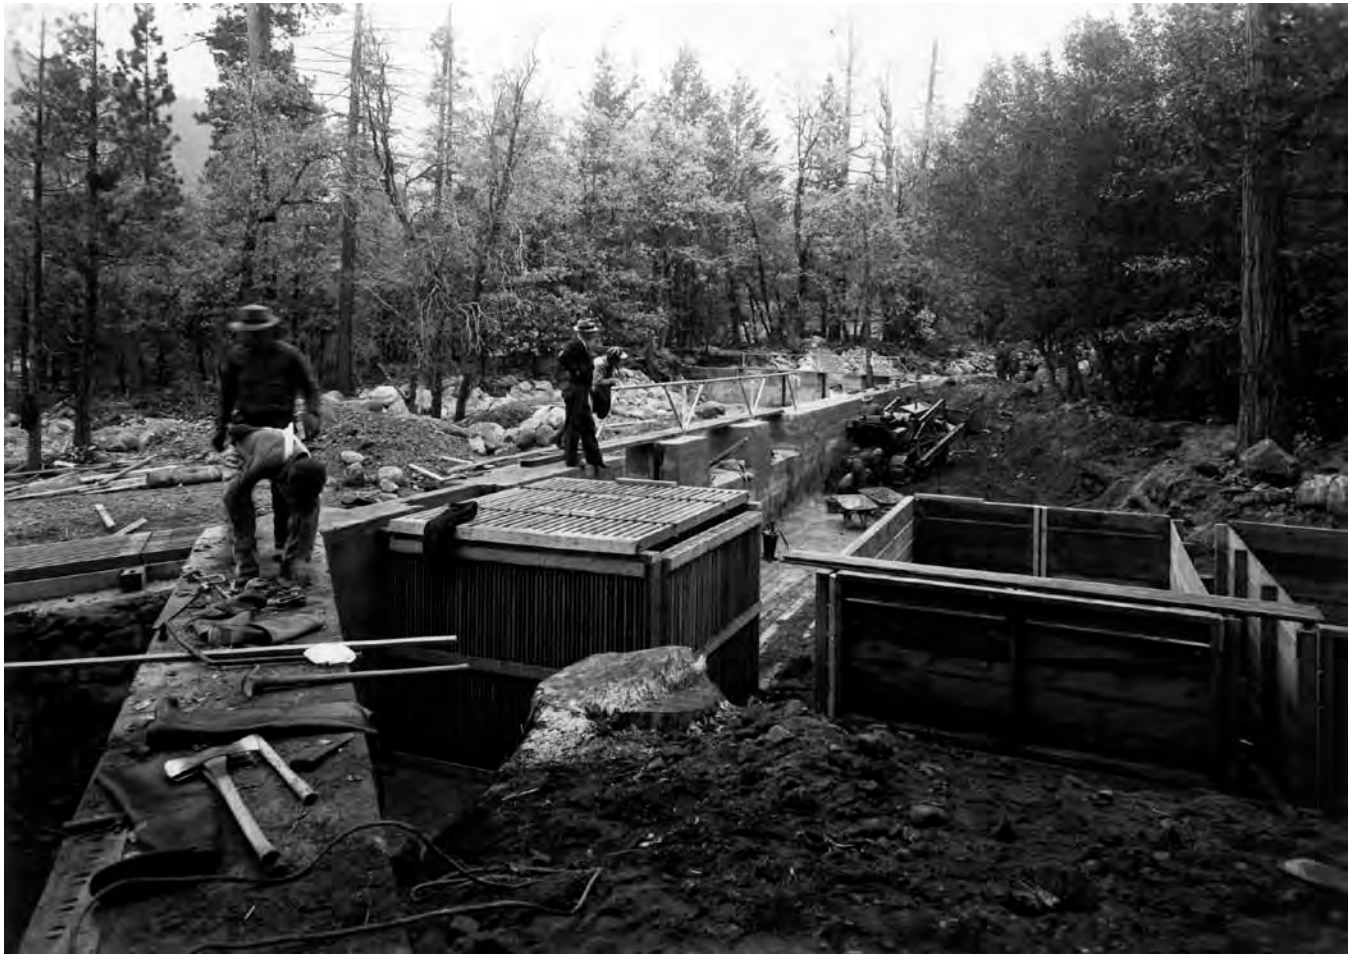
Historic Photo 3

Construction photograph of egg-collecting station at Frog Creek, facing northeast.
