**NATIONAL REGISTER OF HISTORIC PLACES
REGISTRATION FORM**

historic name The German Bank Building of Walnut, Iowa
other names/site number Walnut State Bank Building

street & number NW Corner Highland and Central Sts. not for publication
city, towns/site number Walnut vicinity
state Iowa code IA county Pottawattamie code 155 zip code 51577

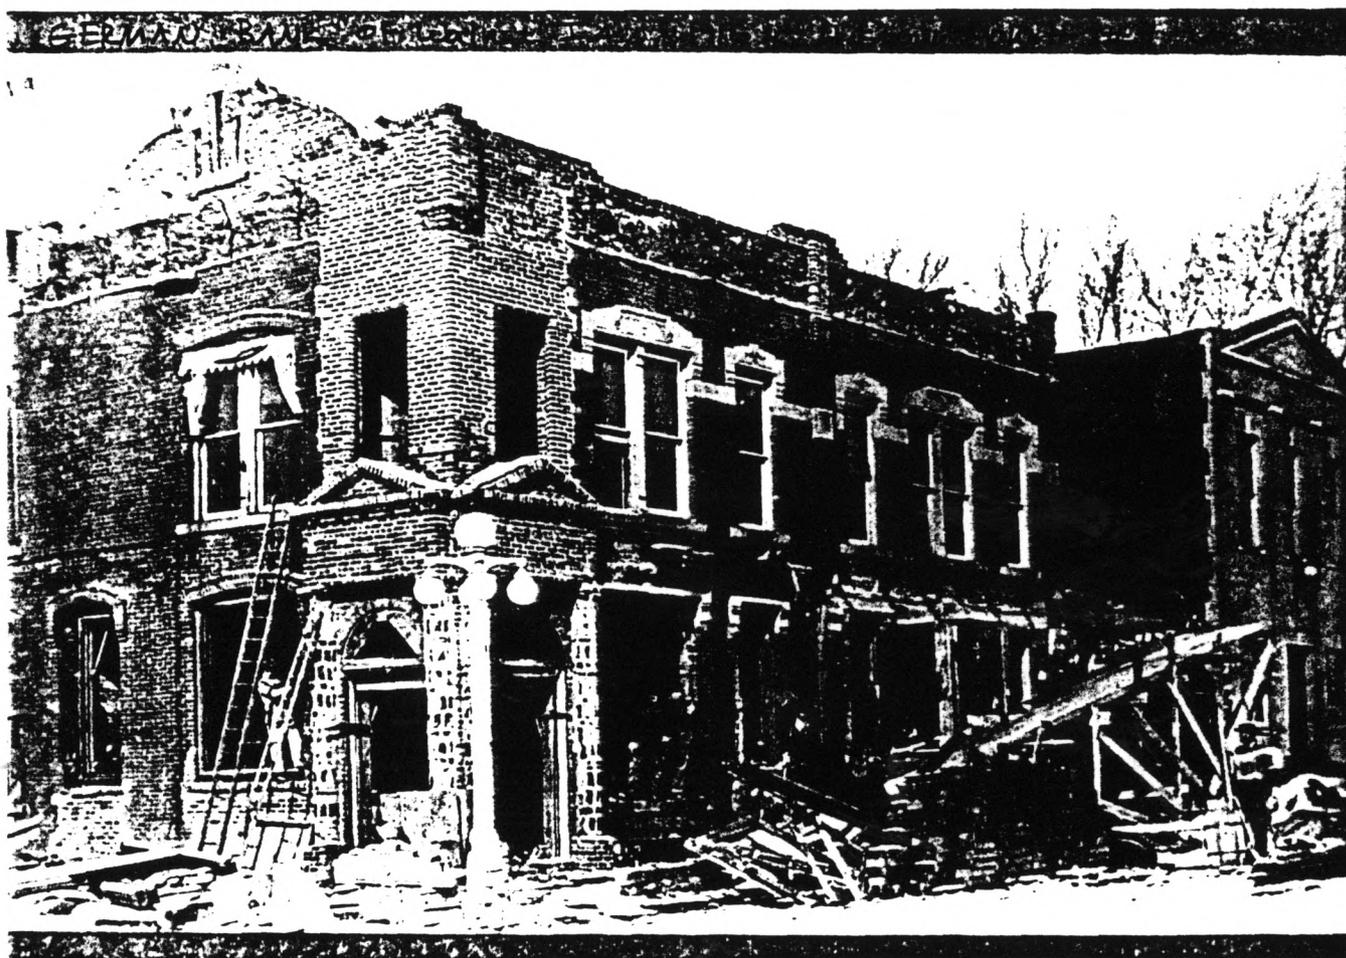
GERMAN BANK OF WALNUT, IOWA, 1916

The 73x36' building has a flat roof and is two stories and essentially rectangular. Vault space and the rear club room are 36' wide, the main banking lobby at the front, 27' across. (See floorplan.)

Blueprints prepared by the St. Louis Bank Equipment Company show that the modernized bank was intended to be essentially one large banking room with partitioned offices and other uses (50x27' plus the vault space) and a "club room" to the rear (22x36'). Running along the single front or south bay was a "private room," which now has two offices rather than just one. The "public lobby" provided access to the tellers and cashier's office space. The "directors

room" for board meetings was at the north end and opened into the club room behind it. Also as part of the 1916 renovation, stairs that had been on the west side at the front of the bank were removed, and the present stairs were installed at the north end off the club room. On the second floor nine offices of varying size were created. Three (the present board room) were located in the 27' wide front section, the remainder located off a central hallway.
