NATIONAL REGISTER OF HISTORIC PLACES
REGISTRATION FORM

historic name: Harmony Presbyterian Church

city/town: Harmony

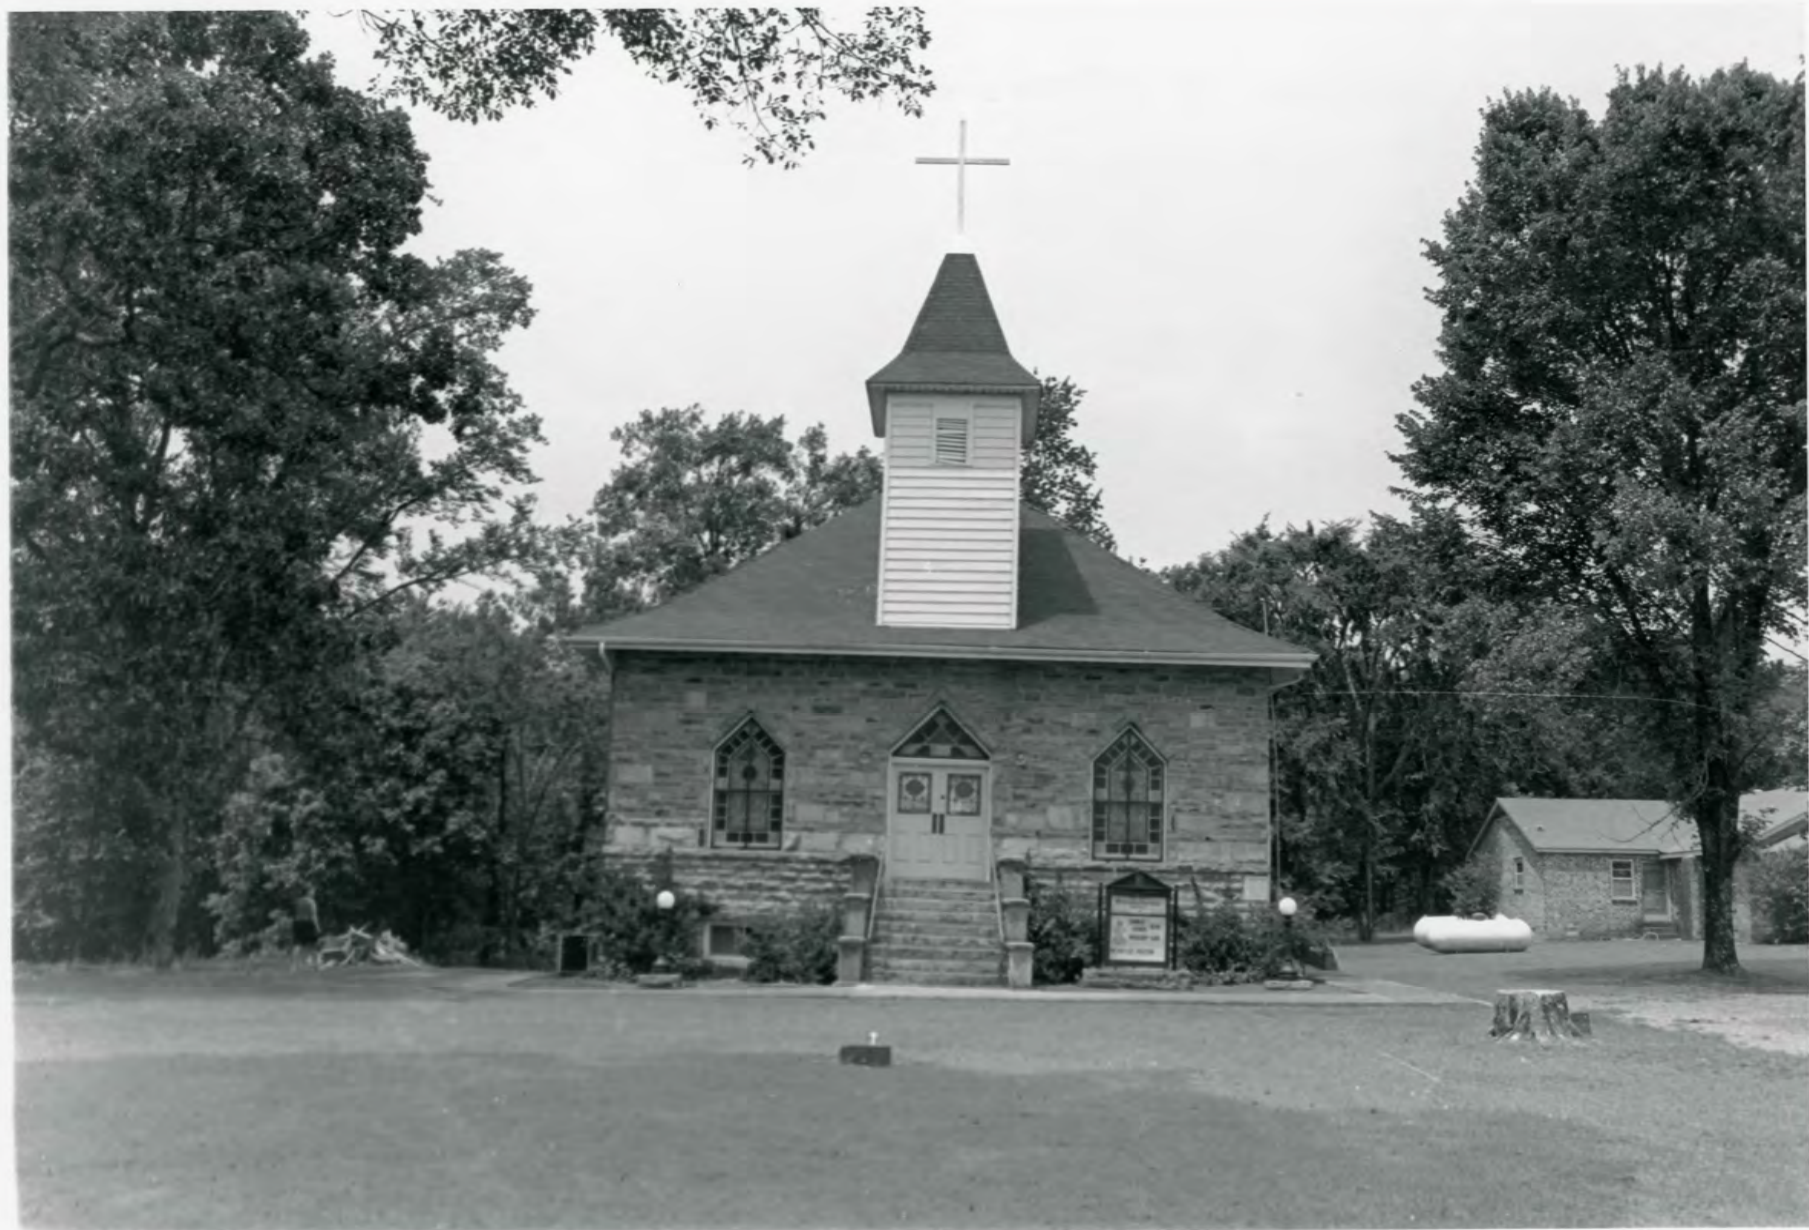
VIEW FROM SOUTH

The southern or front elevation is composed of the two triangular-headed stained-glass windows flanking the central double-leaf entrance with its triangular stained-glass transom window. The multi-pane stained-glass windows are actually set into a double-hung sash configuration, and the colors of purple and light green predominate, as they do in all the stained-glass windows. The same stained-glass fills the central entrance transom and the windows of the doors themselves. The elevation is dominated overall by the tall belfry with its own hipped roof; it has been recently sheathed with artificial siding (however, it is the only artificial siding to be found on the entire structure). The raised basement is sheathed in a cut stone of rougher finish than that laid above the projecting water table. The entrance staircase is also constructed of cut stone.

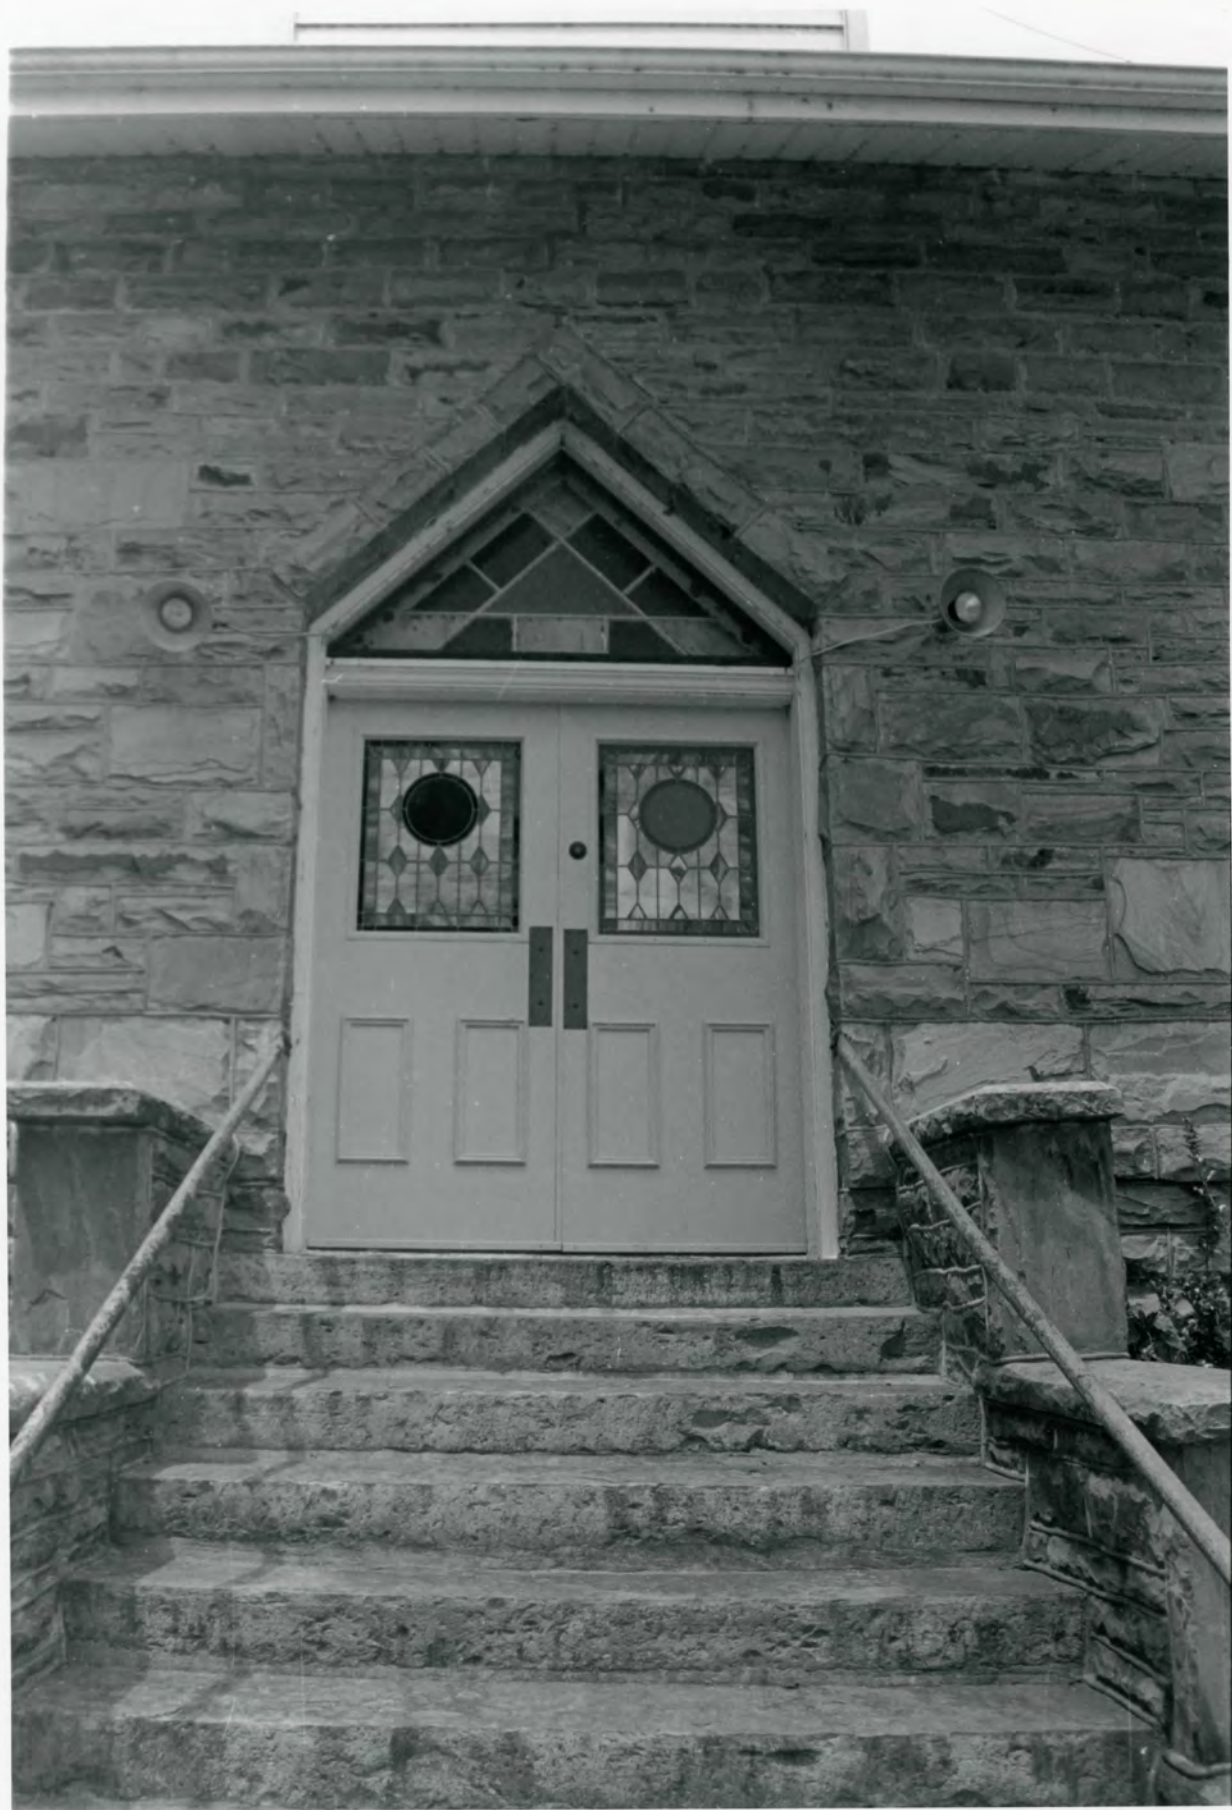
DETAIL OF ENTRANCE
