National Register of Historic Places Registration Form

Historic name: Fuqua Farm

Other names/site number: VDHR File #020-0337

Street & number: 8700 Bethia Road

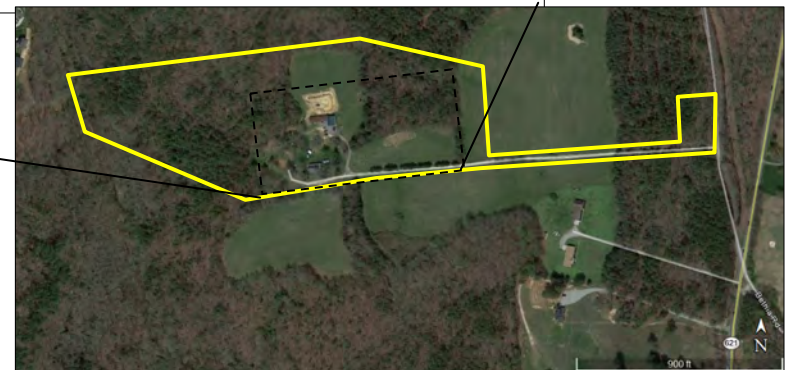
SKETCH MAP
Fuqua Farm, Chesterfield County, VDHR #020-0337

north and leads to a garage and gravel parking area. The dwelling sits at the southern end of a small grouping of secondary resources including a well (c. 1785), chicken house (c. 1940), hen house (c. 1940), carriage house replica (c. 2016), two garages (c. 1940 and c. 2012), and three sheds (c. 1940 and c. 2010). The domestic complex is at the south end of a clearing located roughly at the center of the parcel. The western portion of the parcel is heavily forested, while the eastern portion has a rectangular clearing along its southern half, paralleling the driveway. Located within the woodlot northeast of the dwelling are multiple springs, which are currently used for water access. Associated with the springs are two structures, a spring house (c. 1940) and a pump house (c. 2010).

North, west, and east of the dwelling are a mix of historic and modern outbuildings and structures. Those secondary resources constructed in the first half of the twentieth century, within the period of significance, are considered contributing to Fuqua Farm. Those recently constructed, though largely completed in a complementary manner, are non-contributing as they postdate the property's period of significance.
