National Register of Historic Places Registration Form

Historic name: Brooks Family Farm

Street & number: 584 Silver Shoals Road

City or town: Lula State: GA County: Banks

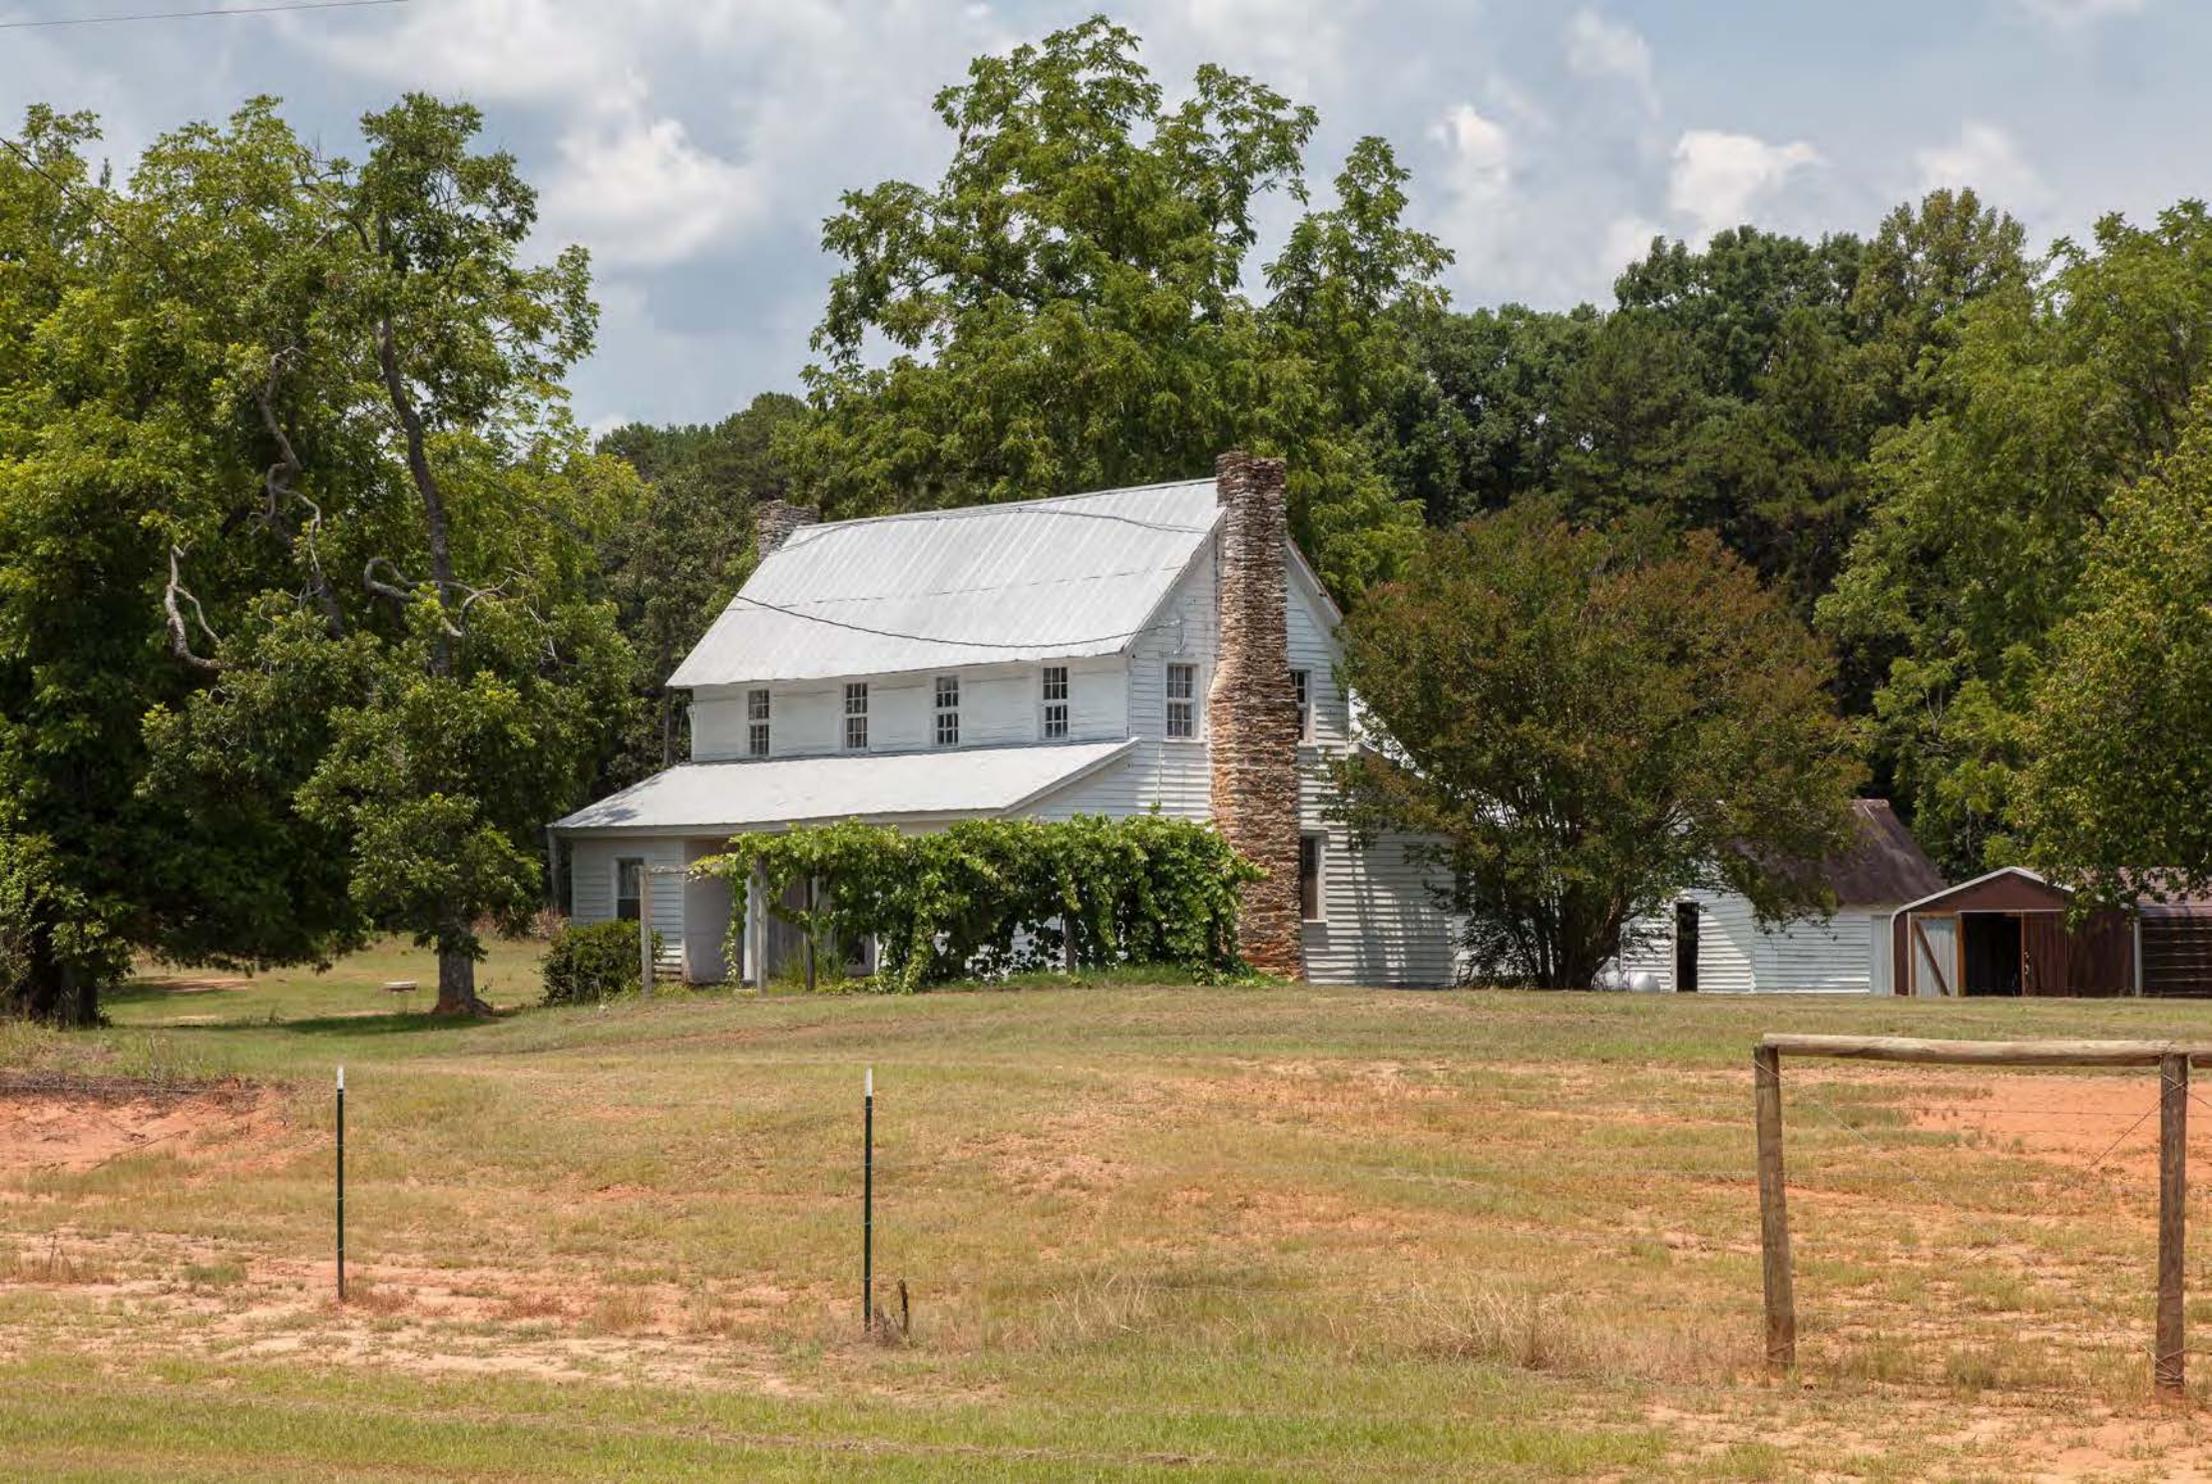
- 1 of 25. Main house and outbuildings, photographer facing west.
- 2 of 25. Main house, front façade, photographer facing north.
- 3 of 25. Main house, front porch detail, photographer facing north.
- 4 of 25. Main house, east side, photographer facing west.
- 5 of 25. Main house, detail of chimney, east elevation.
- 6 of 25. Rear ell, exterior, photographer facing southwest.
- 7 of 25. Rear ell, west enclosed porch interior, photographer facing southeast.
- 8 of 25. Main house, front porch traveler's room, photographer facing east.
- 9 of 25. Interior view, west traveler's room, photographer facing southwest.

The main house, built in 1873, is a two-story, I-house with a rear ell. The front porch features two traveler's rooms, one on each end of the porch (photos 1-2). The frame house rests on a stone foundation, is clad in weatherboard, and is surmounted by a steeply pitched, metal roof. The two end chimneys are built of coursed rubble (photos 4-5). The main façade consists of four bays and a shed-roofed porch that includes two traveler's rooms (photos 2-3). Five wood-paneled doors open onto the porch. The windows on the front façade consist of six-over-six double-hung sash windows.

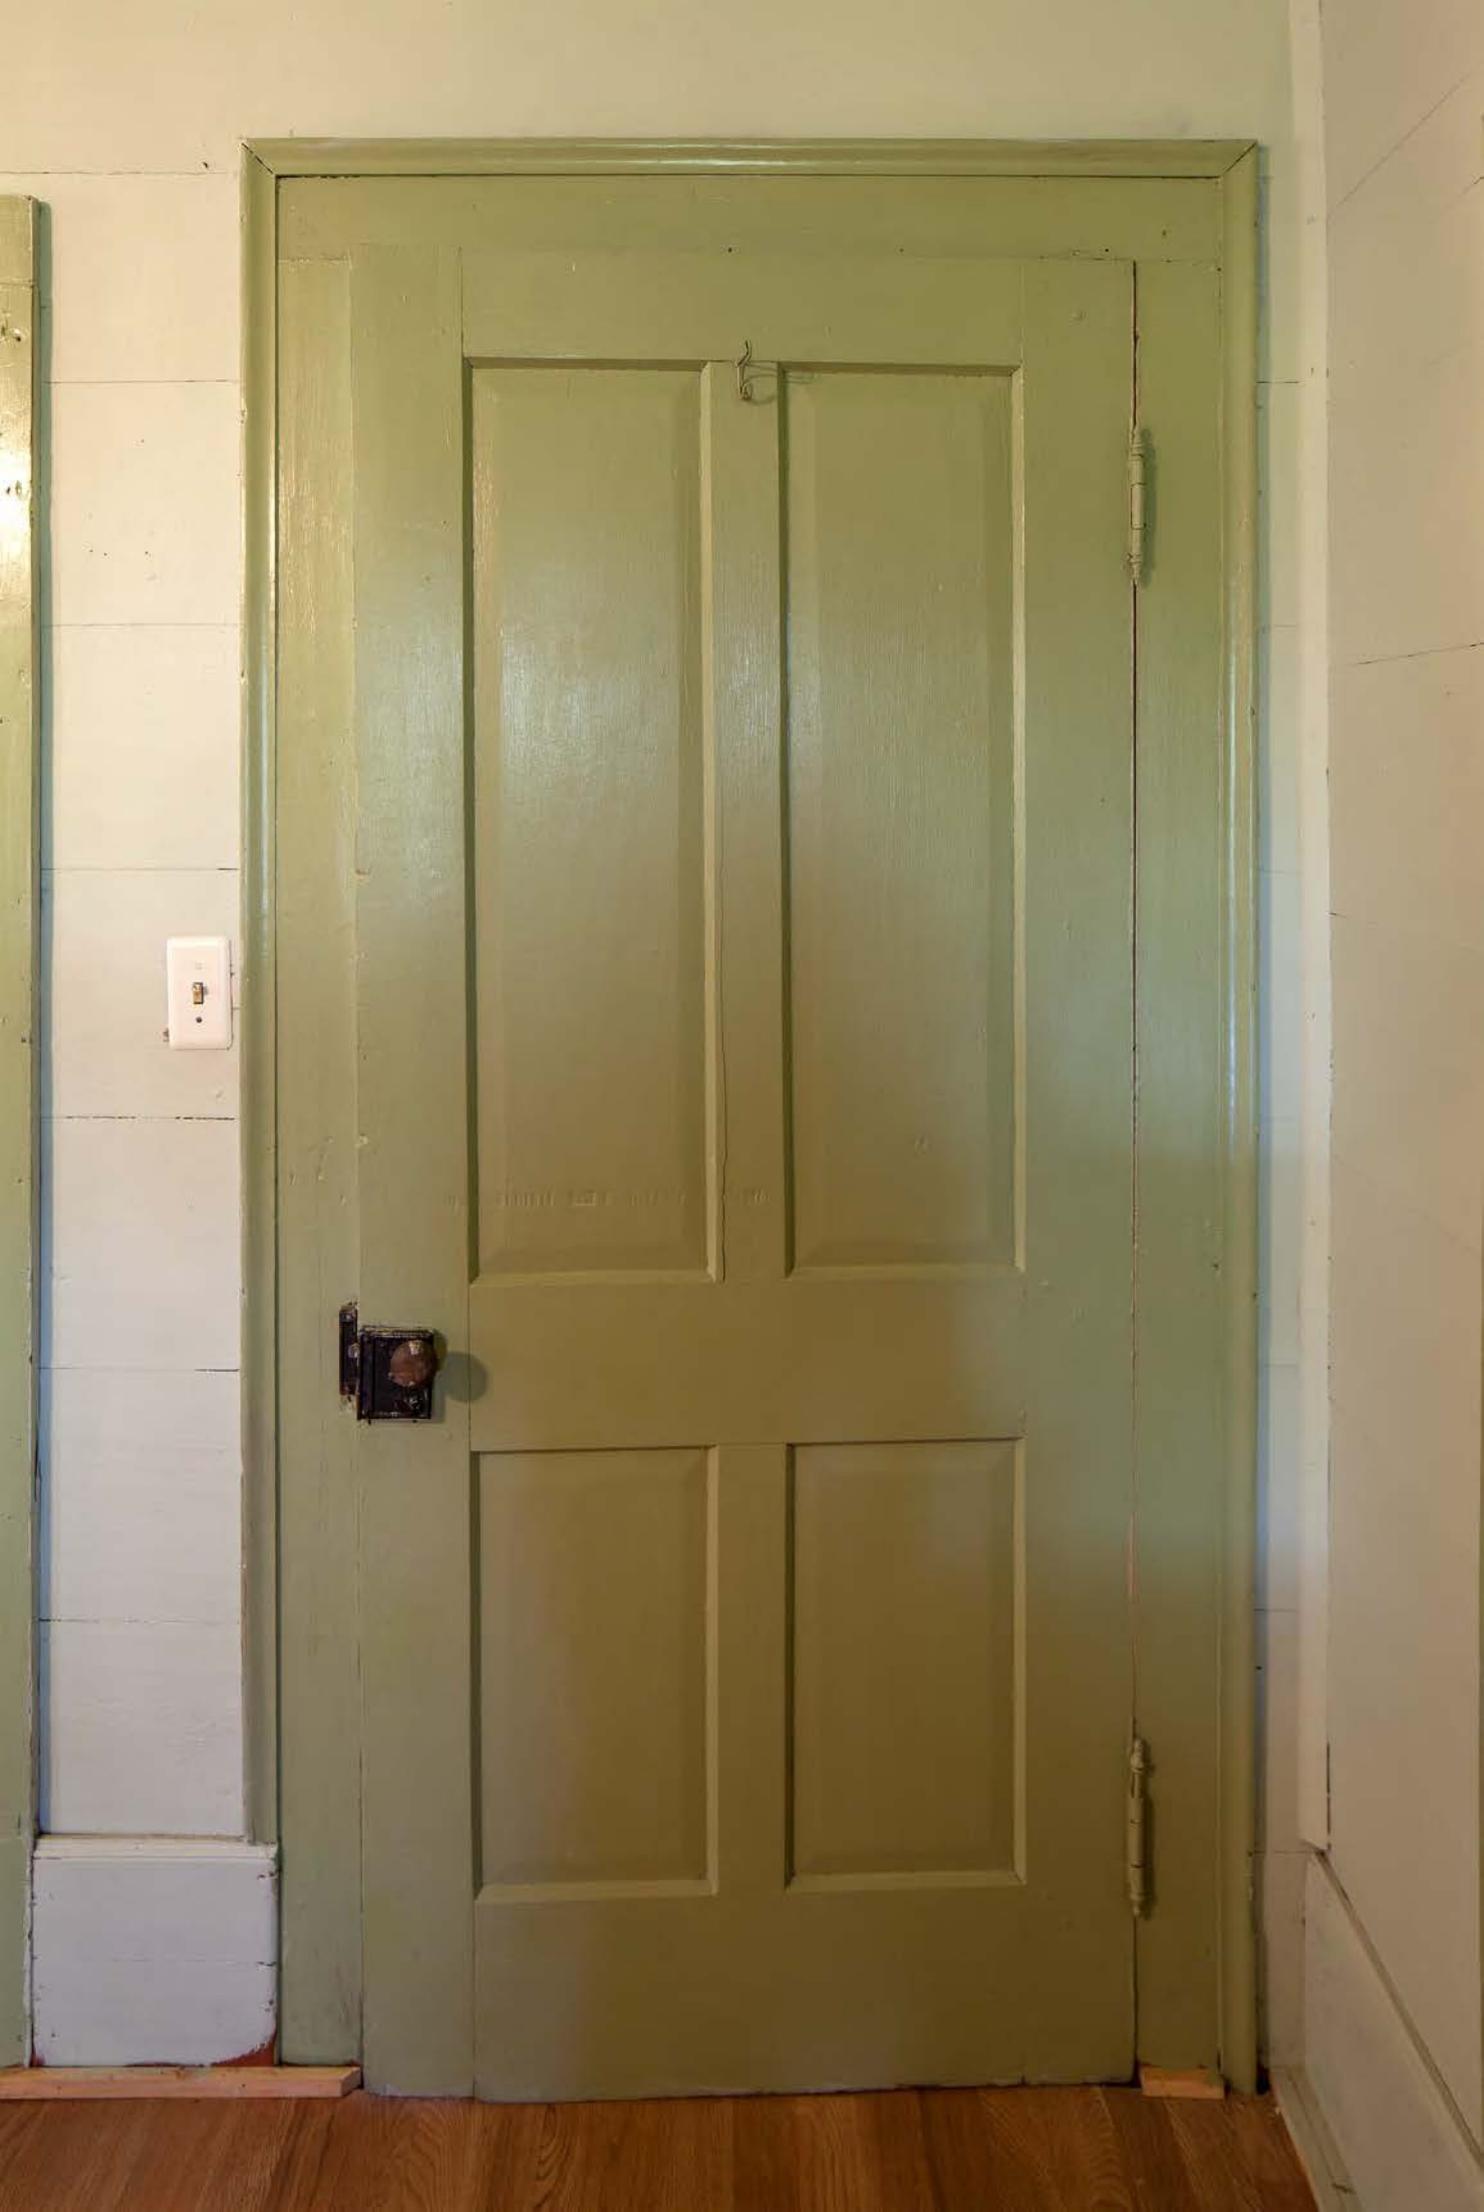
- 12 of 25. Interior view, door to rear ell, west bedroom, main house, photographer facing north.
- 13 of 25. Interior view, kitchen, rear ell, photographer facing southeast.

The interior of the rear ell consists of the kitchen, bathroom, a bedroom, and two enclosed porches. The ell is entered from the west bedroom (photo 12). The ell opens to the back yard through the west-side enclosed porch that preserves unpainted exterior weatherboard and surviving decorative floor patterning (photo 7). In the center of the ell, flanked by two enclosed porches, is the current kitchen, which originally served as the dining room until it was

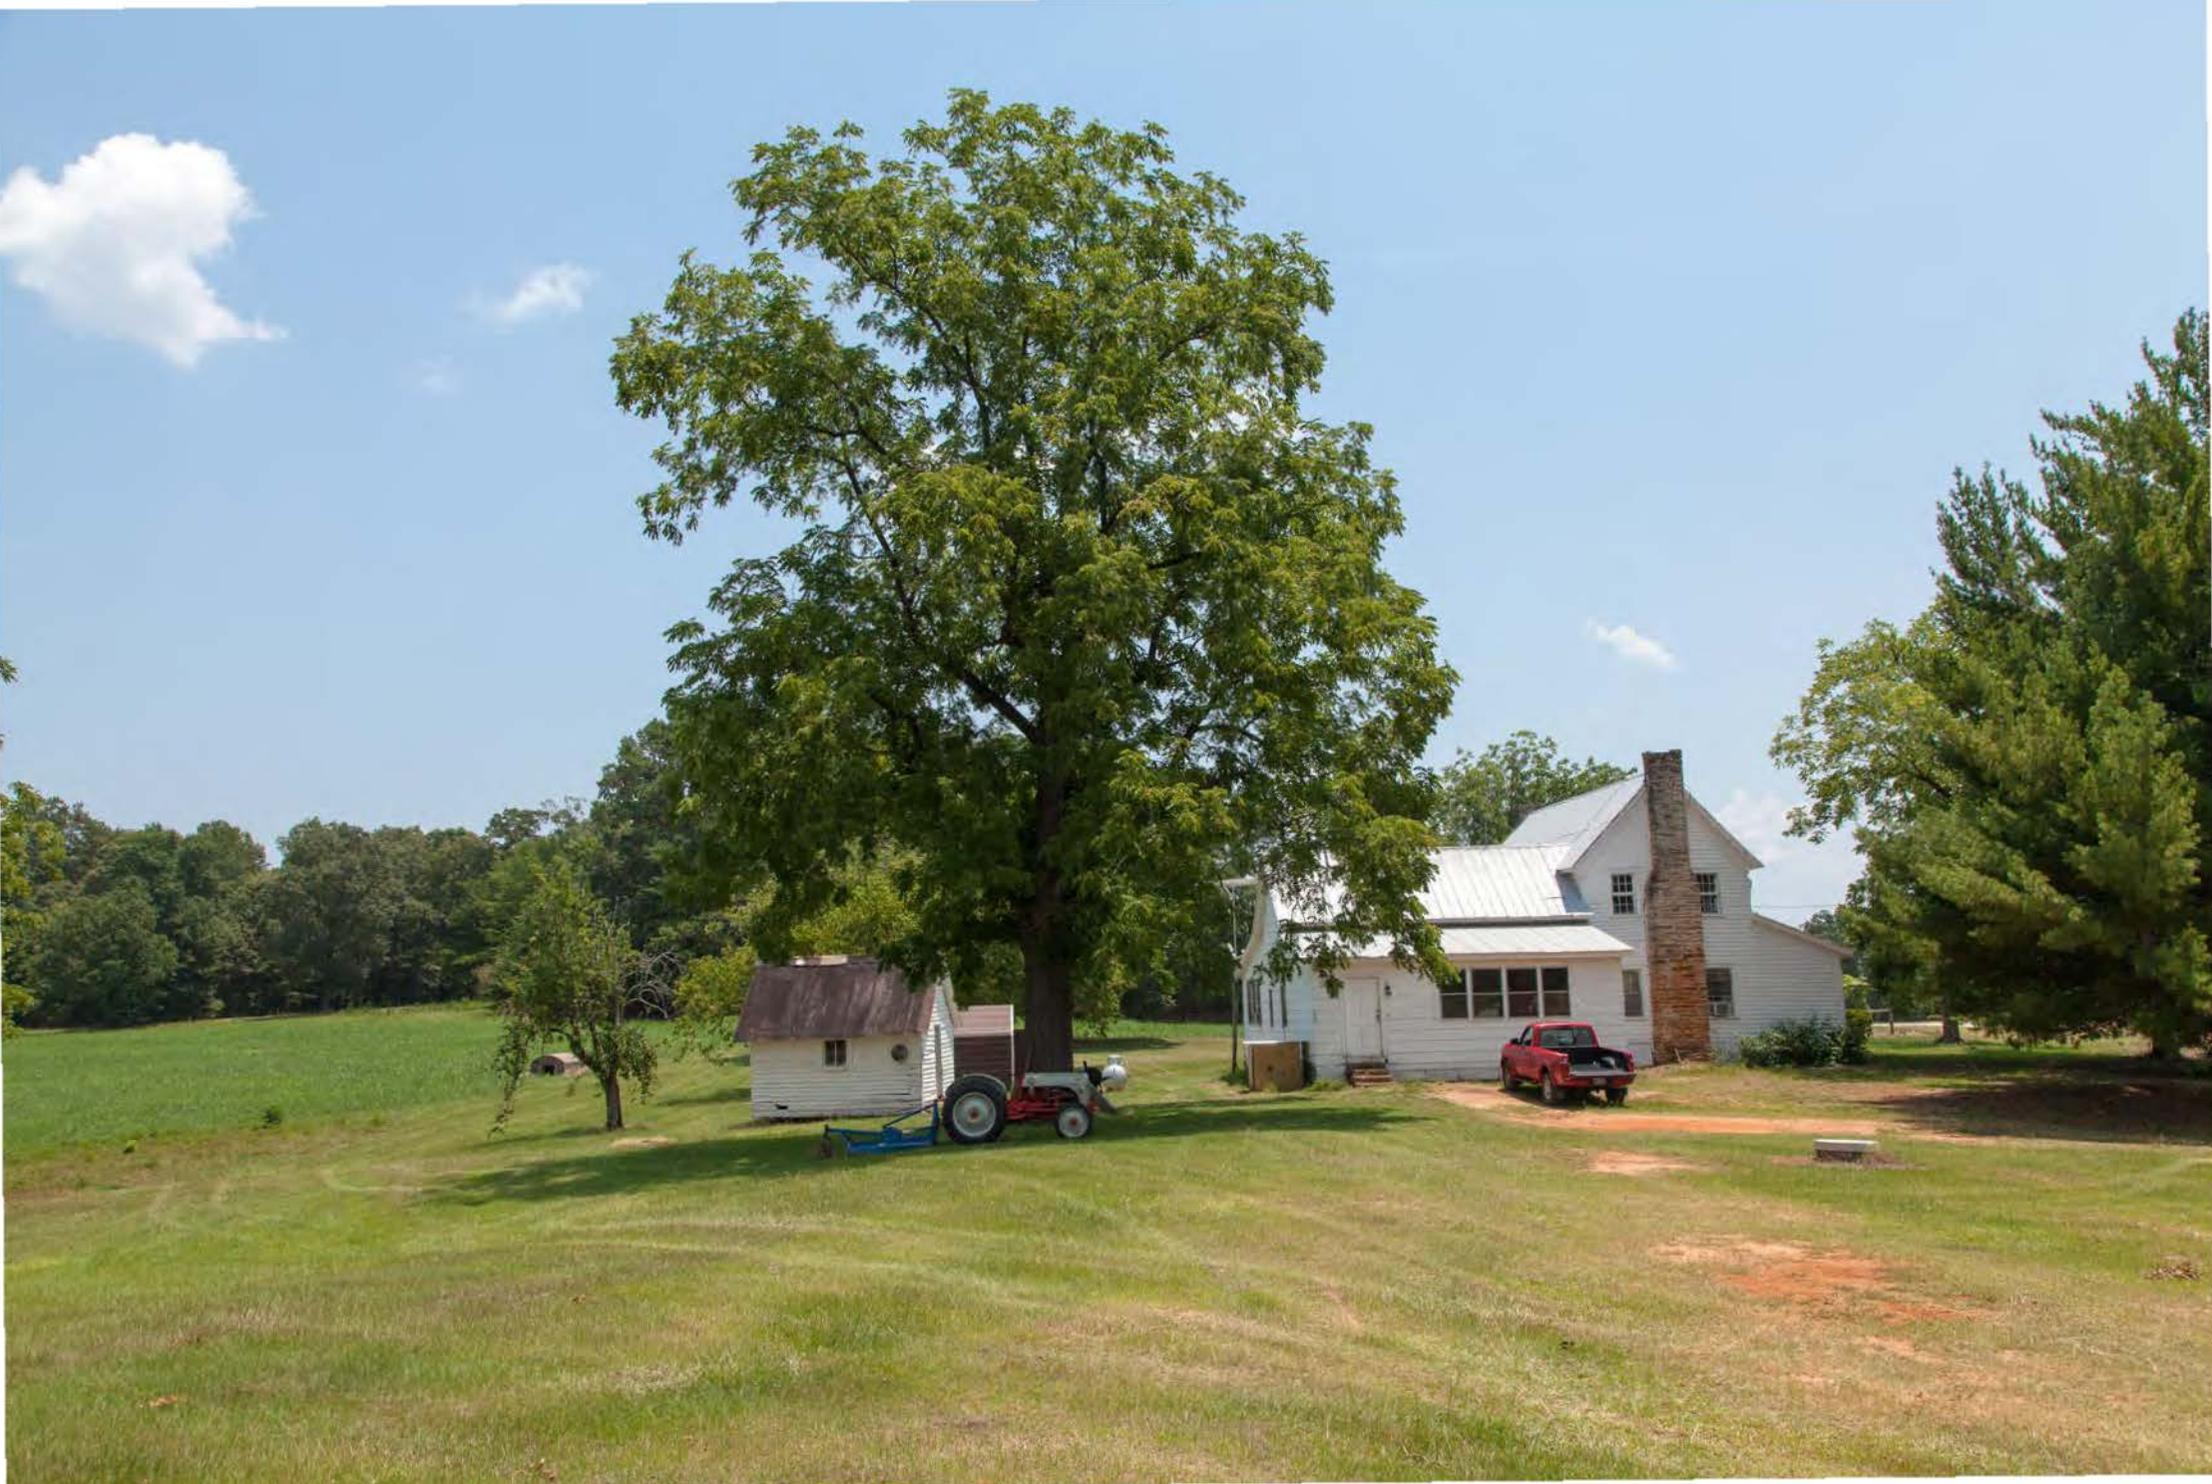
- 18 of 25. Main house and outbuildings, photographer facing east.
- 19 of 25. Summer kitchen, photographer facing northeast.
- 20 of 25. Summer kitchen interior, photographer facing north.

The summer kitchen, built in 1873, located north of the rear ell, is a one-story frame, gable-front building clad in weatherboard. It rests on a rubble masonry foundation. The roof, which is framed with an exposed truss, is covered with sheet metal. The two doors are composed vertical wood planks and the window, located on the east side, is a fixed four-light window (photos 18-20).

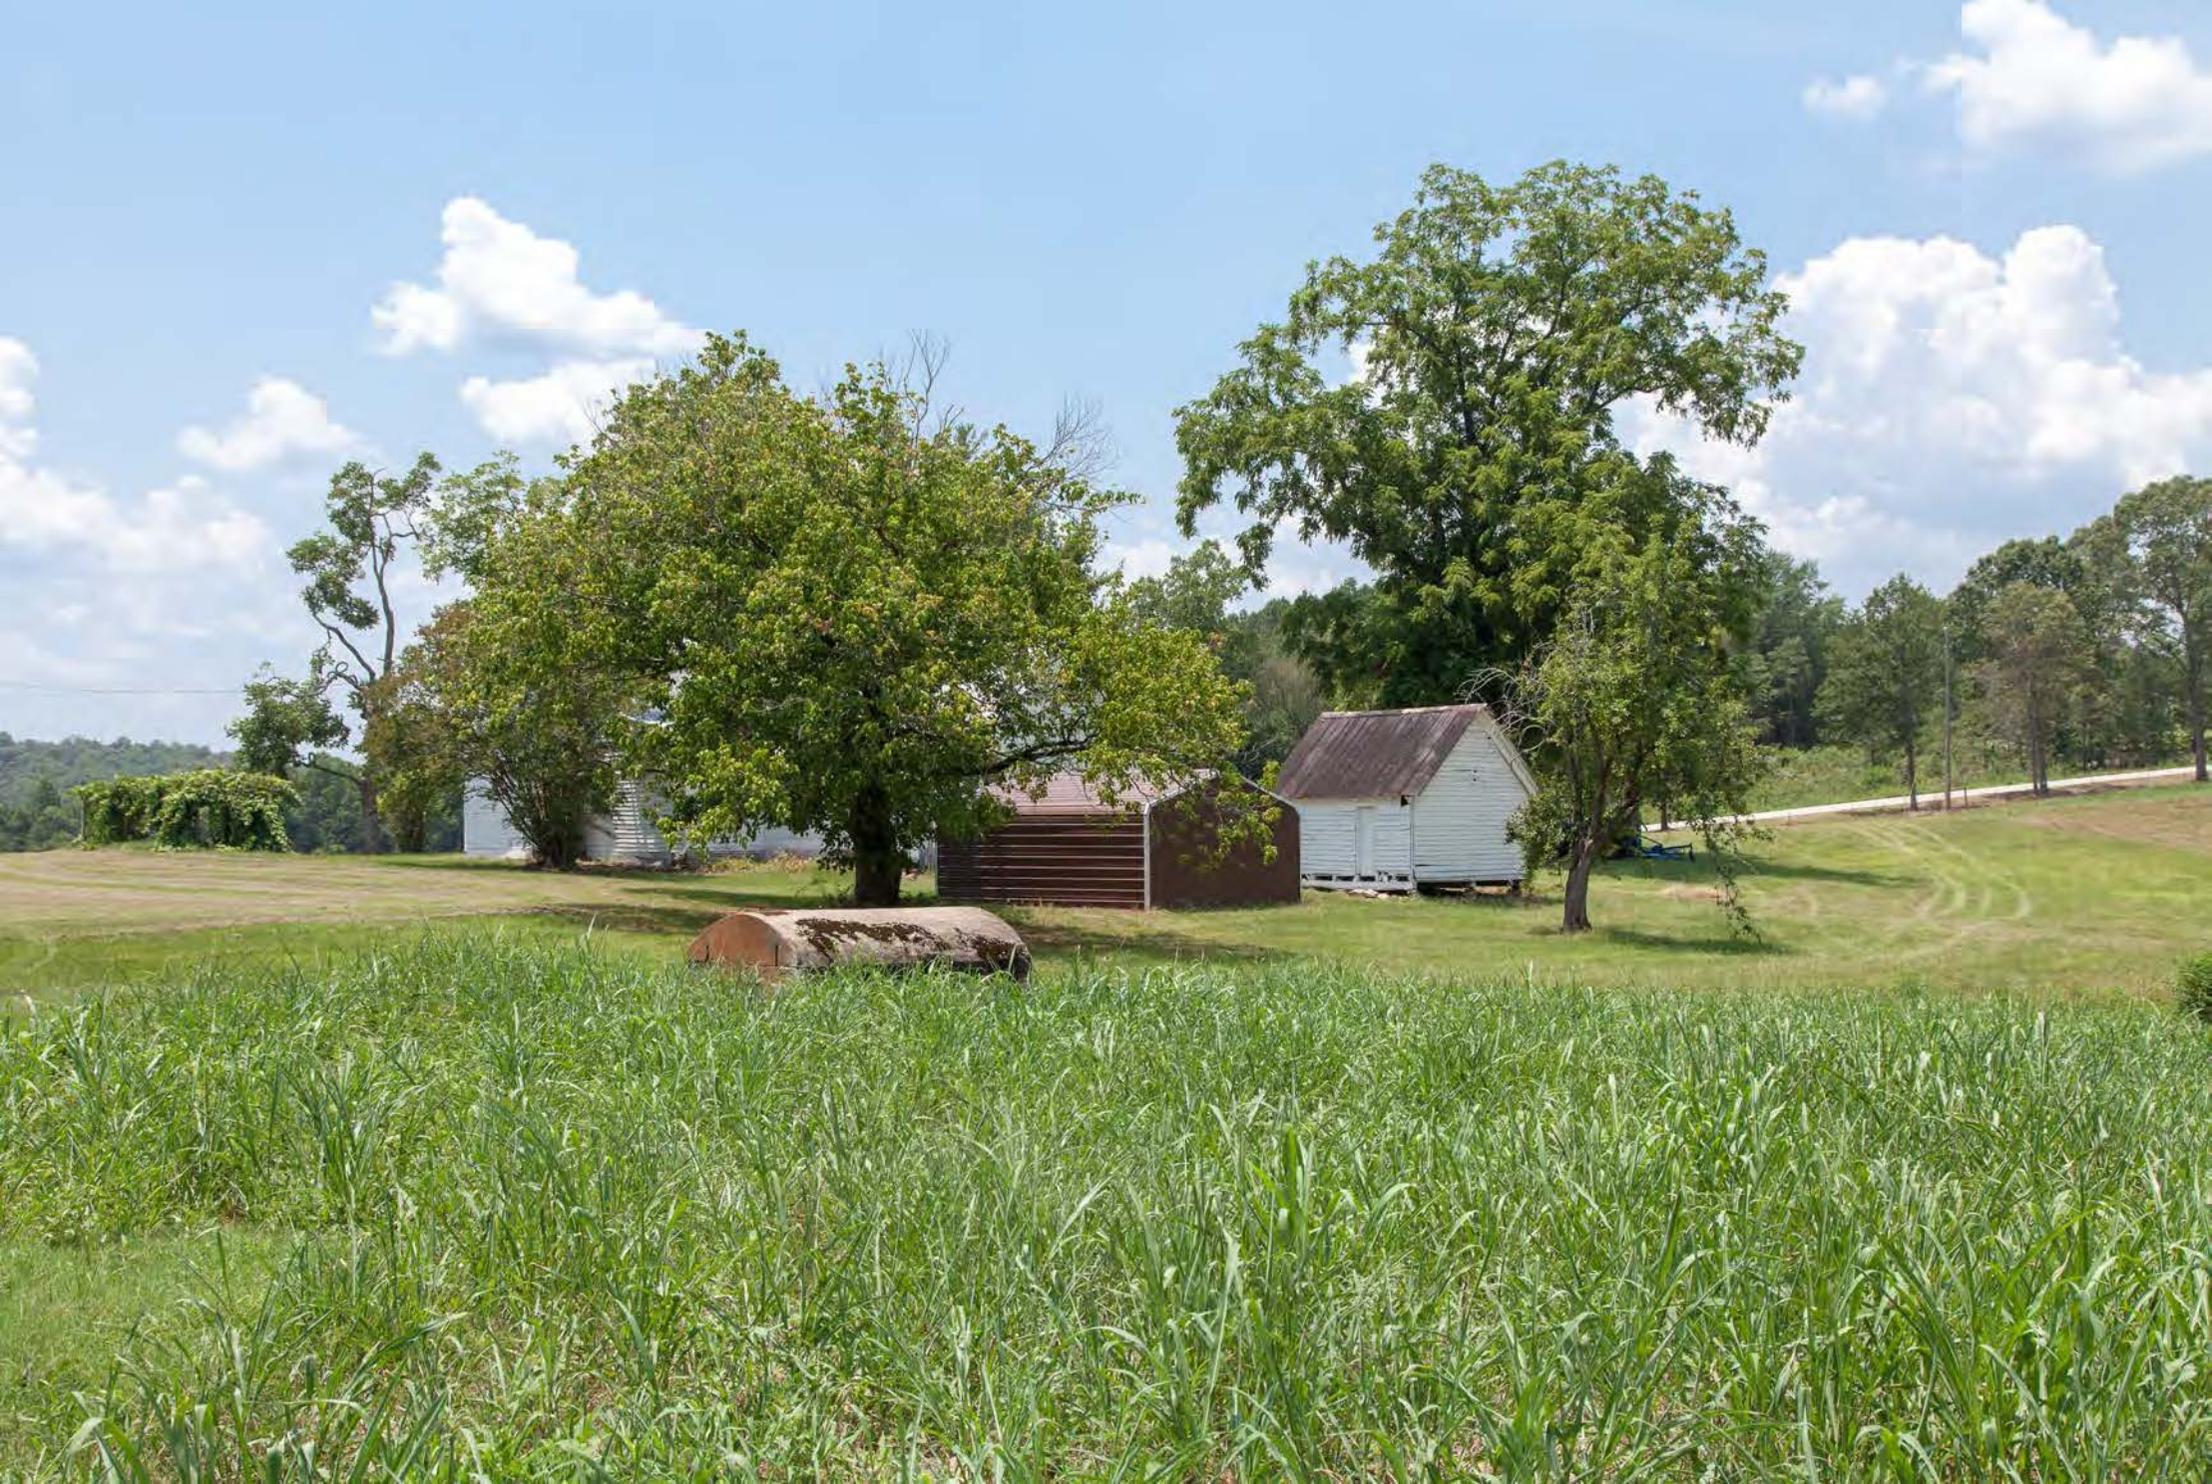
- 21 of 25. Potato house and outbuildings, photographer facing southwest.
- 22 of 25. Potato house exterior, photographer facing northwest.
- 23 of 25. Potato house interior, photographer facing east.

The potato house, built in 1886, is located northwest of the main house (photos 21-23). Constructed of poured concrete, the potato house served to preserve potatoes and other root vegetables. It is a low rectangular building, half buried, with a vaulted roof. The structure is entered through the west end.

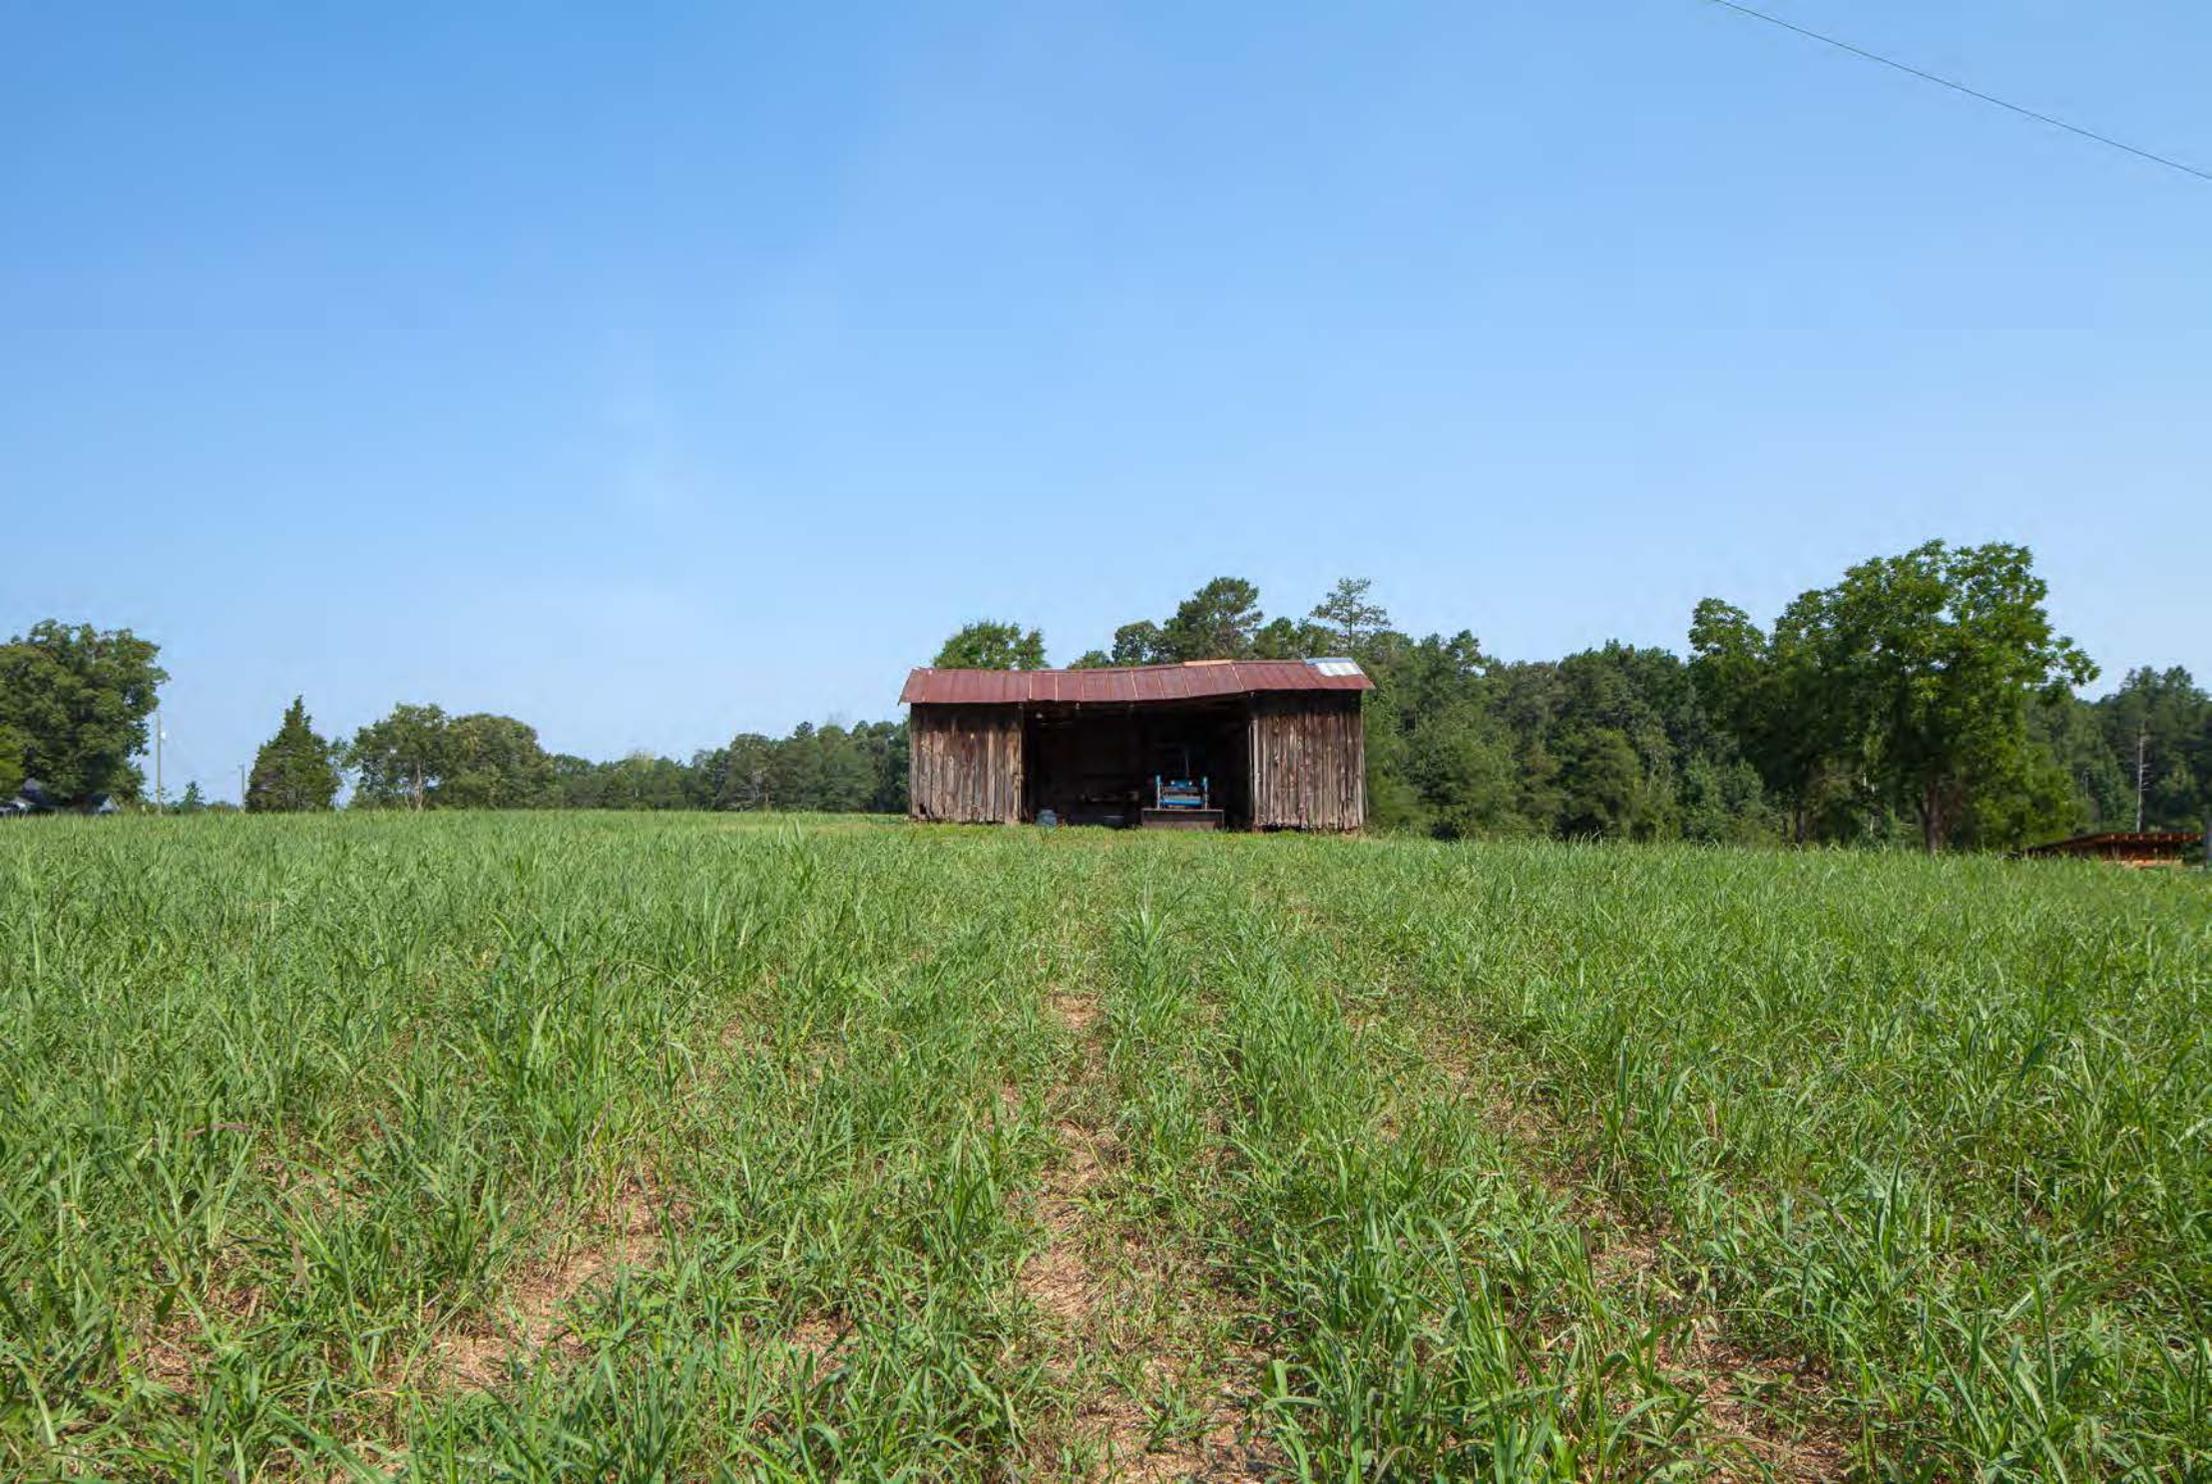
- 24 of 25. Crib barn, photographer facing west.
- 25 of 25. Livestock barn, photographer facing north.

The crib barn, built in 1951 from timbers of an earlier barn, is located in a hay field northwest of the main house. It is a frame, side-gabled building, with an exposed roof truss. The open center bay served as equipment storage. The two cribs were used to store dried grains, such as corn (photo 24).
