1189
CLASSIFIED STRUCTURE FIELD INVENTORY REPORT
(Attach 4" x 5" Black and White Photograph)

STRUCTURE NAME Murphy Trail STRUCTURE NUMBER ISKY-19

REGION RMRO PARK/AREA NAME Canyonlands Natl. Park PARK NUMBER 1340
STRUCTURE NAME Murphy Trail Bridge STRUCTURE NUMBER ISKY-18
LOCATION OF STRUCTURE Murphy Trail PARK LOCATION CODE PG
NATIONAL REGISTER _____ DATE: / / MANAGEMENT CATEGORY: (A) (B) (C) (D)
NPS LEGAL INTEREST FEE MANAGEMENT AGREEMENT: NO

The Murphy Trail Complex(ranching theme):

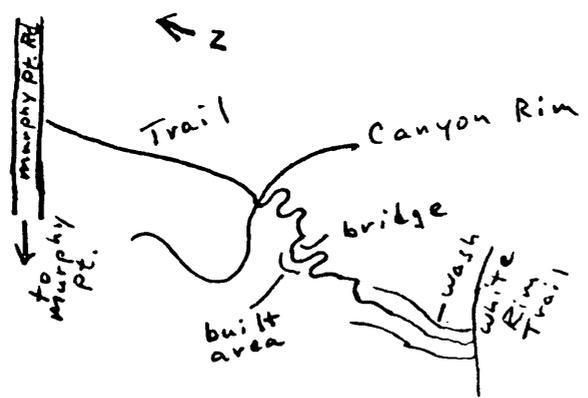
Condition: Good
Documentation: Fair
Significance: L
Internal Impacts: L/POP/WEA
External Impacts: L/POP/ERO

Type: OT (Trail)

Material: EA/ST

Dimensions: 2' to 4' wide; 3 miles (approximately) long that at numerous points shows the work of man through cribbing and filling as well as scattered debris (lumber)-- see photos

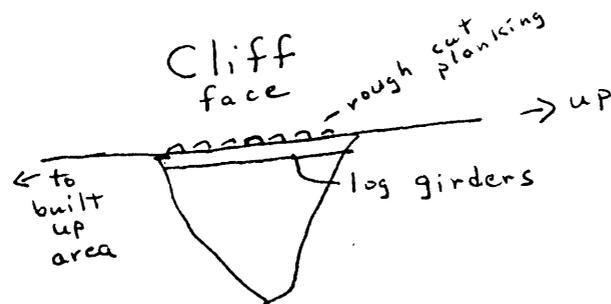
Condition: Good/Fair
Documentation: Fair
Significance: L
Internal Impacts: L/POP
External Impacts: L/POP/ERO

Material: WD (split, rough hewn logs, log poles)

Type: BR (log girder bridge)

Dimensions: 12'x4' approximate (varies)
