NATIONAL REGISTER OF HISTORIC PLACES
EVALUATION/RETURN SHEET

PROPERTY Goldade, Johannes, House
NAME:

**National Register of Historic Places
Inventory—Nomination Form**

historic Goldade, Johannes, House

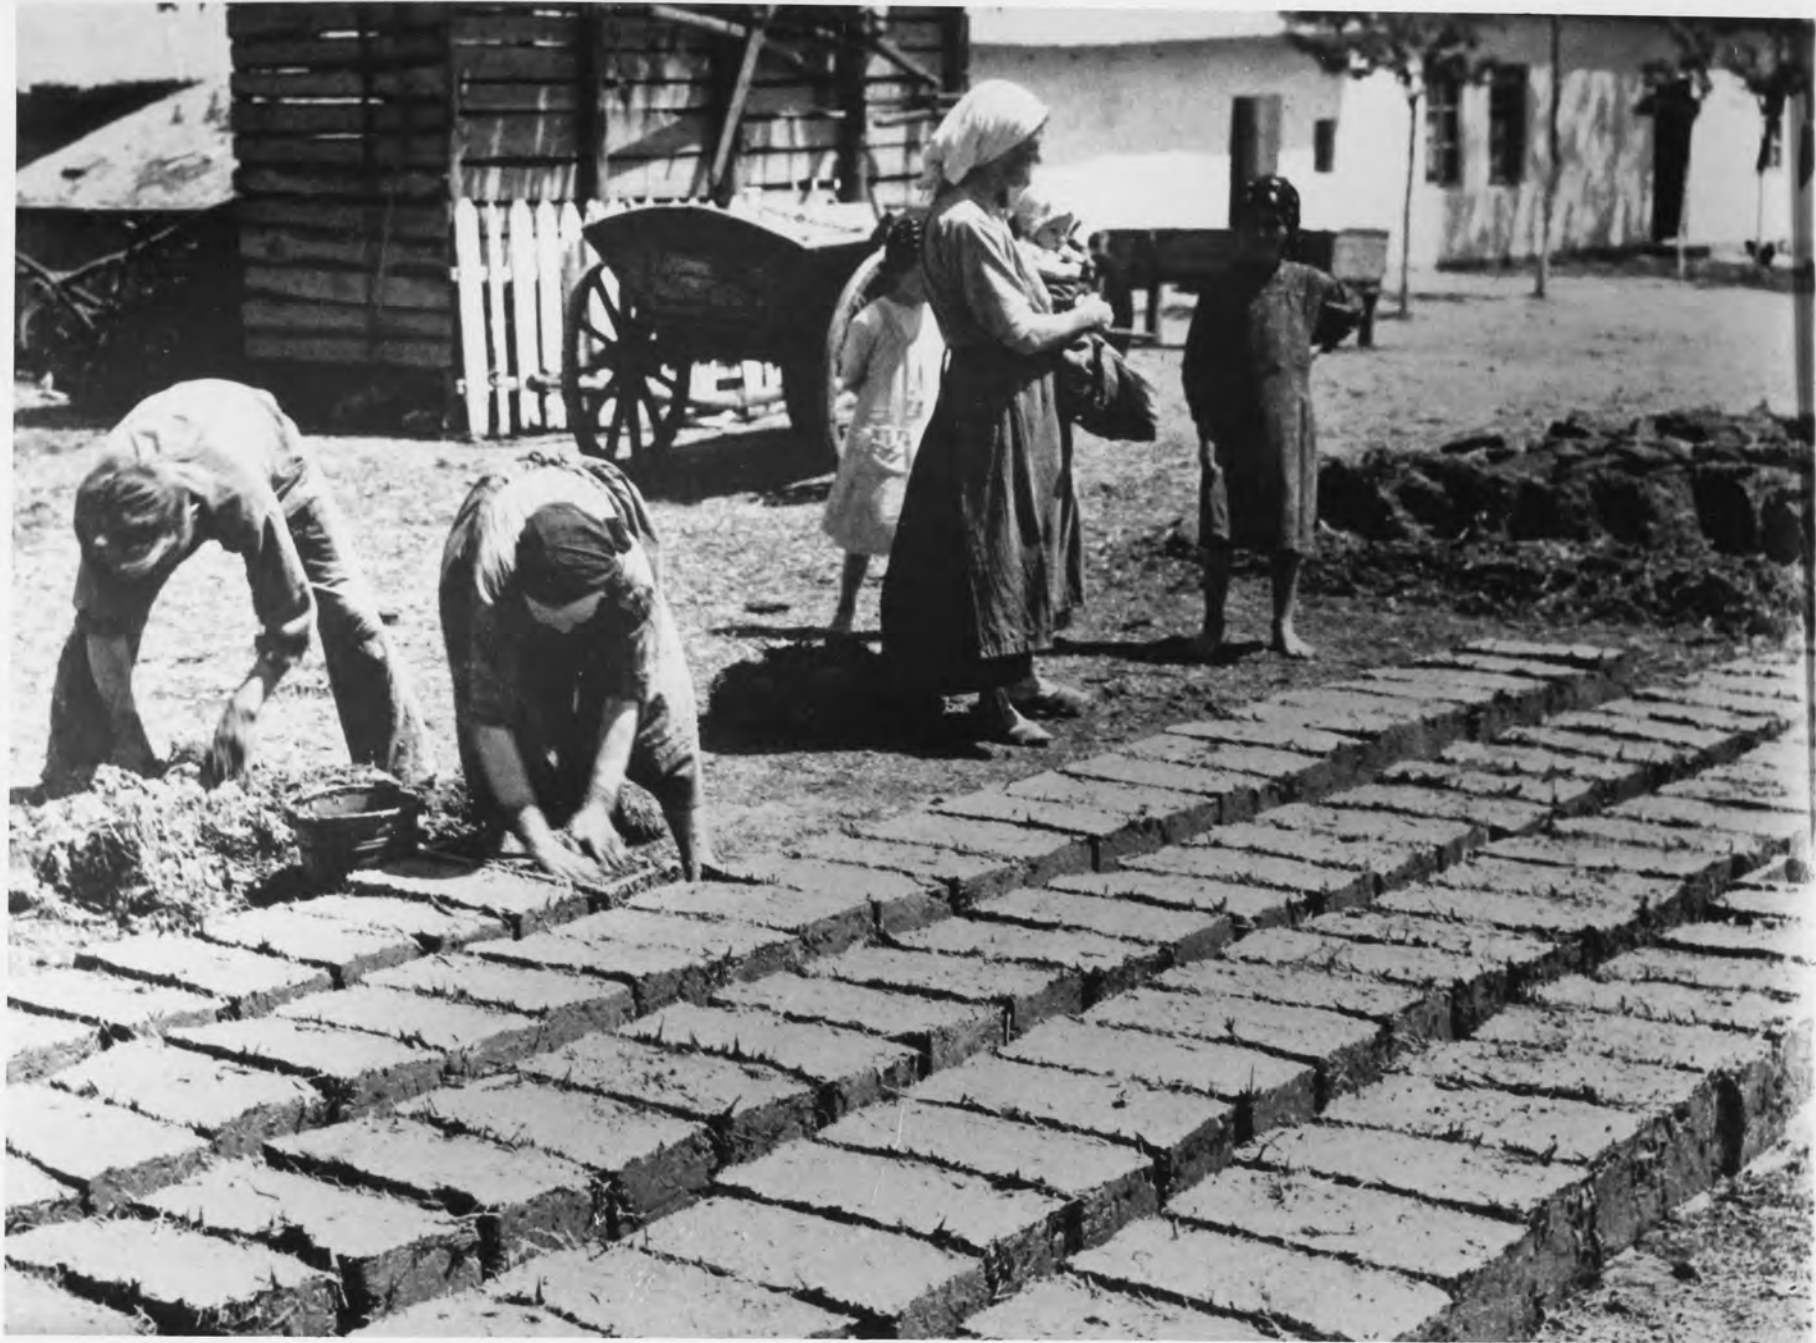
Photo 1 of 11

Handforming clay bricks in Russia.

Mortar throughout the house is a mixture of native clay, straw and water. The bricks were manufactured by ramming a similar mixture into a wood mold. The wet bricks were sun-dried for several months and when dry, are hard enough to spark a flint and provide insulation against both extreme heat and cold.

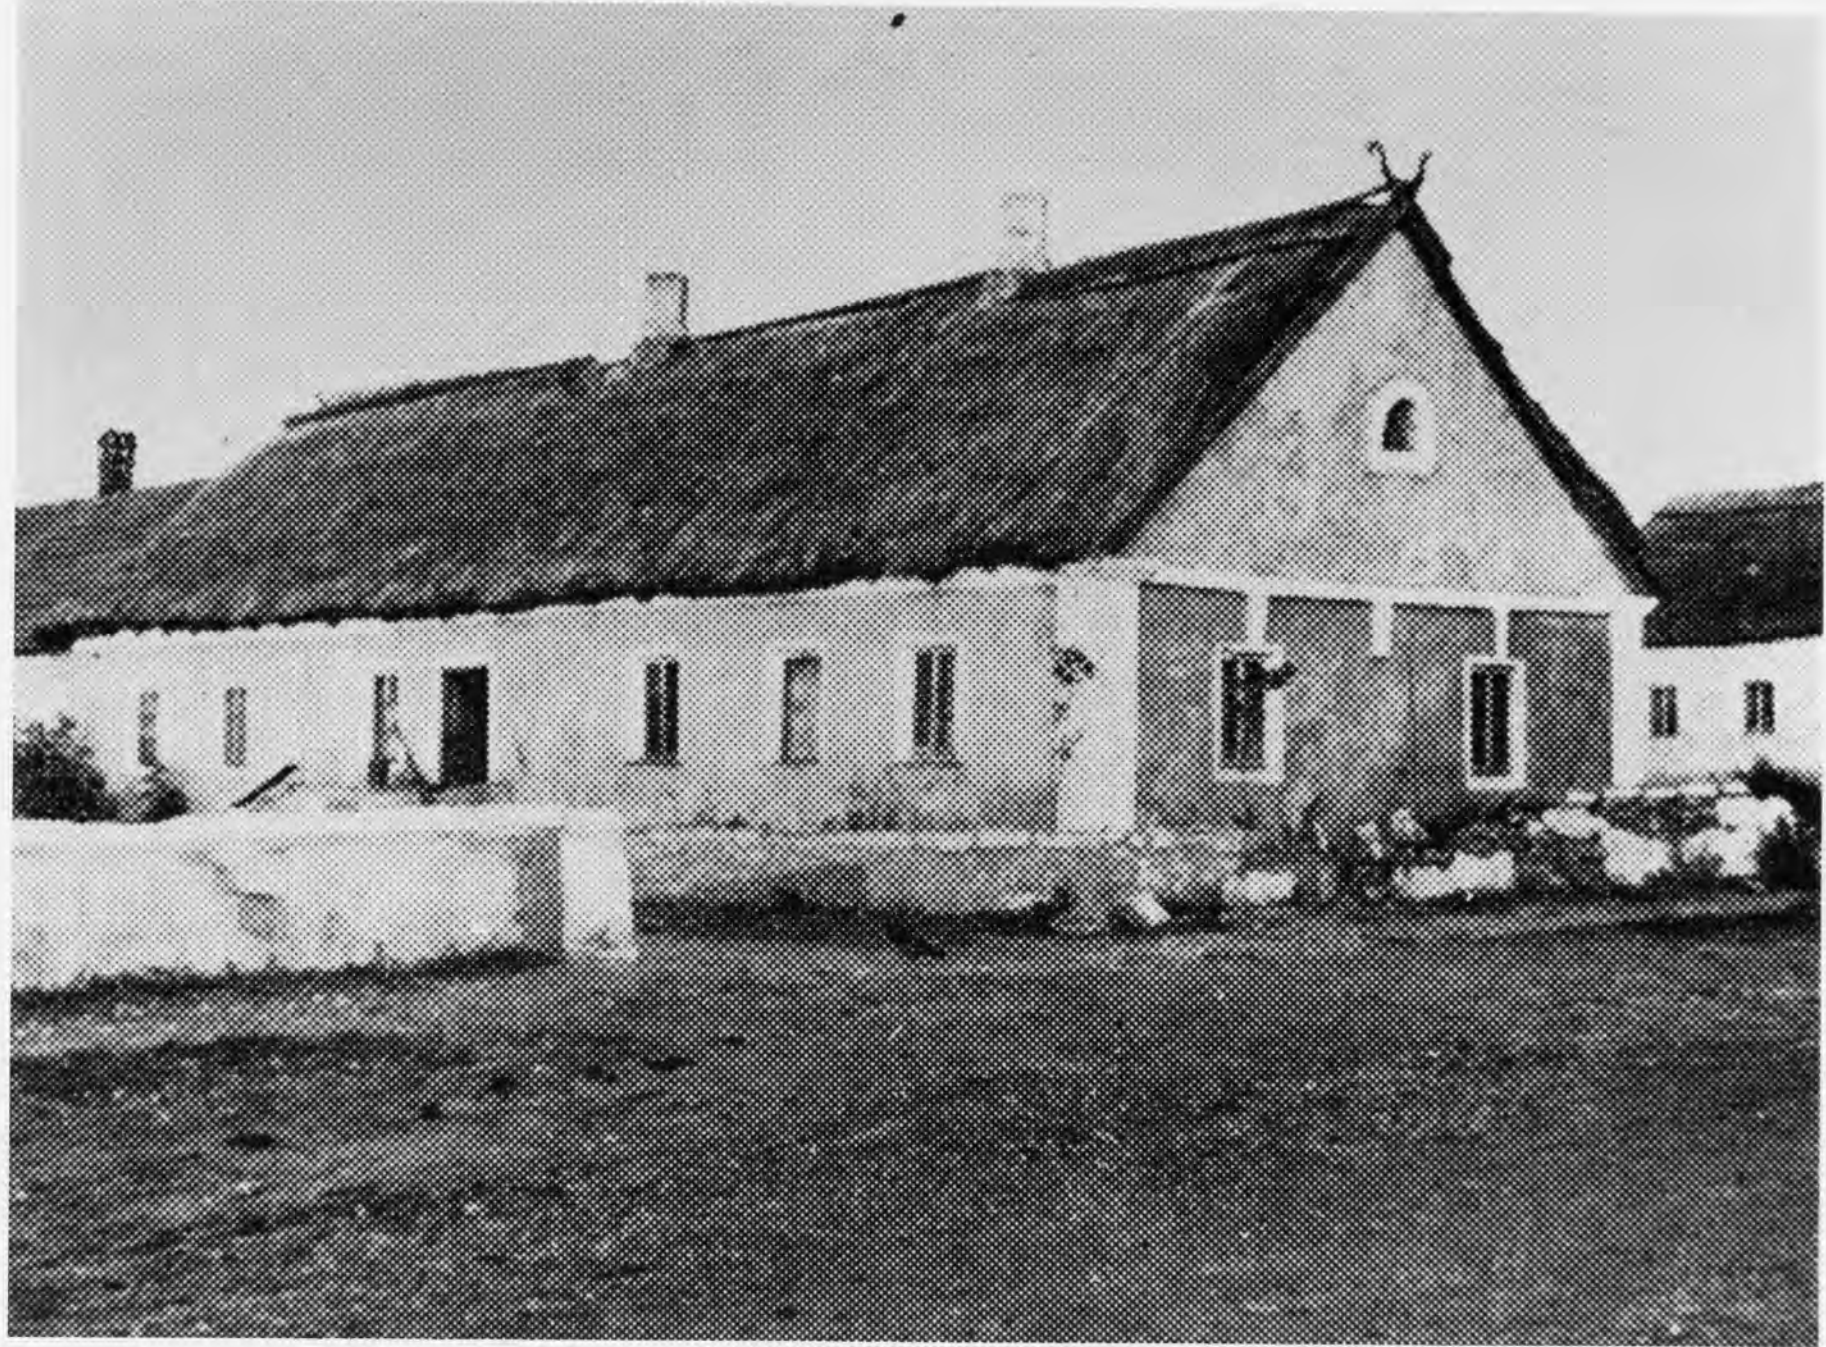
Photo 2 of 11

Typical house in Strassburg, Russia; north of Odessa in the
Black Sea region.

The general floor-plan of the colonist house was remarkably similar to the Franconian-Alsatian archetype in the ancestral motherland. According to a building plan found in the archives at Elsass, the colonial house had a tripartite division. The central part adjoining the side entrance comprised a small hallway or ante room, called the Hausflur,* and the adjoining kitchen. On the right side, facing the street, was located the Vorderstub, or living room . . . At the other end of the house the Hinterstub, or rear room . . . A most practical innovation was the large stone-vaulted cellar which, however, was not located under the house but adjacent to it. (Height 1973:121-125).

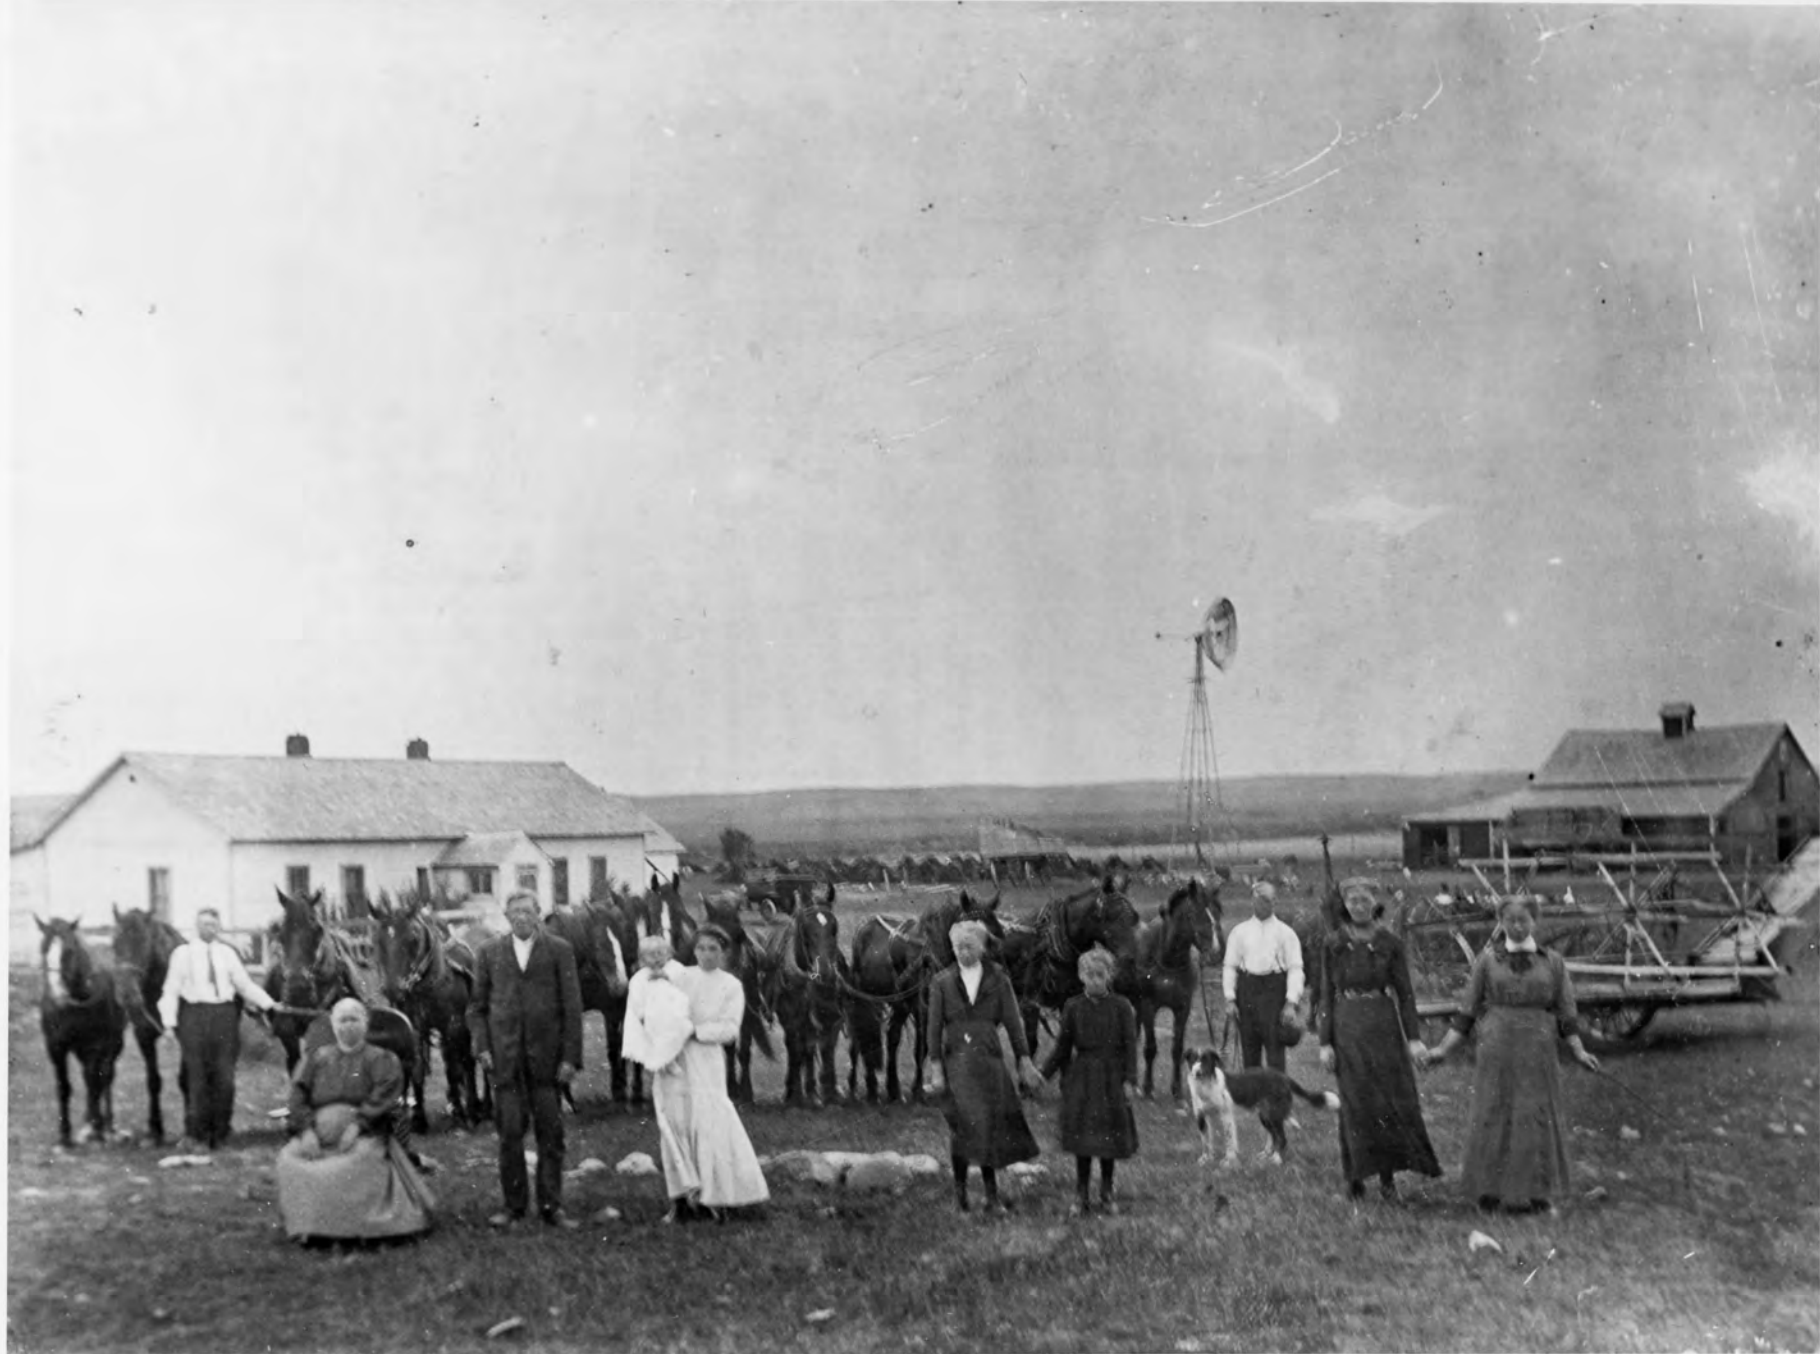
Photo 3 of 11

Original Goldade homestead, Goldade family and horses. View from south, southwest. The rocking chair is still in the house.

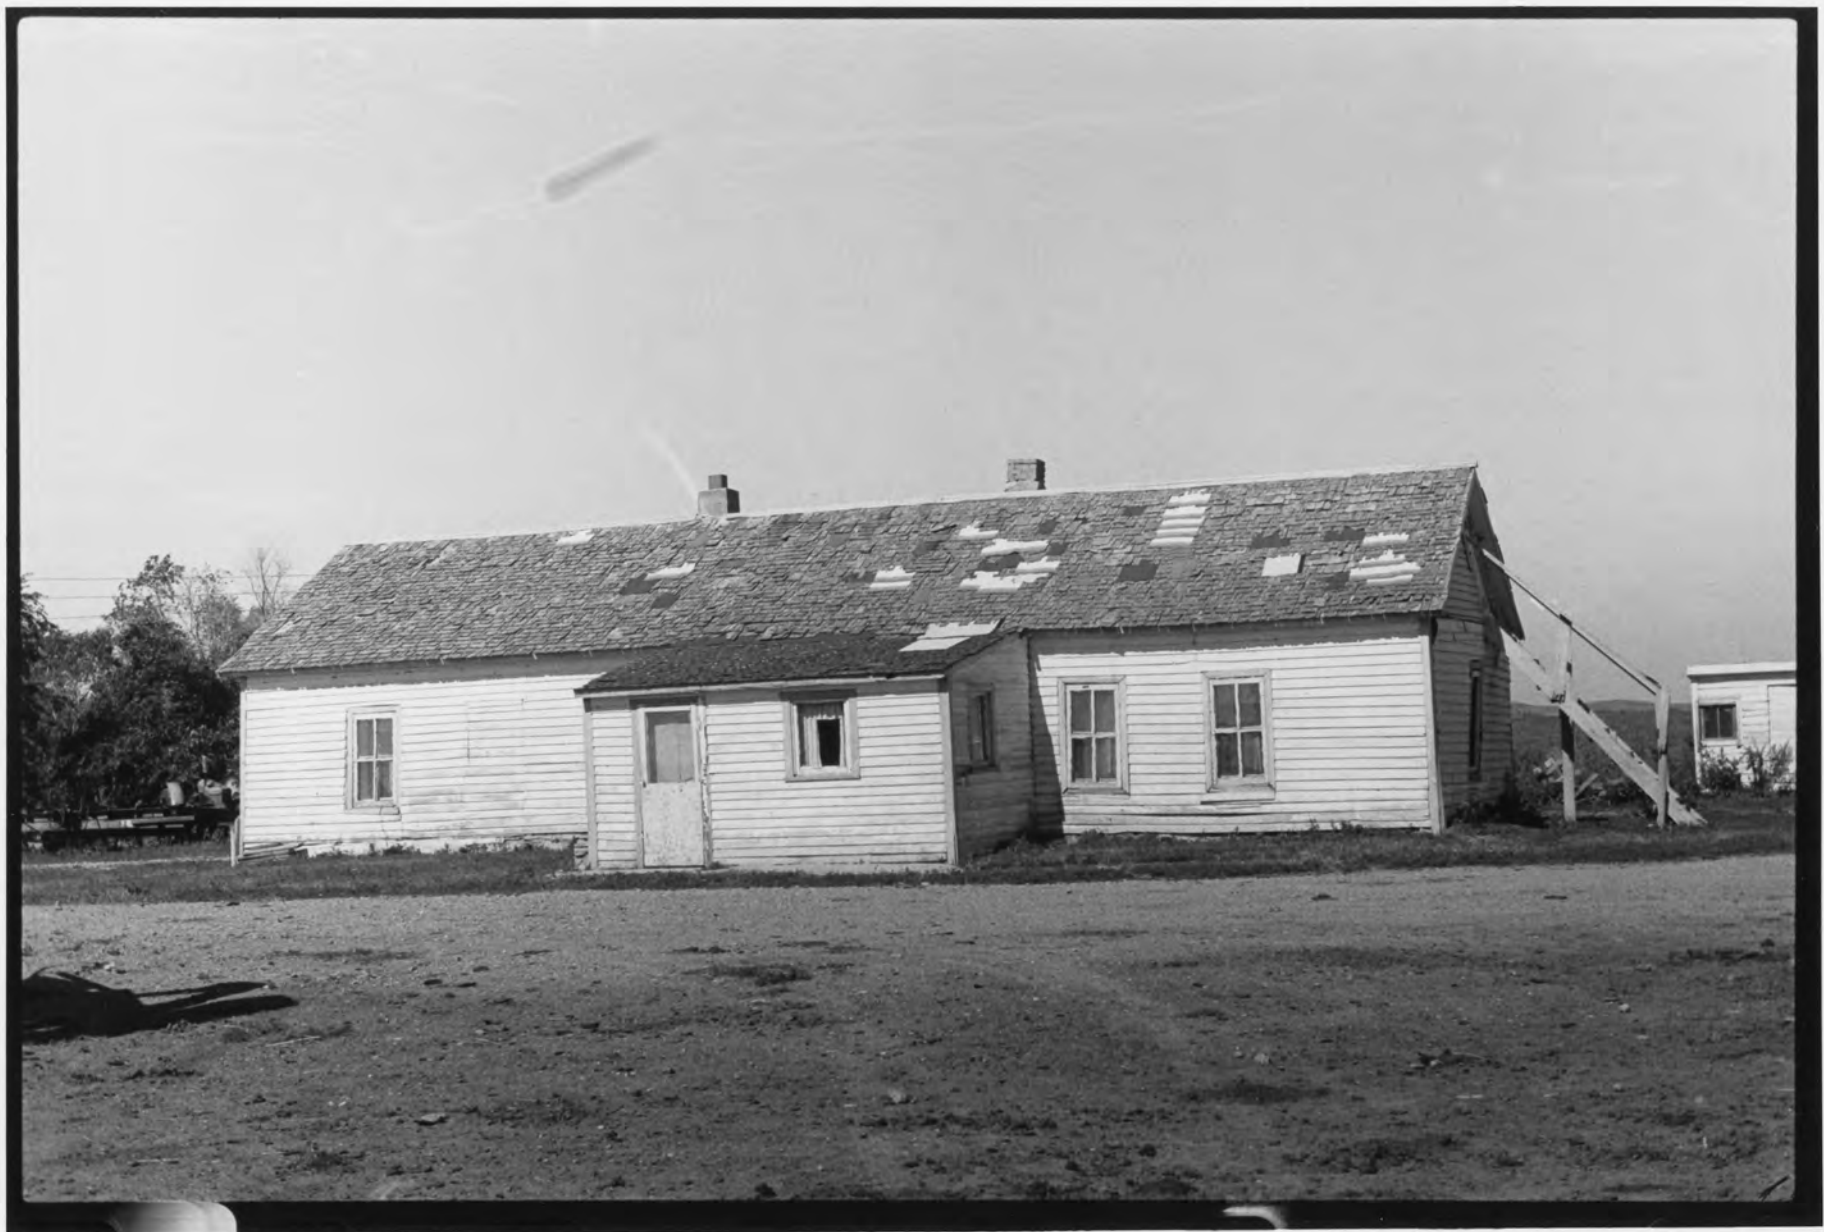
Photo 4 of 11

South (front) facade, view from southeast.

The Johannes Goldade House is a single story, three room linear (19' x 50') building with a gabled roof and a singular entrance protected by a rectangular (14' x 8') shed-roofed entryroom centrally located on the front (south) facade. The east-west leeward orientation of the house is common throughout the area and is typical of the German-Russian utilitarian attitude toward housing. The house is constructed of a double wythe of handmade clay bricks on a two-to-three foot high foundation of sandstone slab. The Goldade house, like many others in the vicinity, has been finished in clapboards providing relatively easy maintenance for the 1½ foot clay walls beneath. The clapboards are painted white and the window trim and gable ends are light, bright blue, a color scheme popular in both interior and exterior decoration of German-Russian homes in the area.

The entryway, commonly called a vorhausel (literally translated "before the house") is a characteristic component in early German-Russian housing in this area and is almost always located on the center front facade of the house and always opens into the kitchen. The vorhausel, depending on its size, is the scene of a variety of domestic activities and can function as a second kitchen or a mud room. Nowadays they often house the washer and dryer or deep freeze. Although a few vorhausels in the area are stone slab or mud brick, the Goldade vorhausel is wood frame. Originally built in a smaller dimension (approximately 8' x 10') with a gable roof, the vorhausel was rebuilt with a shed roof ca. 1940. The original four-panel vorhausel entry door was re-used.

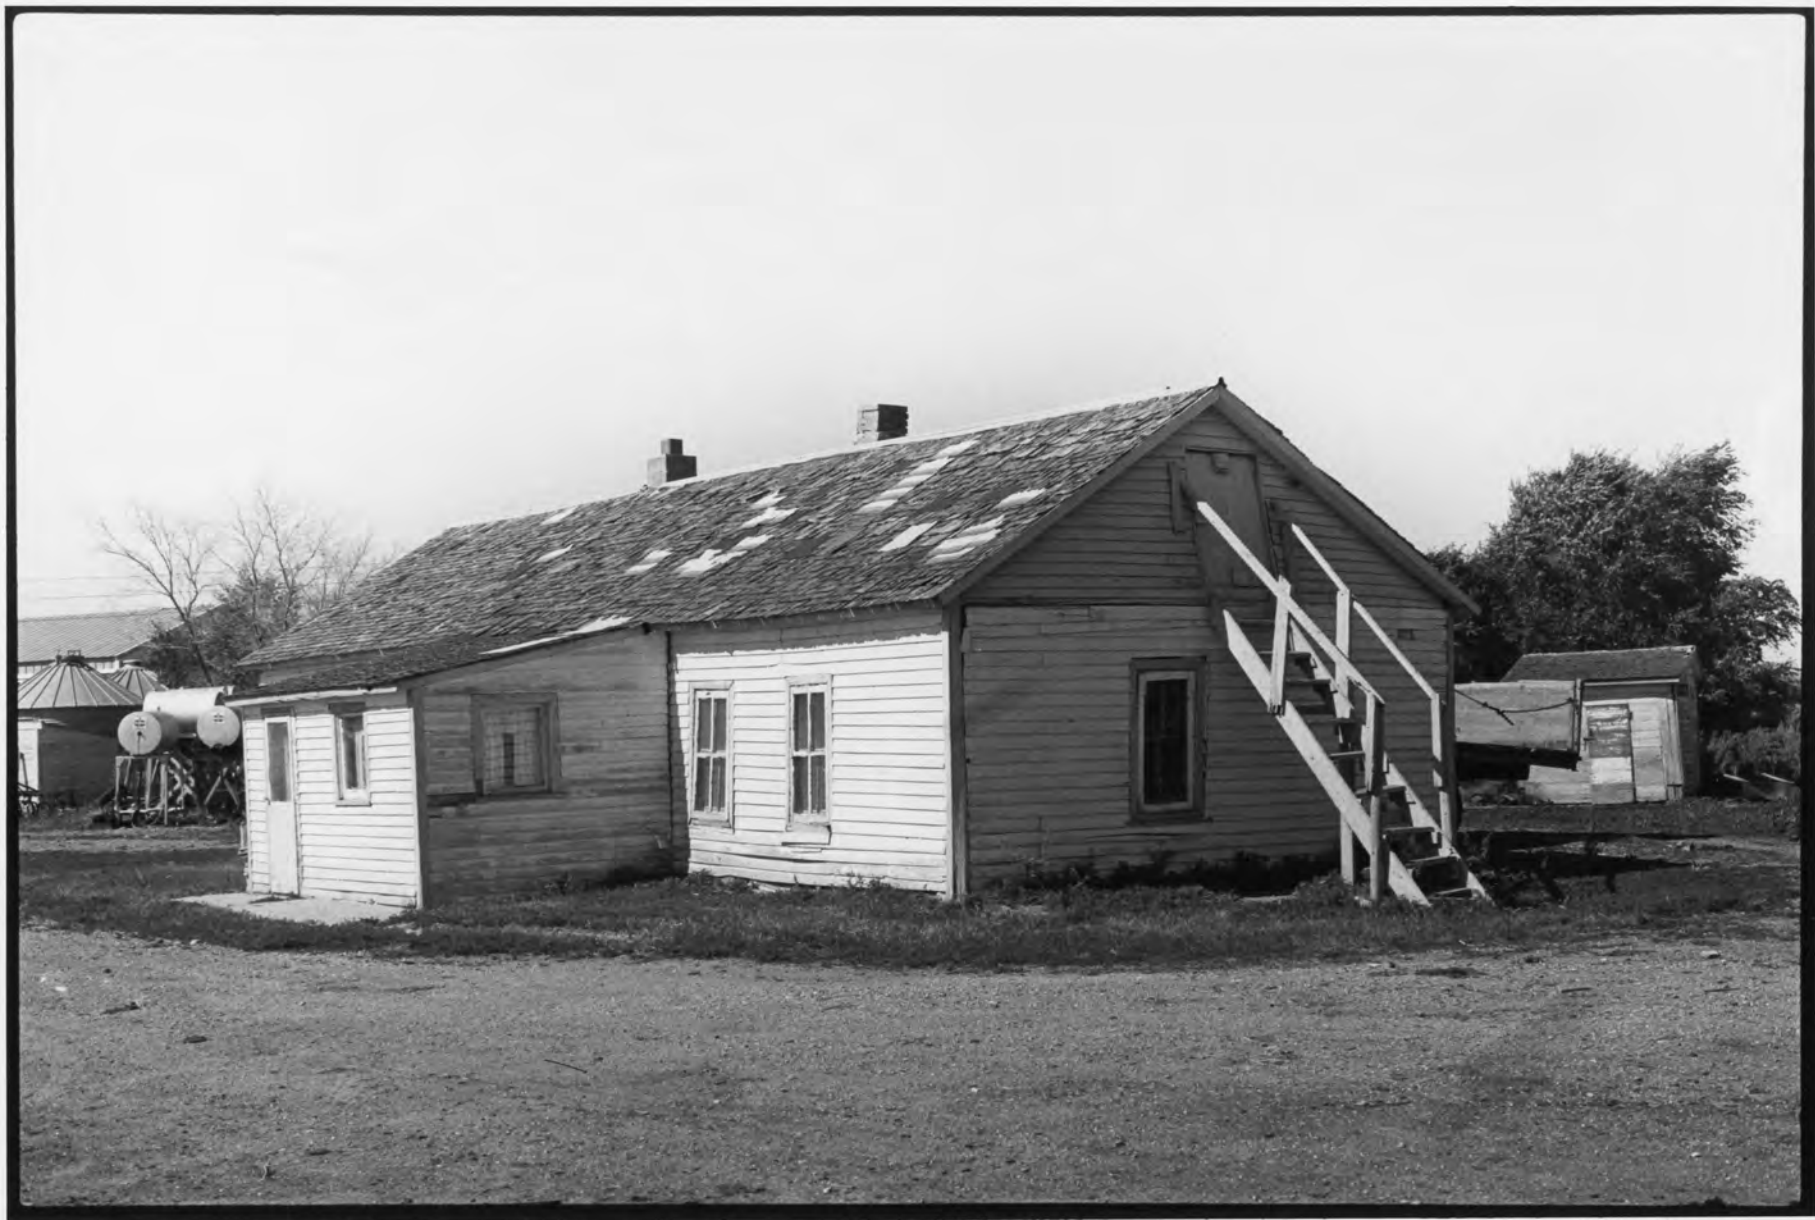
Photo 5 of 11

View from southeast. Note exterior stair on east elevation.
View depicts current condition of house.

An exterior stairway with solid stringer boards and open treads ascends to the loft on the east elevation. A short plank door with a wood latch opens to the half story which the Goldade family has always used for storage. Exterior stairs are found on many houses in the area and the loft is commonly finished for extra living space.

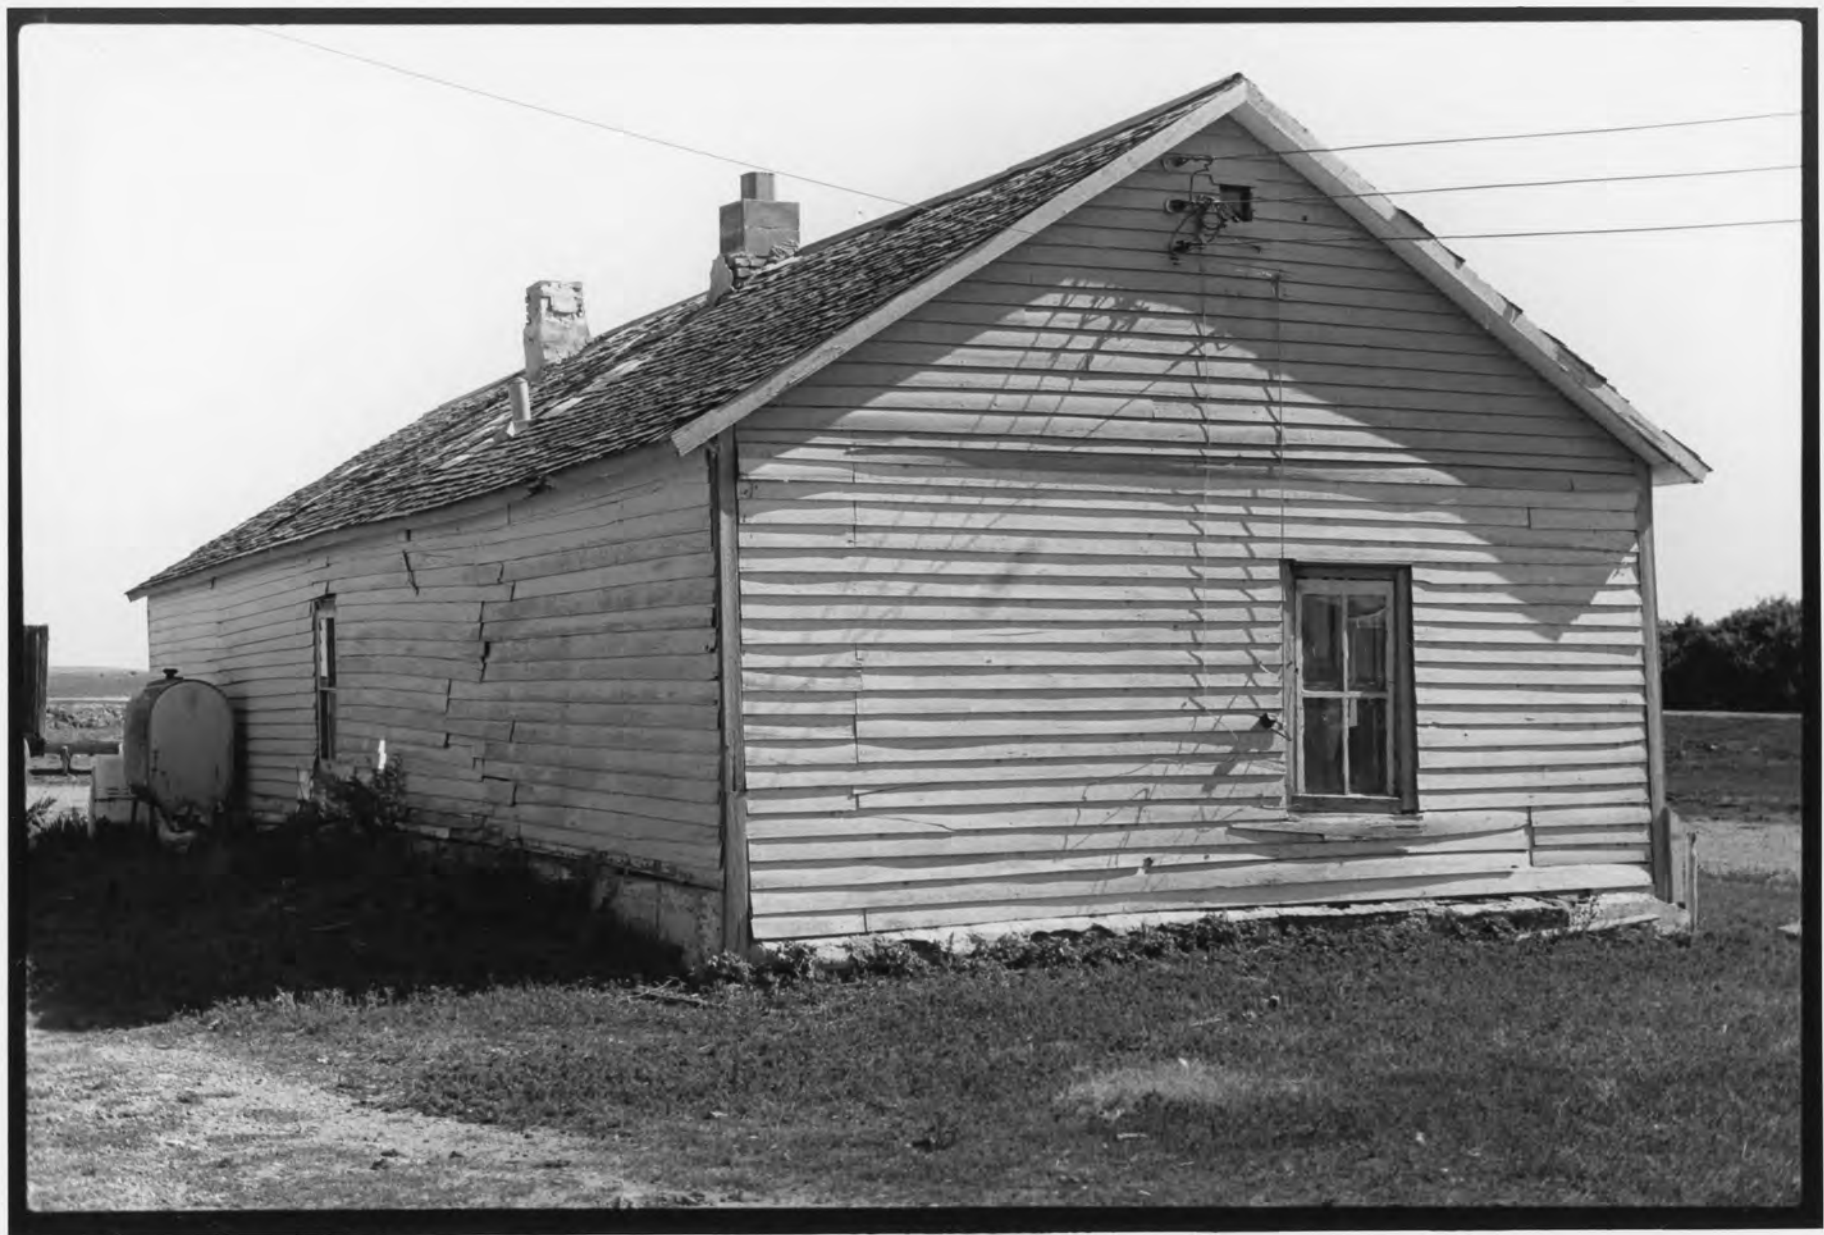
Photo 6 of 11

View from northwest of west and north (rear) elevations.

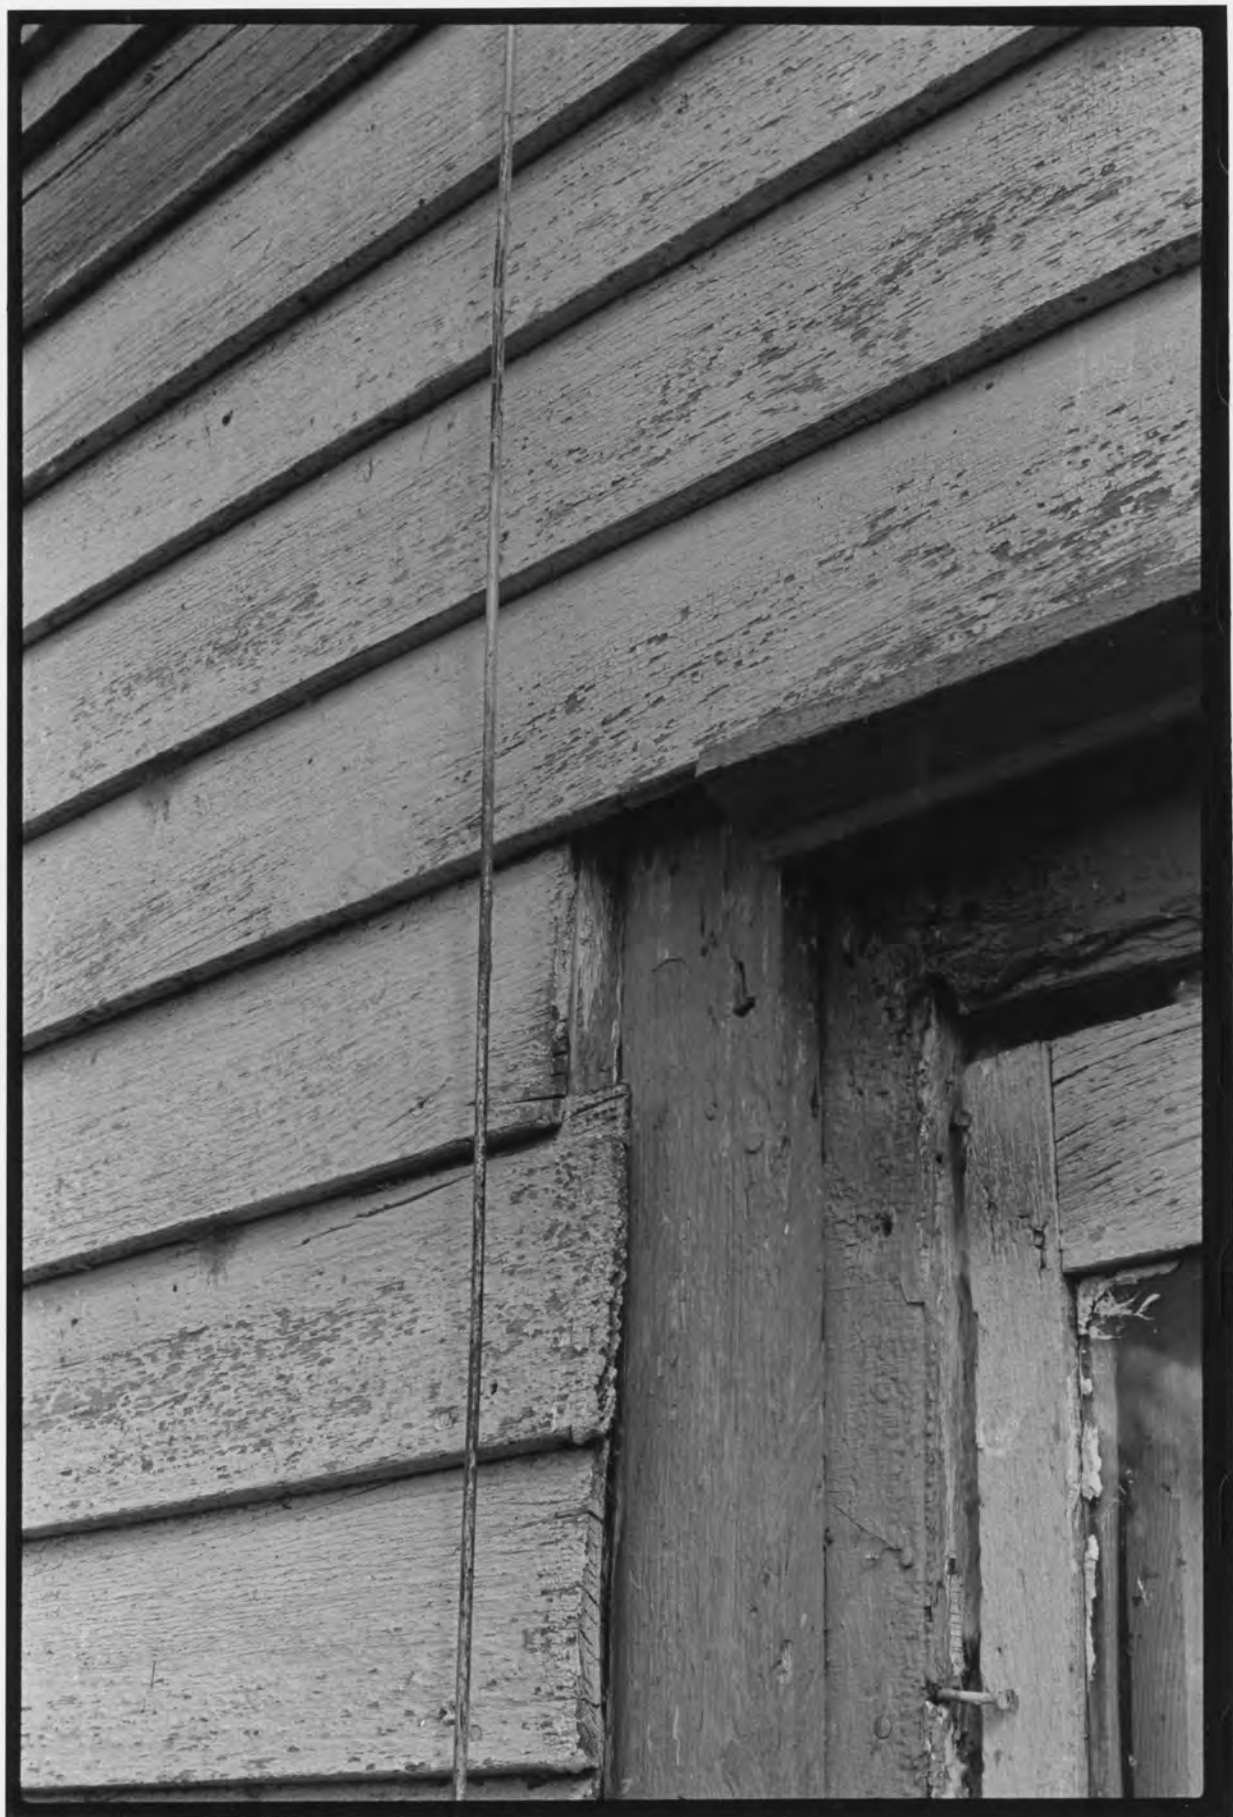
Photo 7 of 11

Detail of window framing and attachment of clapboards.

Seven permanently fixed two-over-two windows originally punctuated the elevations of the house: one on the center north elevation, one on each end elevation and two on either side

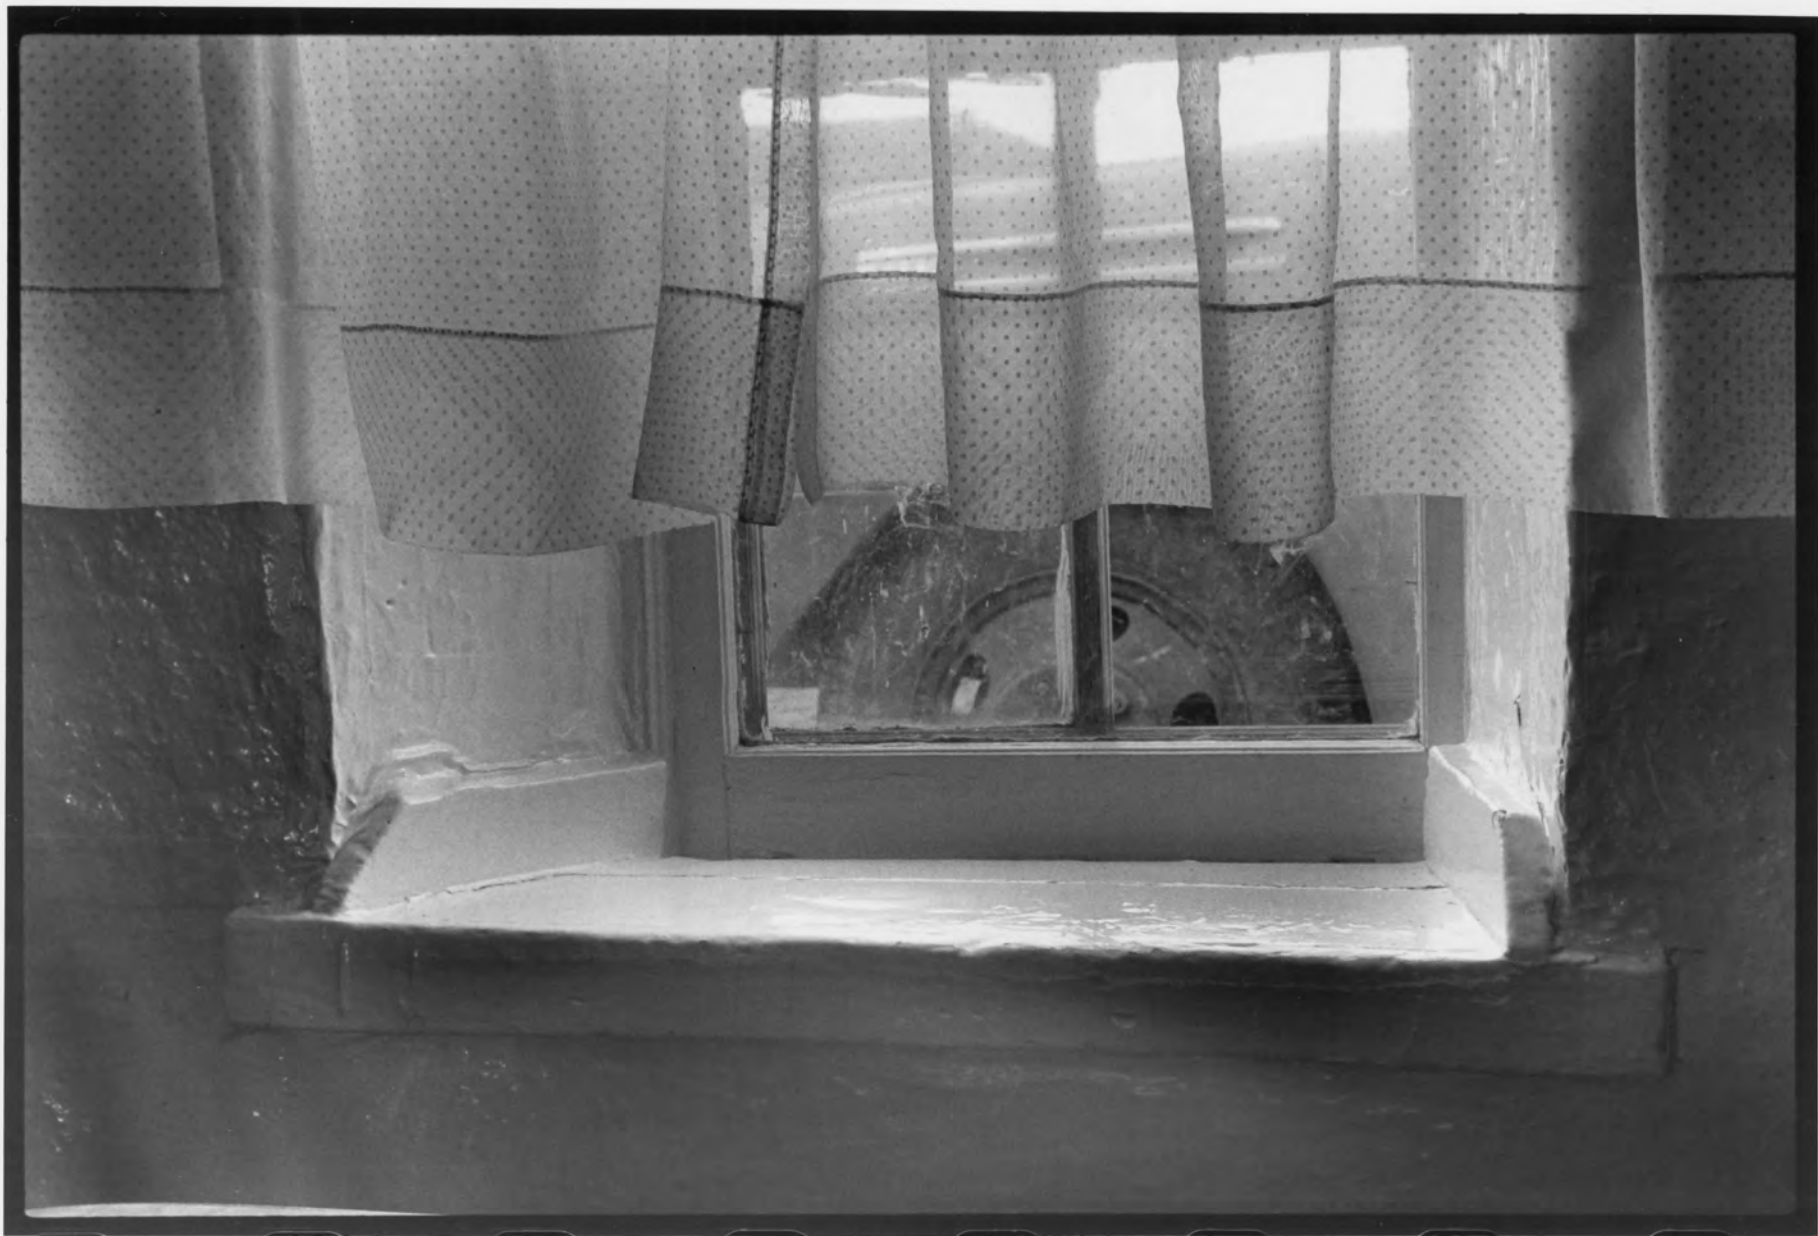
Photo 8 of 11

Detail of window well on the north wall of the kitchen.

The original painted beadboard ceiling was covered with aqua blue acoustic tiles ca. 1955. The floorboards and baseboards are painted dull flat orange and all the floors are covered with unattached linoleum. The four panel door to the vorhausel is painted to match the aqua ceiling. A small dirt root cellar is accessible by a trap door in the NE corner of the kitchen. The livingroom retains the original beadboard ceiling and ceiling molding. The walls are covered with paper painted a shiny light blue with a white border at the top of the wall. The deep window wells are painted white, probably to maximize the interior light. The window sashes are intentionally sealed with paint.

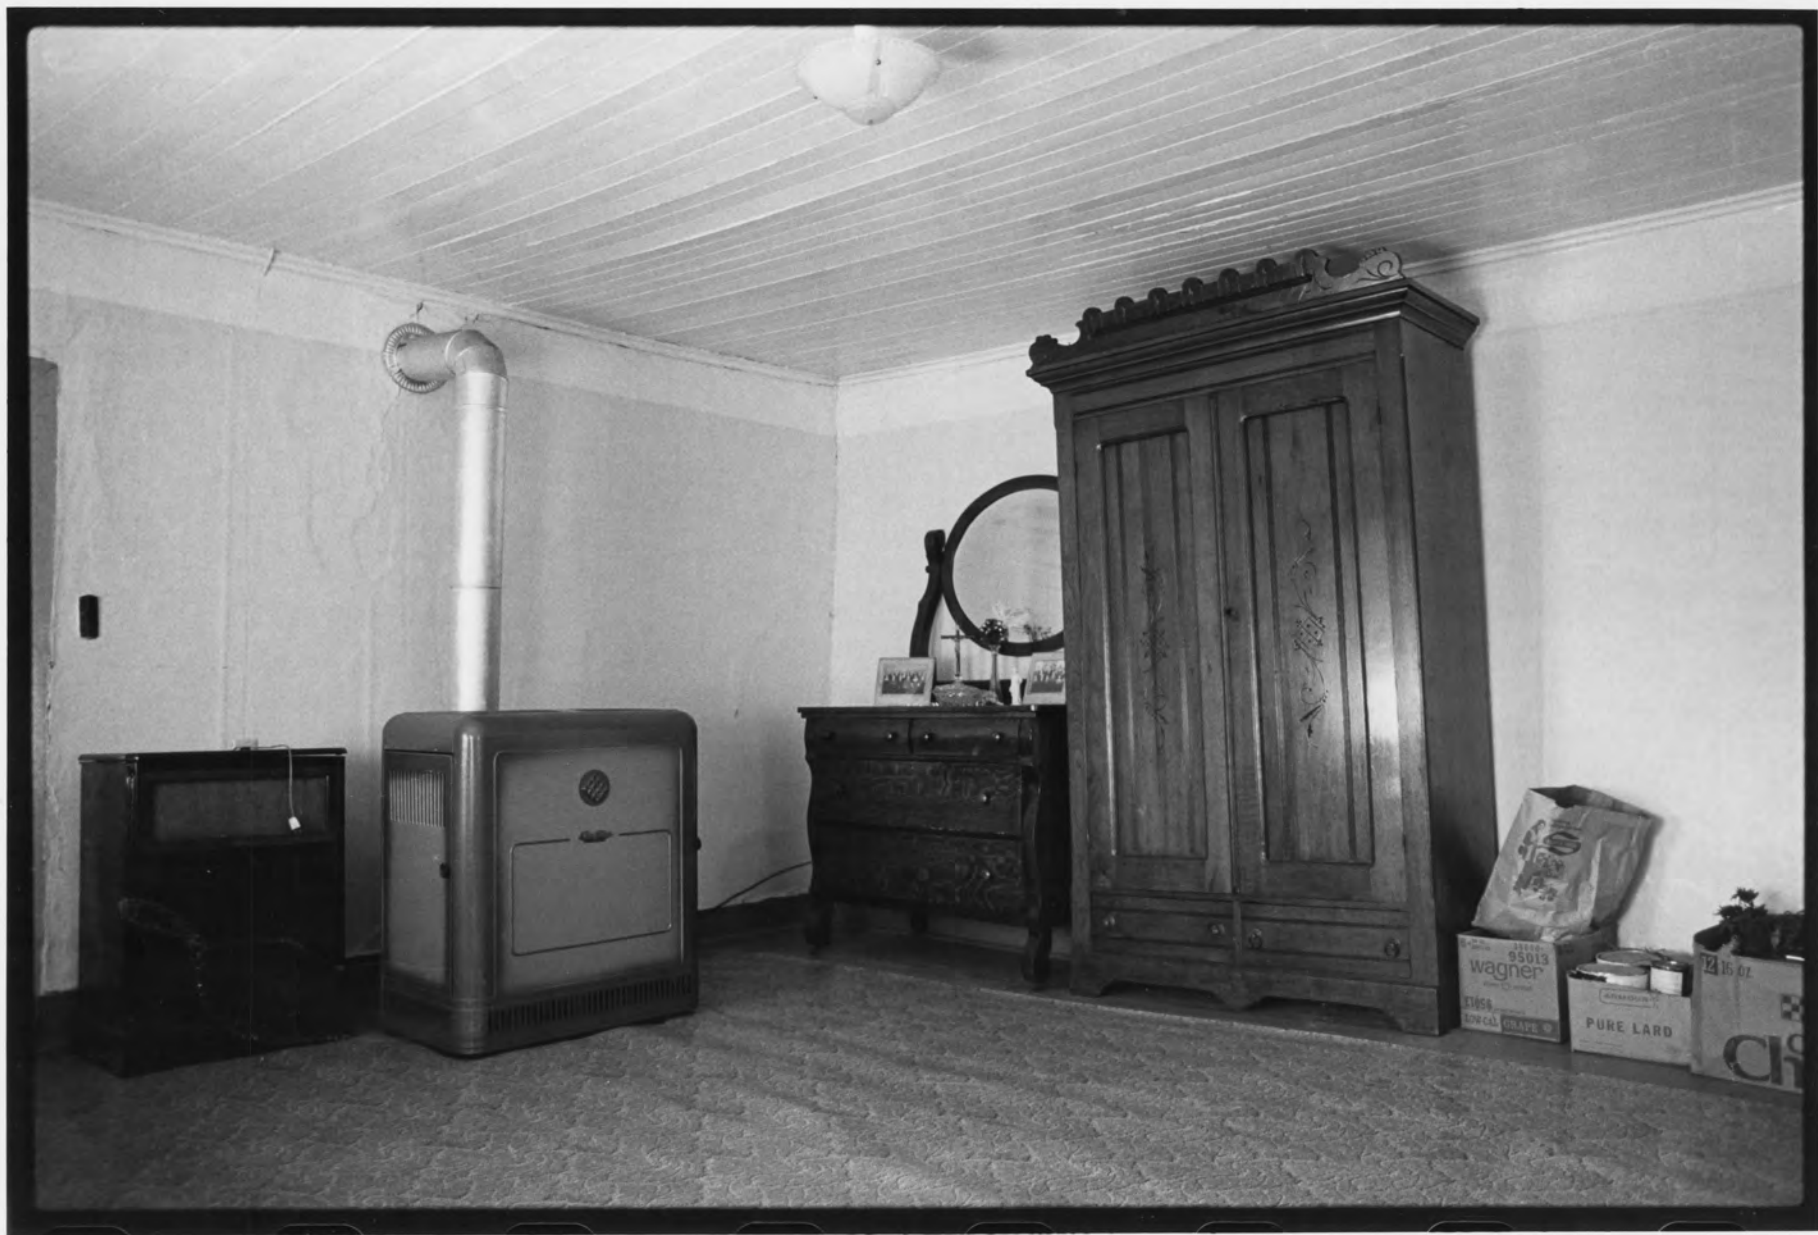
Photo 10 of 11

Livingroom with turn-of-the-century wardrobe and dresser,
view from southeast.

The interior use of space is standard for this three-room house type. The central room is used as a kitchen and is flanked by a bedroom on the west and a livingroom on the east. All three rooms are interconnected by doorways in the thick interior walls.
