NATIONAL REGISTER OF HISTORIC PLACES
EVALUATION/RETURN SHEET

PROPERTY Goldade, Johannes, House
NAME:

**National Register of Historic Places
Inventory—Nomination Form**

historic Goldade, Johannes, House

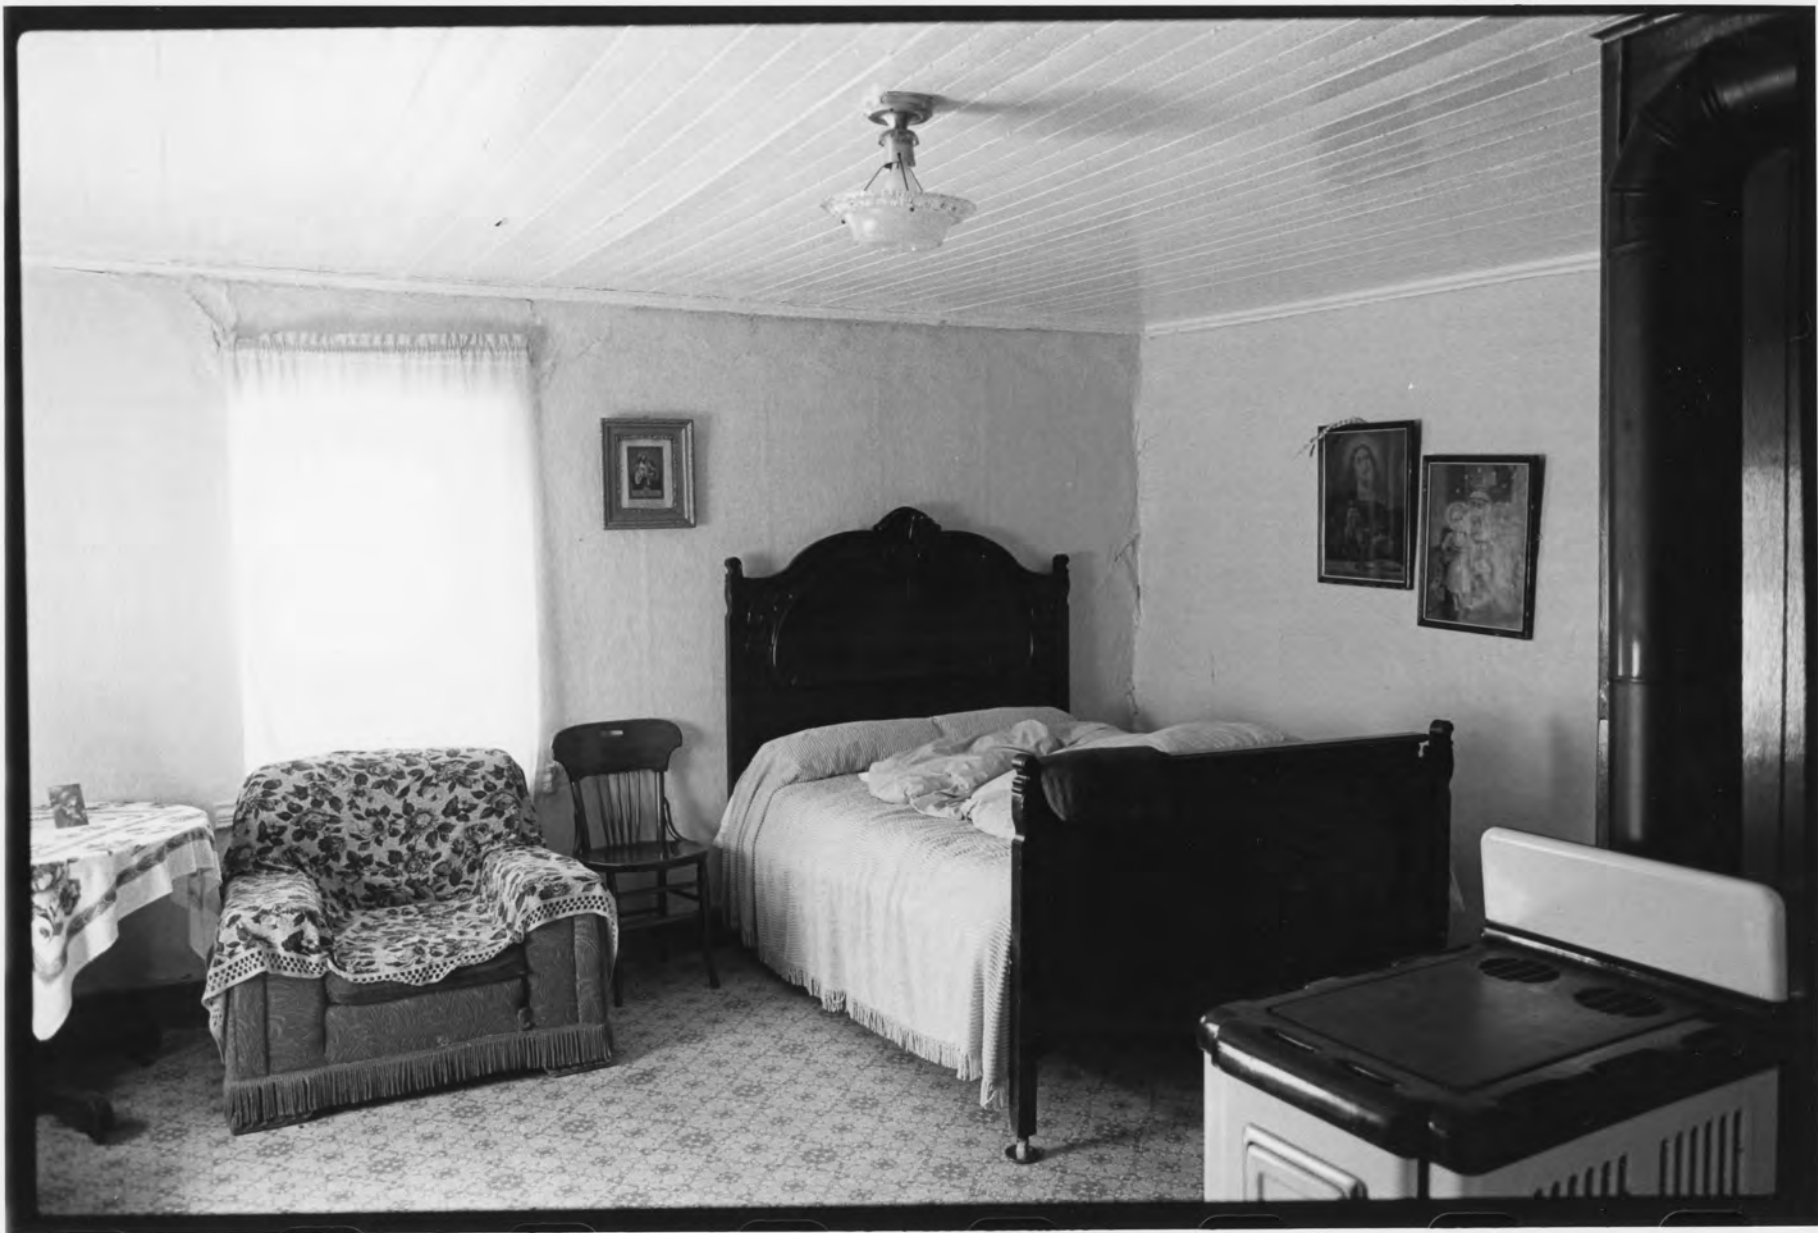
Photo 11 of 11

Bedroom with turn-of-the-century bed, view from southeast.

The bedroom also retains original beadboard ceilings and is finished with wall paper recently painted a deep blue (1980). Both of the four-panel bedroom and livingroom doors, door surrounds and jambs match the orange floor. Door surrounds are limited to one side of the deep beveled doorways. Door height is 5'11".
