Sylvester M. (Vet) Mallette Cabin,
3/4 view of front (behind wood pile) and
north sides, looking southwest

Red River Multiple Resource Area

Red River, New Mexico

New Mexico Historic Preservation Division

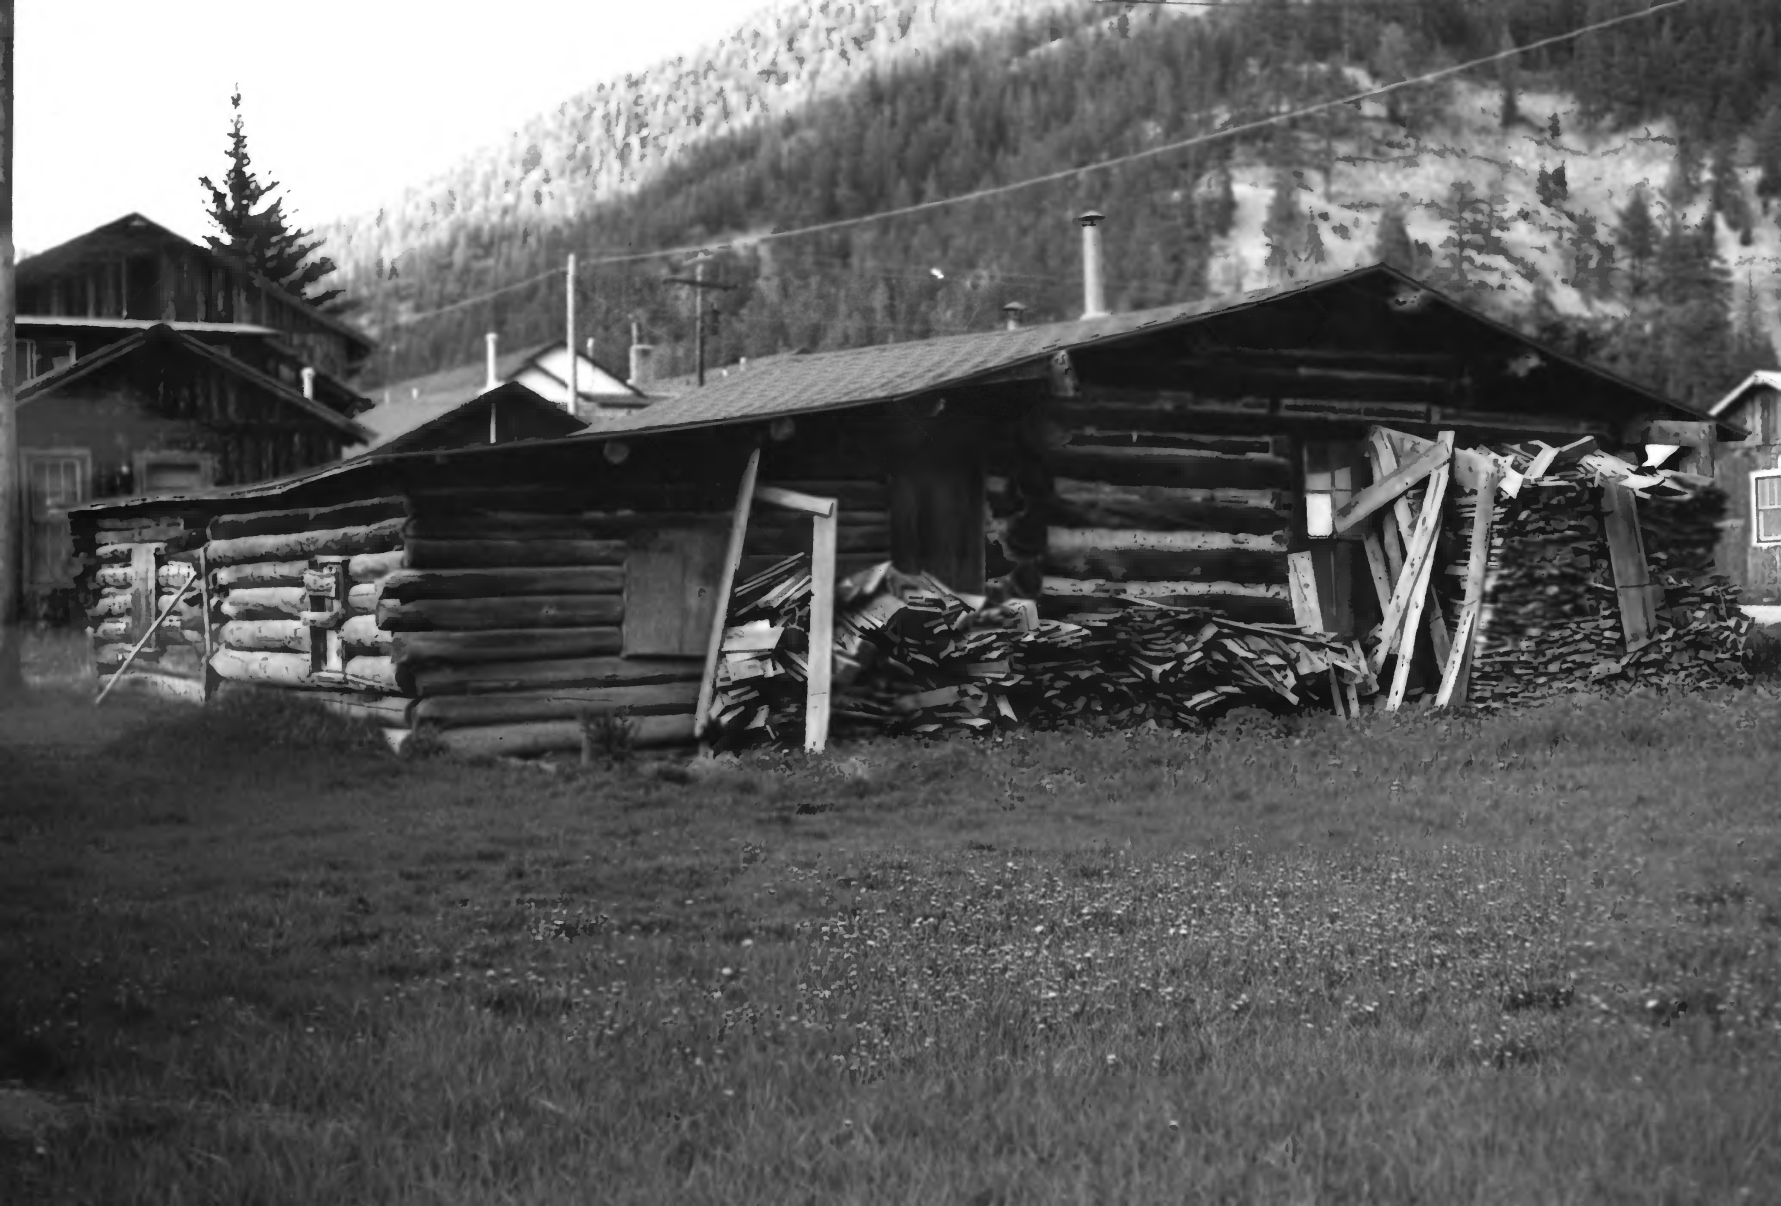
Sylvester M. (Vet) Mallette Cabin,
rear looking northeast

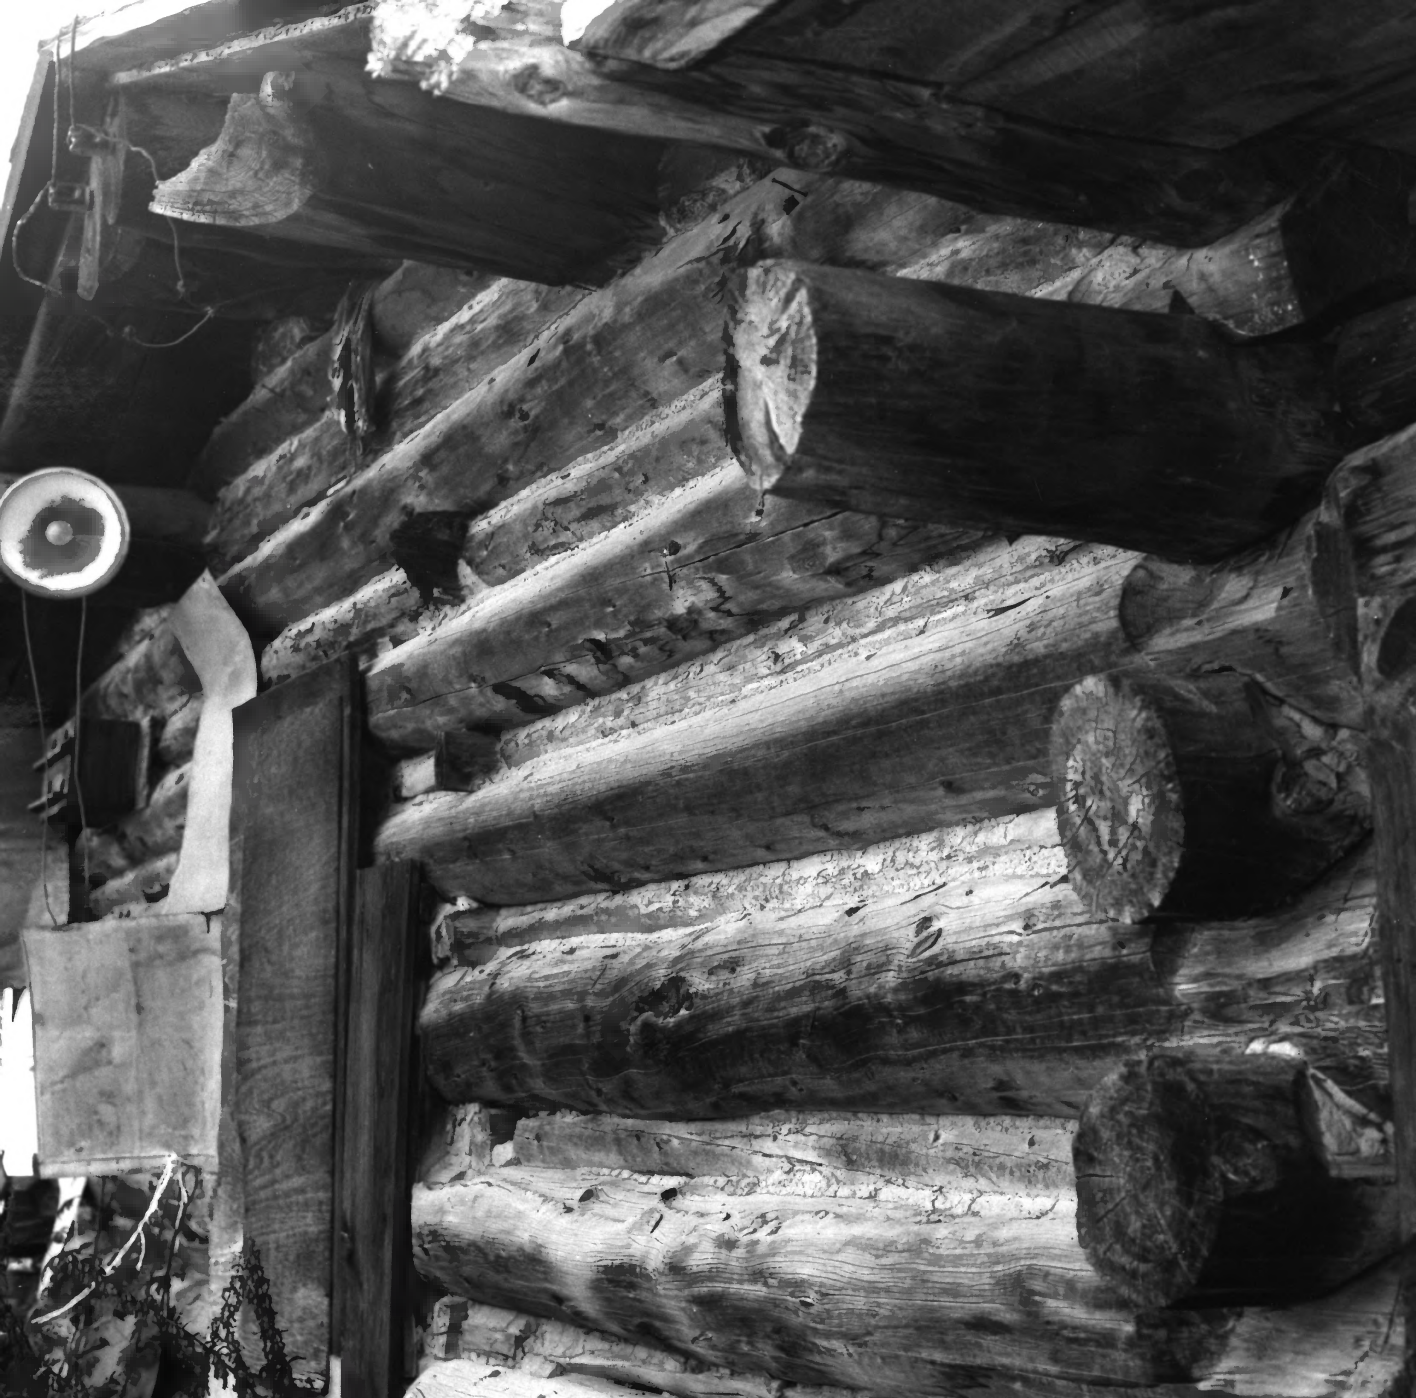
Sylvester M. (Vet) Mallette Cabin
north gabled end, looking east, showing ridge
pole and purlin logs and V-notched corner

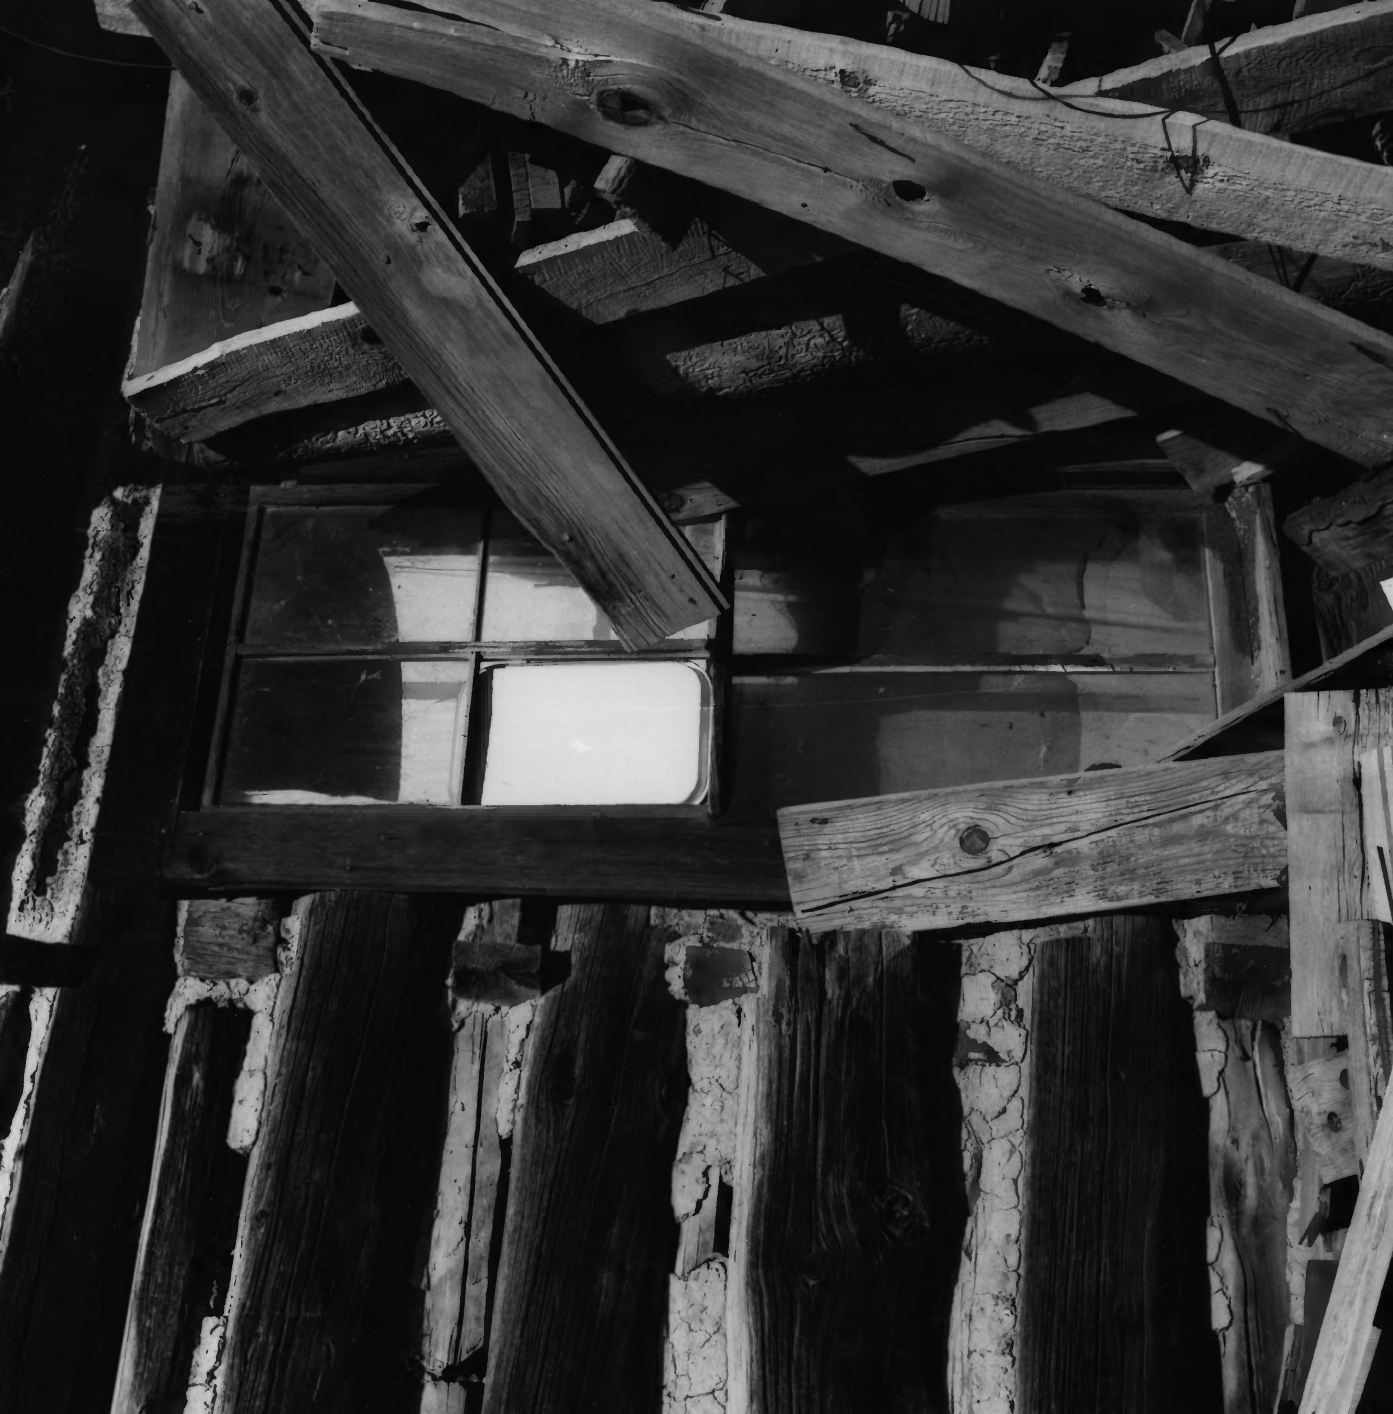
Sylvester M. (Vet) Mallette Cabin, window in south gabled end showing vertical block chinks used beside all openings to support weight of logs

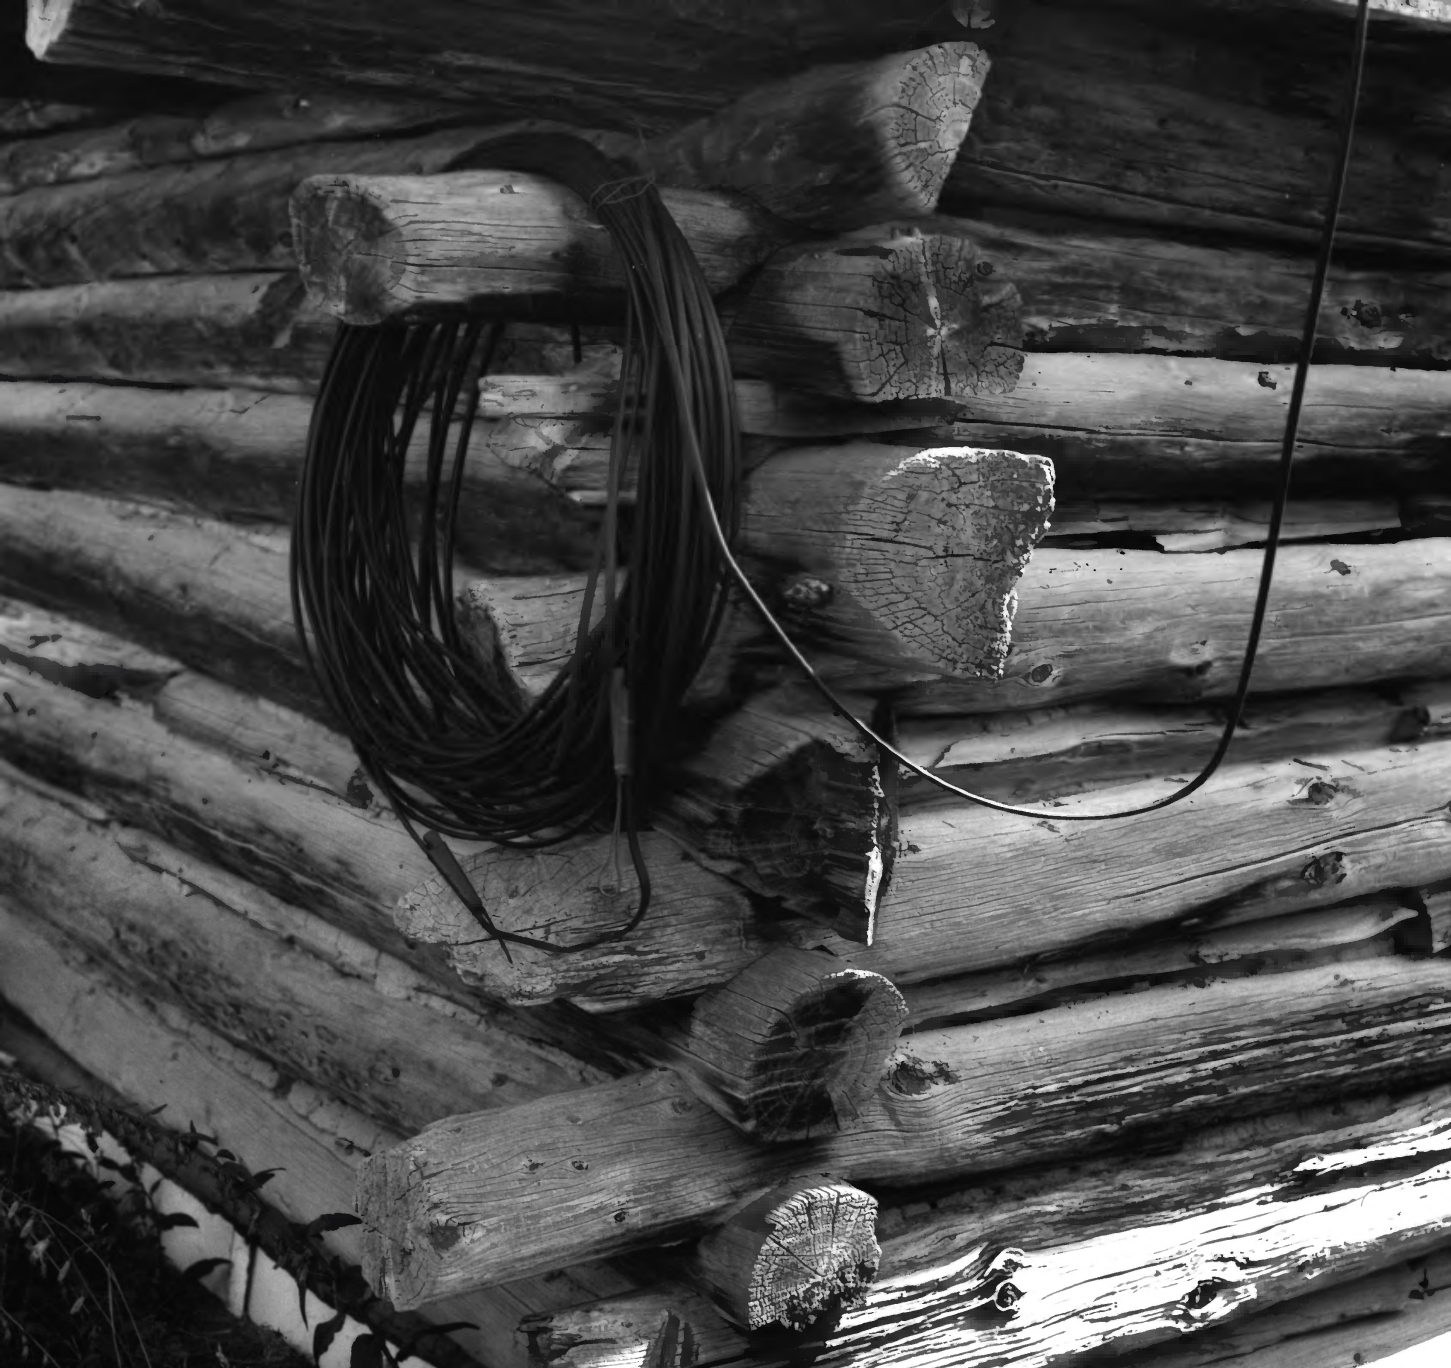
Sylvester M. (Vet) Mallette Cabin
saddle-nothing of northwest corner of north
"shed room"
