National Register of Historic Places Registration Form

historic name Lincoln National Bank

other names/site number Hamlin Masonic Lodge No. 79

street & number 219 Main Street

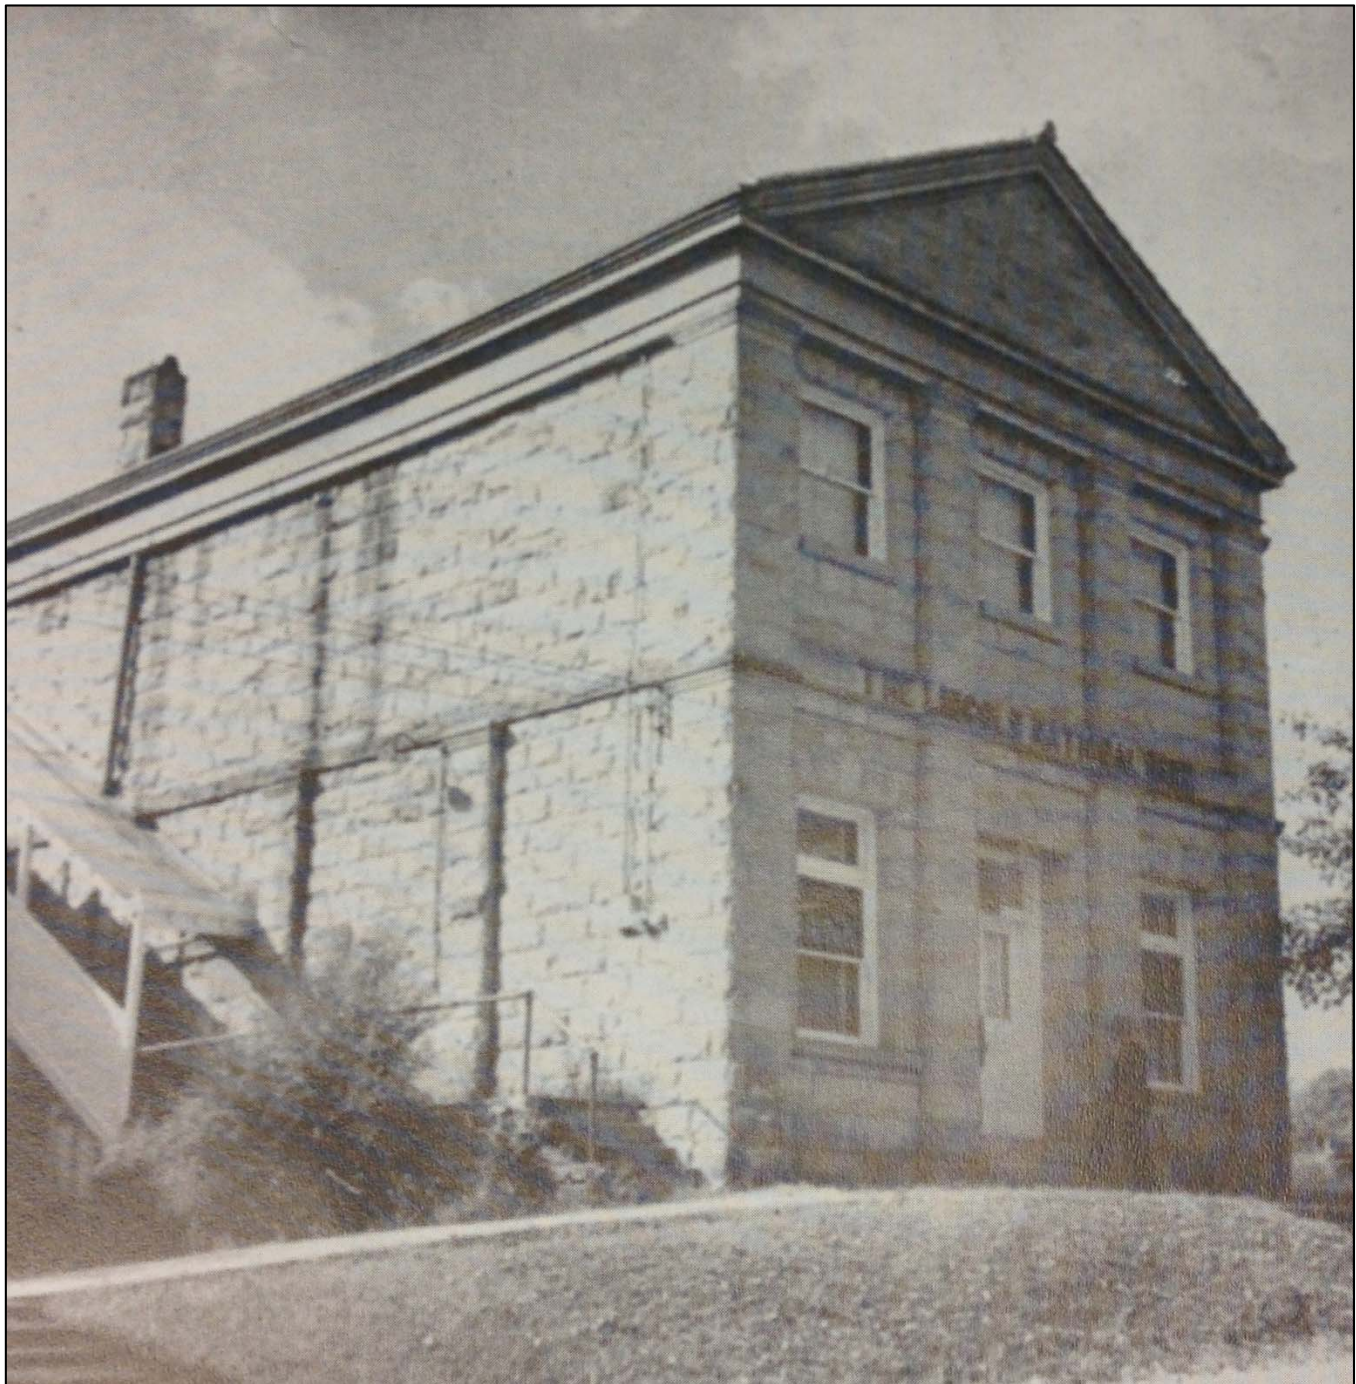
Figure 9. c.1940 Photograph of Hamlin Lodge No.79
Taken from "Images of America: Lincoln County"

local Masonic Lodge occupied the second floor which they accessed through an exterior stairwell (Figure 9).⁷
