National Register of Historic Places Registration Form

Historic name: Slusher, David, Farm

Other names/site number: Moninger Farm, Lindley Farm, Green Springs Farm

City or town: Amwell Township State: Pennsylvania County: Washington

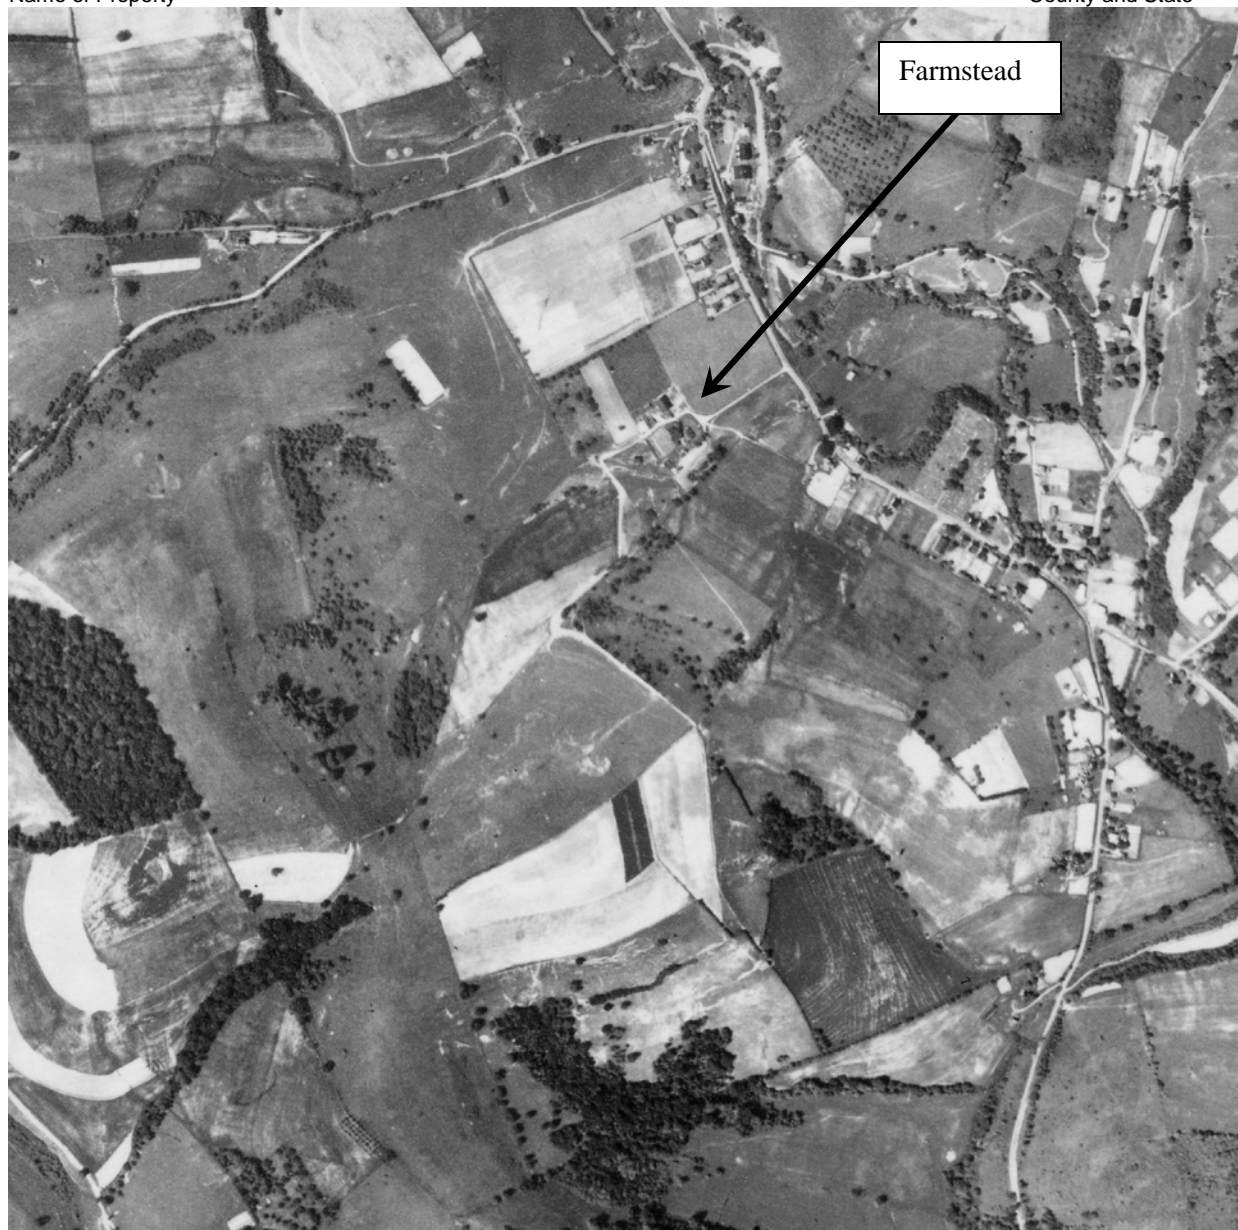
Figure #2: 1939 Aerial image from Penn Pilot web site

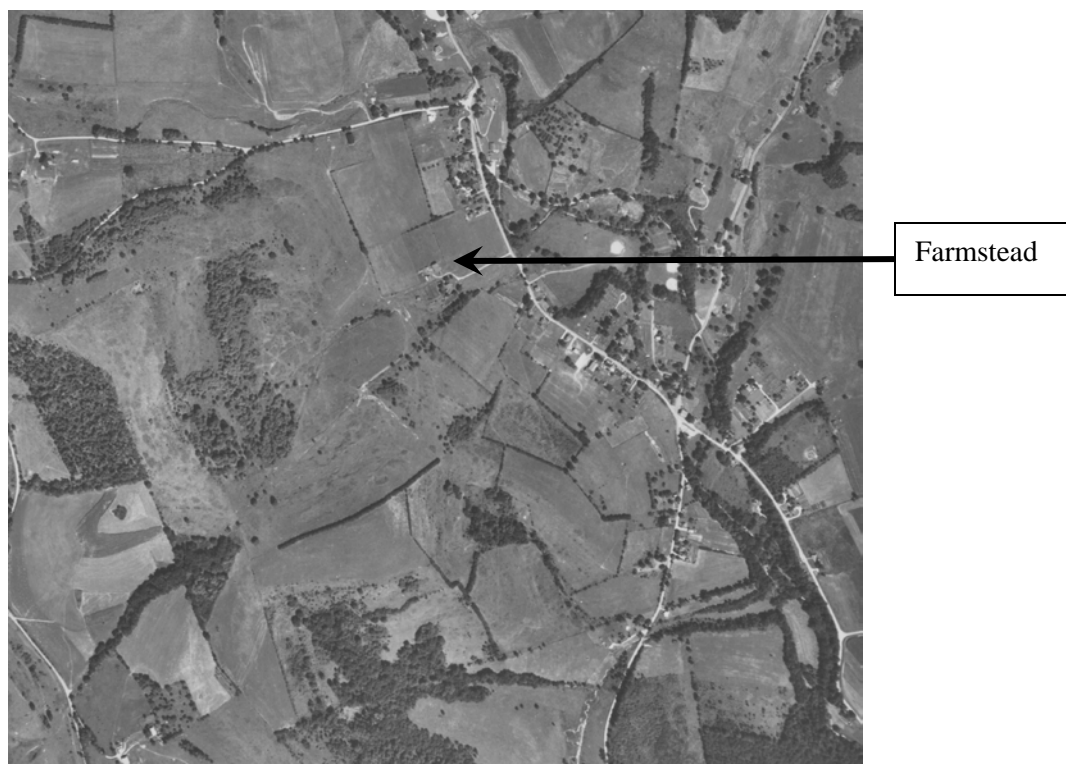
Figure #3: 1958 aerial image from Penn Pilot (above)

The 1958 and 1967 aerial views are similar enough to one another to merit viewing and commenting on them together. While the evenness of color suggests that almost all the acreage was in hay, both images were also taken between mid August and early October, so one might expect to see more contrast in colors from mowing, harvesting, maturity of certain crops, or the effect of dry conditions. While the 1939 photograph shows the land almost completely denuded of trees, tree lines are cropping up along the lines between fields in a distinctive pattern that generally remains today, represented now by much larger trees and some gaps from lost trees. However, the areas where woodlot was taking over are generally in the places that still are hardest to reach from the barn. These are areas of rugged sloped terrain, especially beyond the crest of the hill in the western half of the farm. For instance, one of the places where trees have taken over is at the southwest corner of the farm where there is a deep valley accessed now from a hard-surfaced public road by driving all the way around the farm to the furthest point from the barn and

house and then driving off the road onto a rugged access road. The woodlots in these areas are slightly larger in size in the 1967 map, in comparison to the 1958 image. Otherwise, the most striking difference between the two maps is that, by 1967, Interstate 79, a major north-south highway, had been built just west of the farm, paralleling its western boundary.¹¹ The rectangle that resembled a reservoir in 1939 on the crest of the hill in the farm's northwest quadrant is no longer there (not even apparent as a shadow) in either the 1958 or 1967 views. The sheep barn is still clearly visible in both views, and there are no other noteworthy changes in the farmstead land patterns or buildings. Even the large shade trees clustered around the house are roughly the same in both views and similar to what is seen in 1939 (and today). Both aerial views show the narrow course of the stream that passes by the south side of the house. A large triangular area of the streambed, immediately south of the sheep barn, probably once a valuable wet meadow for raising hay, is now the pond (developed about 1995¹²) at the west end of the domestic area.

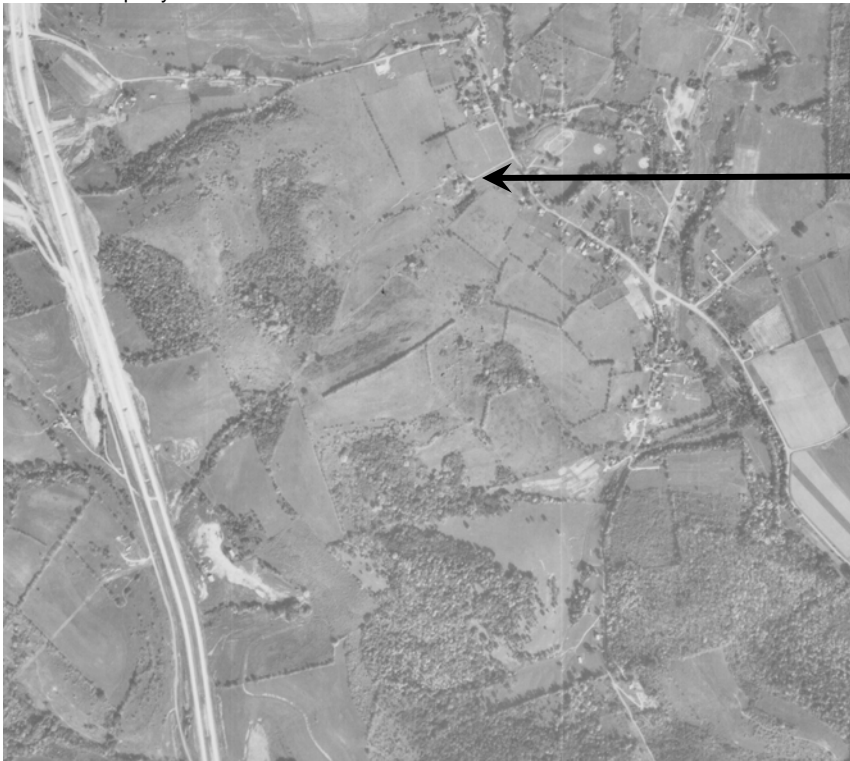
Figure #4: 1967 aerial image from Penn Pilot (above)

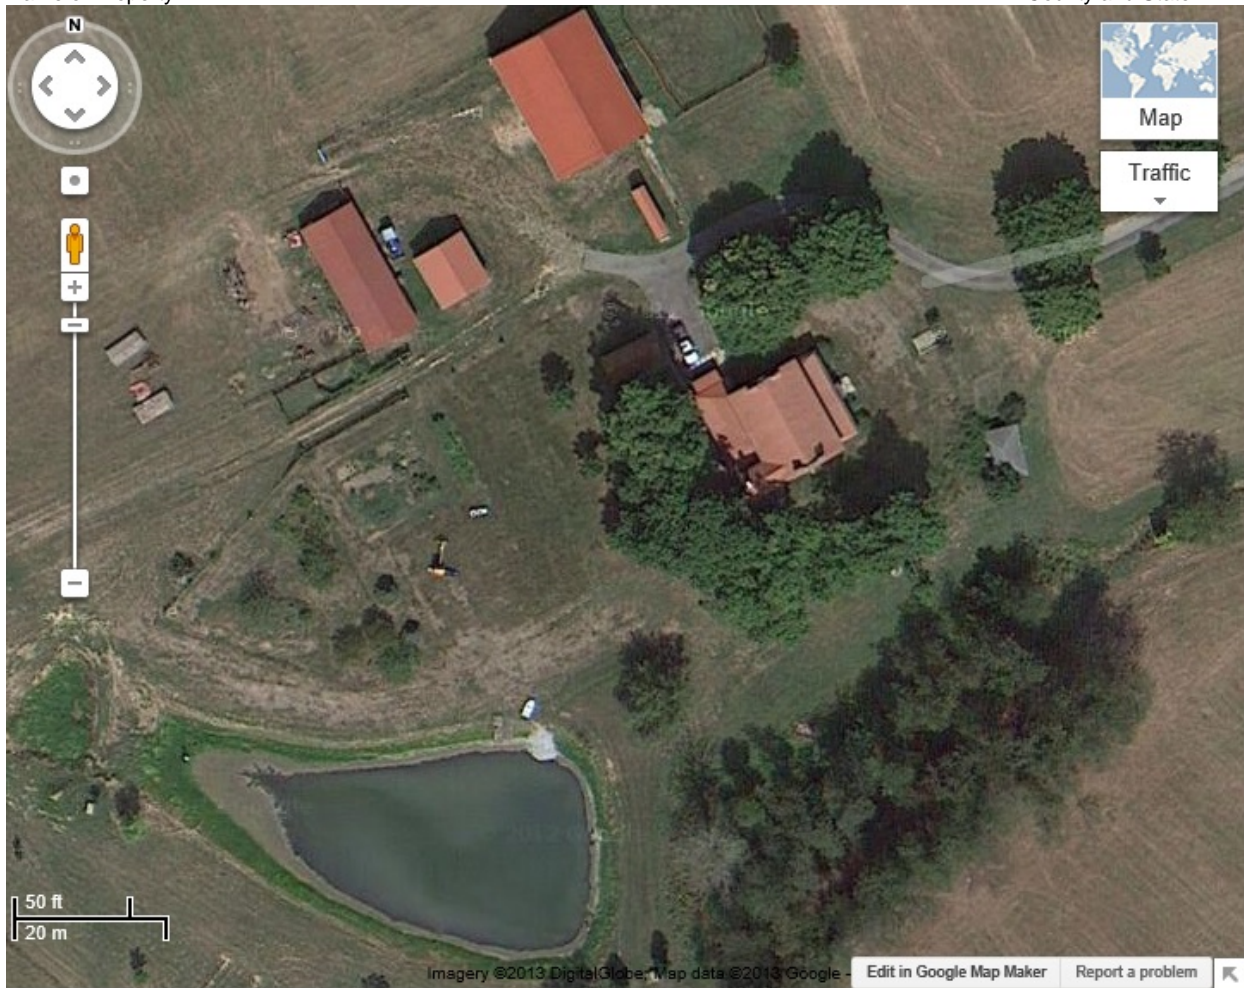
Figure #6: Google maps aerial view, accessed July 2013

The closer-up views, above and below, show that the buildings conform to what is shown in the site plan (although after this image was made, one more building, a tractor shed, was added to the west of the ca.1995 workshop building). While the summer view (from Google Maps, accessed July 2013) shows that the shade trees are still blocking views of the smaller buildings around the farm house, the winter view (from Mapquest, accessed July 2013) makes it easier to see the buildings and their formal arrangement. It is difficult to see the sheep barn foundation in these views. It is the diagonal northwest-to-southeast line found north of the western corner of the pond (i.e., just west of the small cluster of three trees seen north of the center of the pond); however, subsequent to when the views were shot, the foundation was rebuilt as a picnic pavilion. Only the garage and the former sheep barn (current pavilion) deviate from the orthogonal arrangement of the buildings on a slight diagonal to north.

The property contains 12 resources: 7 contributing buildings, and 1 contributing structure (corn crib), as well as 1 non-contributing site (pond), 2 non-contributing buildings (workshop and tractor shed), and 1 non-contributing structure (pavilion) (figure #11). The house and barn, which anchor the farmstead in views from its surroundings, are similar in size and form; they are aligned to appear as a balanced pair from Lone Pine Road, a distance of about 500 feet (photo #1). The driveway enters the property on axis with the house, passing through several acres of hay fields, and then turns in a slight "S" curve to pass between the house and barn. The buildings are arranged with the domestic and food processing facilities surrounding the house while most of the facilities for animals, machinery, repair work, and crop-storage are within the barn or directly behind it (figure #11); a farm lane that extends the driveway serves as the line between the two groupings (figures #6 and #7).

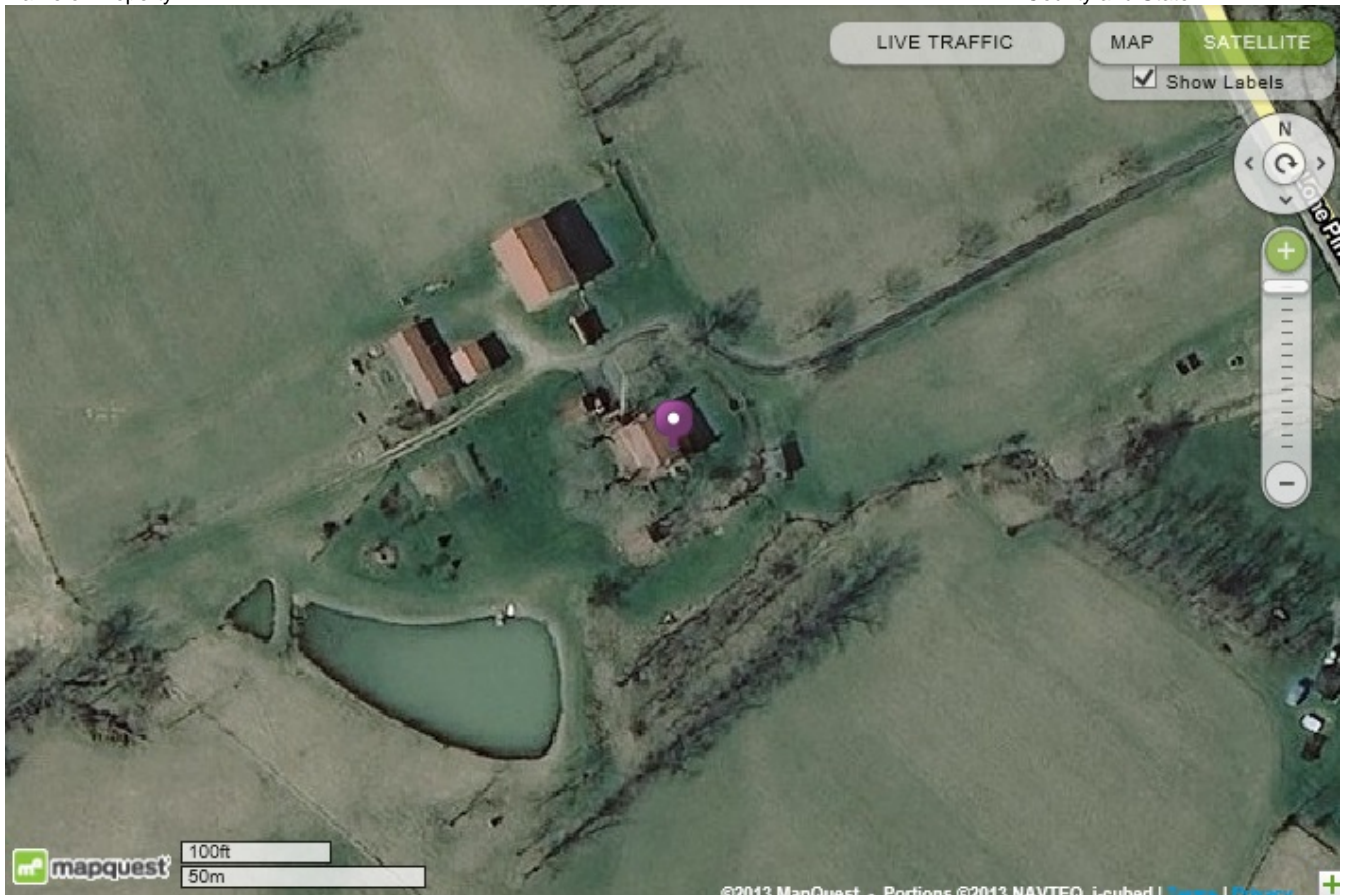
Figure #7: Mapquest aerial view, accessed July 2013 (note that it is a winter view)

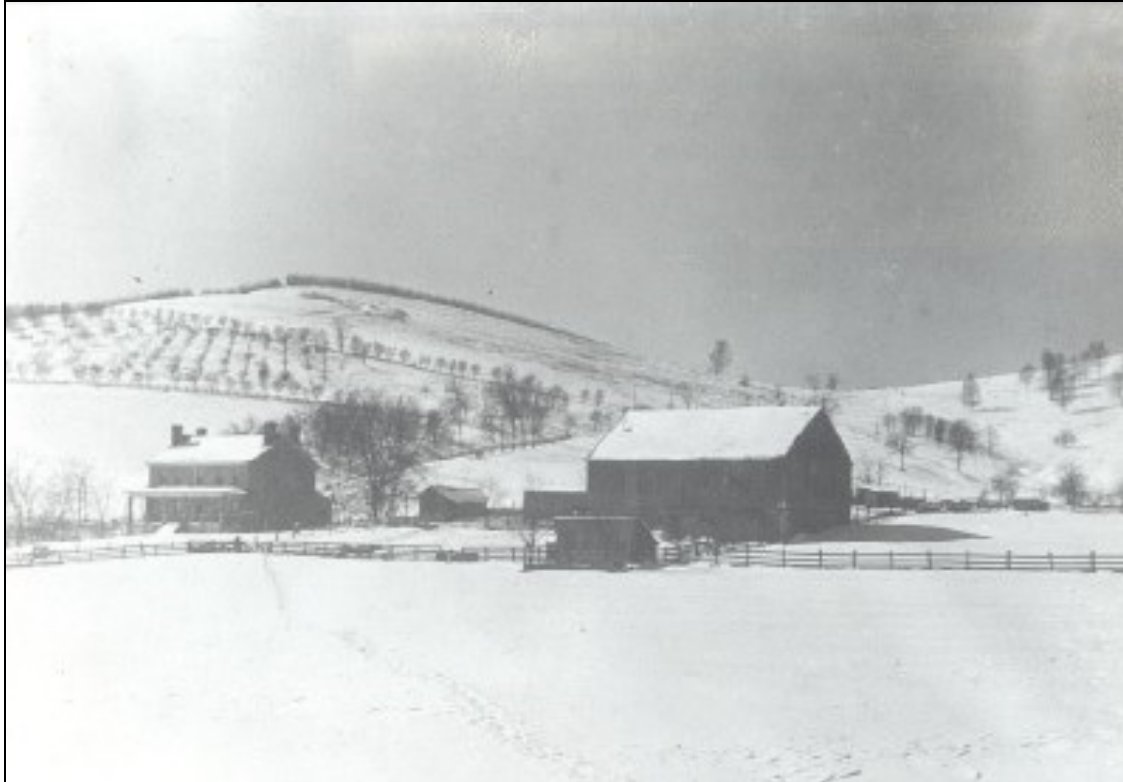
Figure #12: David Slusher Farm ca.1900

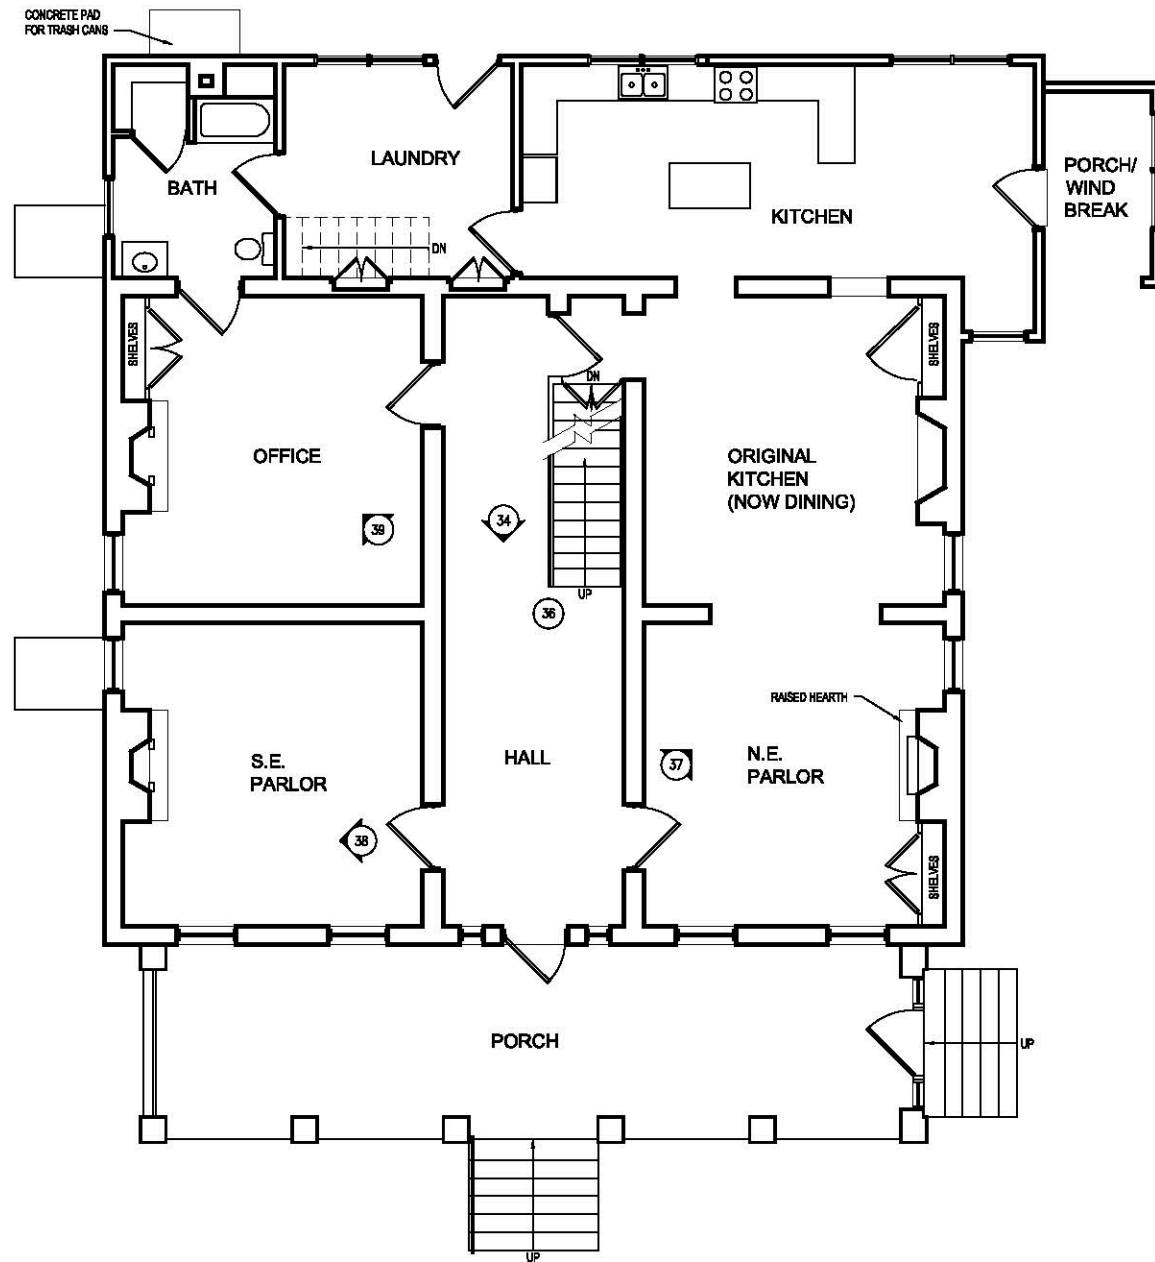
Slusher, David, Farm
 Washington County, PA
 Farmhouse Floor Plan

The house's interior has a center hall plan with a fine three-story staircase as the centerpiece (photos #31-32). To each side of the stairs in each story are two rooms; these rooms feature plaster walls and ceilings and hardwood floors. To the north of the stairway on the first floor are a parlor at the front of the house and the original kitchen behind it and to the south of the stairway are another parlor at the front of the house and an office behind it. On the second floor are four bedrooms and a small bathroom at the front of the hallway. The southwest bedroom features a closet in the two-story section of the addition. Throughout the house, the woodwork varies slightly from room to room, but is generally in a consistent though somewhat "naïve" rendition of the Greek Revival style. In the four original rooms of each of the two stories are found seven of the original eight fireplaces. One, in the northeast parlor, was altered by the 1960s by the removal of the mantelpiece and closing in of the firebox; the firebox was reopened and a raised hearth was installed about 2000. The original kitchen (which now serves as the dining room) has a large walk-in cooking fireplace with a stone surround and a high mantelshelf with mitered casing below a paneled frieze that supports the mantelshelf (photo #33). The doors of the house are all based on a design of having two vertical panels around a center stile. The panels are nearly full length, held in place in most cases by mitered ogival panel molding. Most of the doorways have corresponding full-length panels in the reveals with a convex style of panel that is nearly half-round in profile. Three of the four original first story rooms have chimney cupboards. In the southwest room of the first story (the office), the chimney cupboard has a casing incorporating a peaked lintel.

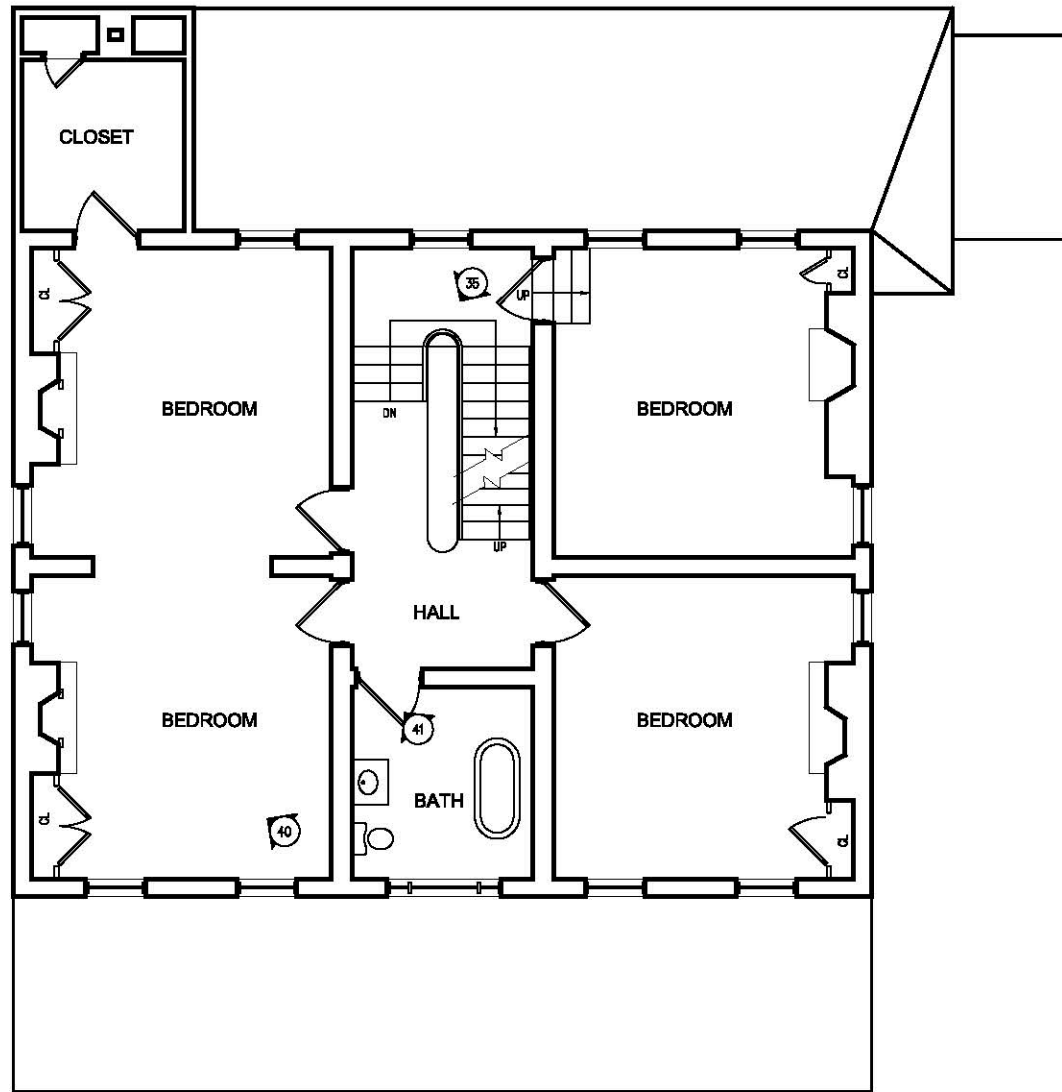
Slusher, David, Farm
 Washington County, PA
 Farmhouse Floor Plan

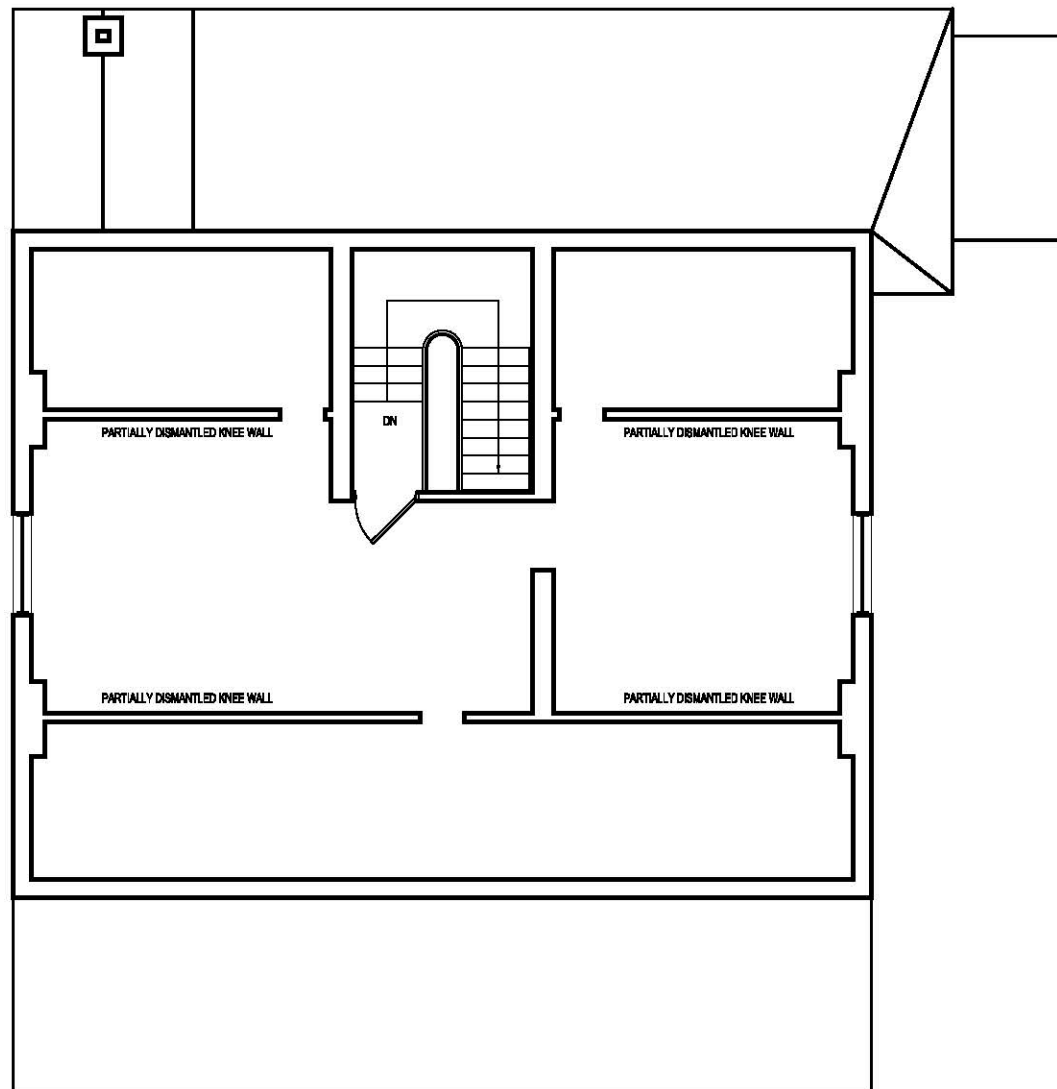
Slusher, David, Farm
 Washington County, PA
 Farmhouse Floor Plan

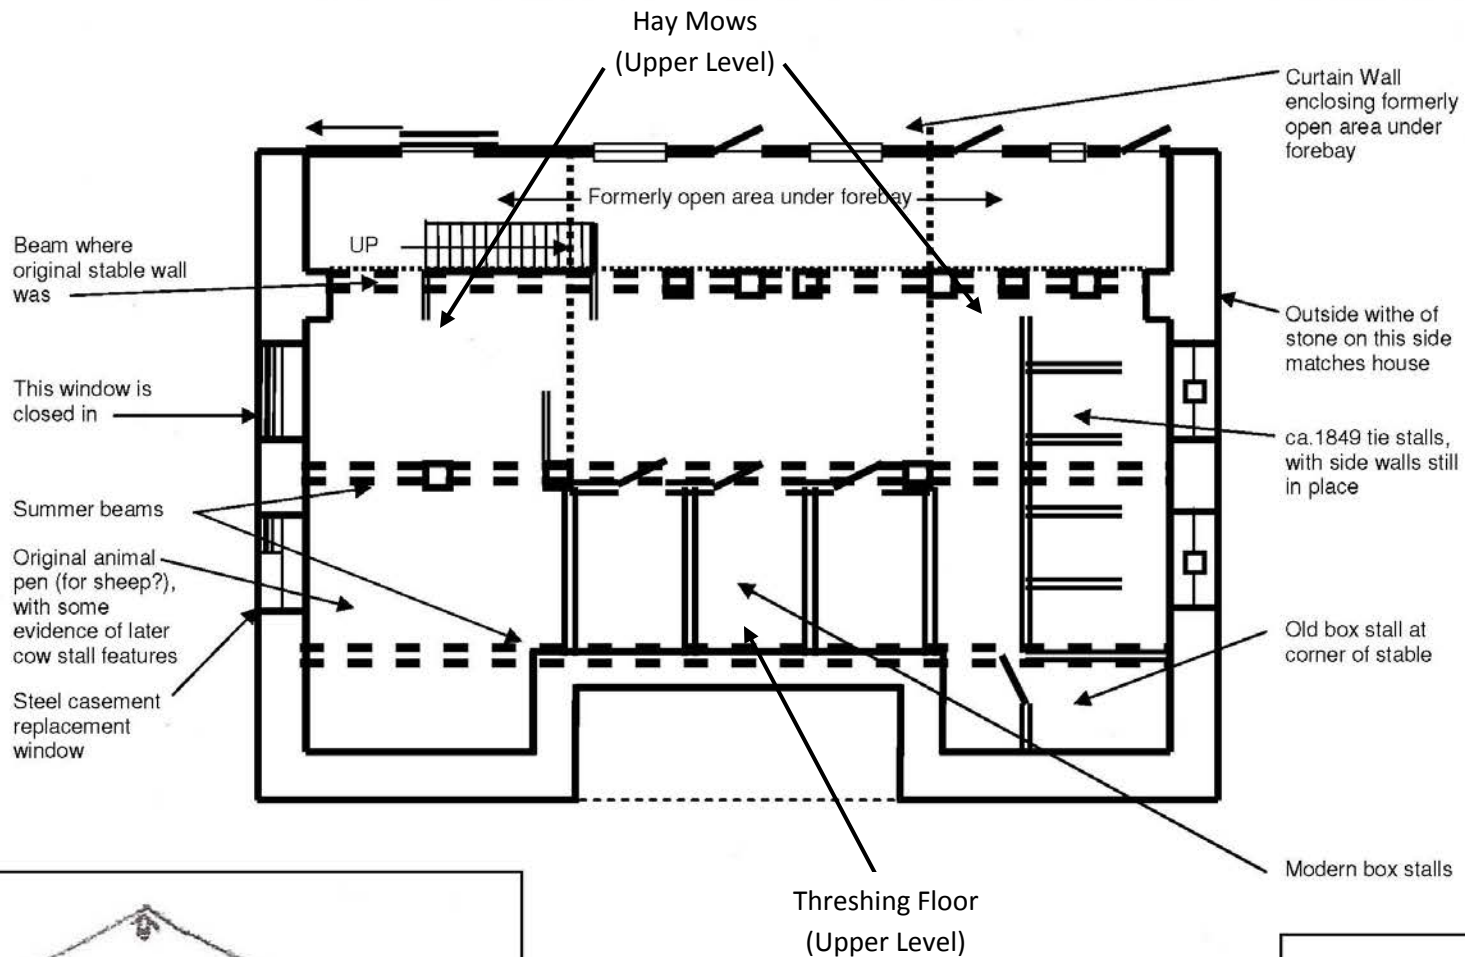
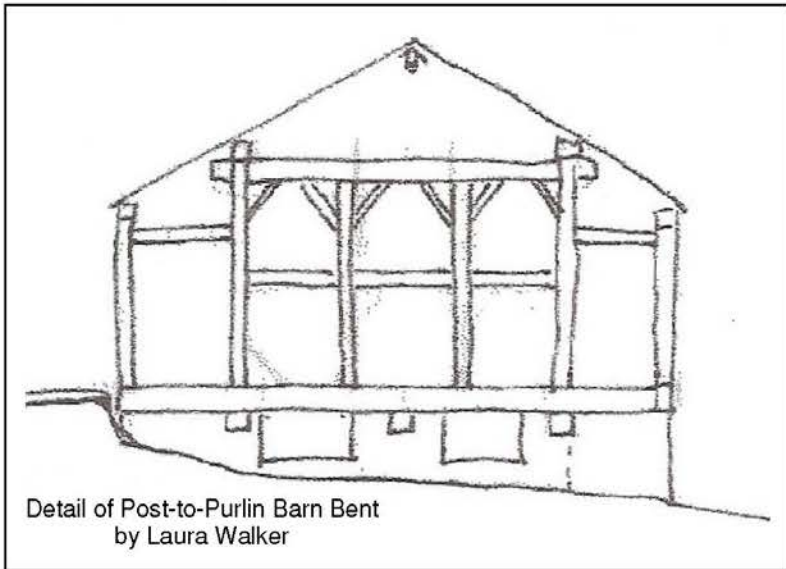
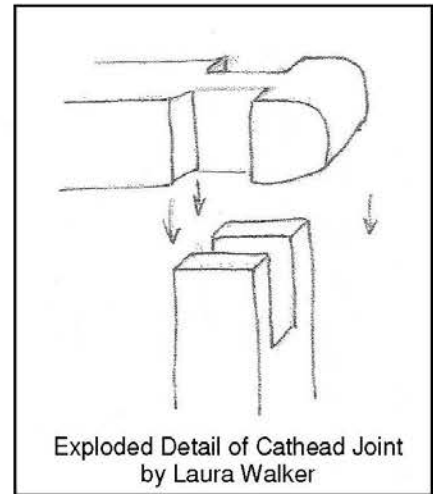
Slusher, David, Farm
Washington County, PA
Barn Floor Plan and Details

The farm retains its historic 40’x60’ ca.1849 bank barn (photos #3-4, 9, 20-28). The barn is a Pennsylvania Standard barn in style. The barn’s framing is post-to-purlin, a style of barn construction that has the outward form of a Standard Pennsylvania barn but also reveals its relationship to earlier, asymmetrical Sweitzer barn forms. The name of this type of barn framing comes from the use of tall, vertical posts, each at approximately the one-fourth point, coming in along the gable end from each corner. These posts support continuous roof purlins (beams running parallel to the roof ridge), providing mid-span support for the rafters. This type of construction provides a line (at the purlins and posts) between the forebay area and the hay mows, and the same line appears symmetrically at the opposite side of the gabled form, dividing the hay mows to create the equivalent division on the uphill side, a construction configuration that can be seen as derived from barns where outsheds have been added on this side (in incrementally expanded barns). While the characteristic asymmetrical Sweitzer silhouette is sometimes disguised by the presence of original integral outsheds located to balance the design and by a ramp shed on the uphill side, this barn takes that transformation one step further with a flush west wall on

the uphill side, making it a Standard Pennsylvania barn. However, behind the symmetrical silhouette the post-to-purlin construction has the proportions of the narrower and taller bents found in Sweitzer barns. The exterior siding reflects this aspect of the framing in the way it steps up to the tie beam in the end walls below each gable.
