NATIONAL REGISTER OF HISTORIC PLACES
REGISTRATION FORM

historic name: Vance Farmhouse
other name/site number: Meeks Farmhouse
Dean's House
Bicentennial House

Vernacular I-House

VANCE FARMHOUSE

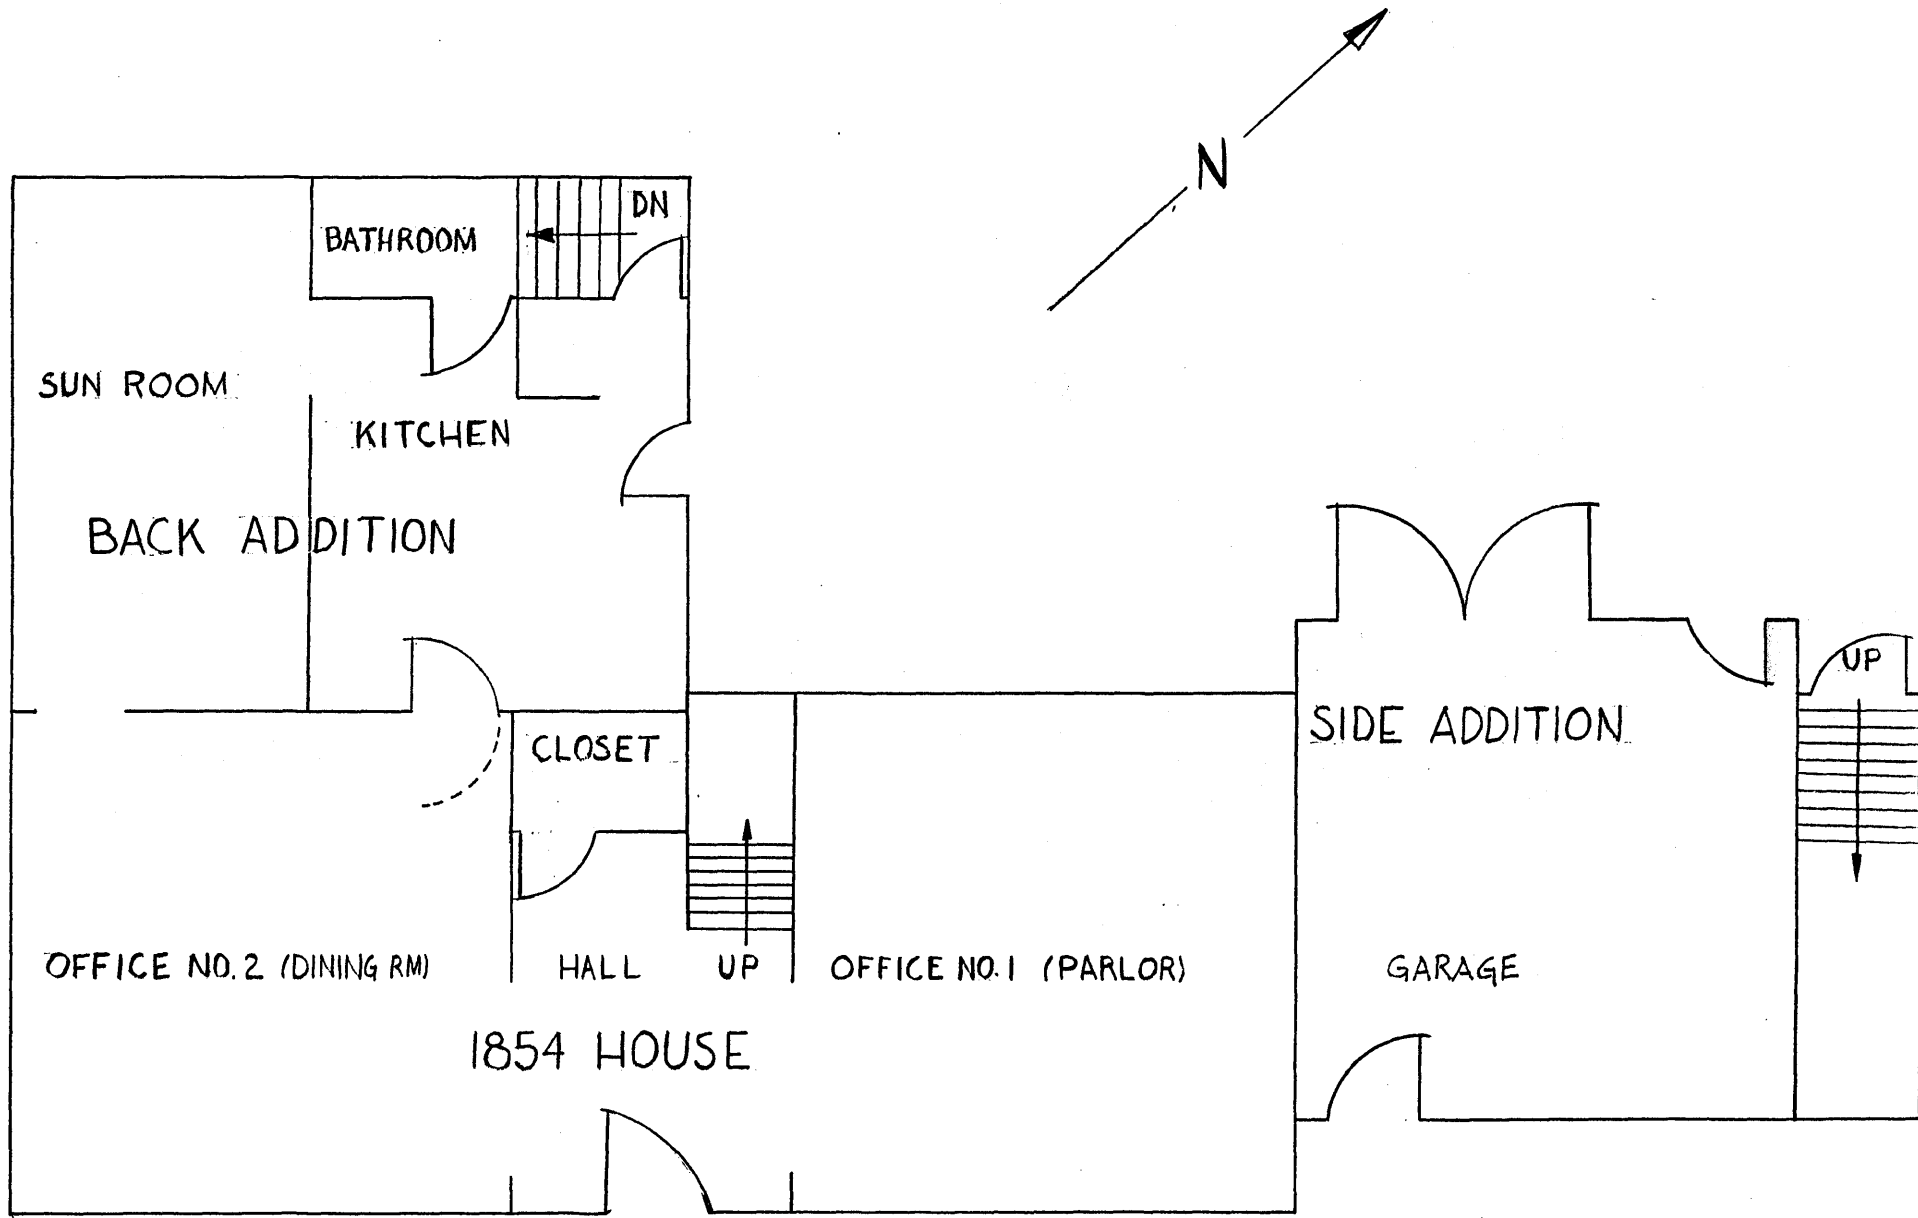
FIRST FLOOR

To the right of the front hall is the former parlor and to the left, the dining room; both now are offices (See first floor plan). The former parlor, now Office No. 1, has a fireplace with an oak mantelpiece, with Ionic columns supporting the mantel shelf and a red tiled hearth (See photograph #9). To the left of the mantel is a built-in bookcase.
