13. CATLIN WILSON HOUSE
237 Wilson Ave.

Mrs. Cecil R. Glass and Mr. William R. Ward
237 Wilson Ave.
Eutaw, AL 35462

CATLIN WILSON HOUSE CONTINUED

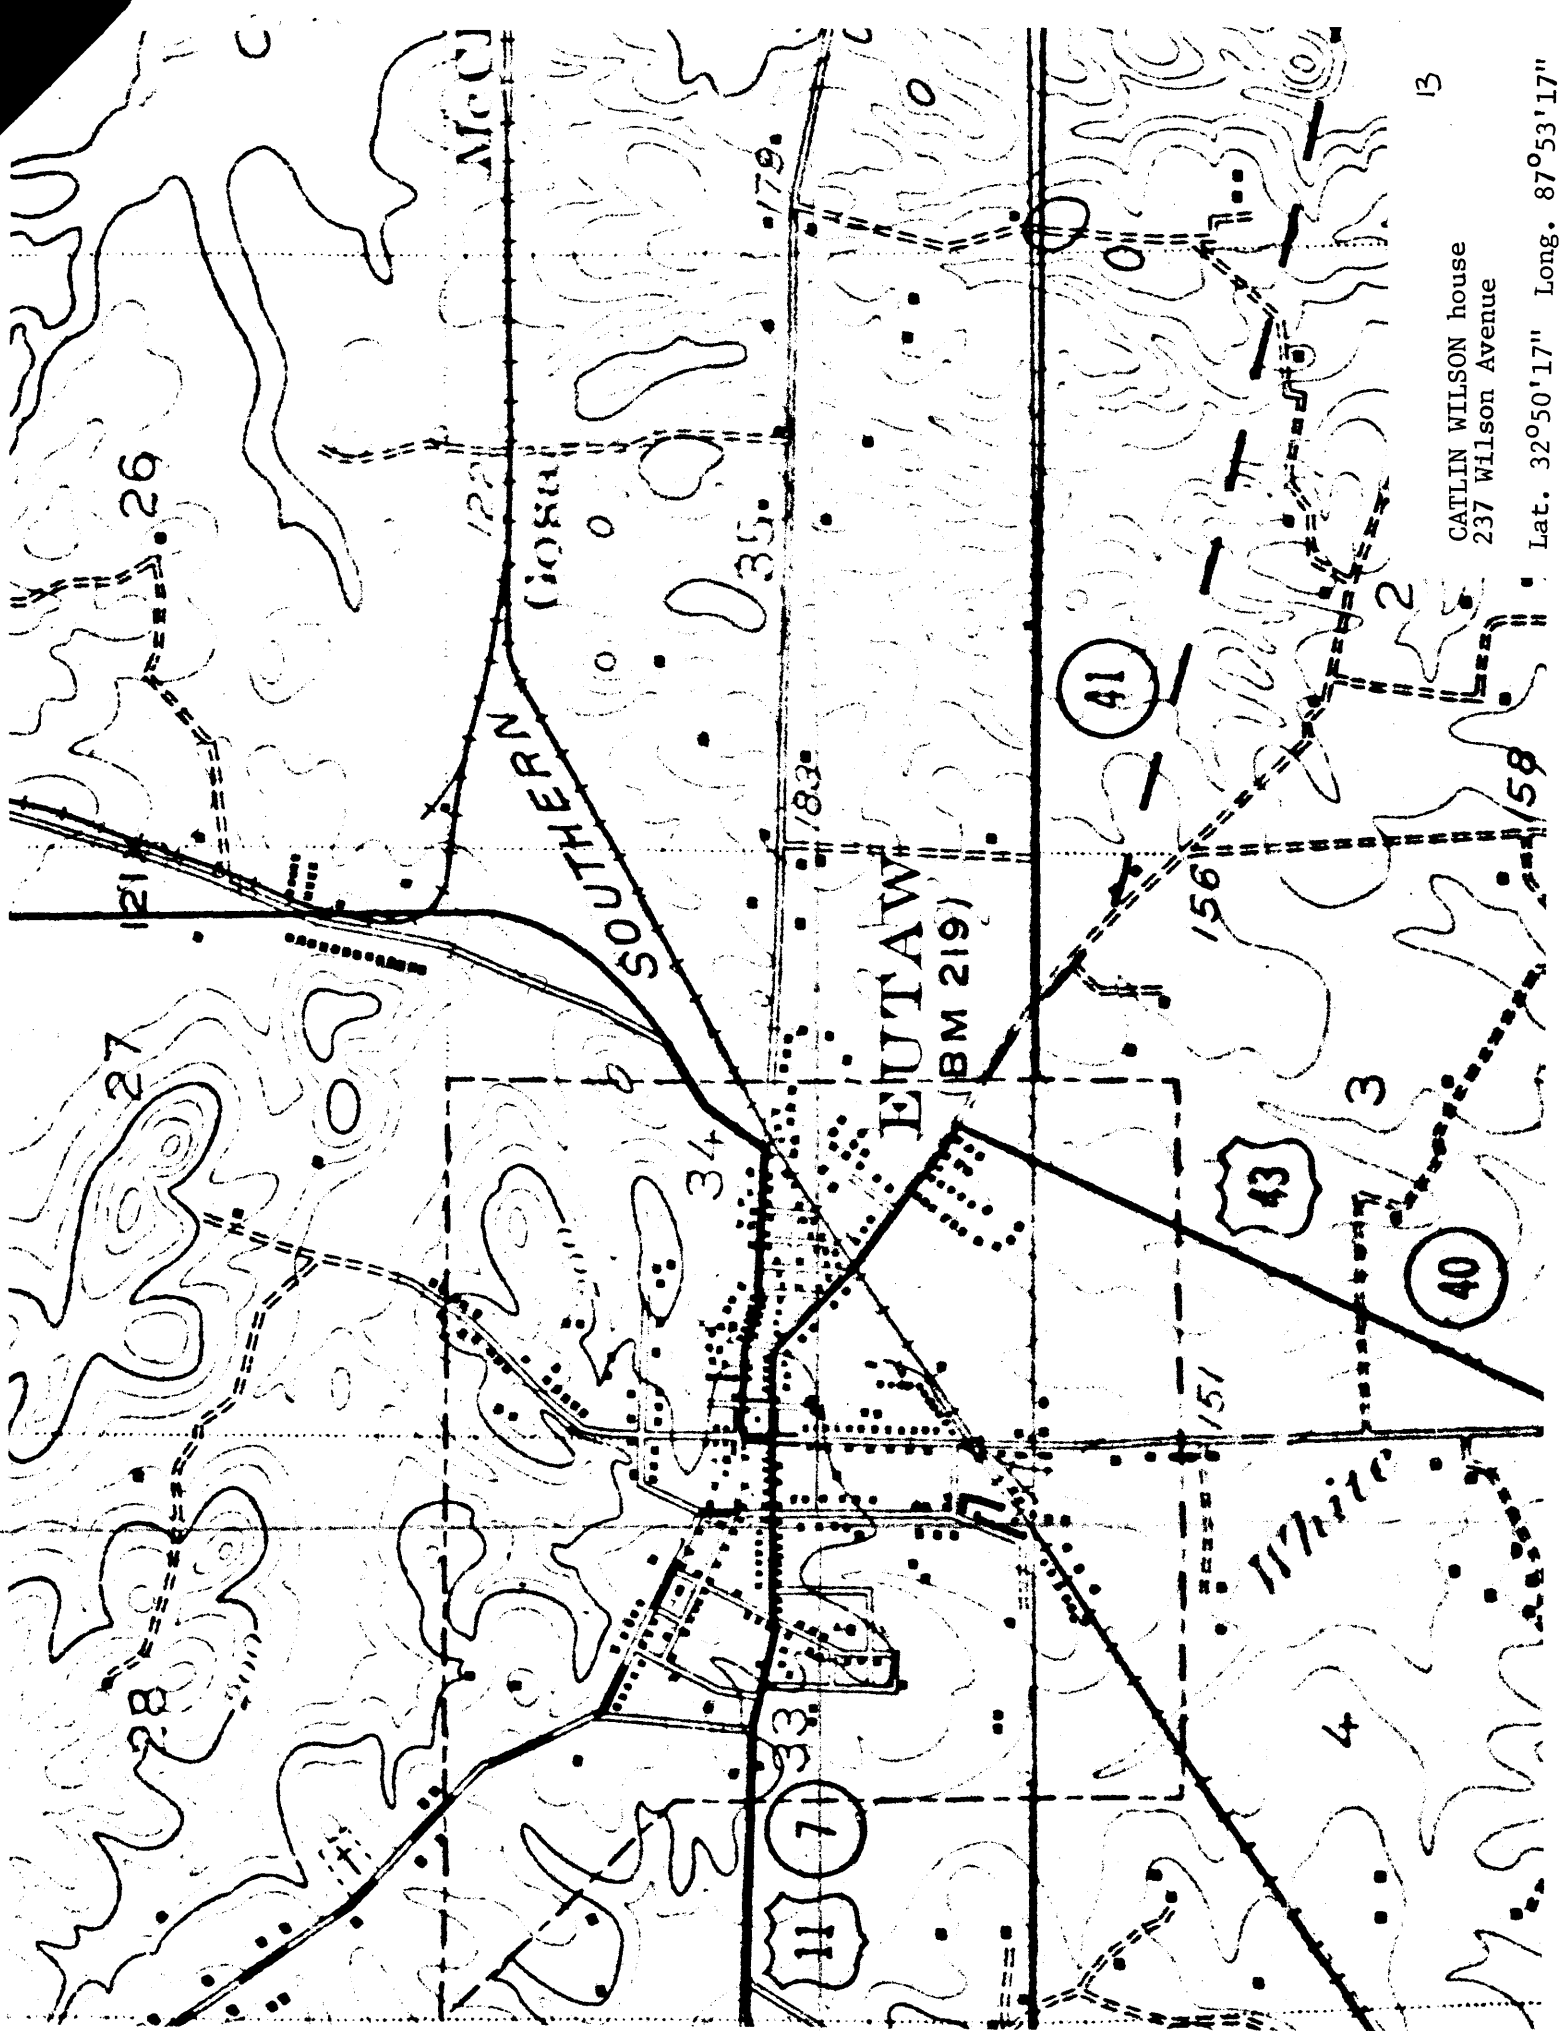
13

CARLIN WILSON house
237 Wilson Avenue
