Property Name: Icelandic Evangelical Lutheran Church

# National Register of Historic Places Registration Form

Historic name: Icelandic Evangelical Lutheran Church

Other names/site number: Ukrainian Orthodox Church of St. John

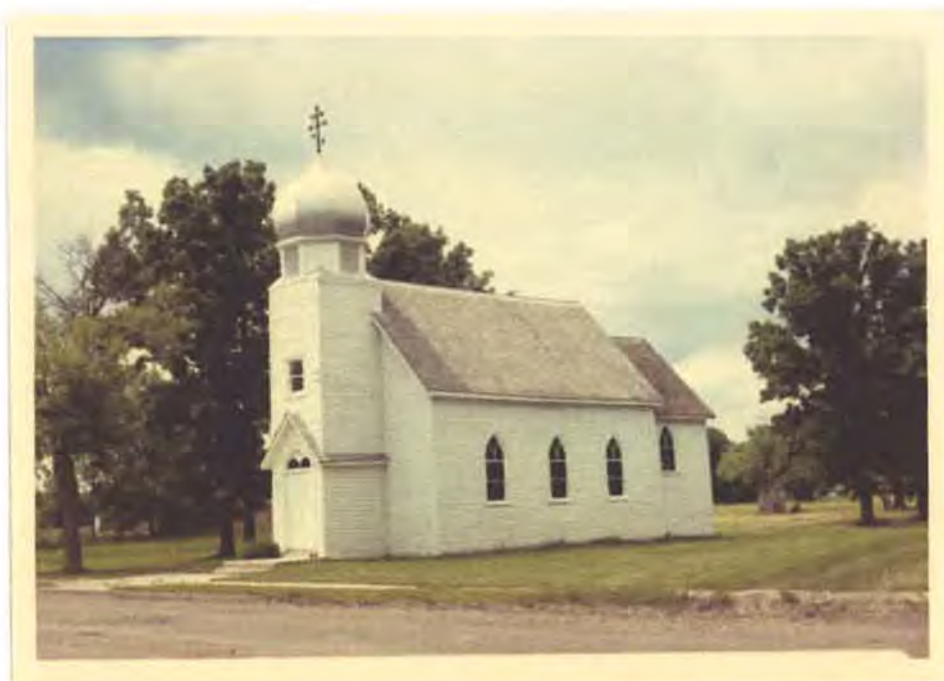
Fig. 9: Historic photo of Ukrainian Orthodox Church of St. John, ca. 195? (State Historical Society of North Dakota)

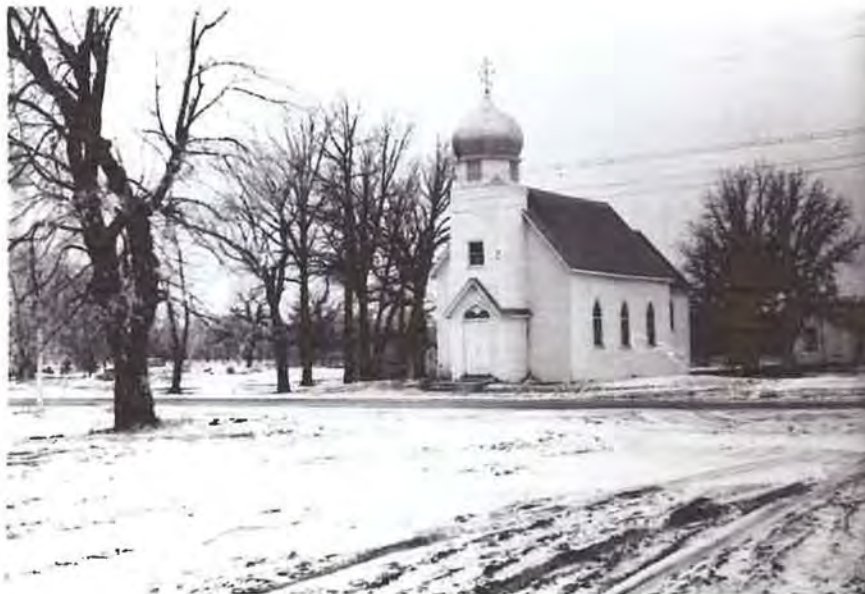
Fig. 12: Historic photo of Ukrainian Orthodox Church of St. John, ca. 1963 (courtesy of Fort Pembina Historical Society)

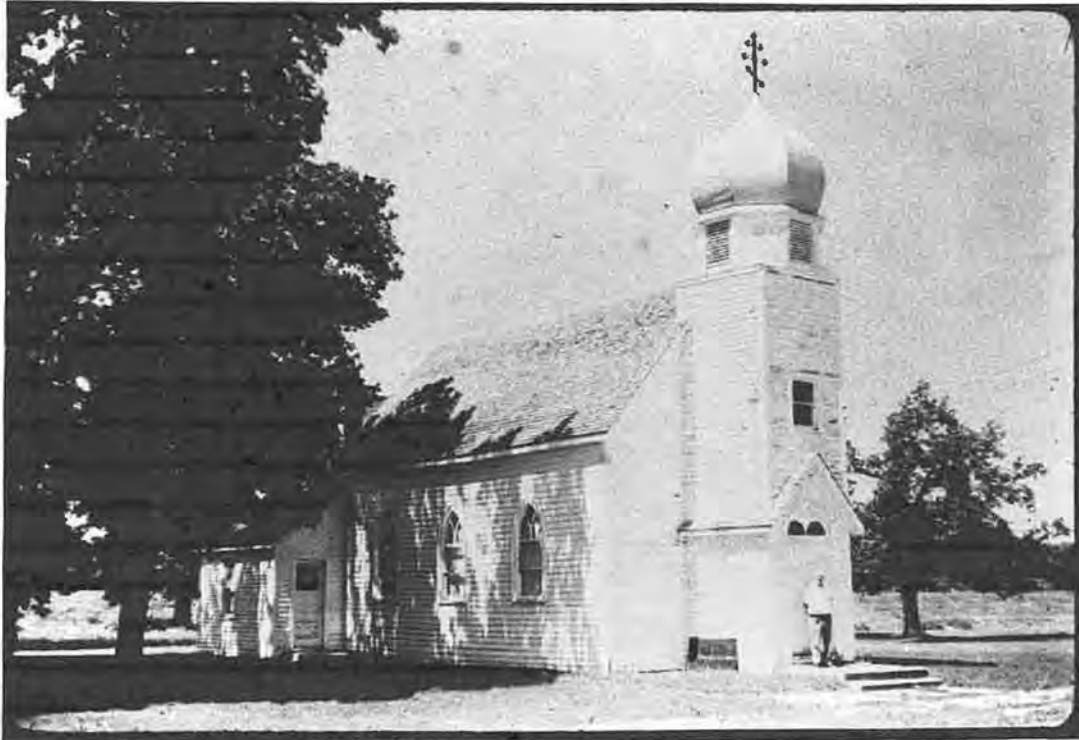
Fig. 13: Historic photo of Ukrainian Orthodox Church of St. John, ca. 1984 (courtesy of Fort Pembina Historical Society)

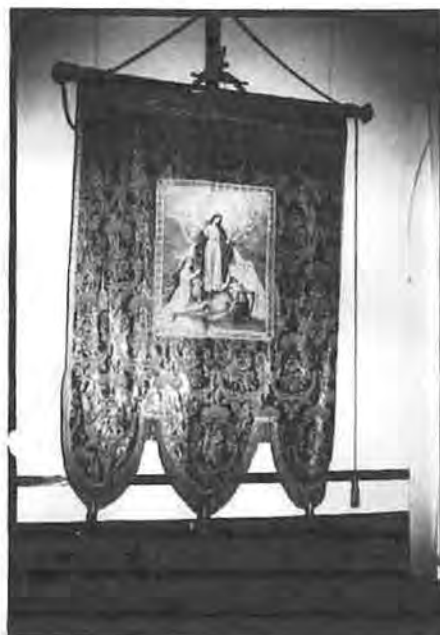
Fig. 14: Historic photo of Ukrainian Orthodox Church of St. John, interior, banner with silk brocade and oil on canvas icon, ca. 1984 (courtesy of Fort Pembina Historical Society)

In the sanctuary / nave, there are eight wooden pews and two benches as well as glass cases containing historic articles. Framed paintings of icons and tapestries hang throughout the sanctuary / nave and chancel. Embroidered linens, banners (*Additional Documentation, Fig. 14*), a detailed wooden scaled model of a Kiev church (used as a tabernacle), and a large wooden
