National Register of Historic Places Registration Form

historic name Woman's Club of Rutherford Clubhouse

other names/site number Iviswold Stables

street & number 201 Fairview Avenue

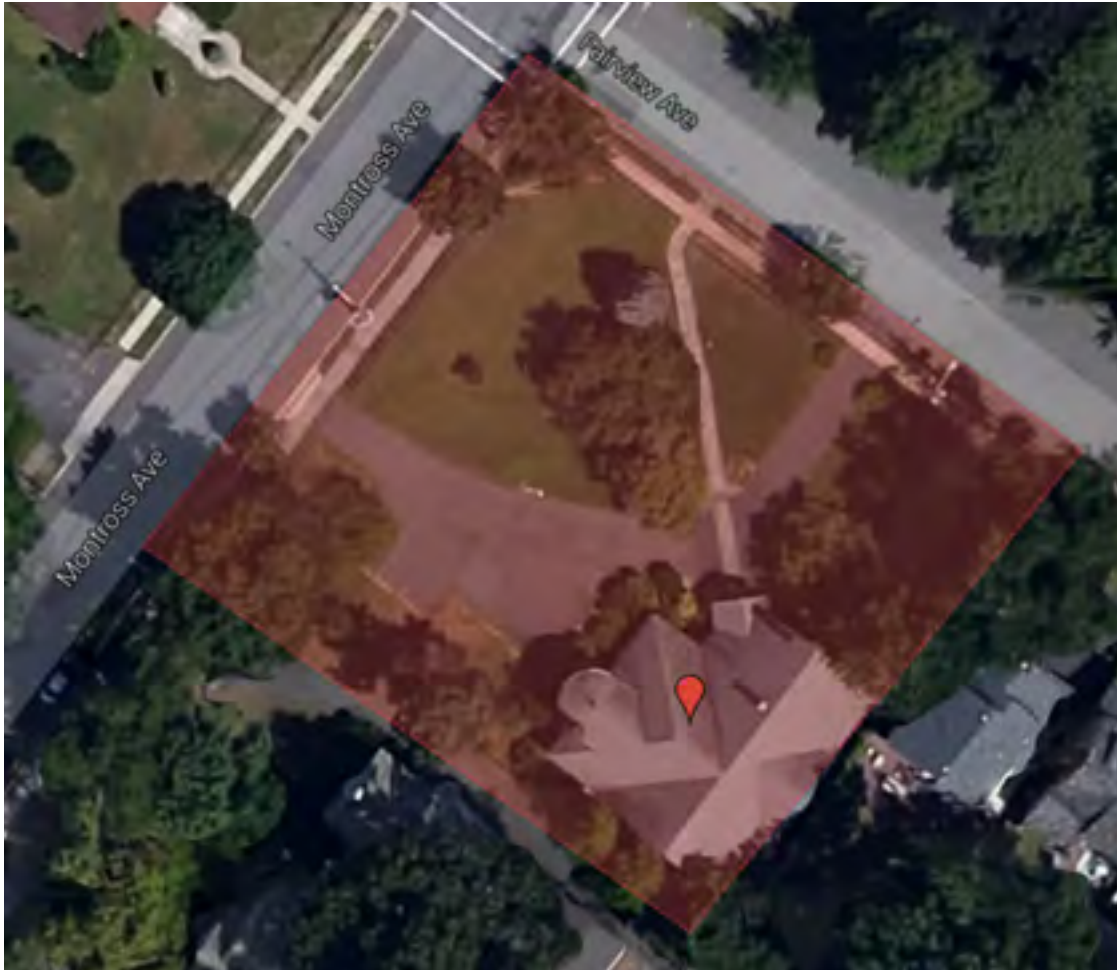
Site acreage (in red): .633 acres. Image and edit courtesy of Google Maps.

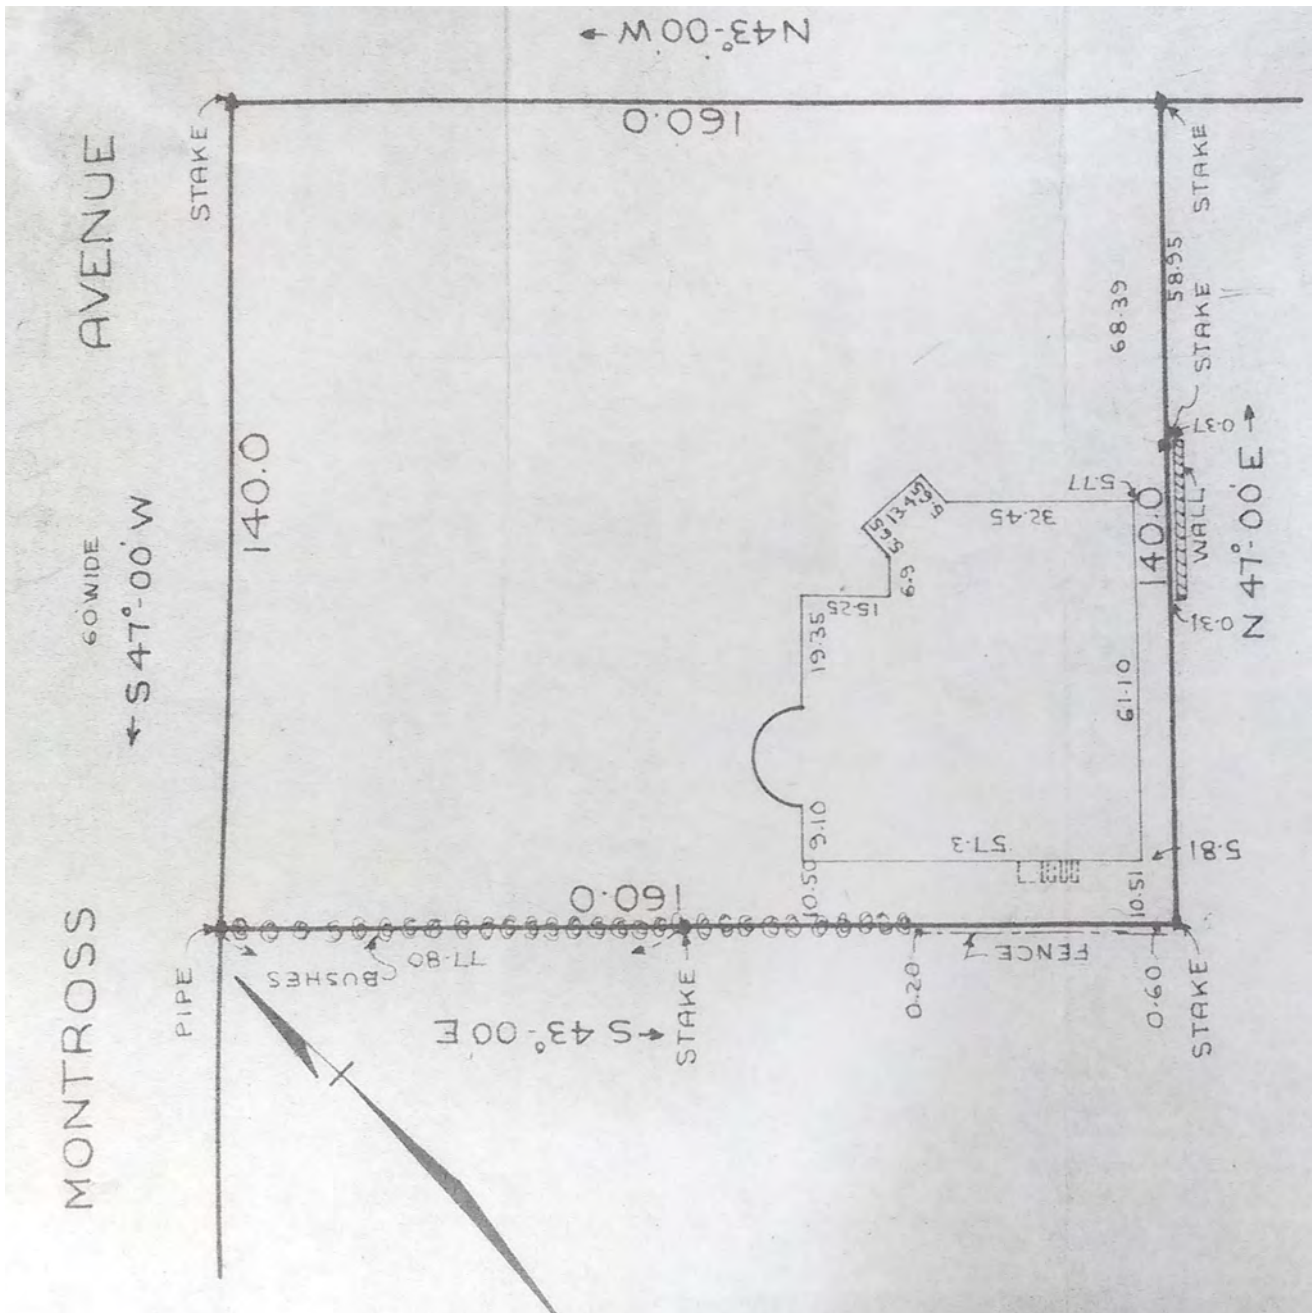
Site plan

December 1967 - Site Plan. Survey completed by Michael L. Neglia. Image not to scale.

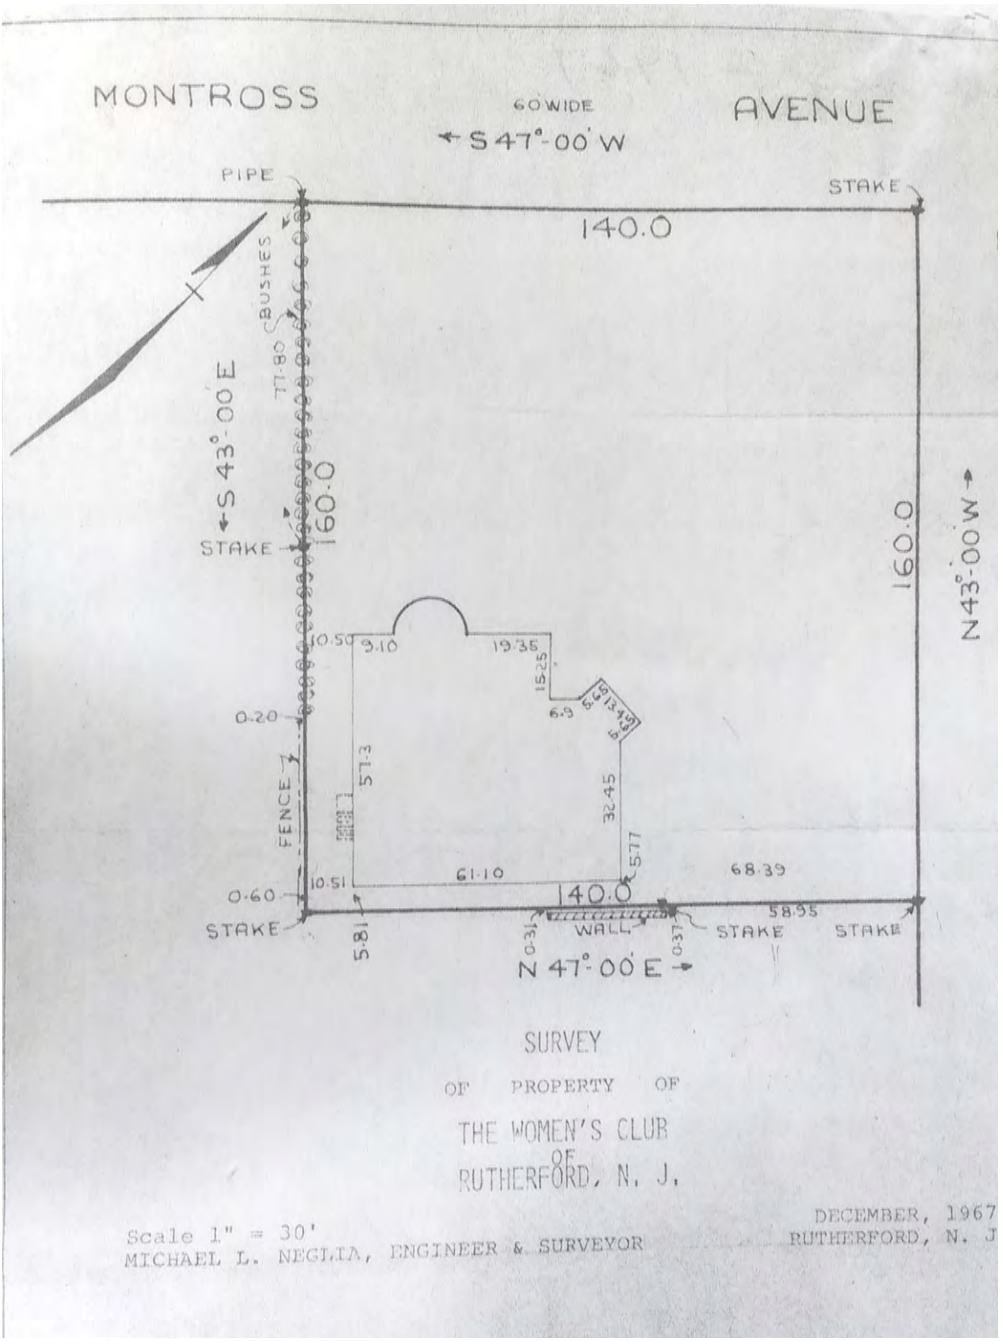
Figure 3 of 18:

Dec. 1967 - Site map of the Woman's Club of Rutherford. The site survey was carried out by Michael L. Neglia. Image courtesy of the archives of the Woman's Club of Rutherford.

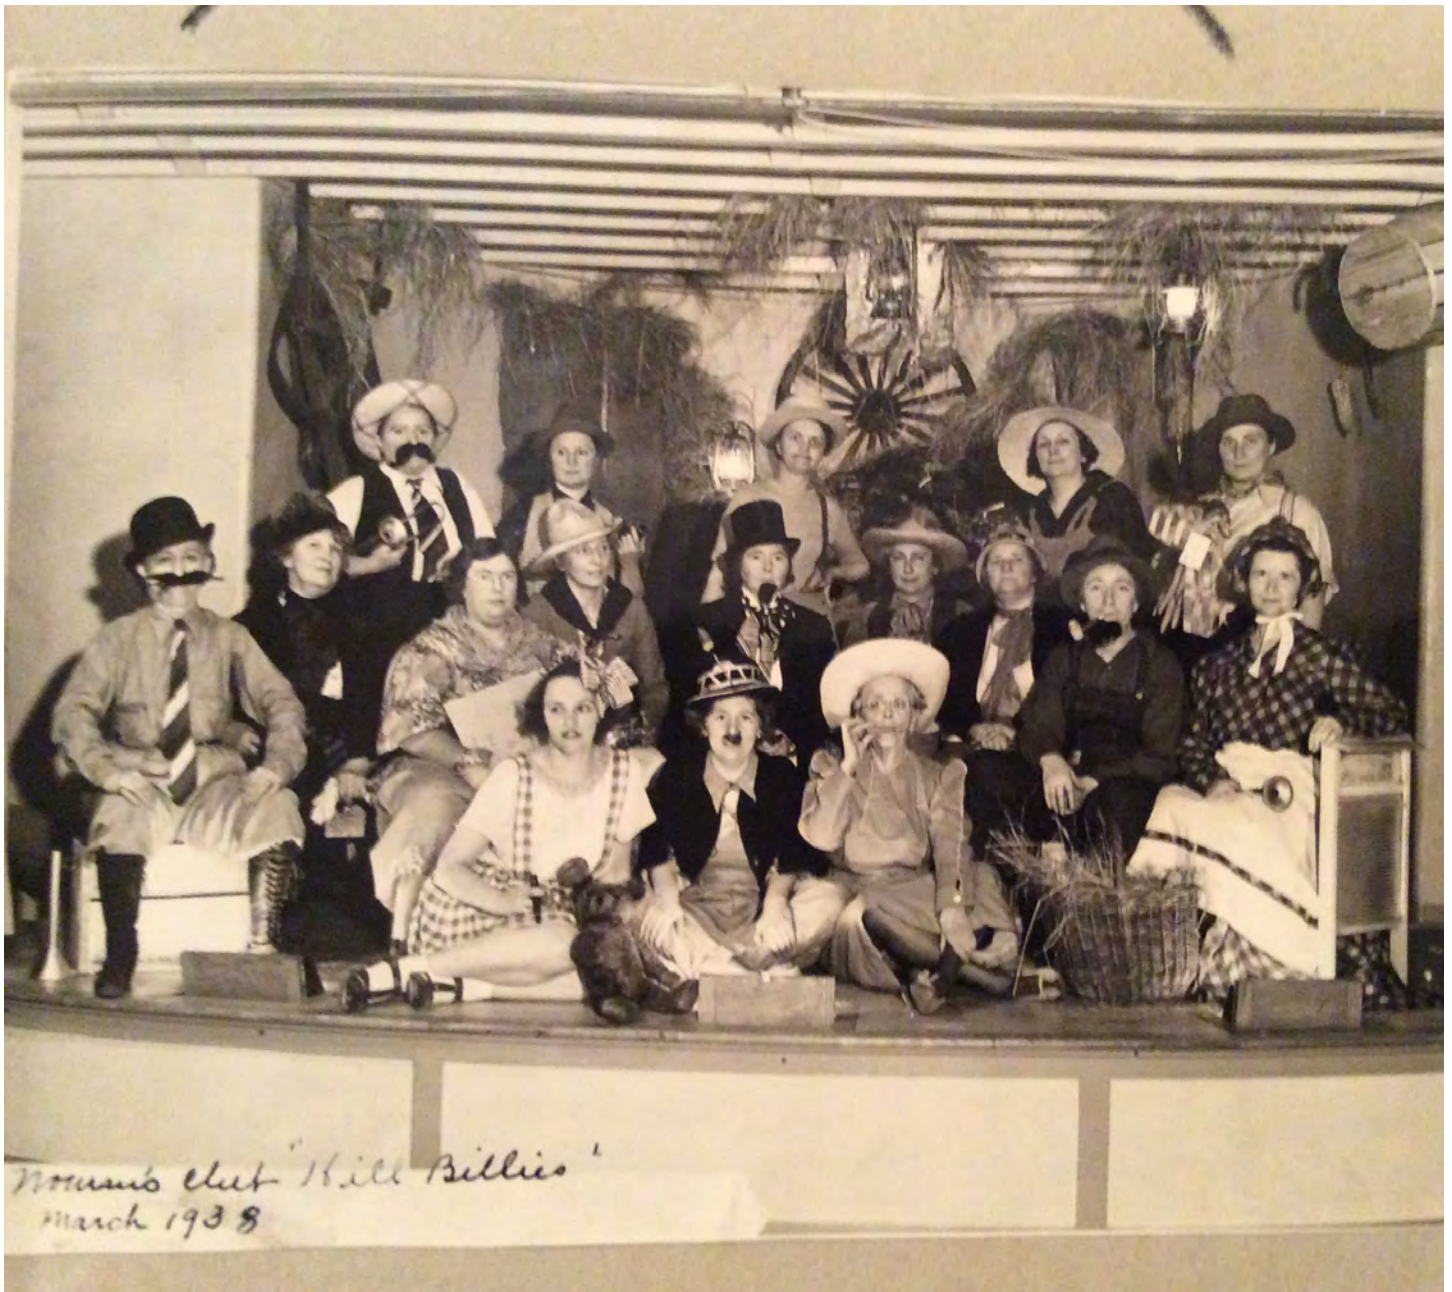
Figure 5 of 18:

Historical photograph taken of a Woman's Club production of a play, 'Hill Billies,' performed on the stage in the building's auditorium. The date on the photo is March 1938. Photograph comes courtesy of the archives of the Woman's Club of Rutherford.

Auditorium & Stage: The most significant space on the first floor is the auditorium (Photograph 17). This is the largest space and the most heavily used. It has narrow wood floorboards, and painted, rough cast plaster exterior walls pierced with pairs of hopper windows on the south and east walls. There is a dropped 2x4 ceiling with recessed fluorescent lights, and above this ceiling are exposed wood floor joists supporting the second floor boards with cross bracing between the framing members (Figure 6). The exposed beams that support the floor joists may have sub-divided the space into two: one space to the east for the stables and one space to the west for the storage of carriages. The plan shows the location of cast iron columns, which may have formed the access between stable stalls. The piers on the north and south wall with the beam above may have been a wall dividing the two spaces (Figure 13). The west end of the auditorium has a stage platform raised approximately 3 feet off the

The original footprint of the building has not been modified. However, there have been a few physical modifications to the building exterior since its original construction as a carriage house and stable. This includes the addition of an egress door on the East Elevation, infill of the large opening on the South Elevation, the replacement of wood windows with metal windows, especially on the second floor, the cladding of the exterior gables with metal clapboard to conceal the half timber and pebbledash finishes, and alterations to the basement access entrance with the removal of a pitched roof. The interior was substantially modified and adapted for use by the Woman's Club when it was purchased in 1924. However, there is still some significant evidence above ceilings, of early framing members that appear to have been painted and left exposed during the early period of the Woman's Club (Figure 5).

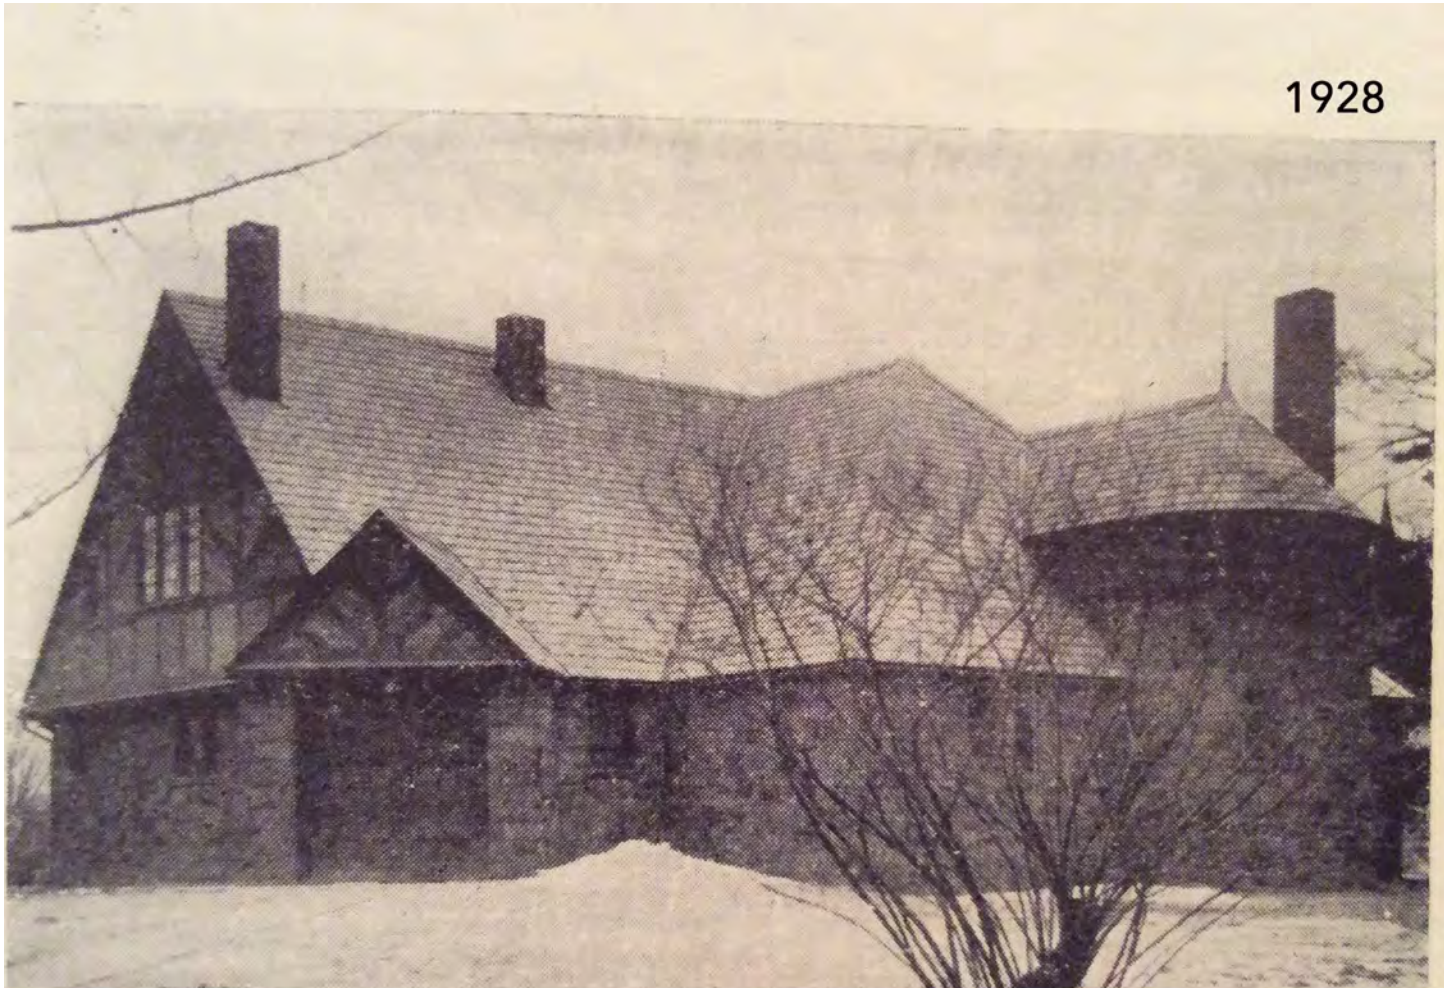
Figure 7 of 18:

1928 – This photo of the Woman’s Club building shows how much it has changed over the decades. It shows a facade of pebble-dash and exposed timbers, none of which remains visible today. None of the metal siding that covers the facade at the second floor level has been installed, and no foliage grows at the foot of the walls. Carriage tracks are faintly visible leading to the front door at bottom left. Image courtesy of the archives of the Woman’s Club of Rutherford.

The building retains integrity of design, materials, and workmanship from its original 1887 construction, especially on the exterior. Probe investigations under the metal siding have uncovered the pebbledash pink stucco and half timbers on the gable above the entrance. The three large gables appear to have had the pebbledash stucco and half timbers removed and replaced with horizontal wood siding with a rough face painted finish and beveled edge detail (Photograph 28). The wood siding was then clad in metal siding that remains today. Both these cladding systems were added after the period of significance. The wood brackets at the East Entrance Porch and the supporting projecting gable walls are also intact under the metal cladding (Photographs 29 & 30). Other original exterior features include the brownstone and pink-colored mortar, the decorative metal fencing and finial on the conical roof, as well as the fine lead work in the windows. All of these materials are also found on Iviswold Castle further substantiating the period of construction and confirming the architect William H. Miller's involvement in the design. There is an opportunity to preserve and expose many of the original finishes that would strengthen the integrity of design of the exterior and could potentially restore it largely to its ca.1924 appearance when it was purchased by the Woman's Club of Rutherford and converted into a clubhouse for their use (Figure 8). Without a description of the scope of the alterations that Williams designed for the Club, it is difficult to fully evaluate the integrity of the interior for the period of significance. From the evidence of material finishes, however, it is clear that the auditorium and stage remain largely as they were built in the 1920s. It is also clear that the other rooms had few significant changes since the building was converted to the Woman's Club of Rutherford. While it is difficult to discern the precise design of the interior conversion of the other second-floor spaces, it may well be that they did not greatly alter them from their previous use as accommodations for the stable staff.

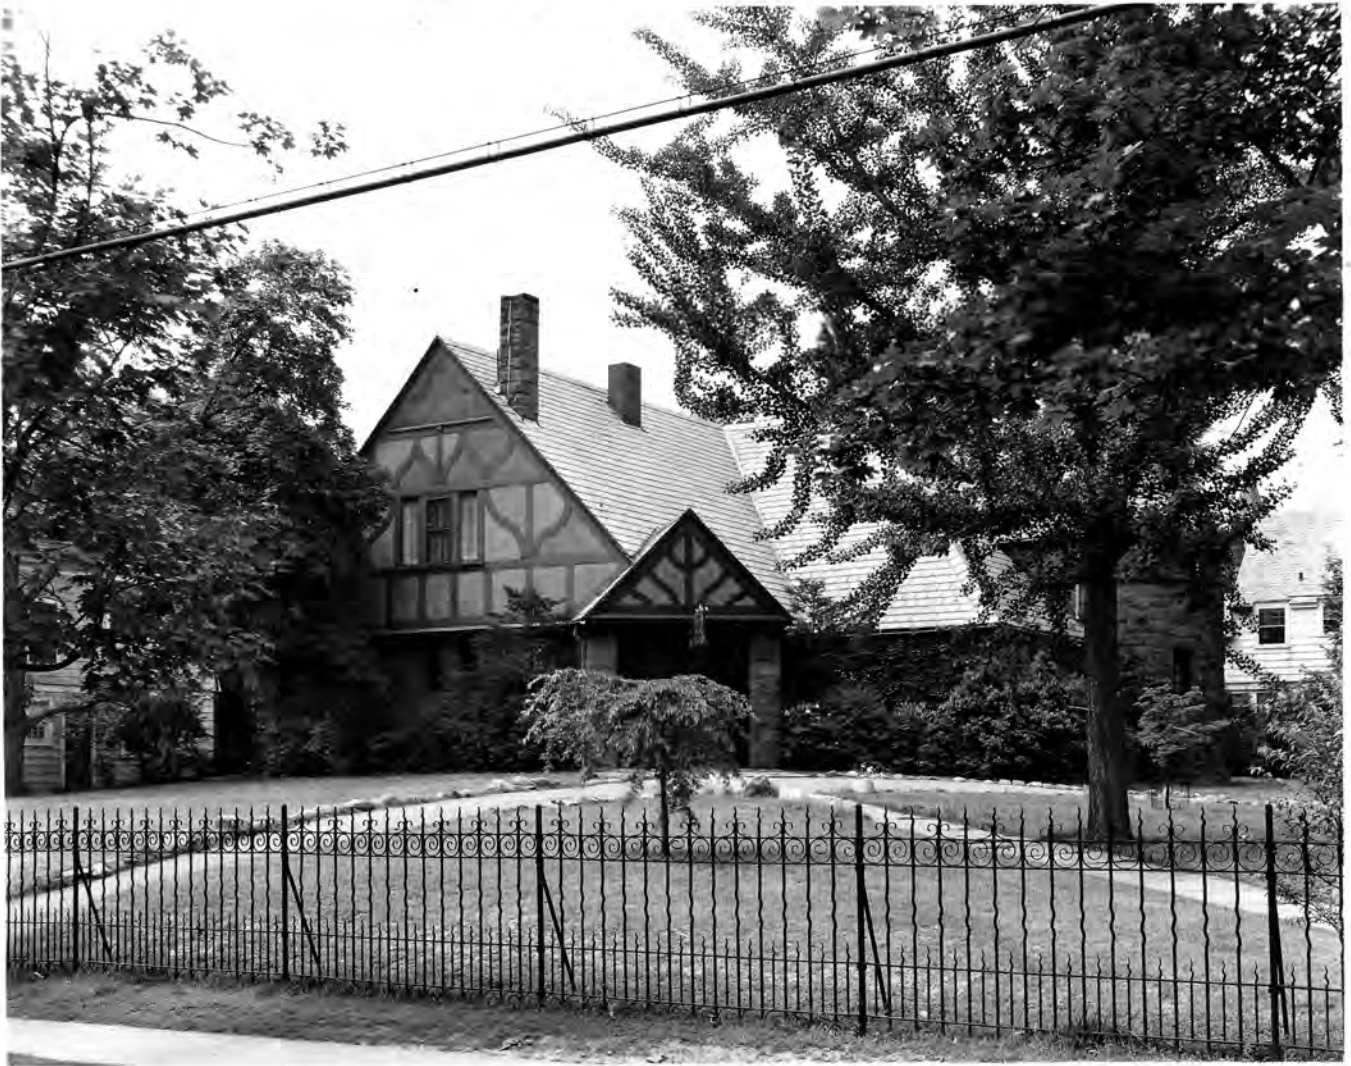
Figure 8 of 18:

1949 - This photo of the Woman's Club Building shows the beginning of the use of metal siding to cover the exterior at the second-floor-level and higher. It has been used to cover the original exterior under the gable facing the photographer. Foliage has been allowed to grow next to the building and new footpaths connect it to the street. Image courtesy of the archives of the Woman's Club of Rutherford.

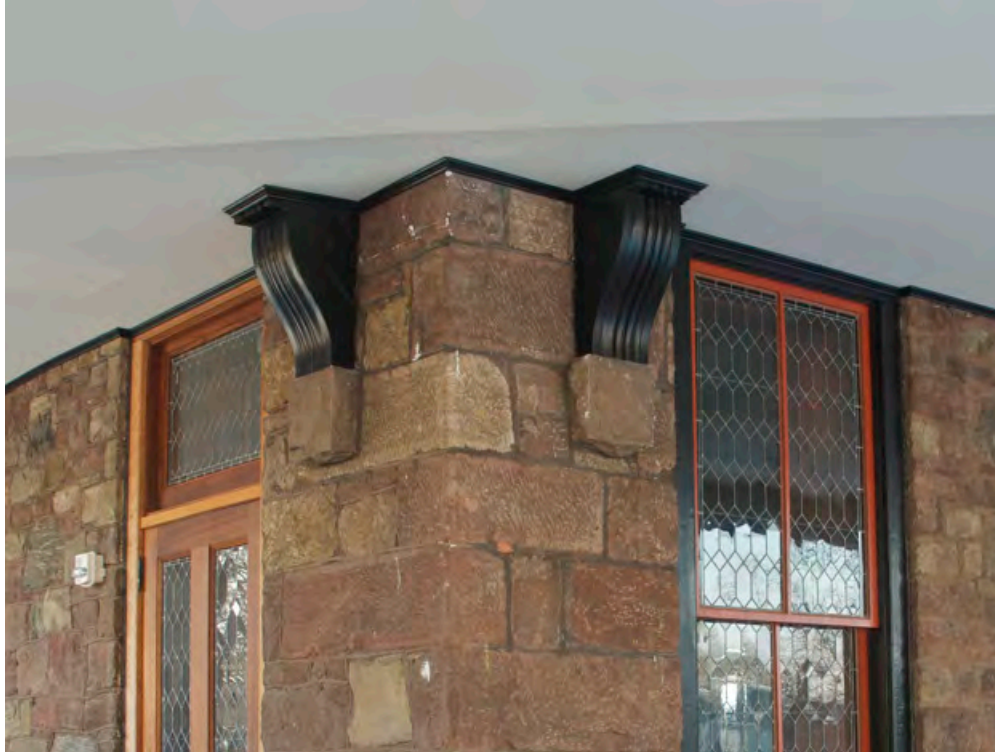
Figure 14 of 18:

2013 - This image shows the wooden brackets used on the exterior of Iviswold Castle, here applied at the corner of the building at its piazza. The same style and make of bracket were used in the construction of Iviswold Stables, but have since been covered by contemporary metal siding. Photograph courtesy of Historic Building Architects.

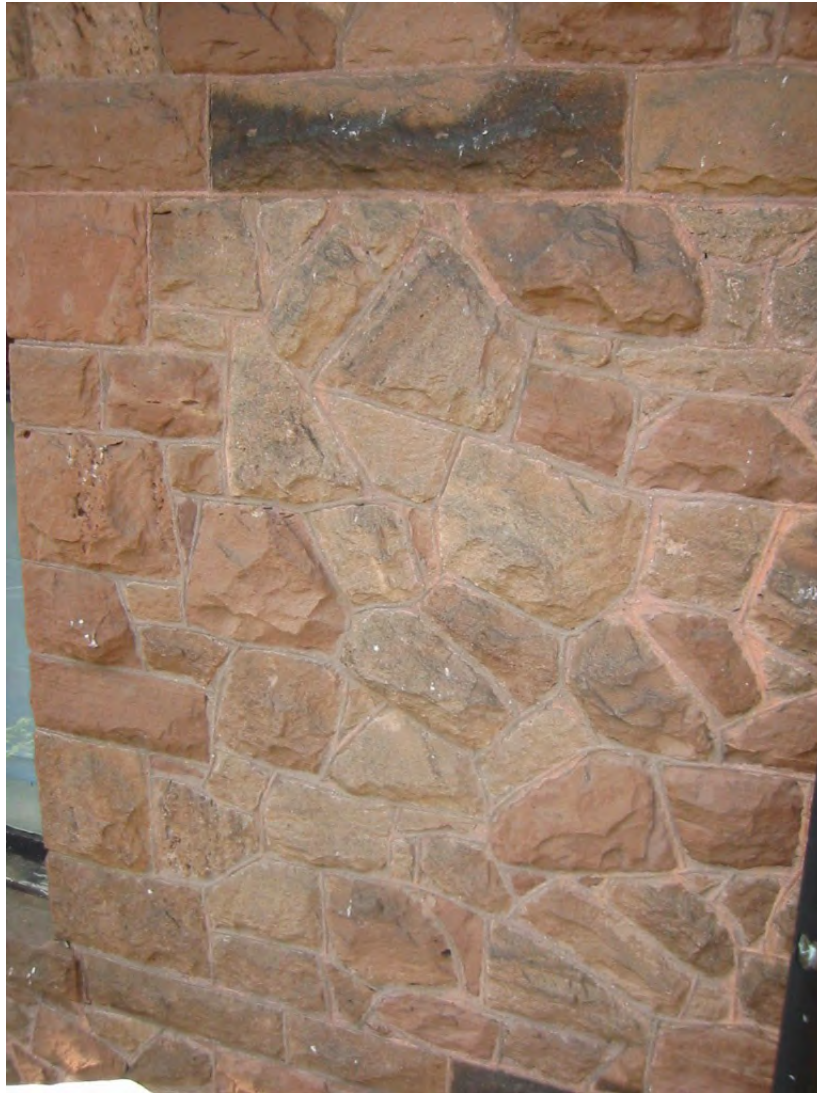
Figure 15 of 18:

2004 - The brownstone masonry used in the expansion of Iviswold Castle, which was accomplished by architect Edgar I. Williams, is the same stone that comprises the exterior of the Woman's Club of Rutherford. The stone was quarried from the same source and suffers from similar patterns of surface staining due to biological growth and parging due to trapped moisture. The stone wall depicted is from Iviswold Castle. Its color is somewhat lighter than typical stone masonry from the Woman's Club, as it had been cleaned at the time at which the photograph to be taken. Image courtesy of Historic Building Architects.

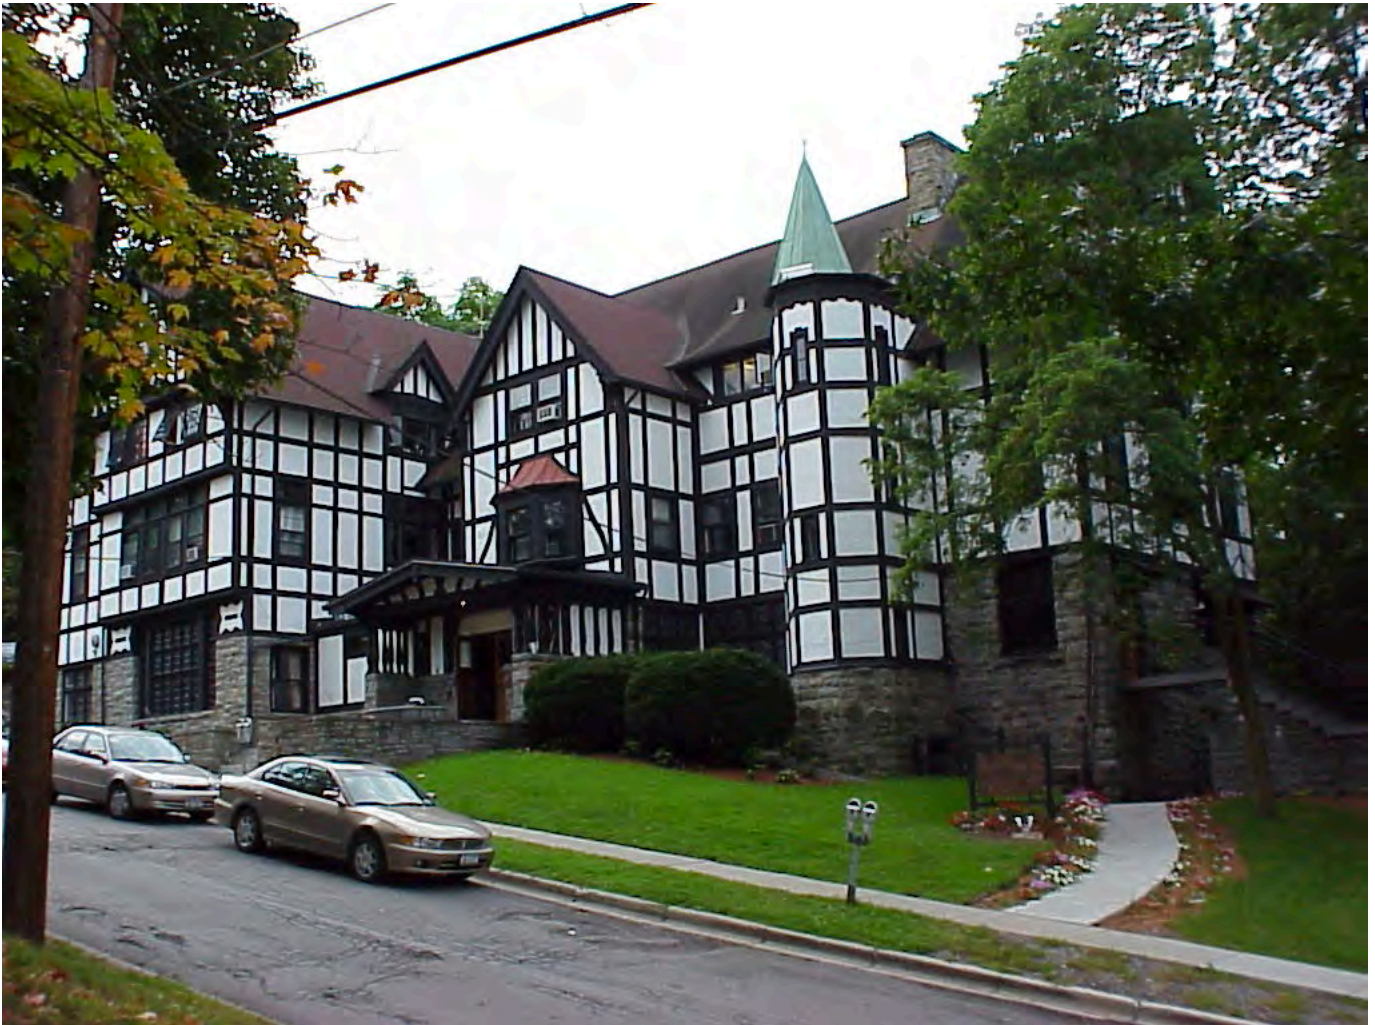
Figure 16 of 18:

William Henry Miller designed an expansive Tudor mansion at 107 Edgemoor Lane in Ithaca that would become the home of the Cornell chapter of the Chi Phi fraternity. Built in 1890, the structure is an example of the architect's early use of a Tudor-inflected style. Information and image from Cornell University - Infrastructure, Properties, and Planning: http://www.fs.cornell.edu/fs/facinfo/fs_facilinfo.cfm?facil_cd=4716.

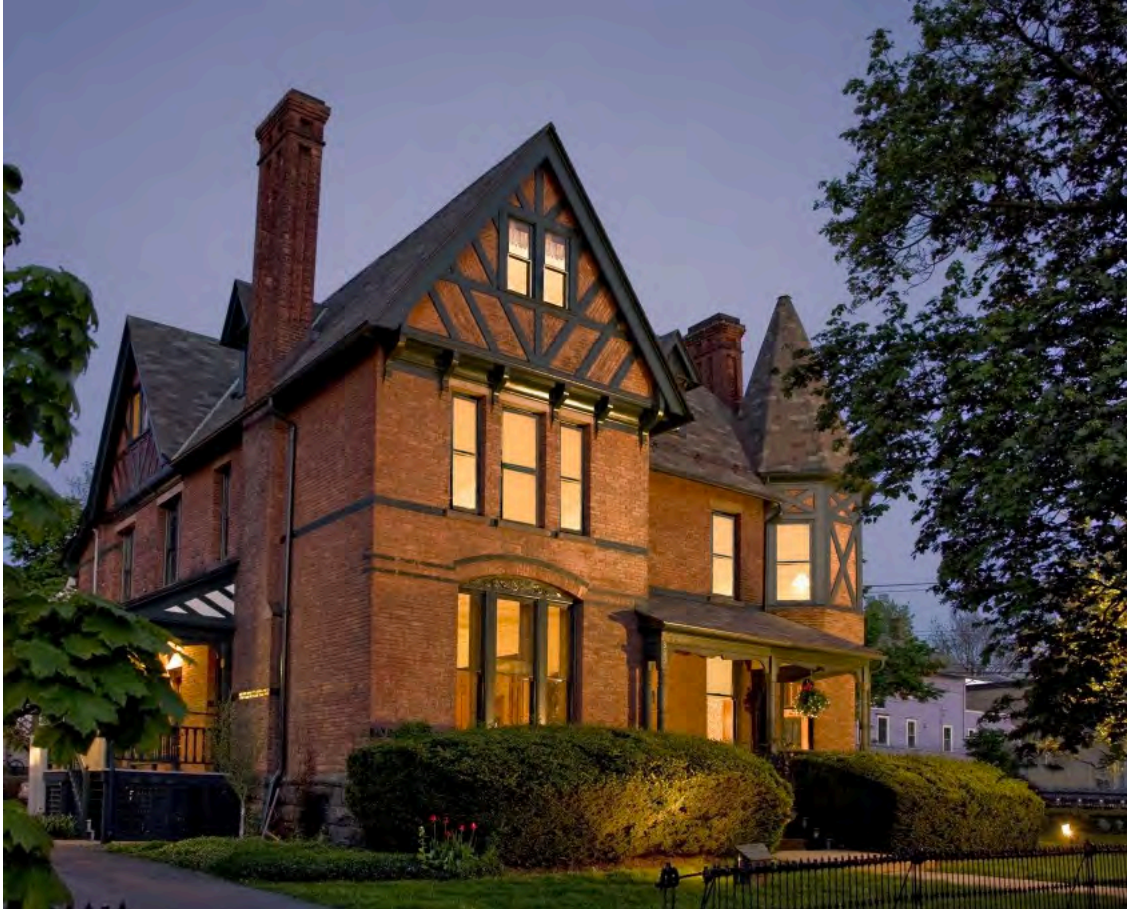
Figure 17 of 18:

In 1878, the Stowell family of Ithaca, NY, commissioned William Henry Miller to design and build their house, which they would occupy until 1914. The house uses Tudor exposed timber work as well as decorative brick coursing, along with Miller's typical asymmetrical elevations. Today, the building is a bed and breakfast: the William Henry Miller Inn. Information and image from: The Miller Inn (home page: <http://millerinn.com/>) and The Miller Inn (about <http://millerinn.com/about/>).
