**NATIONAL REGISTER OF HISTORIC PLACES
PROPERTY PHOTOGRAPH FORM**

Jack Thomas House

The Gardner Place

Leitchfield

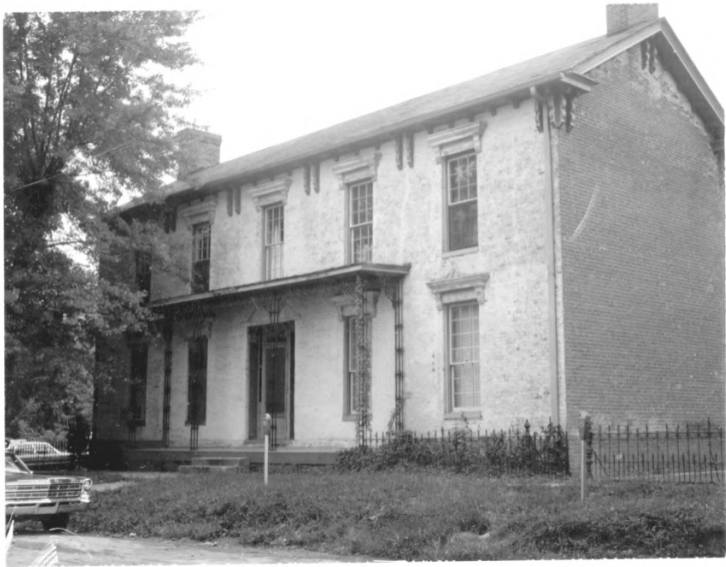
PHOTO NO. 1 of 3

View of the north front of the house from the northwest. The openings were lengthened, hoodmolds applied, the cornice raised and bracketed, and the castiron porch and fence added in the last quarter of the 19th century.

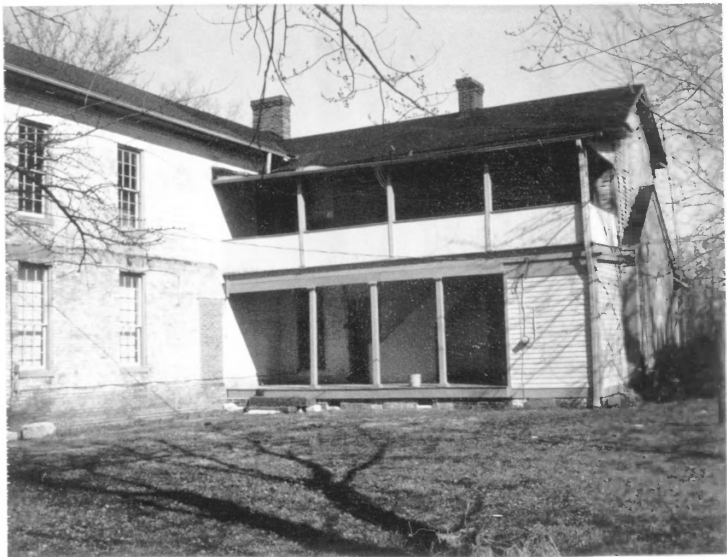
PHOTO NO. 2 of 3

View from the southwest showing the main block at left with the bricked-up round-arched door at the rear of the central hall, and the two-story porch with enclosed staircase probably added when the house was altered in the late 19th century.

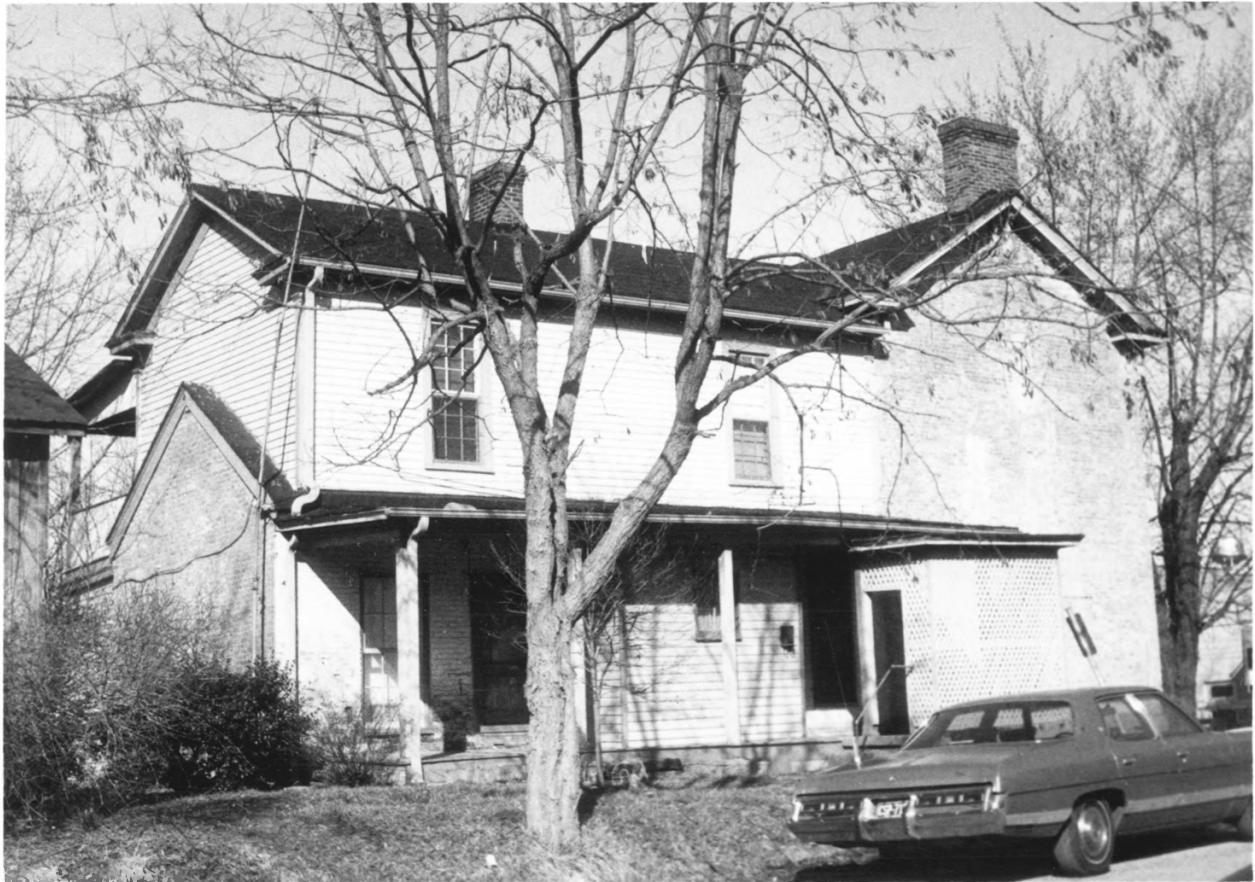
PHOTO NO. 3

View from the southeast. The brick one-story wing at left (with later frame addition above and recent additions in foreground) is thought to be the oldest part of the house. It originally faced the old road that ran along a cliff off the picture to the right. The present rear wall of the ell (at left) originally had a center chimney flanked by small "lookout windows" in the loft, and perhaps other openings now bricked up.

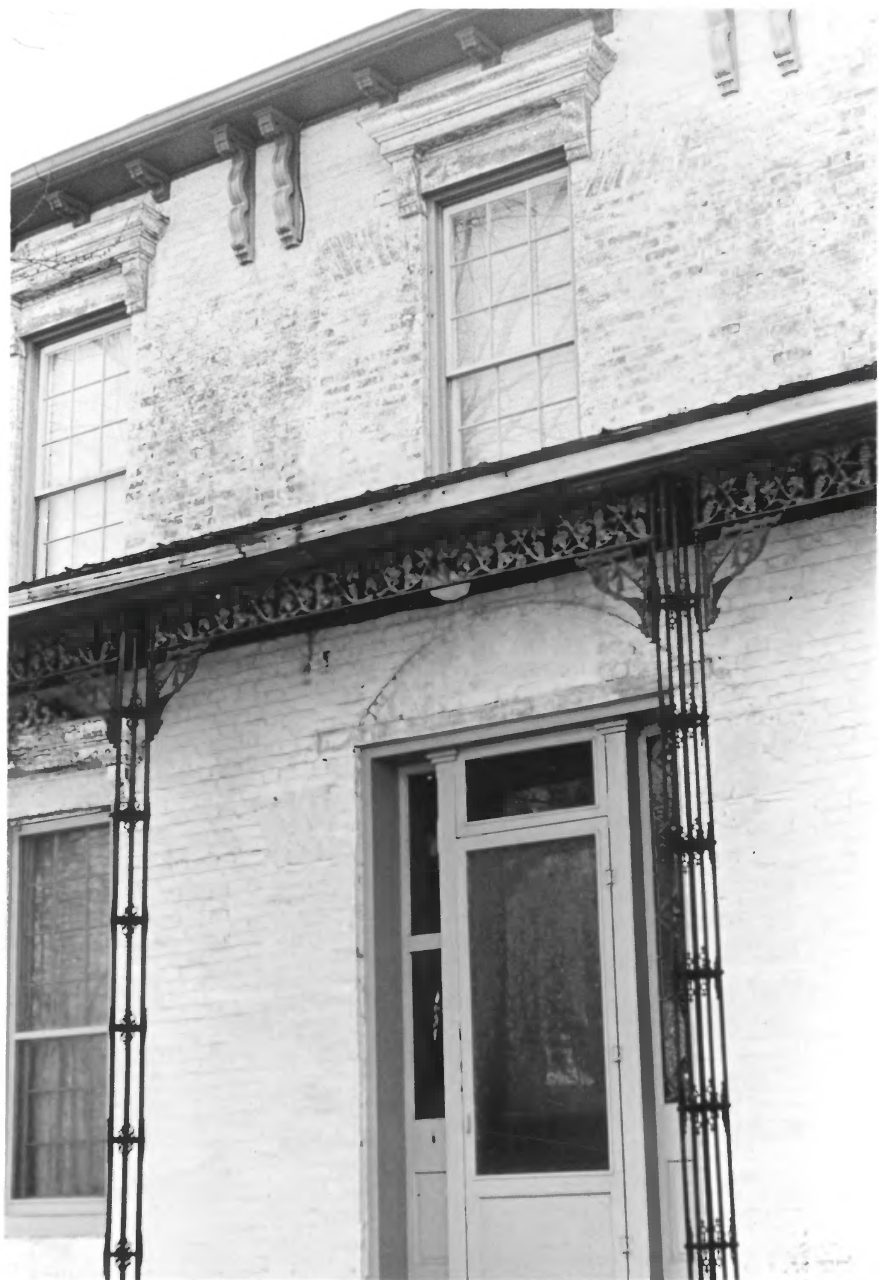
Photo 1. Center portion of north
facade showing detail of Victorian
porch and trim; remnants of
brickwork of original Palladian
windows.
